Operator: CRESTONE PEAK RESOURCES OPERATING LLC

Location Name: IONE 62N66W / NWNE/SEC 2 HZ PAD

Inspection: 709400389

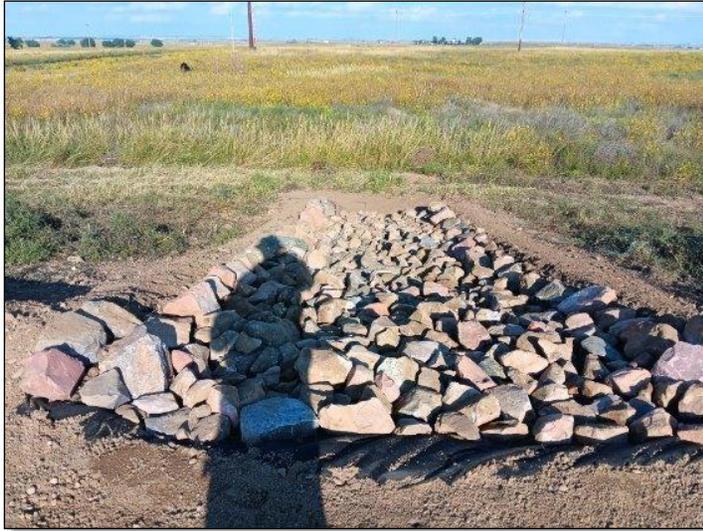
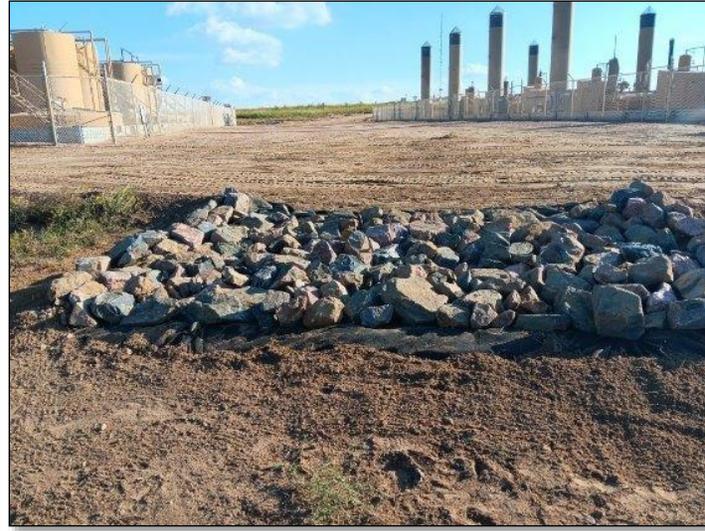
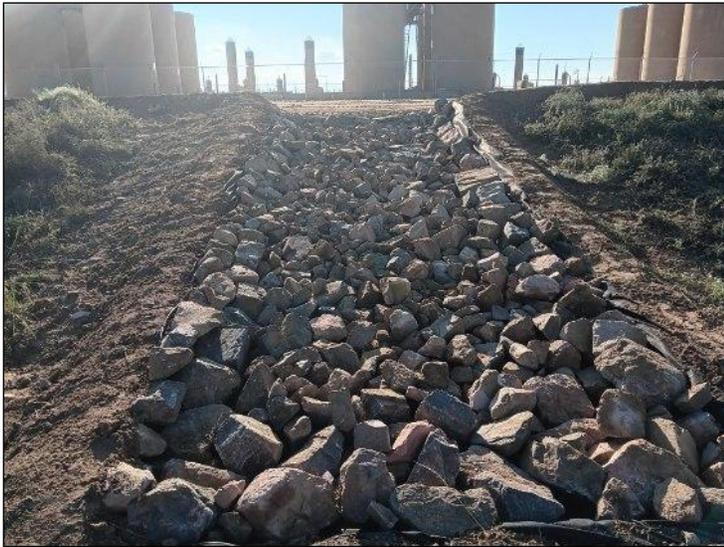
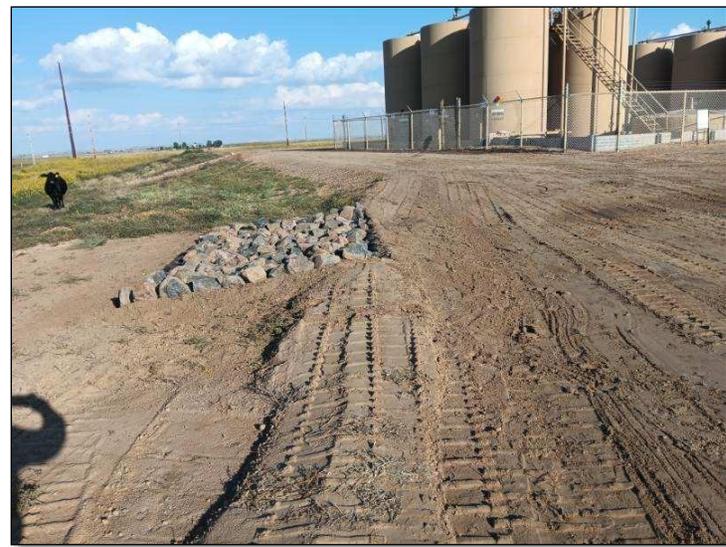
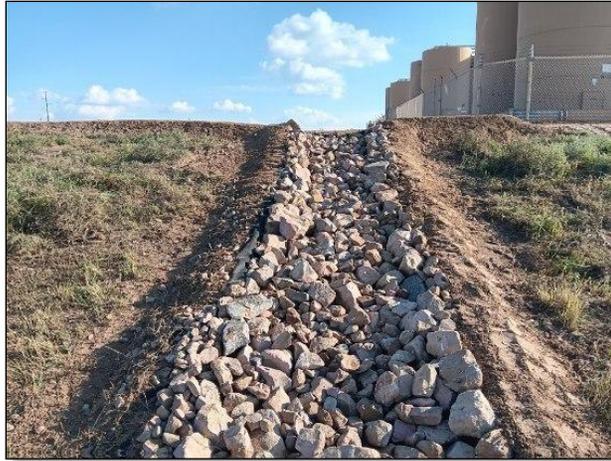
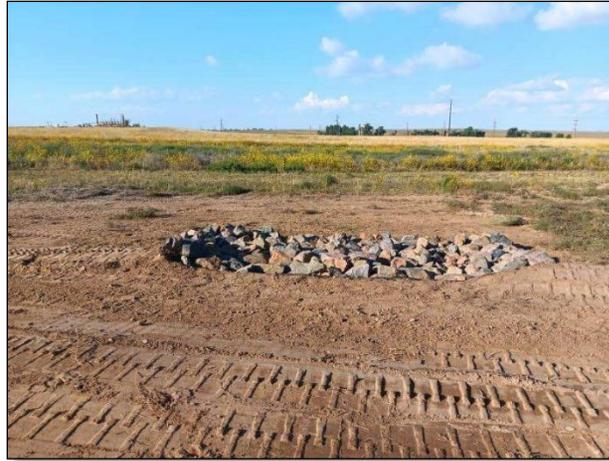
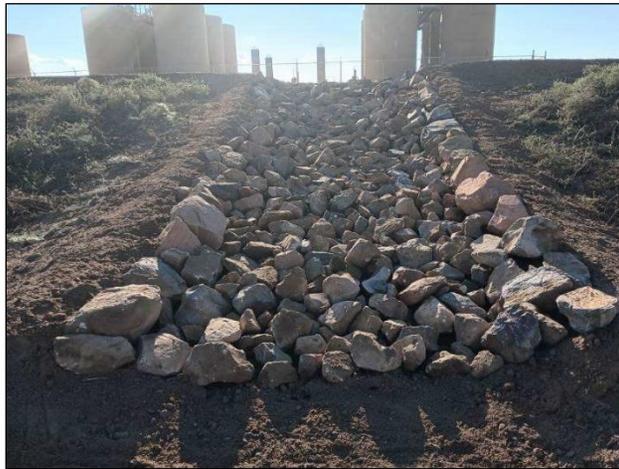
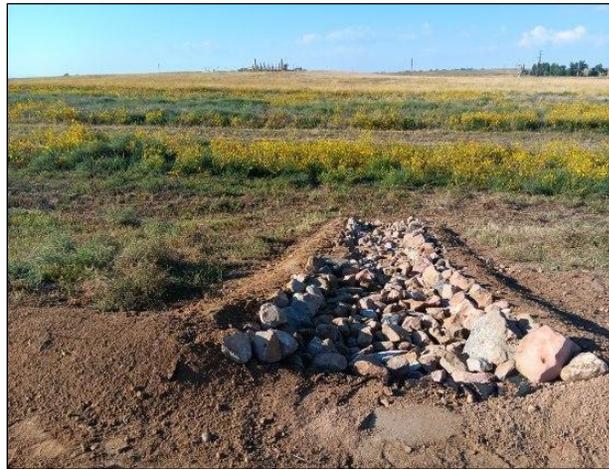
CA: Stormwater erosion onsite and on access road. Comply with Rule 1002.f.

CA Resolution: Operator has reported and provided photo evidence that the identified stormwater erosion onsite has been appropriately addressed and various areas on location have been improved to comply with Rule 1002.f.

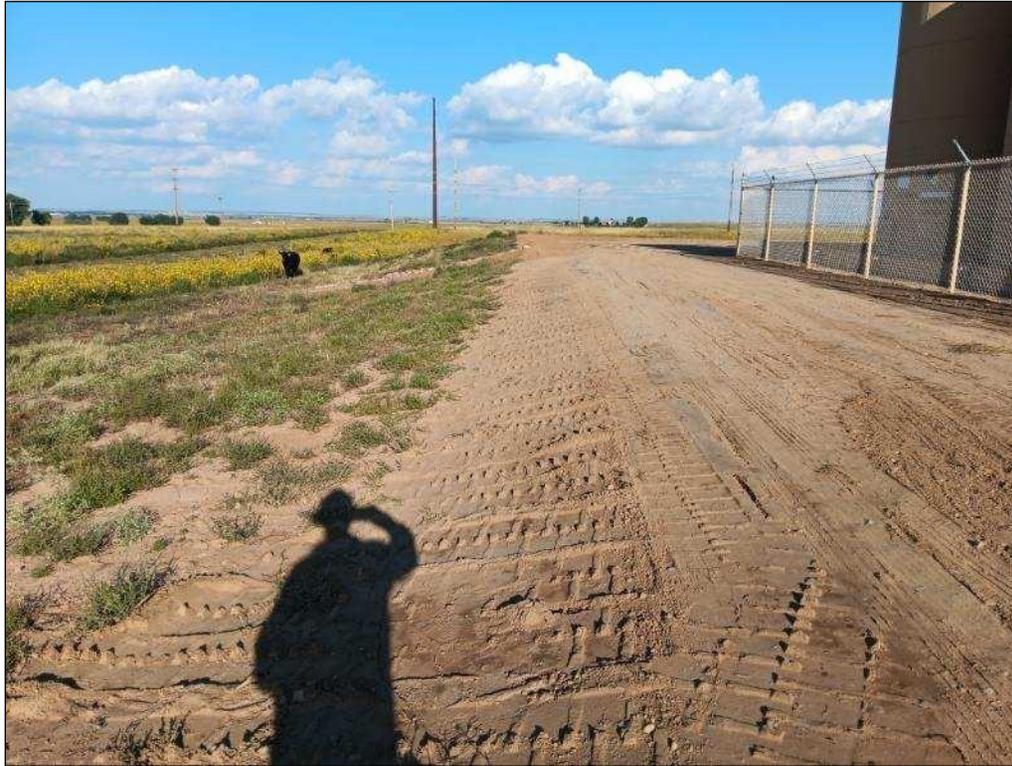
Exhibit A

CA: Failure to control and manage weeds to prevent weed waste and prevent the spread of seeds onto adjacent lands. Comply with Rule 606.c.

CA Resolution: Weeds and debris have been appropriately addressed and cleared from the location to comply with Rule 606.c.
