# Interim Reclamation and Stormwater Inspection

August 29, 2023

Operator: CCRP OPERATING INC - #10665

Inspection Photos  
Location Name: Wagner #11-65 11-1H  
Location ID: 421908

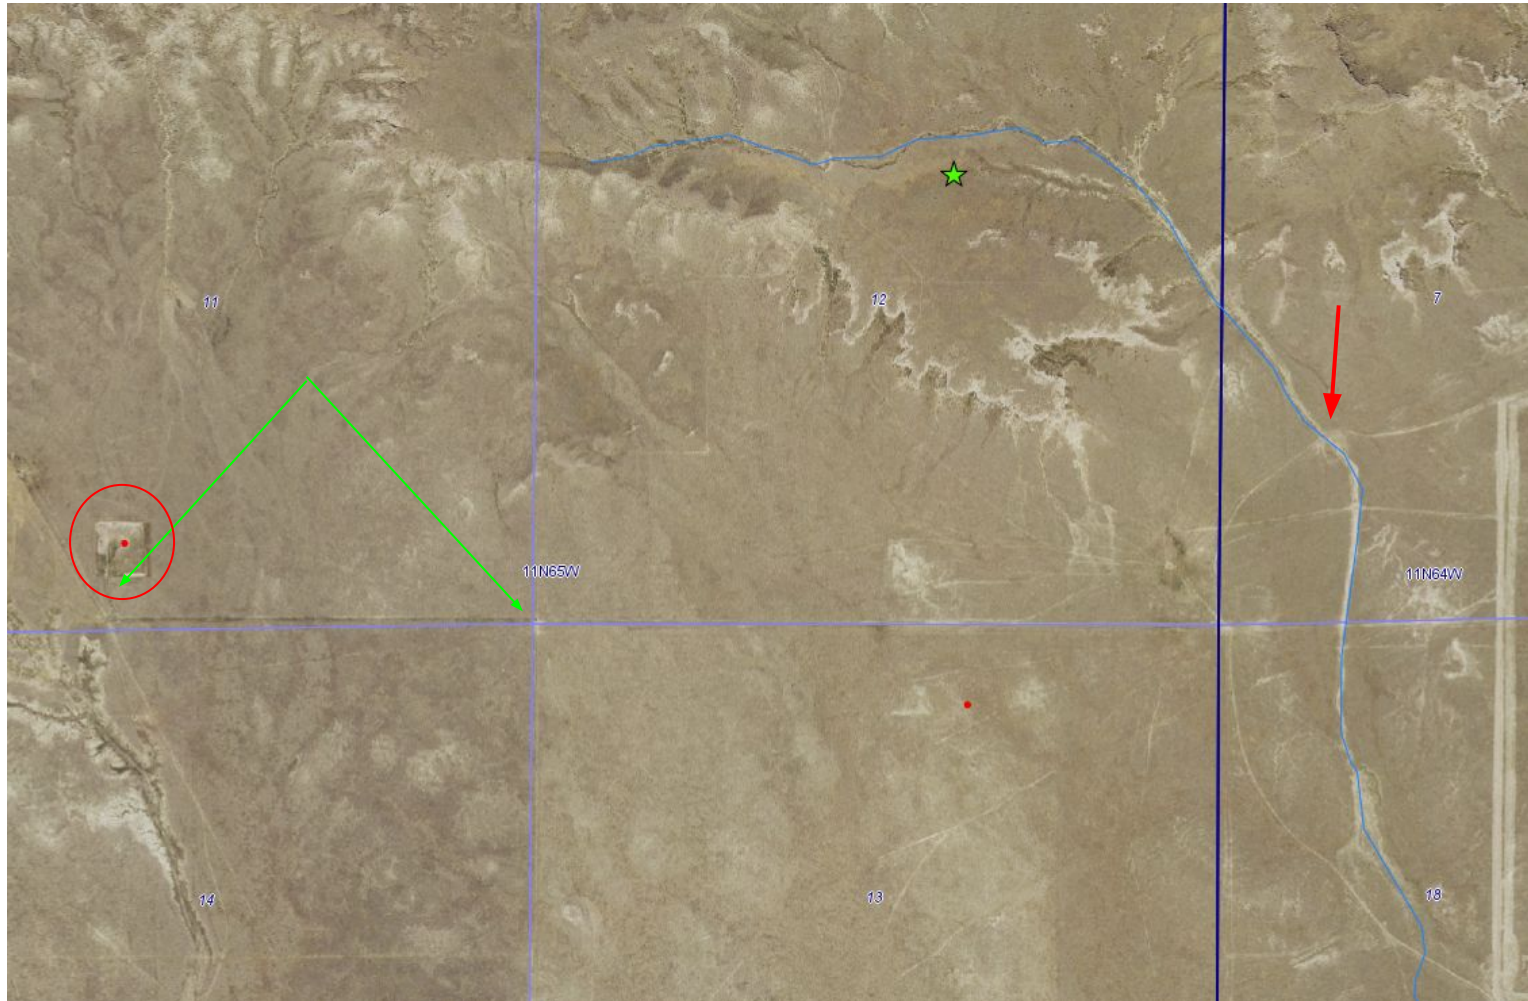
**Photo 1.** ECMC aerial imagery illustrates the associated access road and location. Red arrow points to Willow Creek with stormwater erosion issues; green arrows indicate approximate weed growth along the access road; red circle indicates the location.

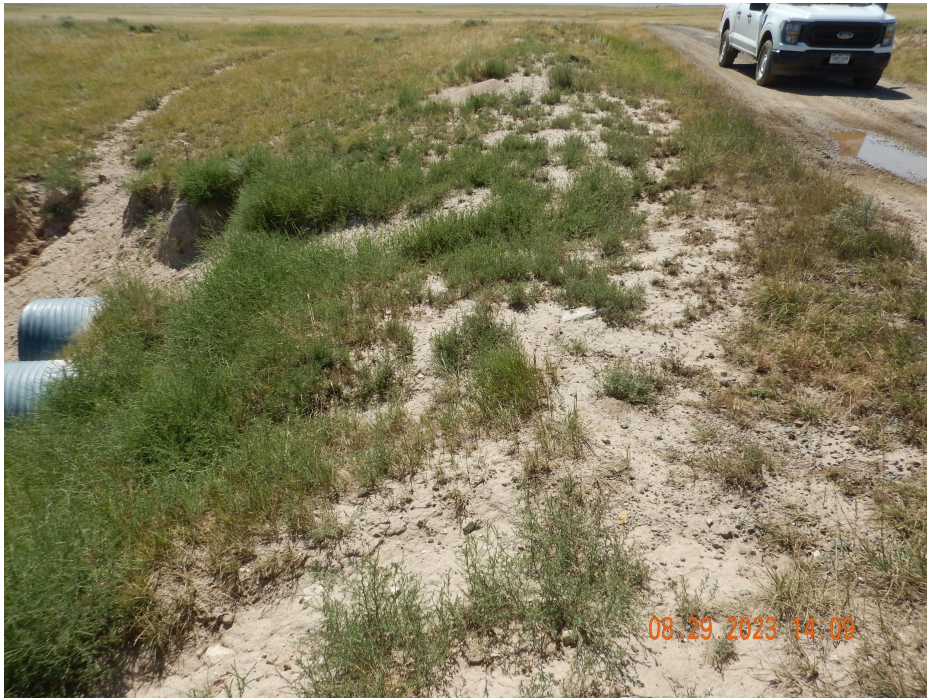
**Photo 2.** Photo taken from intersection of the access road and Willow Creek, facing West. Photo illustrates stormwater erosion is coming off the access road and causing erosion into the Willow Creek on the southern portion of the access road.

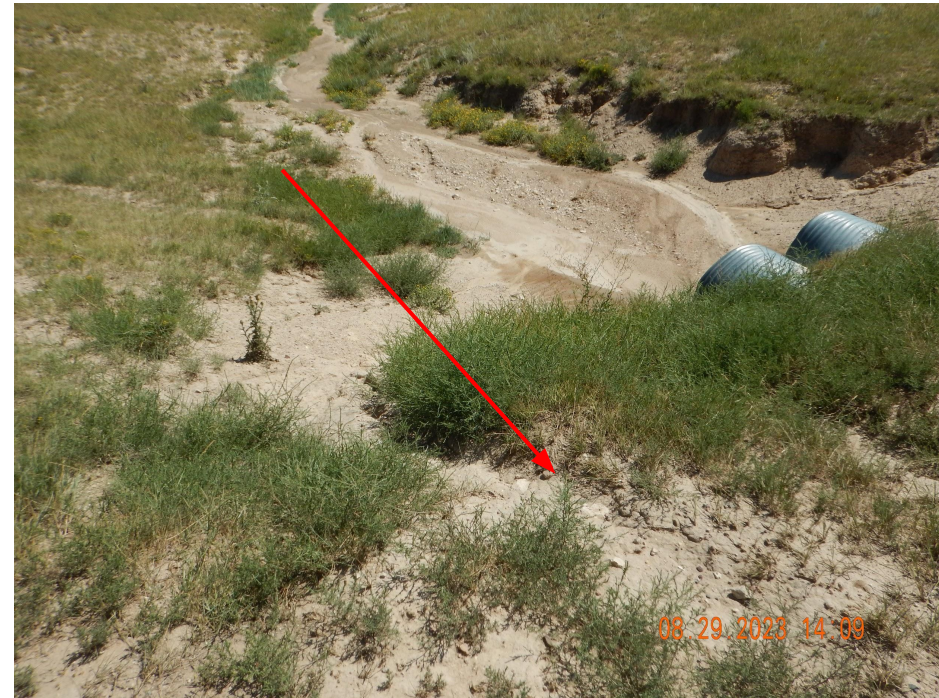
**Photo 3.** Photo taken from intersection of the access road and Willow Creek, facing South. Photo illustrates rill erosion from stormwater runoff from the access road.

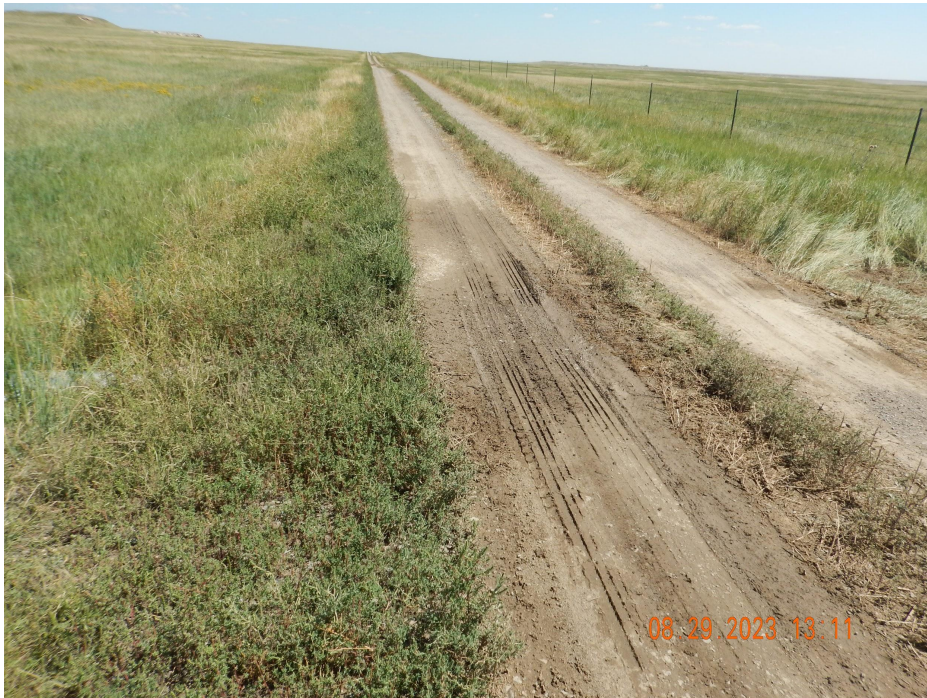
**Photo 4.** Photo taken from a portion of the access road, facing East. Photo illustrates unmanaged weeds along the access road.

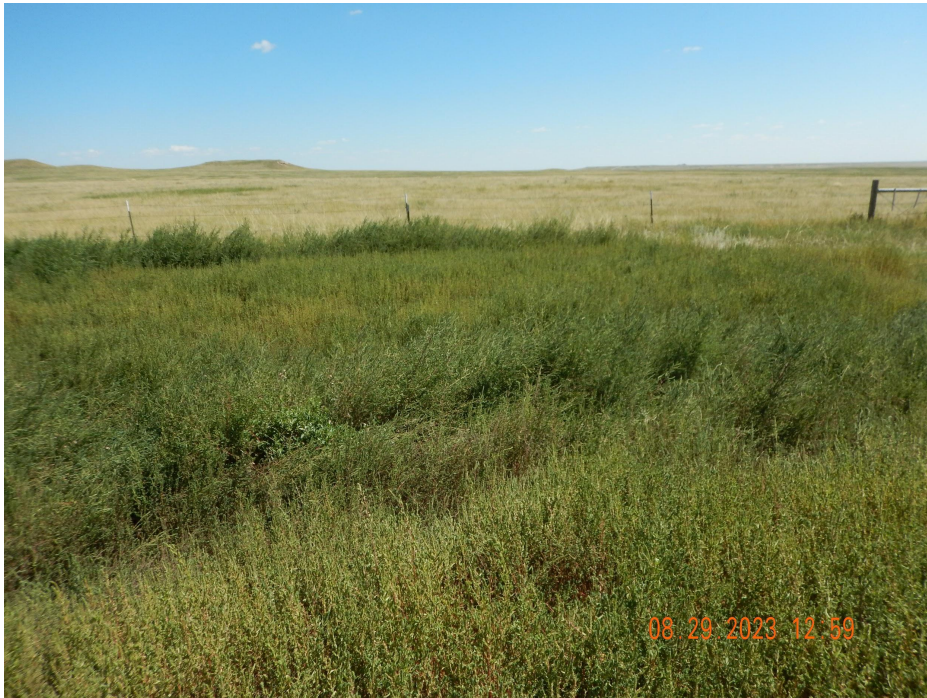
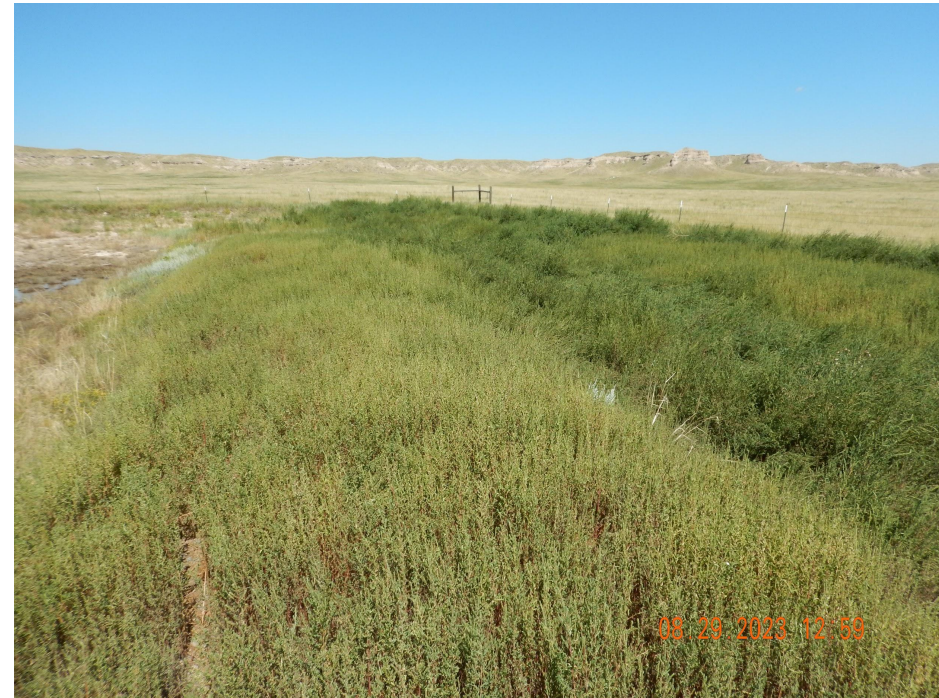
**Photo 6.** Photo taken from the northeastern location, facing Northeast. Photo illustrates unmanaged weeds.

**Photo 7.** Photo taken from the northeastern location, facing North. See comments under Photo 6.

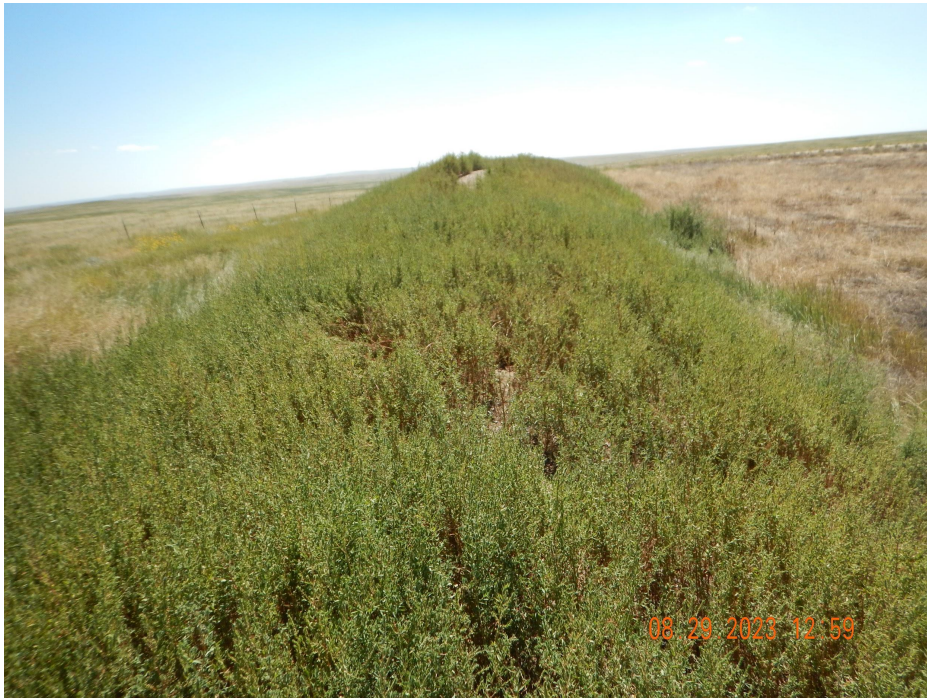
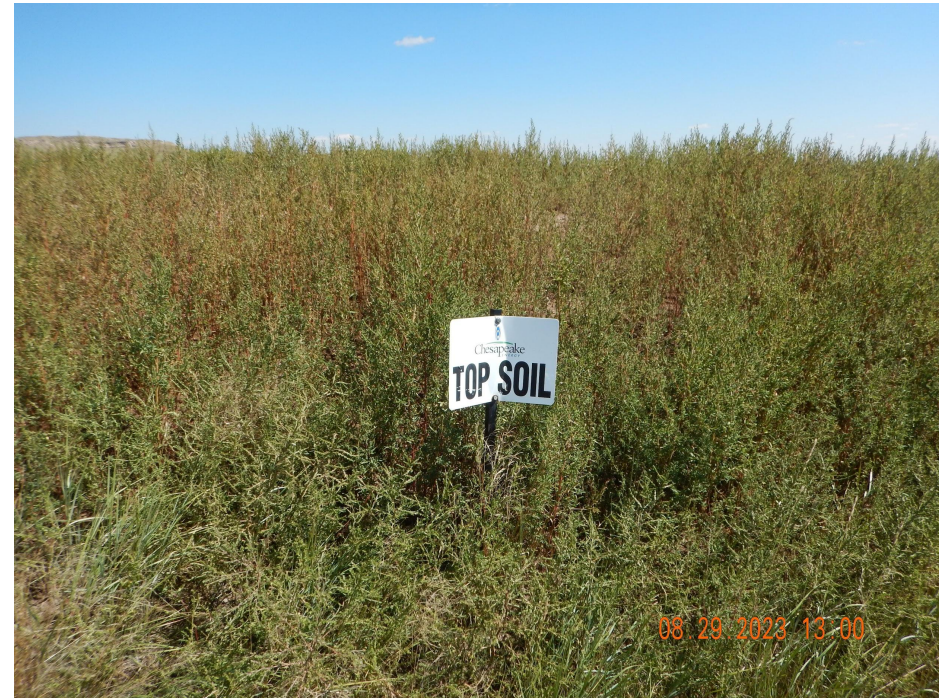
**Photo 8.** Photo taken from the eastern location, facing South. Photo illustrates unmanaged weeds on the topsoil stockpile.

**Photo 9.** Photo taken from the topsoil stockpile. See comments under Photo 8.

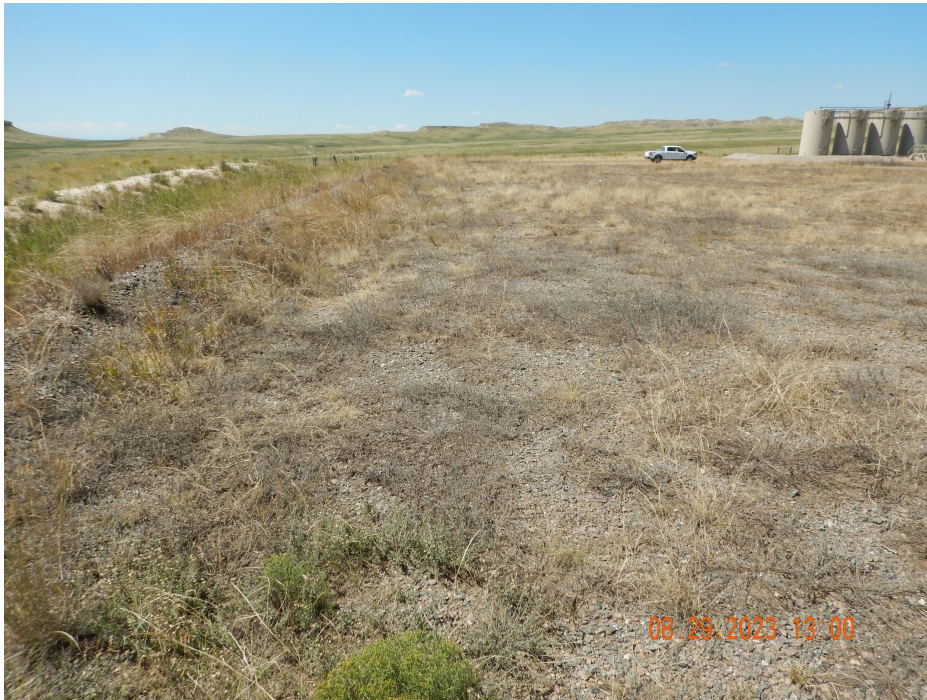
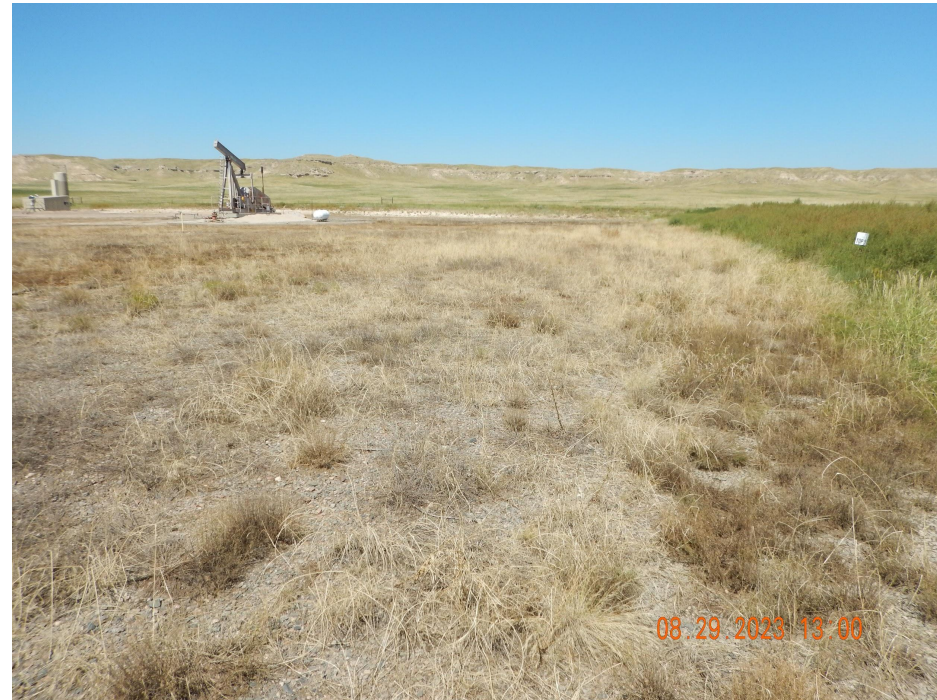
**Photo 10.** Photo taken from the southeastern location, facing West. Photo illustrates the location was never interim reclaimed.

**Photo 11.** Photo taken from the southeastern location, facing North. See comments under Photo 10.

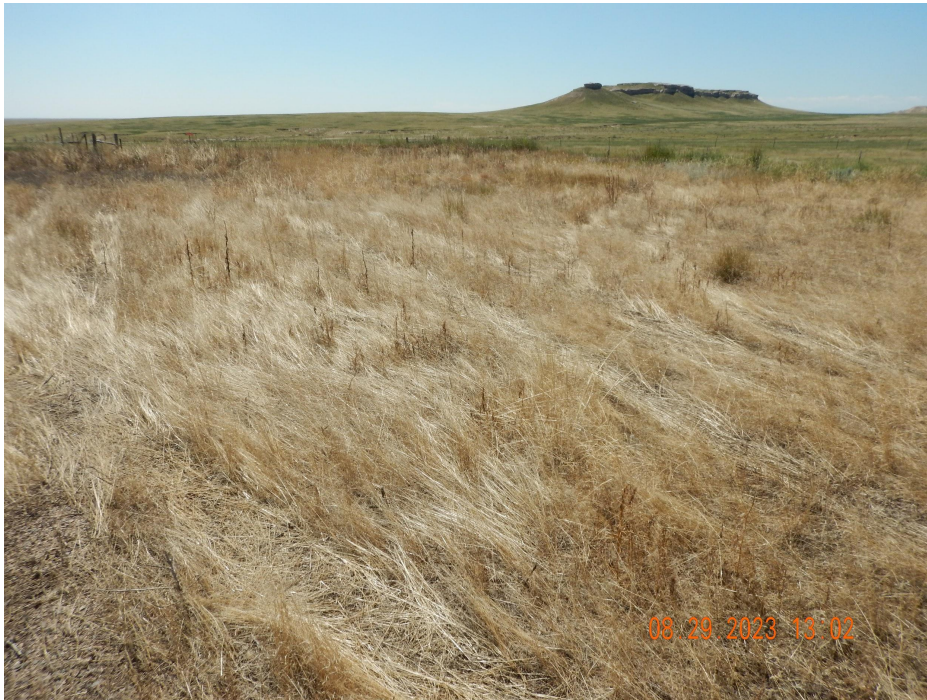
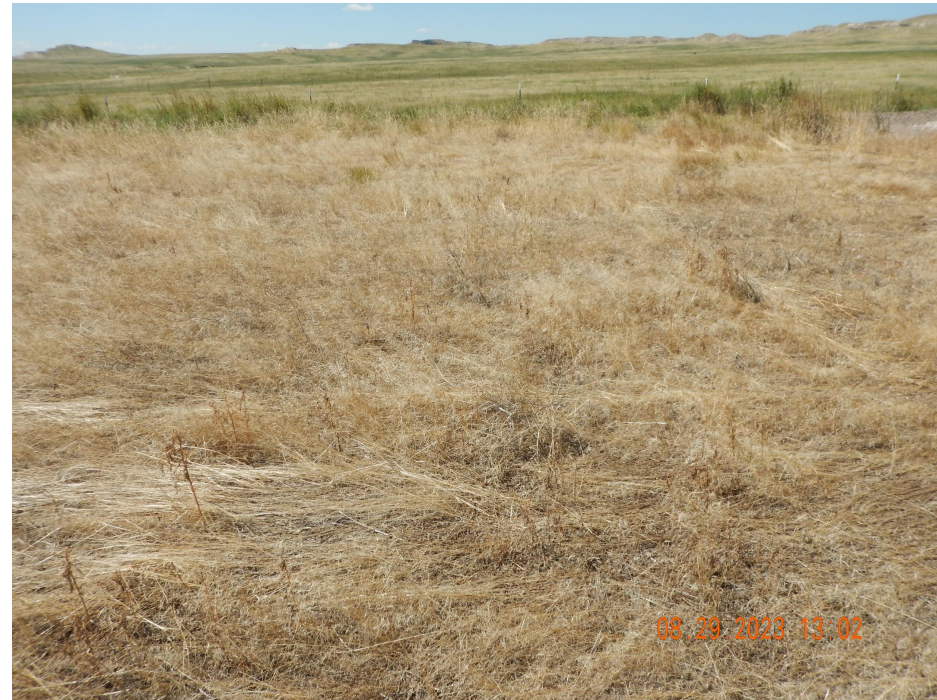
**Photo 12.** Photo taken from the southwestern location, facing South. Photo illustrates unmanaged noxious weed growth of cheatgrass, which has already gone to seed.

**Photo 13.** Photo taken from the southwestern location, facing West. See comments under Photo 12.

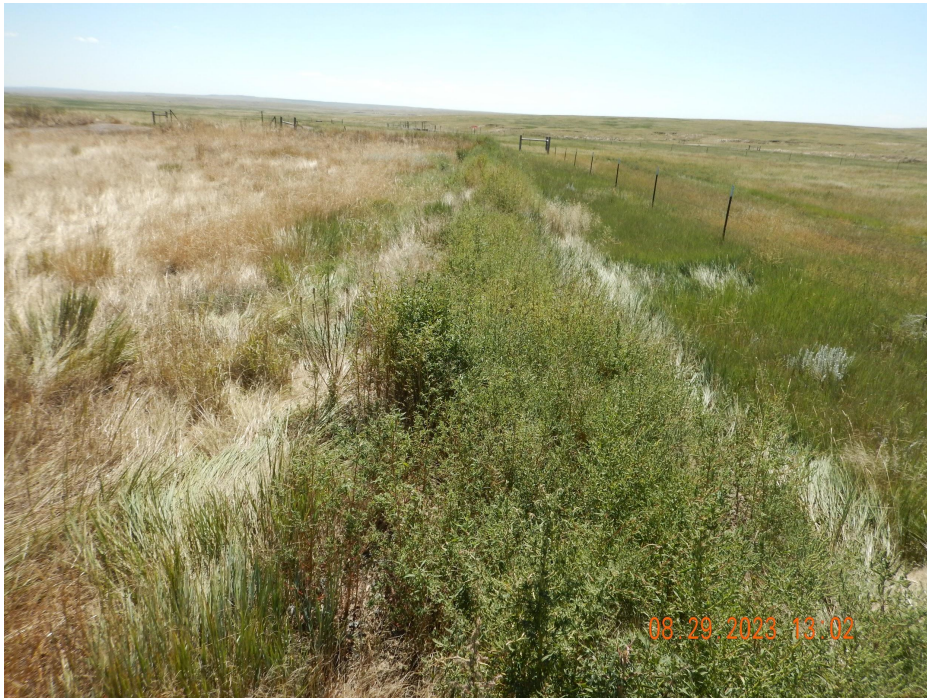
**Photo 14.** Photo taken from the southwestern location, facing South. Photo illustrates unmanaged weeds.

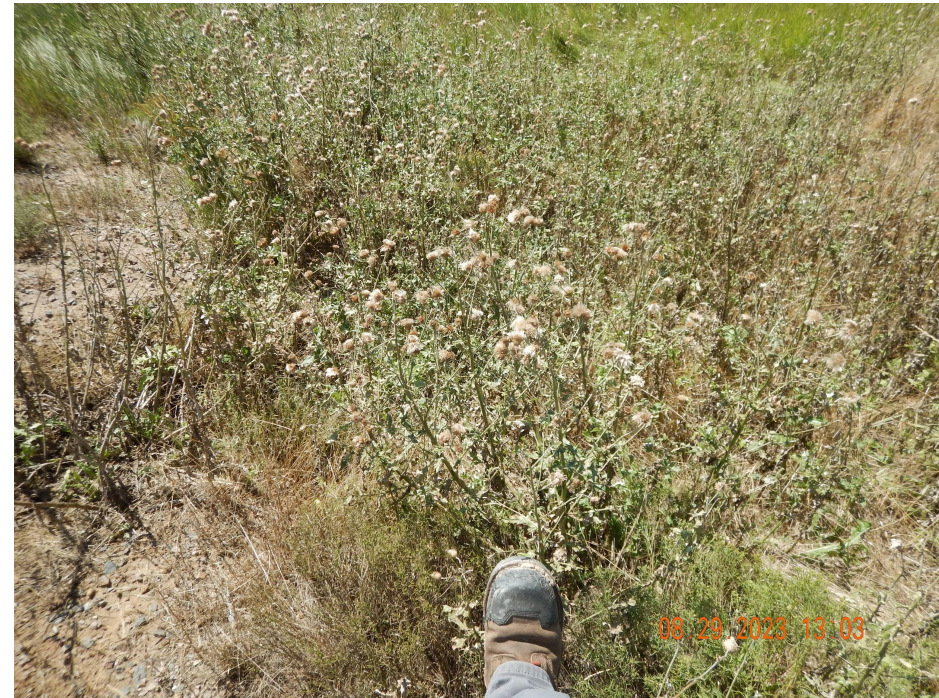
**Photo 15.** Photo taken from the southwestern location. Photo illustrates unmanaged Canada thistle, a noxious weed, which has gone to seed.
