Operator: BONANZA CREEK ENERGY OPERATING COMPANY LLC

Location Name: Antelope 11-20

Loc ID: 424418

Inspection: 709100062

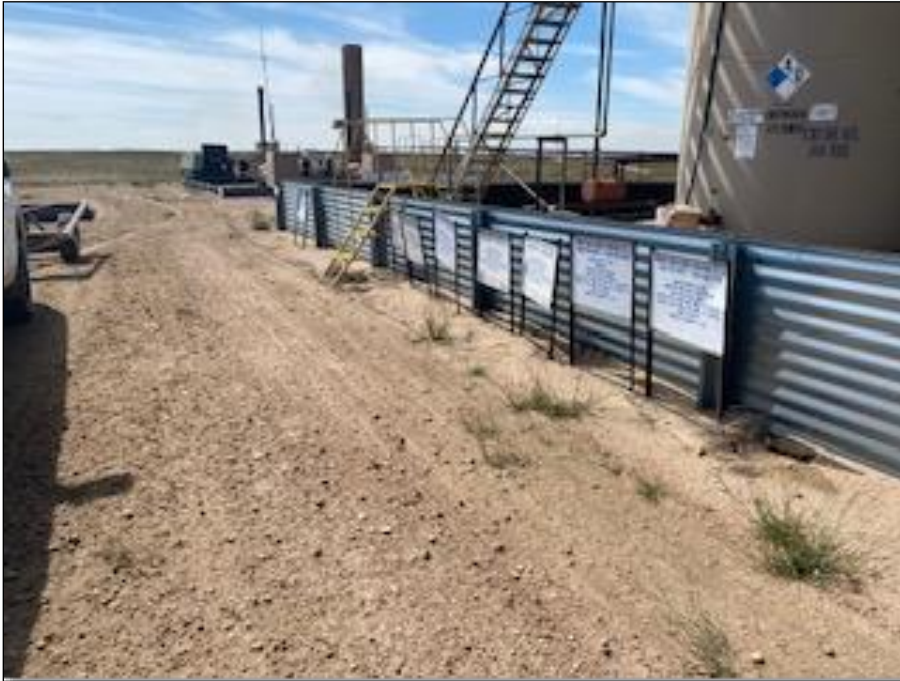
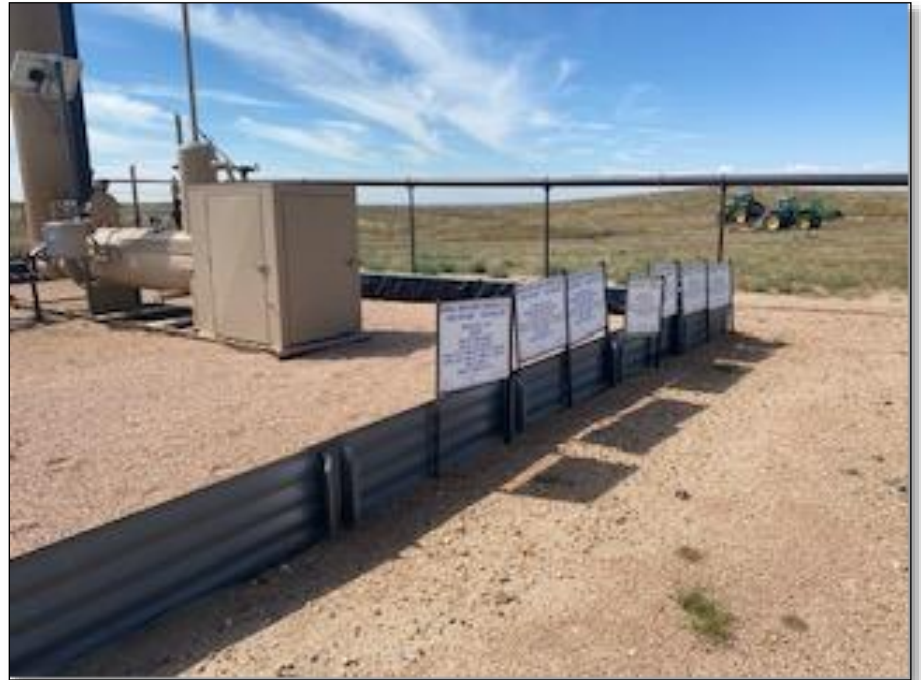
CA: Illegible wellhead signs, sign at tank battery is not installed properly, and emergency contact number on tanks illegible from a distance. Install signs to comply with Rule 605.a.

CA Resolution: Operator has properly re-installed sign at tank battery. New signs for multiple areas of the location have been ordered to ensure that information displayed is up to date and legible. Additional matters regarding signage, including installing legible emergency contact number(s) on tanks, are currently being addressed to comply with Rule 605.a.

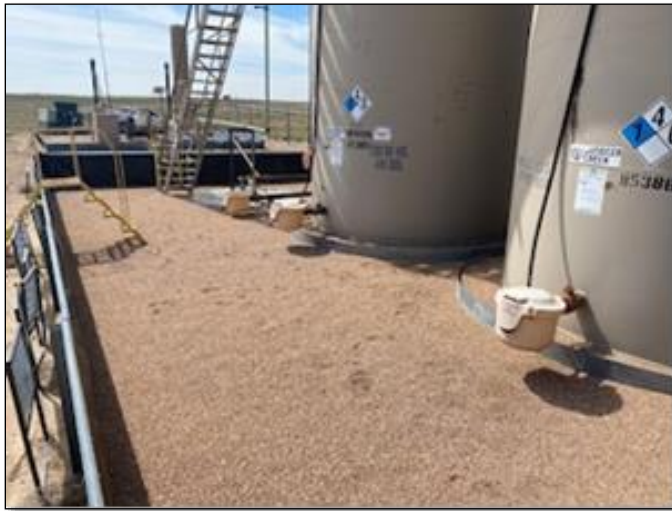
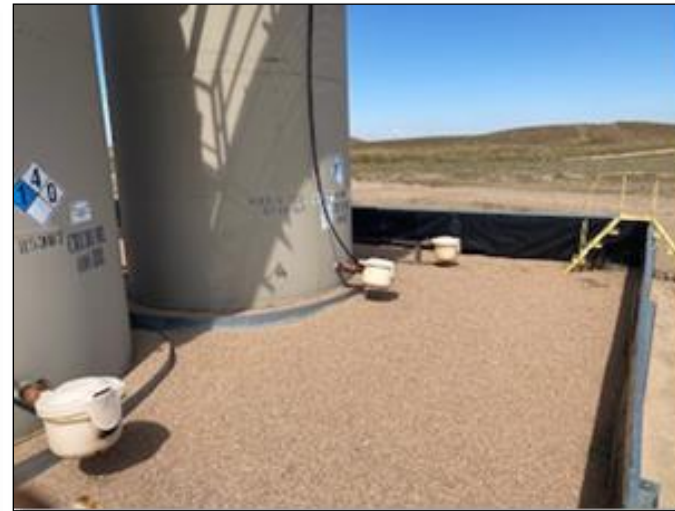
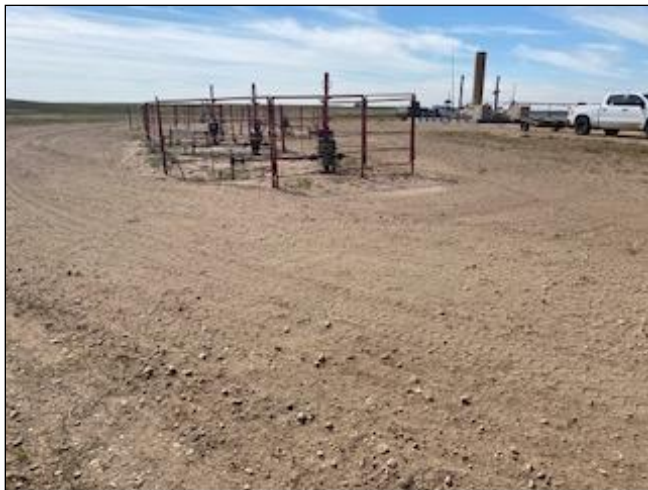
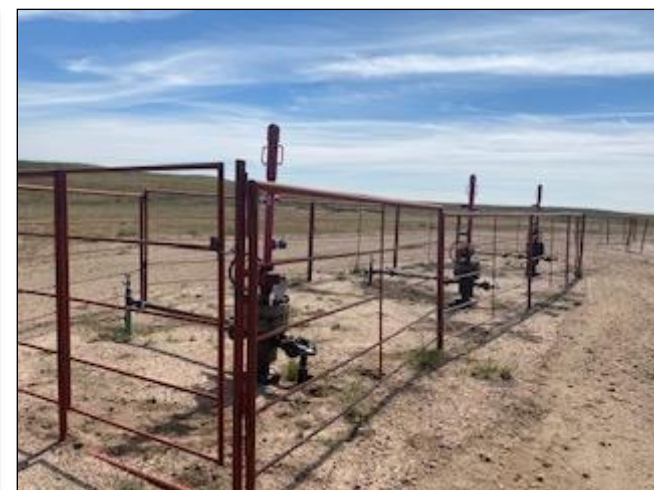
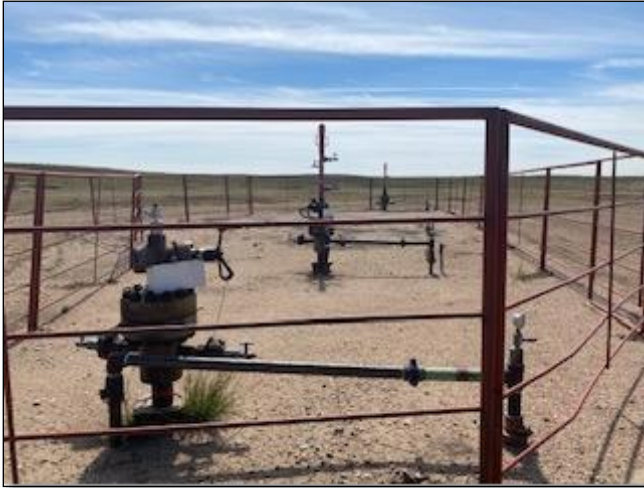
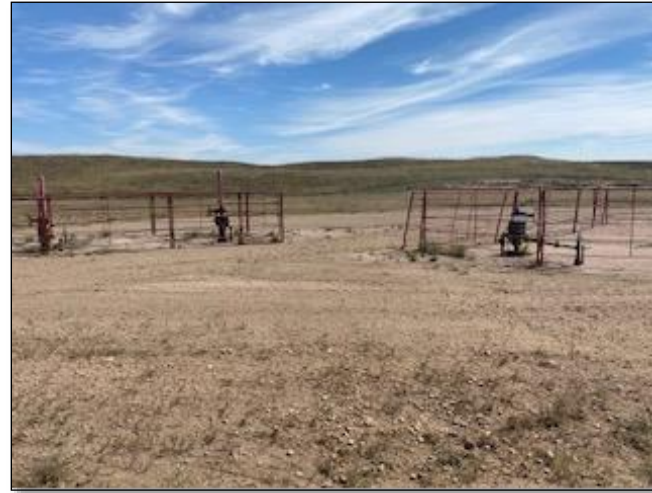
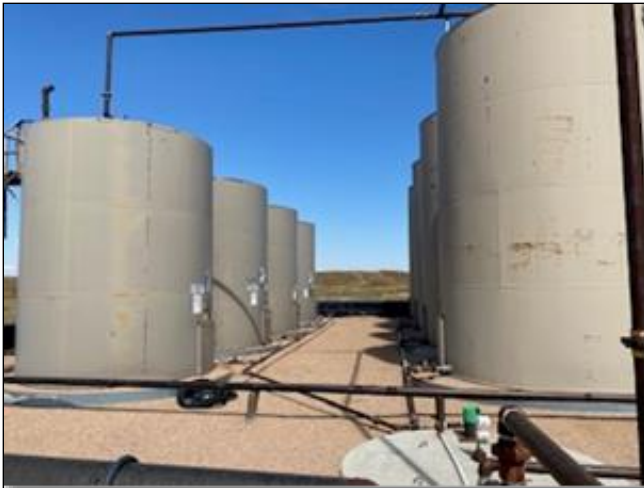
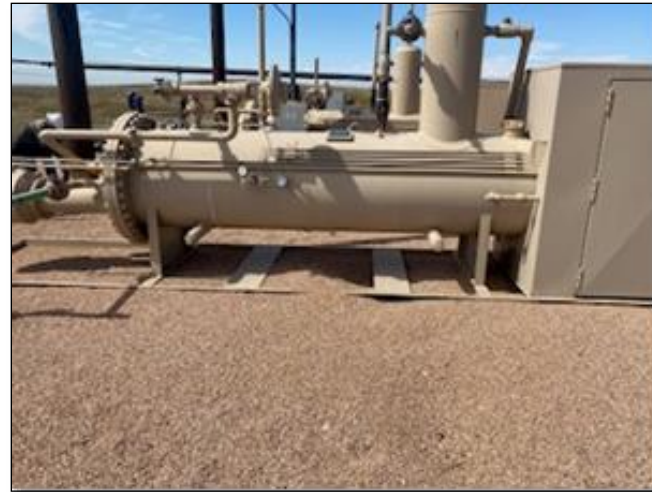
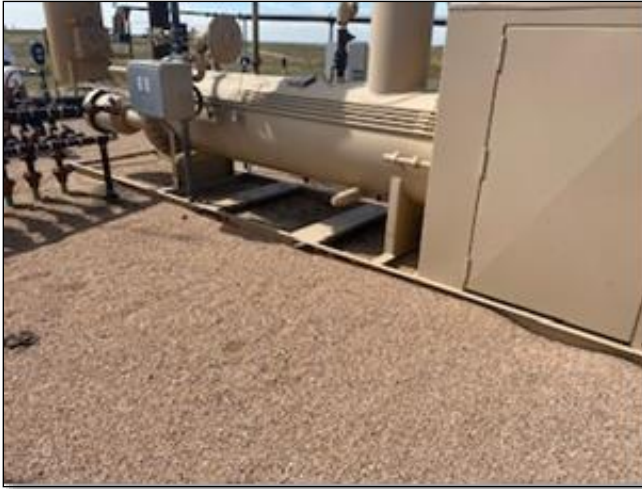
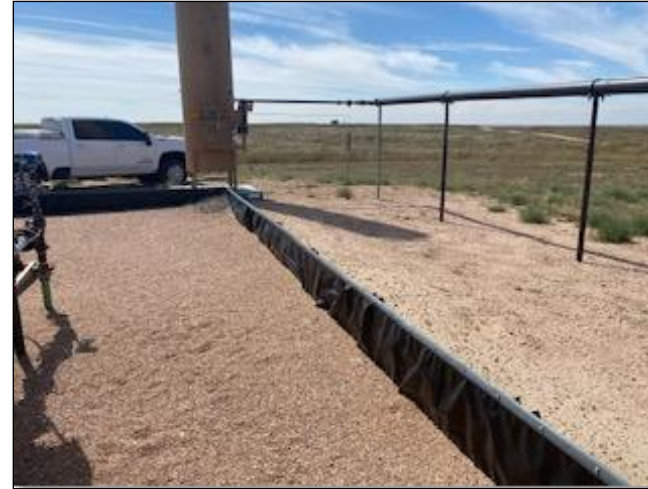
CA: Trash and debris onsite. Comply with Rule 606.d.

CA: Undesirable plant species located throughout the site. Comply with rule 606.c.

CA: Unused equipment on site. Comply with Rule 606.

CA Resolution: Field has appropriately cleared identified trash and debris from location to comply with Rule 606.d.

CA Resolution: Field has appropriately addressed the identified tumbleweeds and debris on location and properly cleared/cleaned the area to comply with Rule 606.c.

CA Resolution: Unused equipment/material has been identified and removed from the location to comply with Rule 606.
