WELLHEAD ABANDONMENT FORM

SITE NAME: Eckhardt 34-1 Wellhead							DATE: 3/10/2023	REM. PROJECT #:	WEATHER: Cloudy, 50's	
SITE DIRECTIONS: CR 50 and CR57 N 0.25 W 0.125 S Into							CLIENT: PDC			
LEGALS AND LAT/LONG: (40.3540238, -104.5334620)							TASMAN PERSONNEL: AO			
SOIL TYPES: Poorly Graded Sand - SP							SURFACE GRADIENT: Southwest			
SOIL SAMPLING							FACILITY INFRASTRUCTURE			
Date/Time	Soil Sample ID	PID (ppm)	Visual	Olfactory	Photo?	Grab or Lab Sample?	EQUIPMENT	Quantity		
							Above Ground Storage Tank (AST)			
3/13/2023 14:00	FL01-01@4'	0.2	No Staining	No Odor	Yes	Lab	Buried or Partially Buried Vessel			
3/13/2023 14:10	FL01-02@4'	0.3	No Staining	No Odor	Yes	Lab	Separator			
3/13/2023 14:20	FL01-03@4'	2.7	Organic Content	Organic Odor	Yes	Lab	Emission Control Device (ECD)			
3/13/2023 14:30	FL01-04@4'	0.1	No Staining	No Odor	Yes	Lab	Dump Line			
3/14/2023 10:50	FL01-05@4'	0.3	No Staining	No Odor	Yes	Grab	Wellhead	1

GENERAL OBSERVATION FORM

Task/Location Description: Flowline and Wellhead Decommissioning

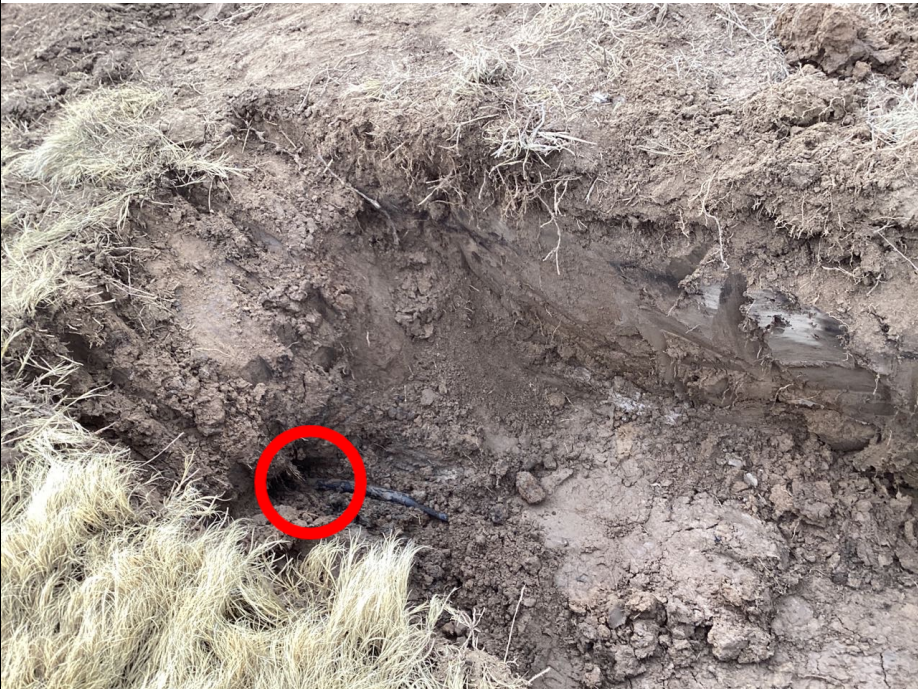
Equipment ID:		Equipment Type:	Equipment ID:		Equipment Type:
Material:	Volume:	Contents:	Material:	Volume:	Contents:
Notes/Conditions: FL01-05			Notes/Conditions: FL01-06

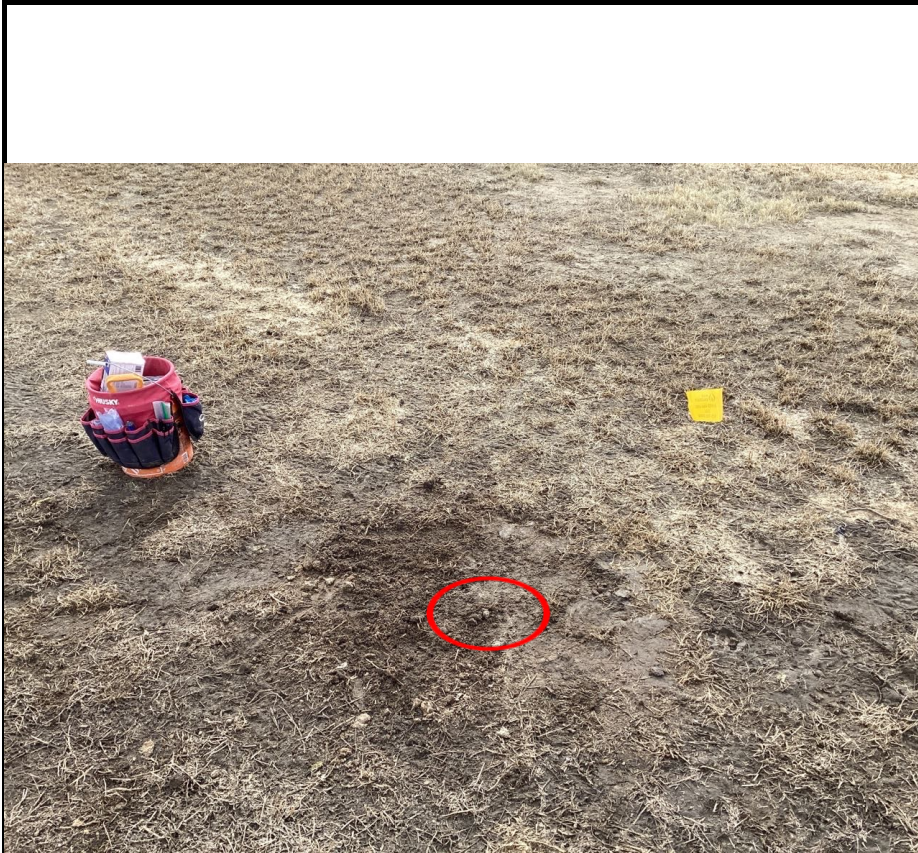
Equipment ID:		Equipment Type:	
Material:	Volume:	Contents:	
Notes/Conditions: FL01-07

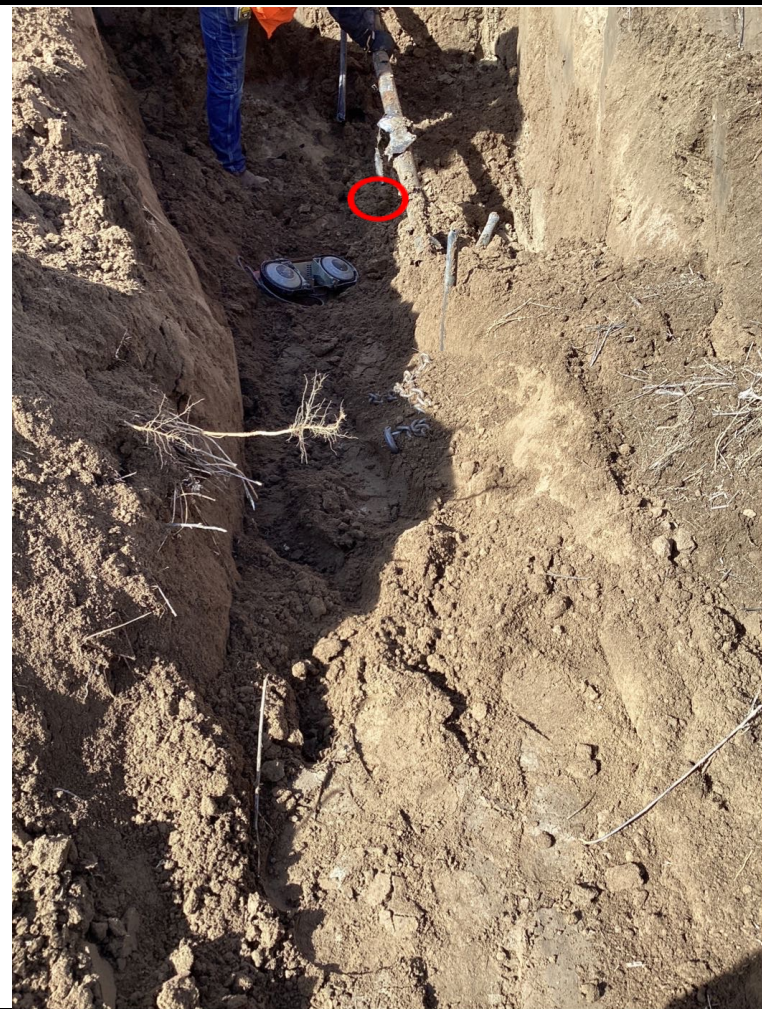
Equipment ID:		Equipment Type:	
Material:	Volume:	Contents:	
Notes/Conditions: FL01-01

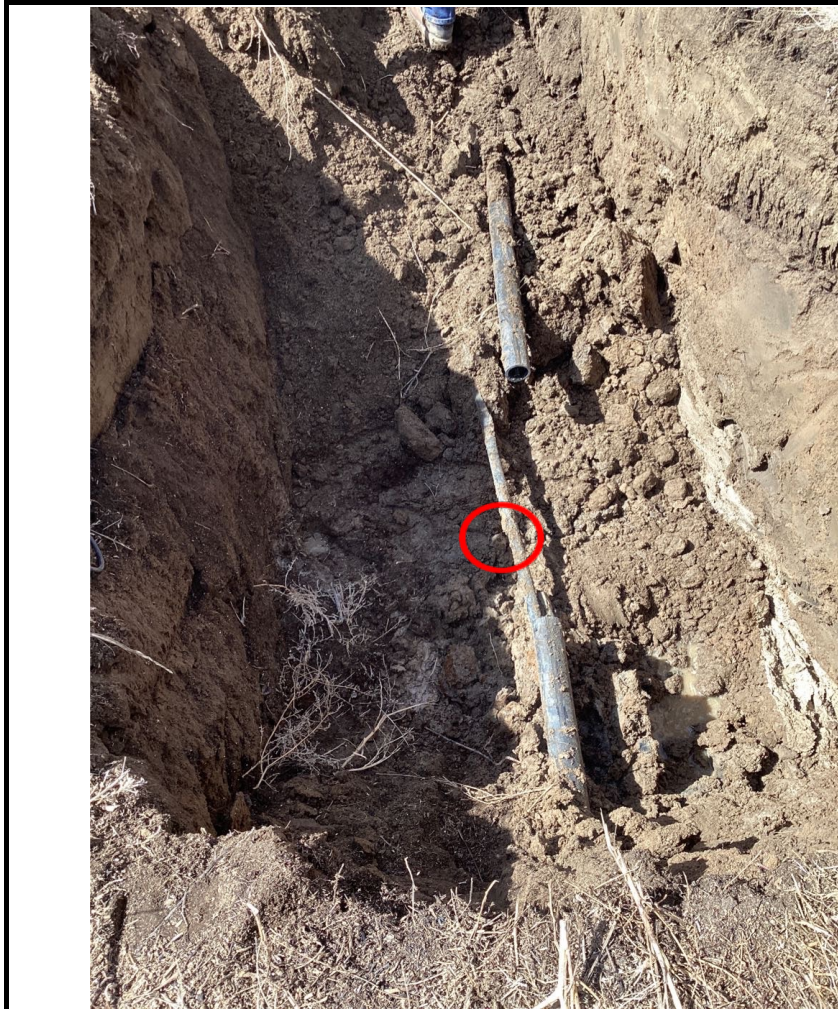
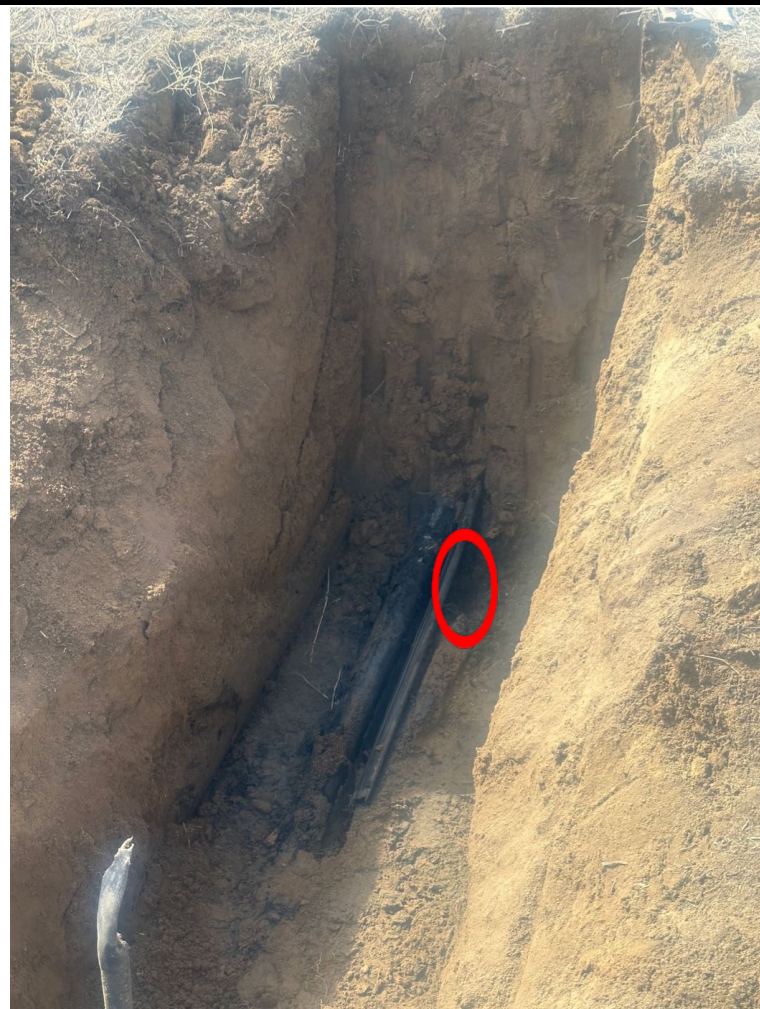
Equipment ID:		Equipment Type:		Equipment ID:		Equipment Type:	
Material:	Volume:	Contents:		Material:	Volume:	Contents:	
Notes/Conditions: FL01-02				Notes/Conditions: FL01-03 Heavy Organic Staining /Organic Odor

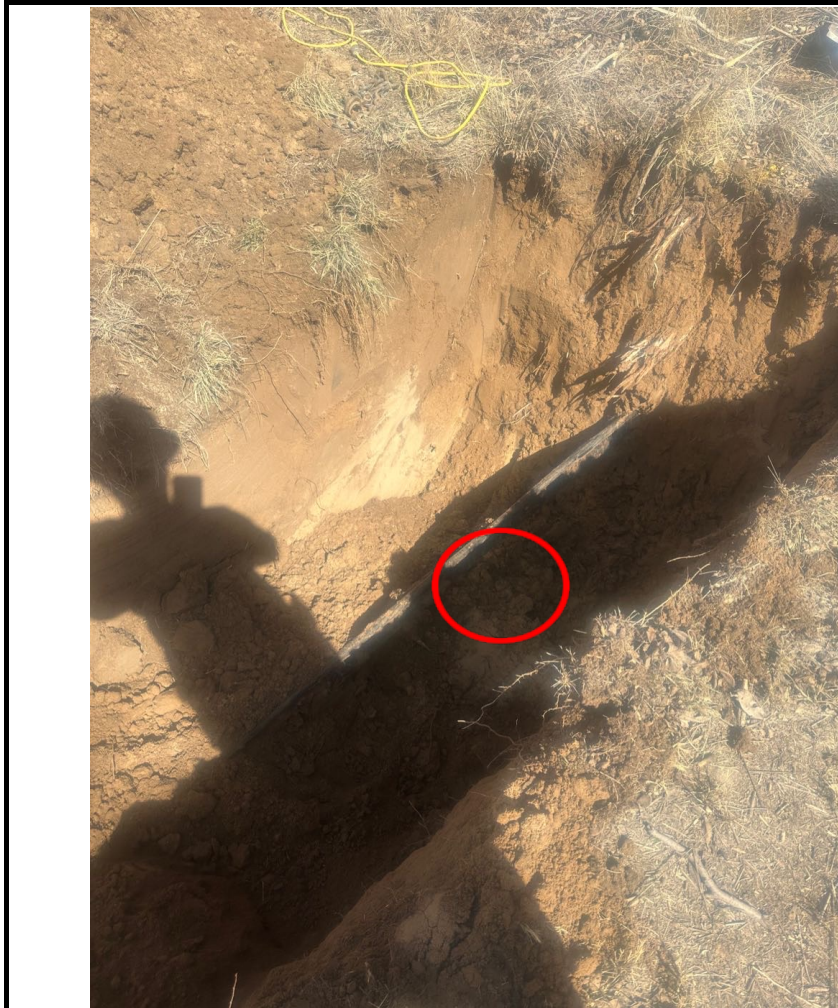
Equipment ID:		Equipment Type:		Equipment ID:		Equipment Type:	
Material:	Volume:	Contents:		Material:	Volume:	Contents:	
Notes/Conditions: FL01-04				Notes/Conditions:
