# Inspection Photos

**Operator:** LARAMIE ENERGY LLC #10433

**Location ID:** 335595

**Inspection No:** 696205255

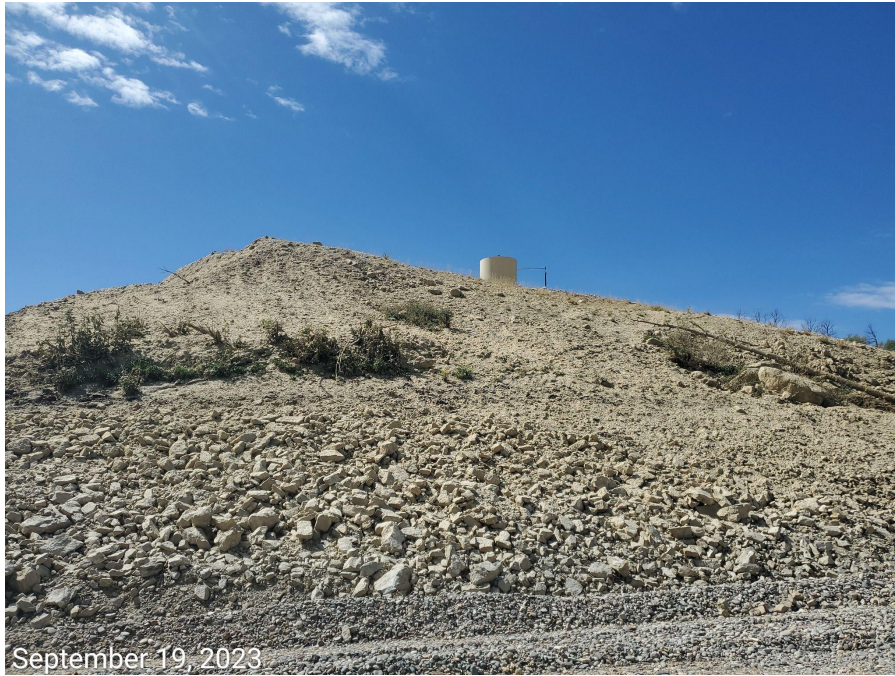
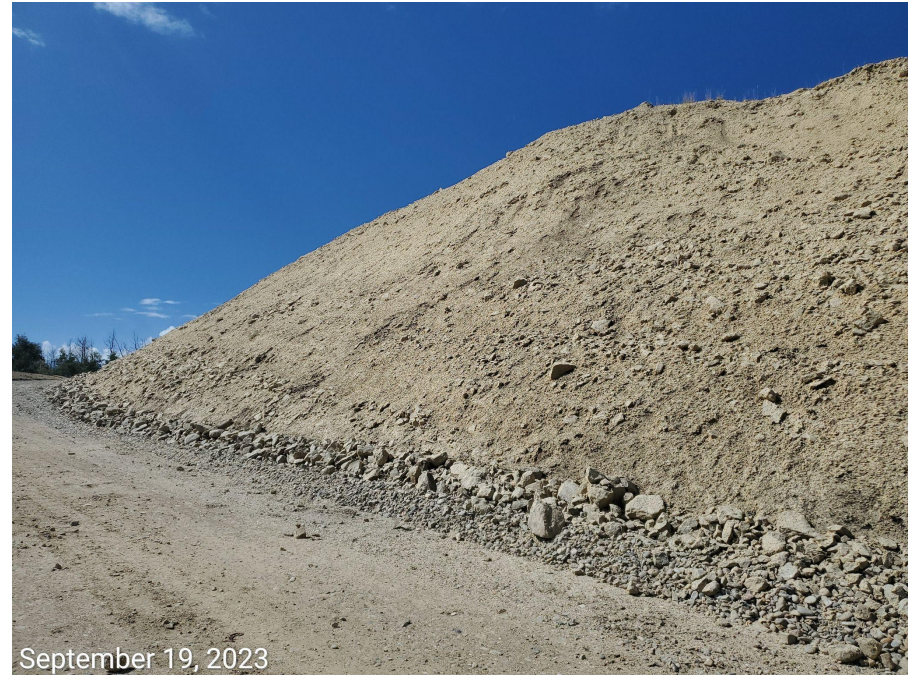
**Photo 1:** Photos taken from the tow of the fill slopes on the northeast and east end of the Location. Photo shows Operator has implemented hydromulch on the slopes. Control measure appeared to be in proper functioning condition at time of inspection.

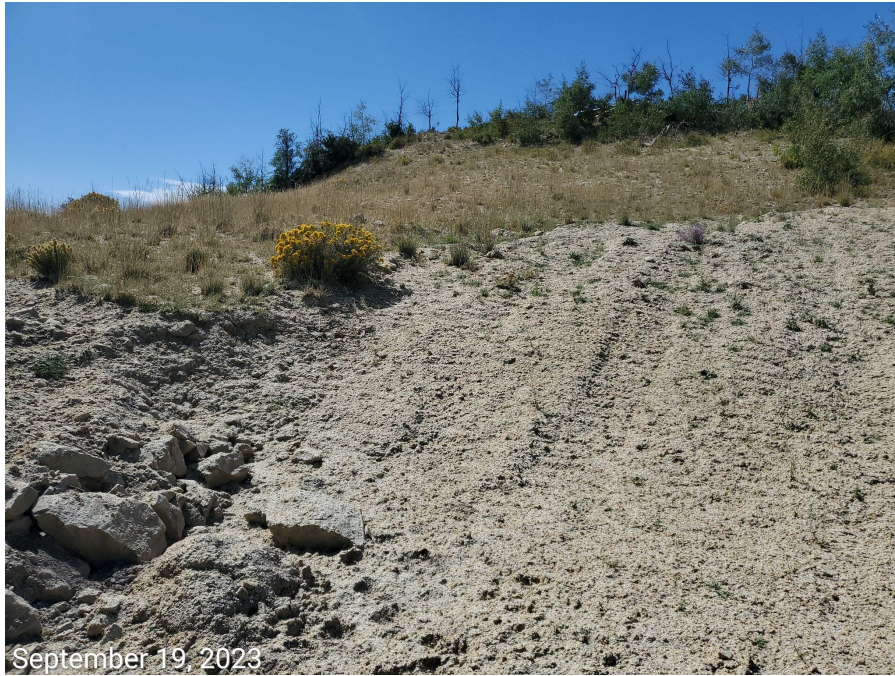
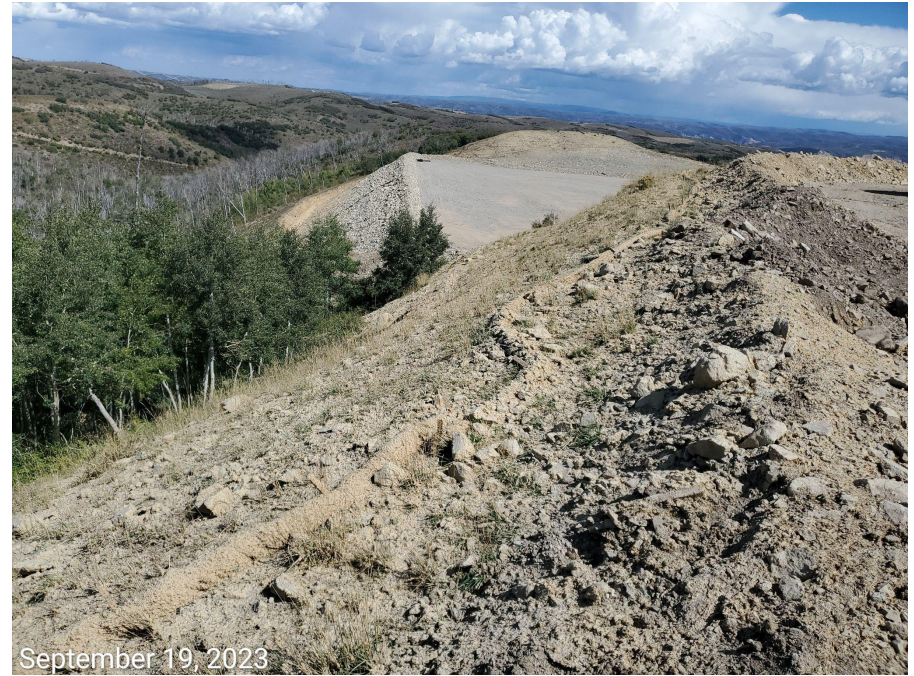
**Photo 3:** Photo left taken from the interim areas on the southwest end of the Location. Operator appears to have conducted additional reclamation work in conjunction with a hydromulch application. Photo right also shows erosion logs have been maintained.

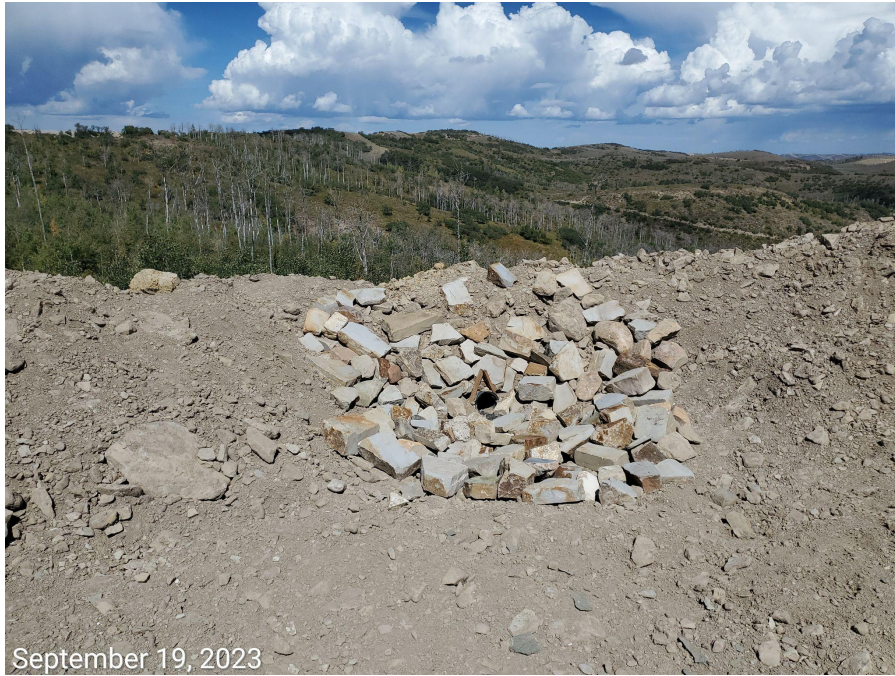
**Photo 4:** Photo left shows the outlet from the working pad surface has been maintained and sediment removed. Photo right shows the slope drain outlet lacks a properly engineered and armored outlet, resulting in off-site degradation.
