# Final Reclamation Inspection

Operator: 44 Canyon LLC - 195

Location ID: 385787

Inspection Photos  
Location Name: Federal 34/2-34-1  
Location ID: 385787

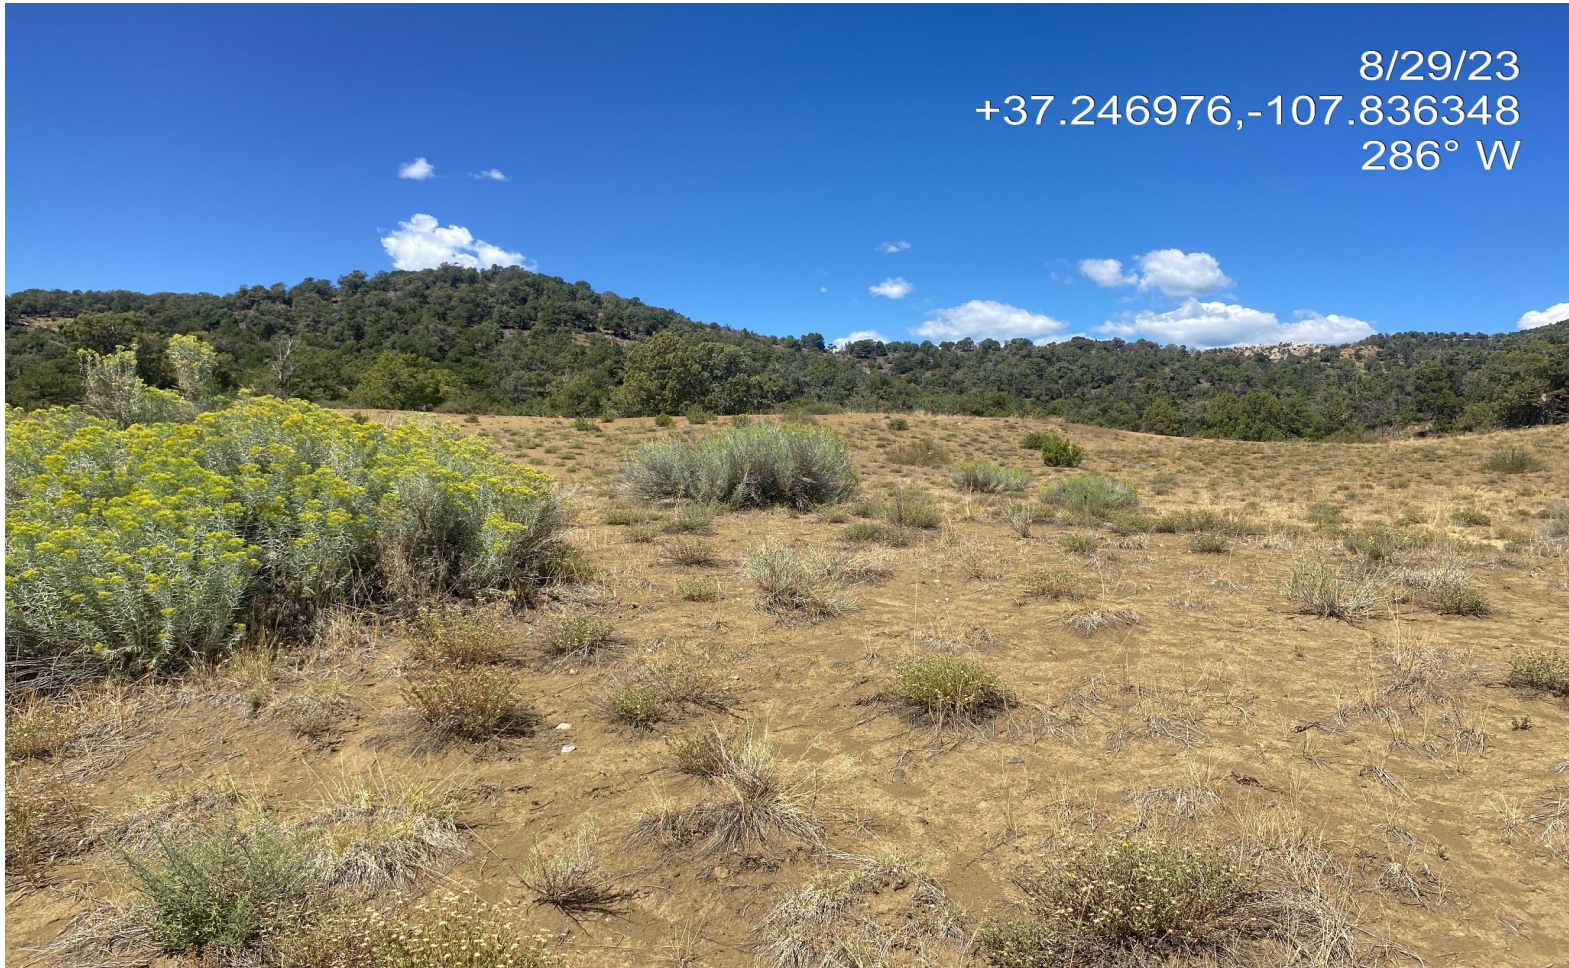
**Photo 1.** Overview photo of the center of the well disturbance taken from entrance.

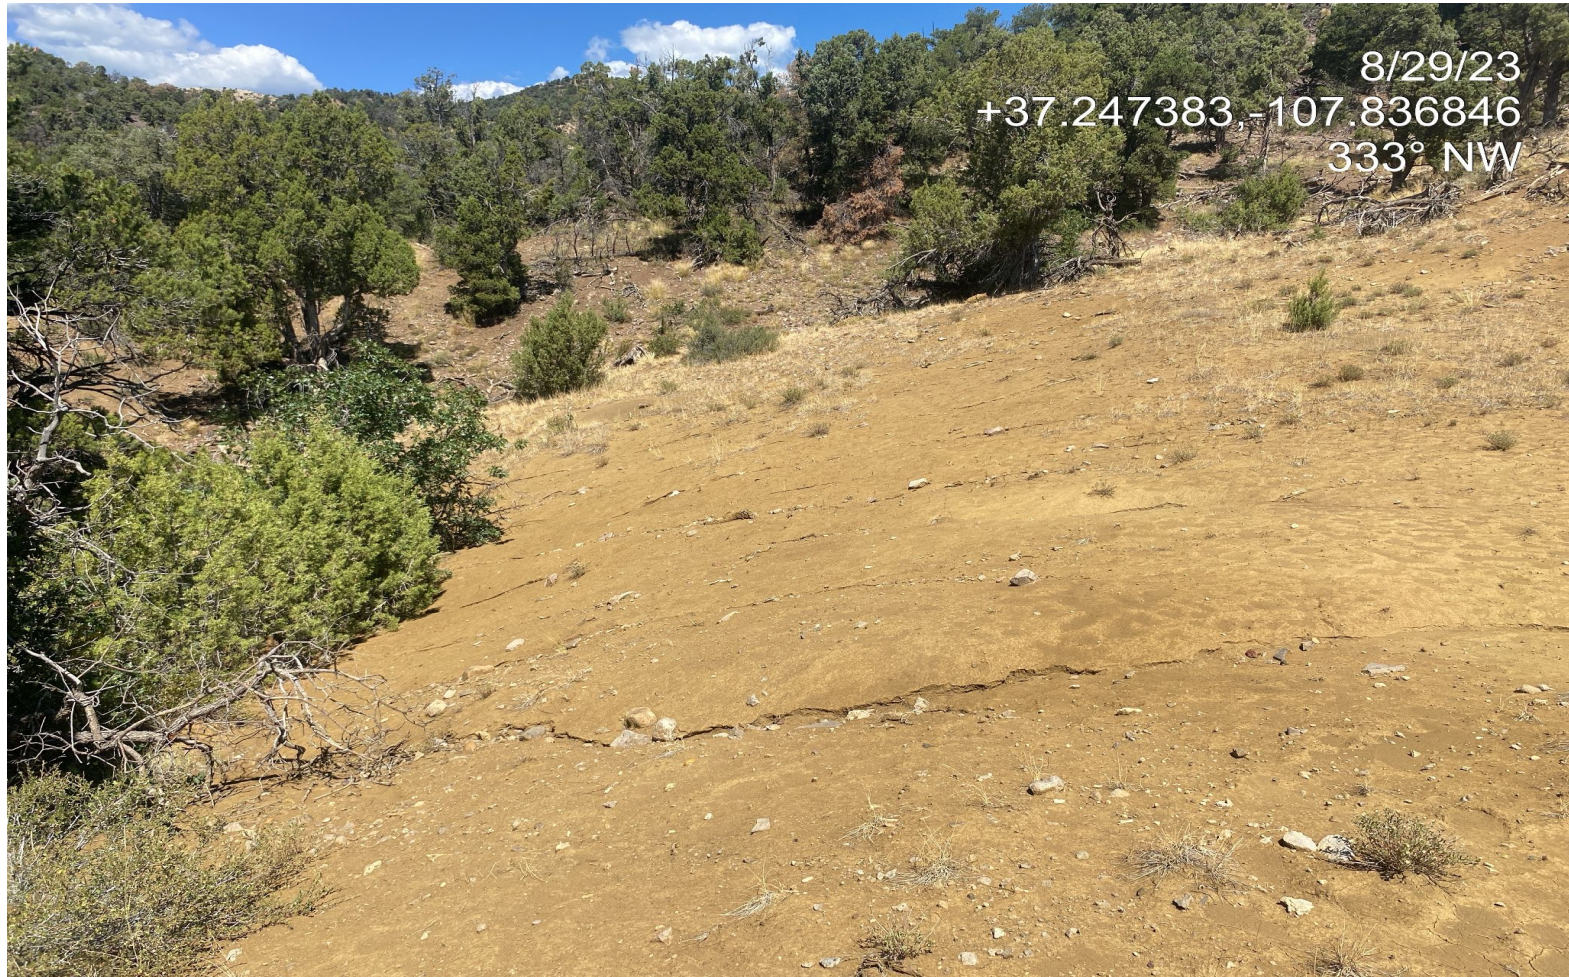
**Photo 2.** View of the northern project area back slope that has sparse vegetation and rill erosion. Stabilization required in this area.

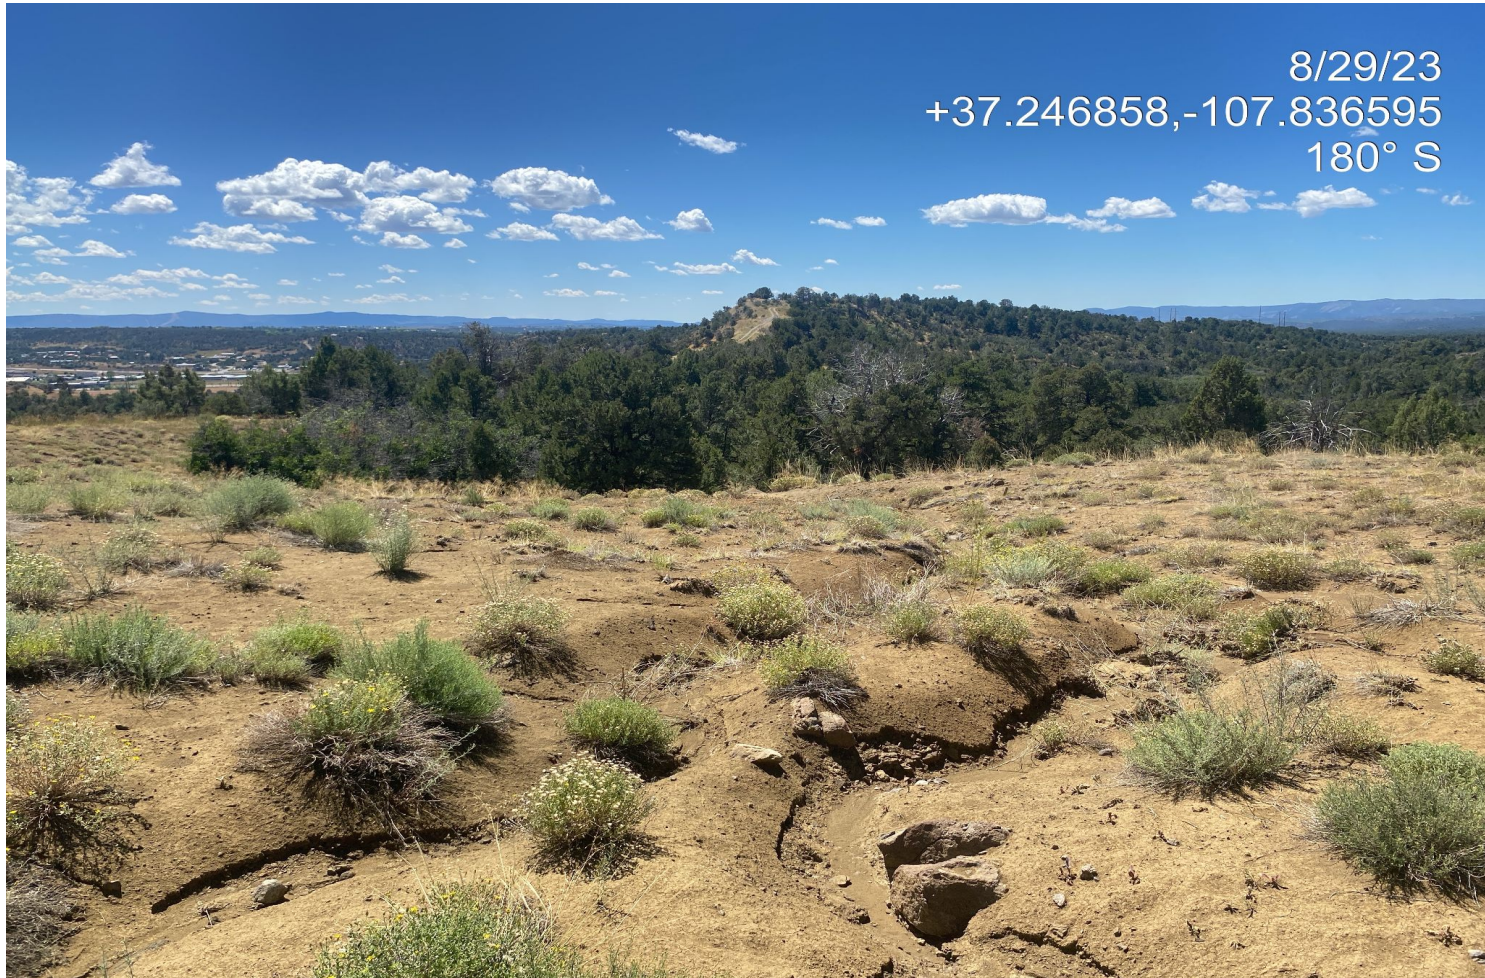
8/29/23  
+37.246858,-107.836595  
180° S

**Photo 3.** View of rilling erosion in the middle of the disturbance. Stabilization issues remain apparent.

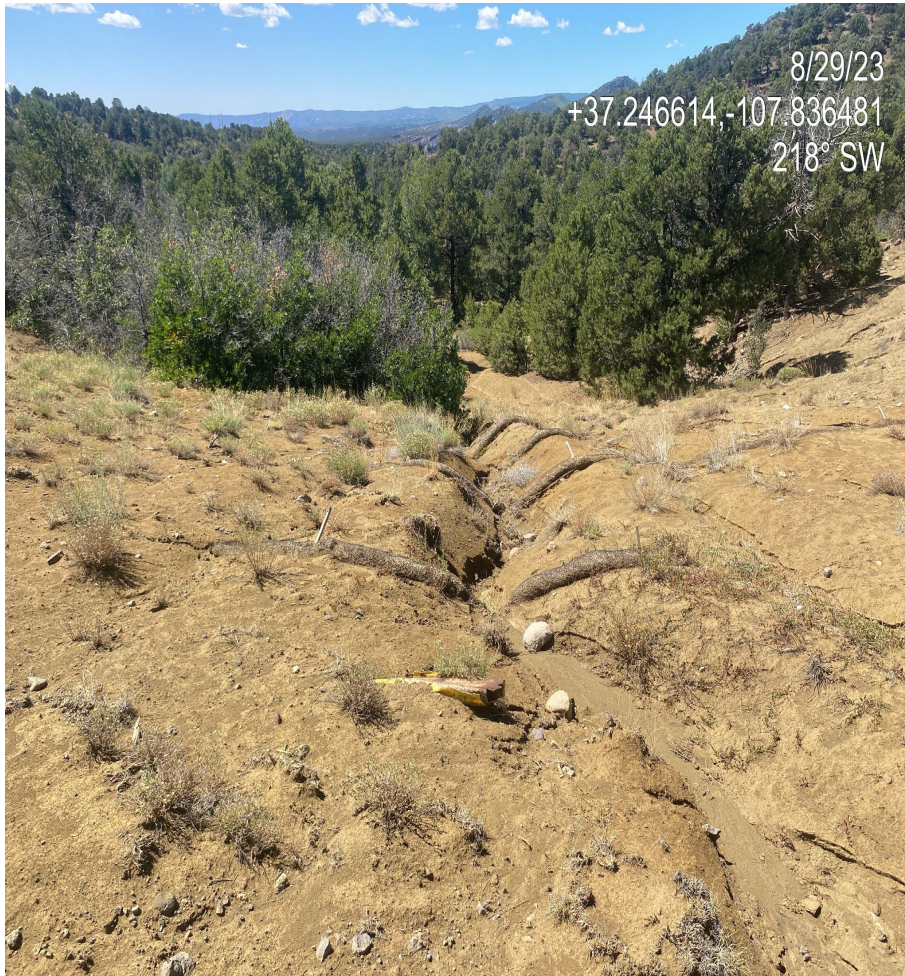
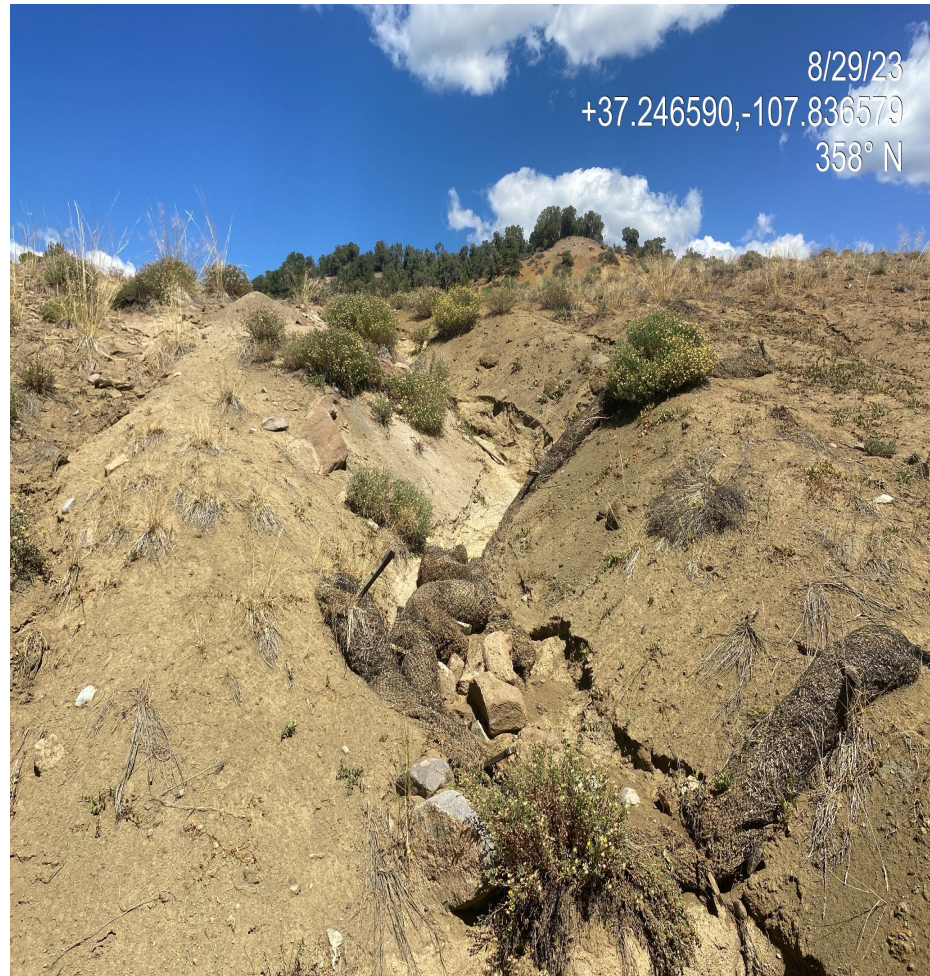
**Photo 4.** Down and upslope views of erosional channel deepening in southwest corner of disturbance. Currently BMPS are not sufficient for this area.

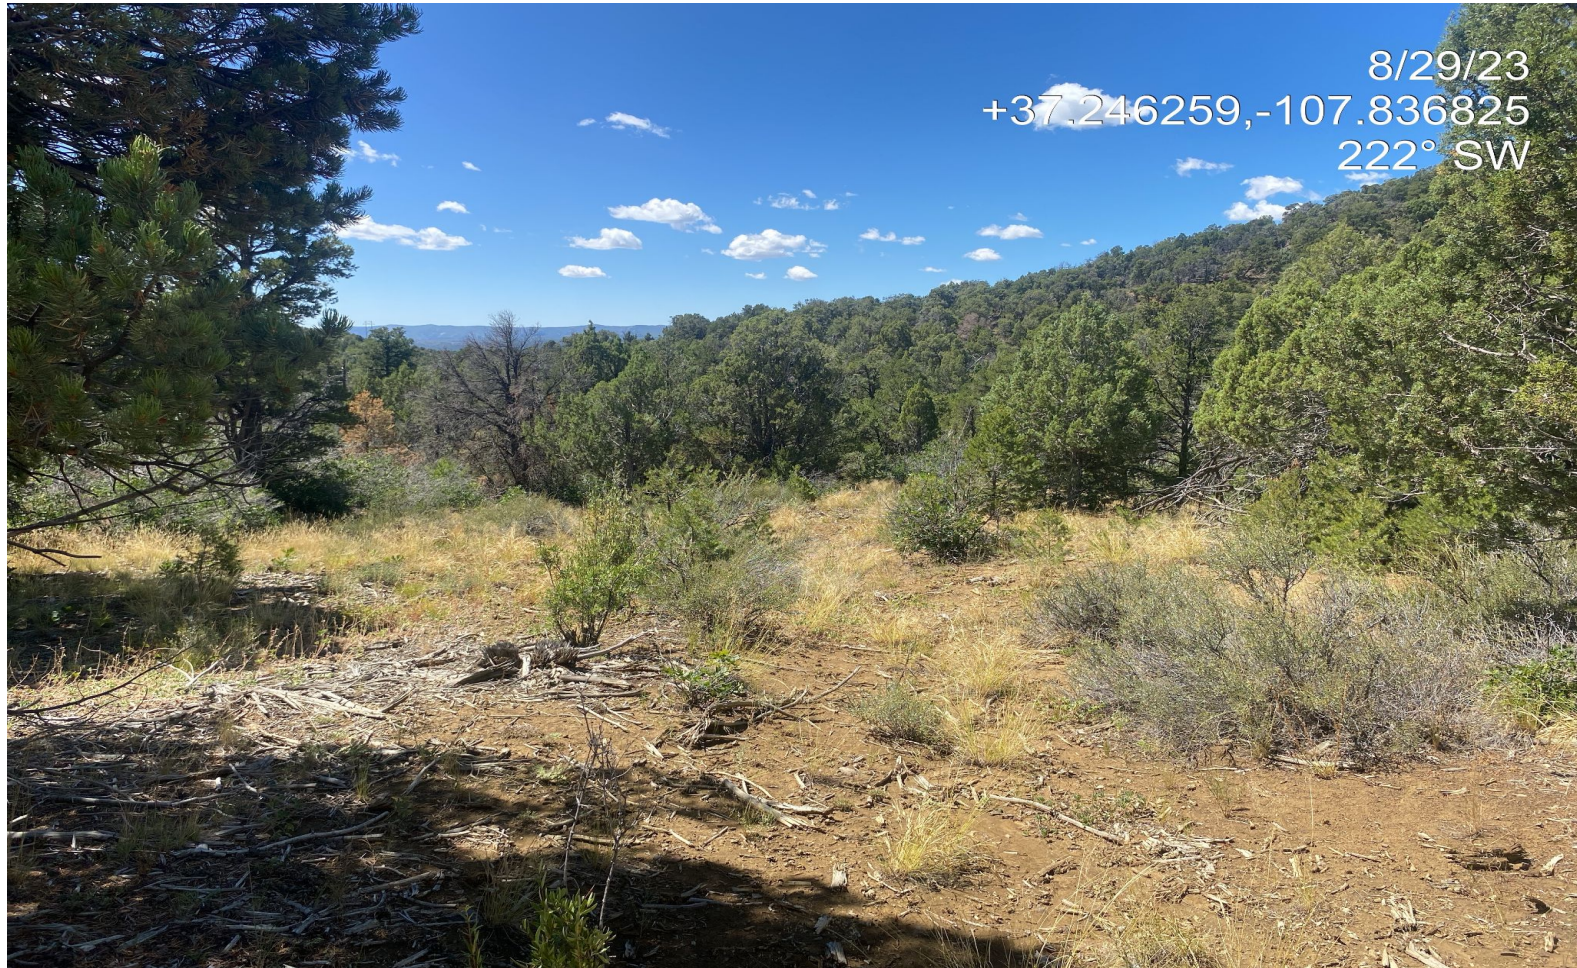
**Photo 5.** View of reference area comprised of Pine, Juniper, Gambel oak, Antelope bitterbrush and Indian ricegrass.
