# Inspection Photos

**Operator:** LARAMIE ENERGY LLC #10433

**Location ID:** 324100

**Inspection No:** 696205265

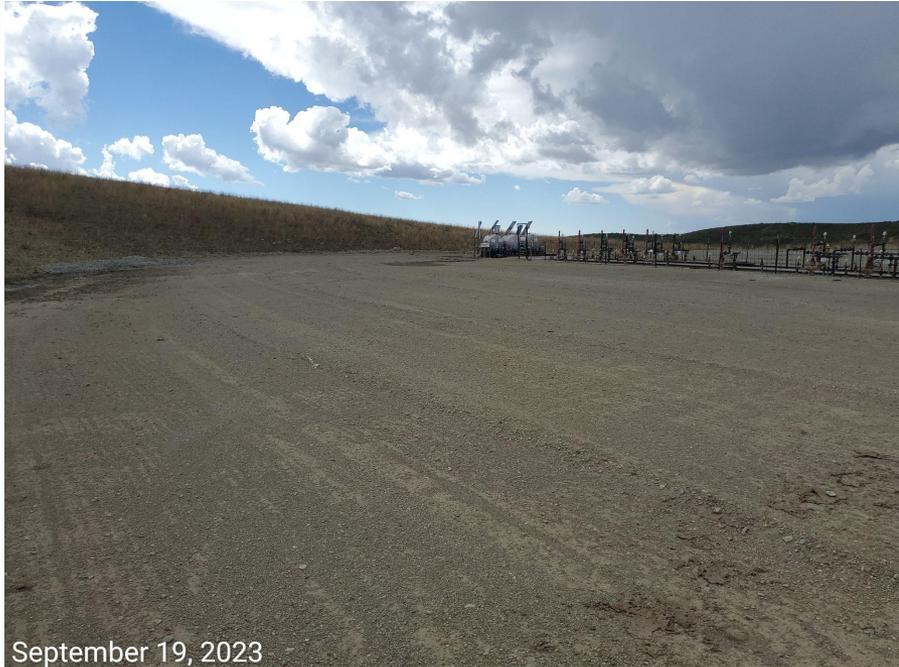
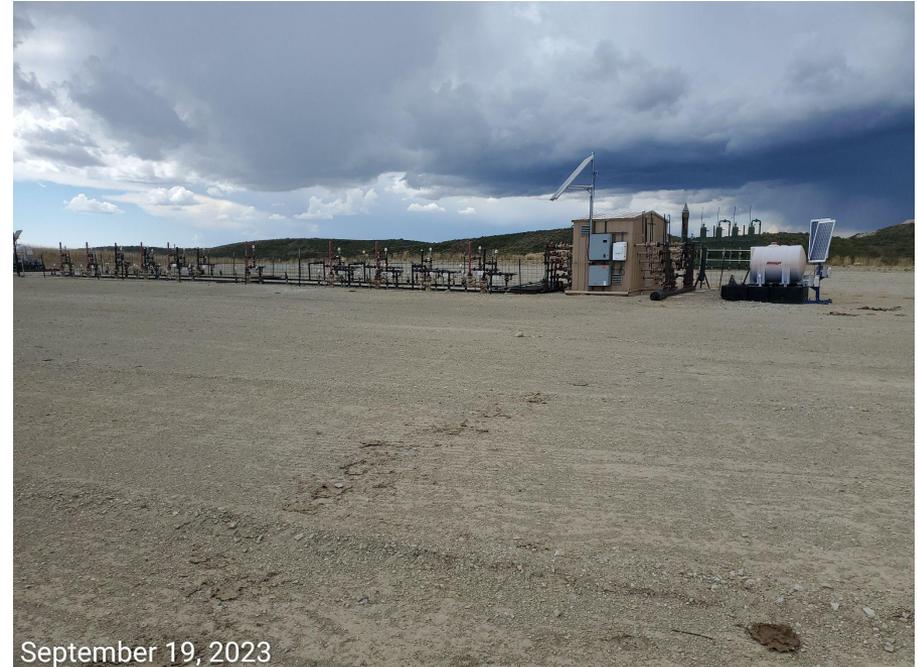
**Photo 1:** Photos taken from the east end of the Working Pad Surface. Photos 1-2 provide an overview of the Location from southwest, west, northwest to northeast

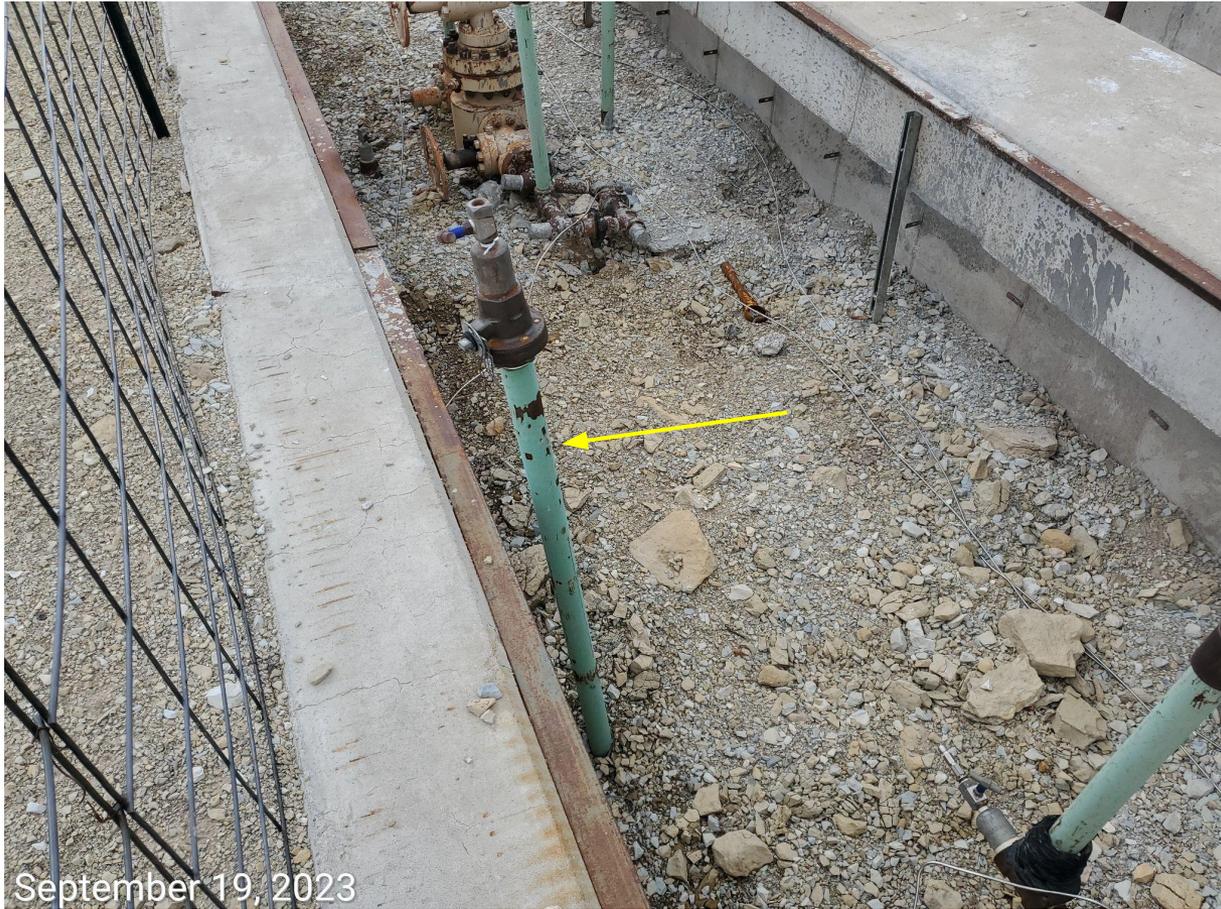
**Photo 3:** Photo taken from the Cascade Creek #697-09-10A well; well was PA 9/10/2021. Photo shows riser remaining.

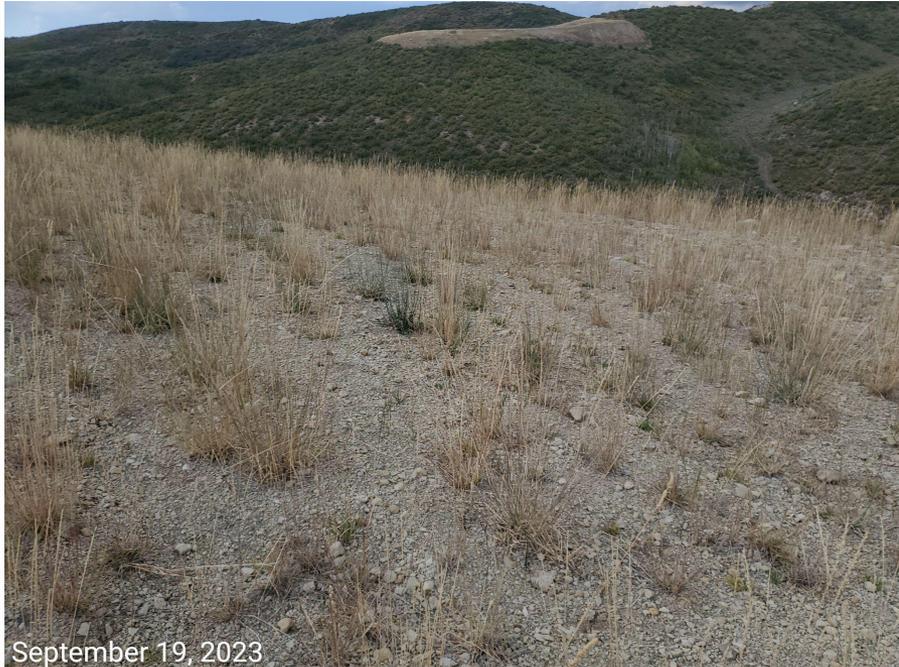
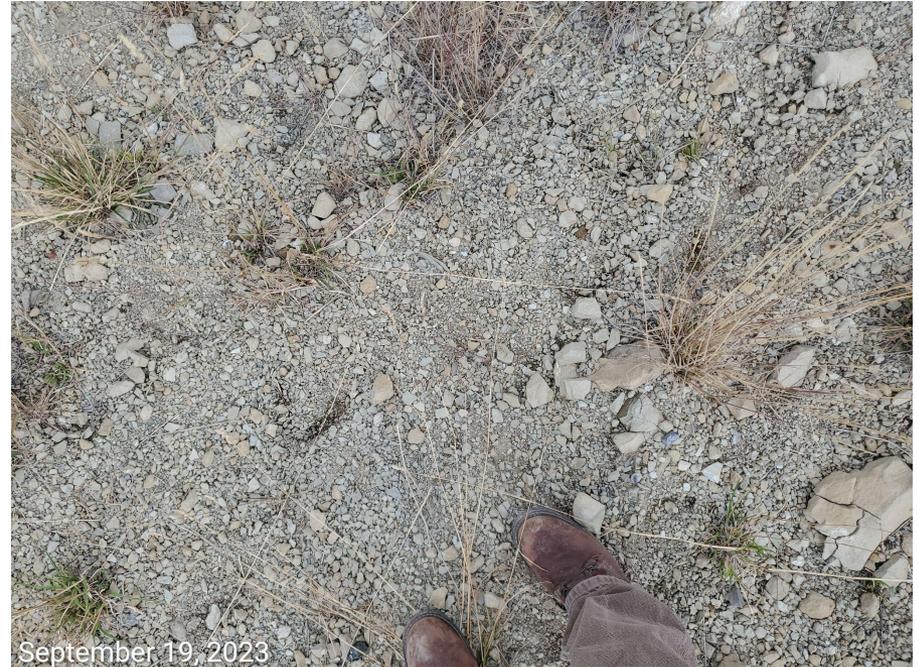
**Photo 4:** Photo taken from the interim areas on the northeast end of the Location. Though vegetation appears to be progressing towards 1003 standards, site has not achieved a uniform establishment. Photos also shows examples of areas where topsoil had not been replaced.

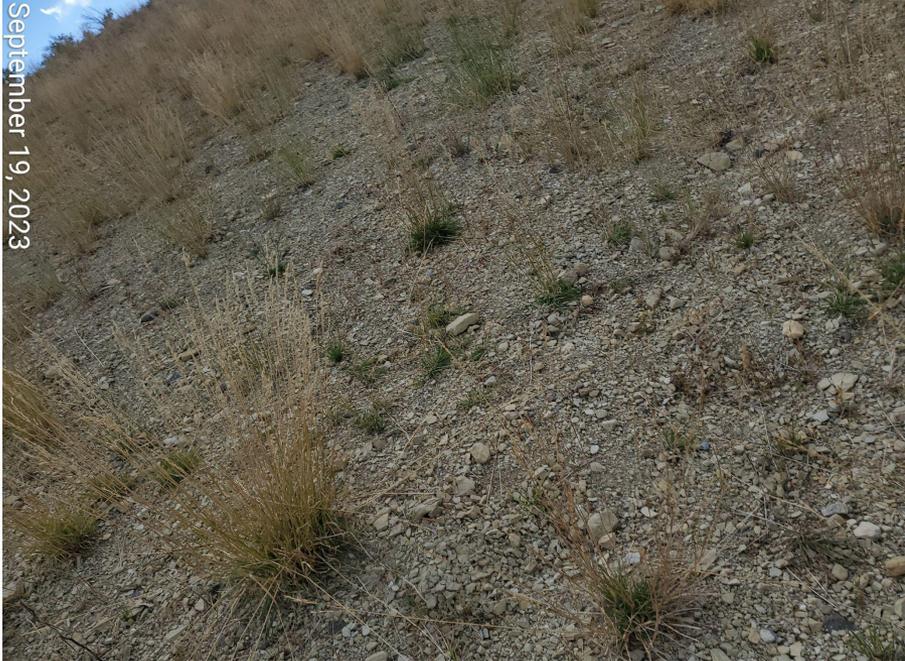
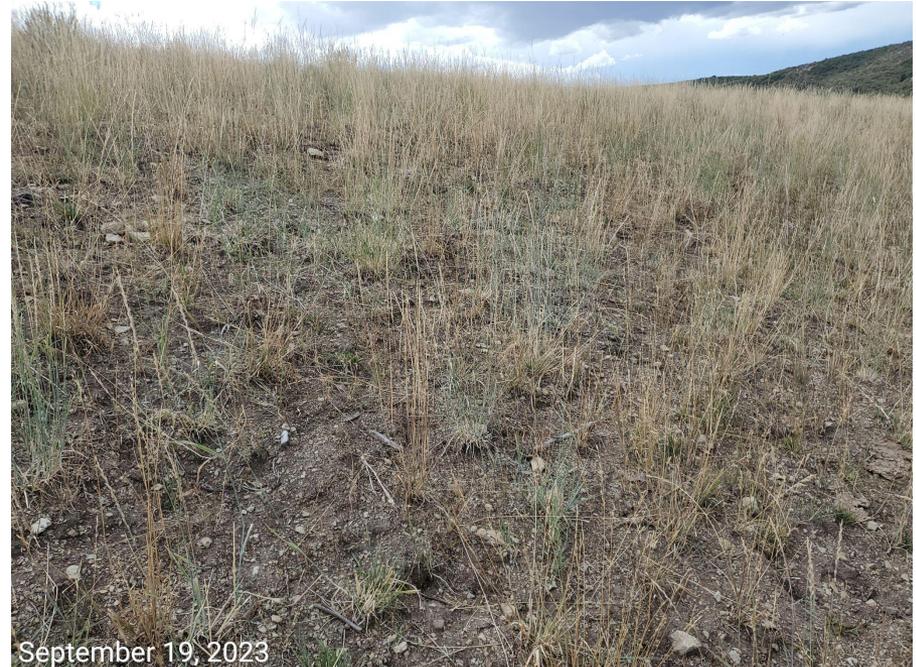
**Photo 5:** Photo right taken from the eastern interim areas where topsoil had not been replaced. Photo right taken from the western interim areas where topsoil had been replaced. Vegetation within areas of the Location where topsoil has been replaced is achieving a more uniform establishment

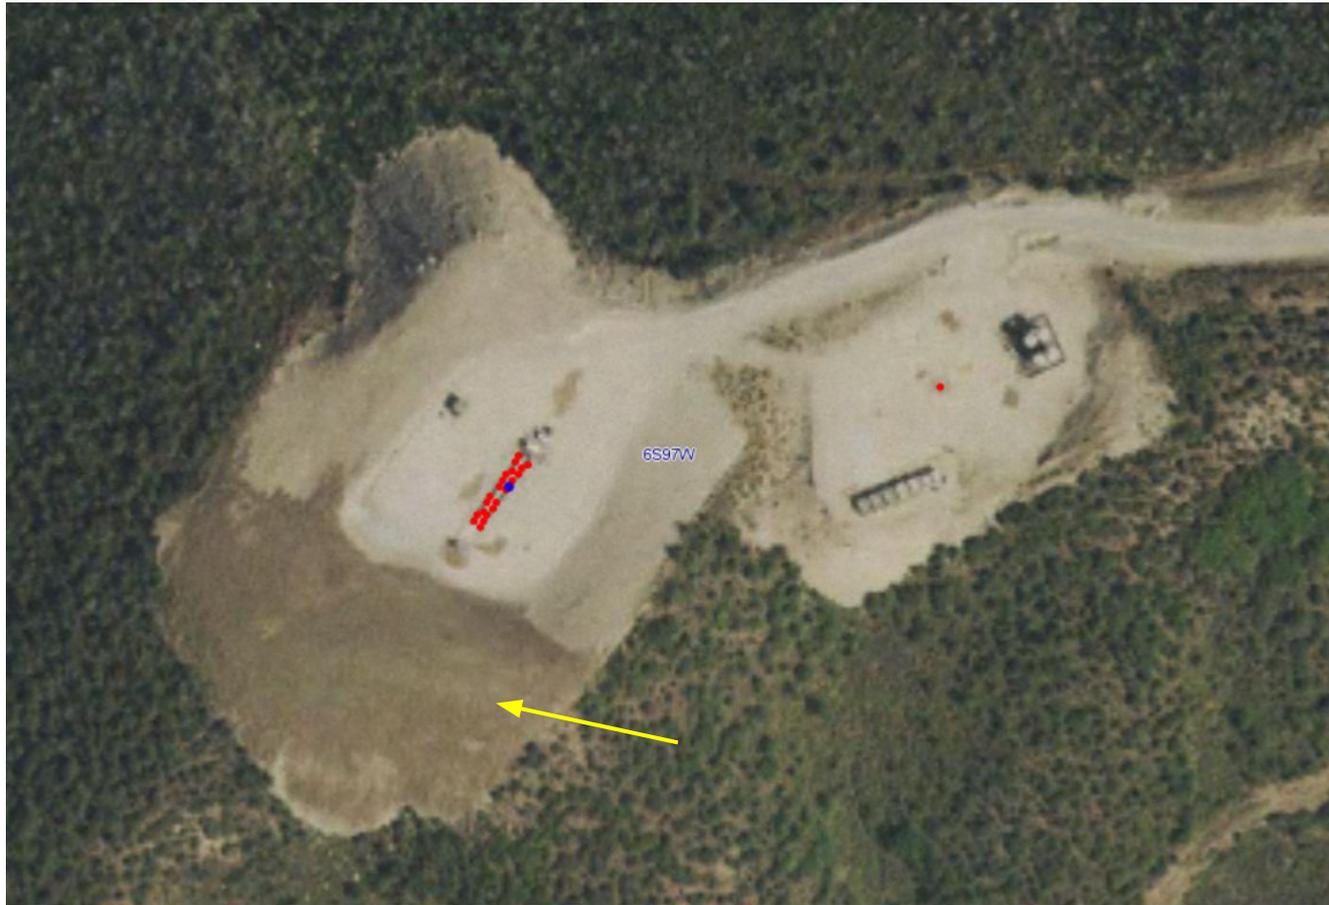
**Photo 6:** 2021 COGIS aerial image. Arrow shows areas of the Location where topsoil had been replaced.
