Inspection Photos

Operator: LARAMIE ENERGY LLC - 10433

Location ID: 312736

Inspection No: 696205303

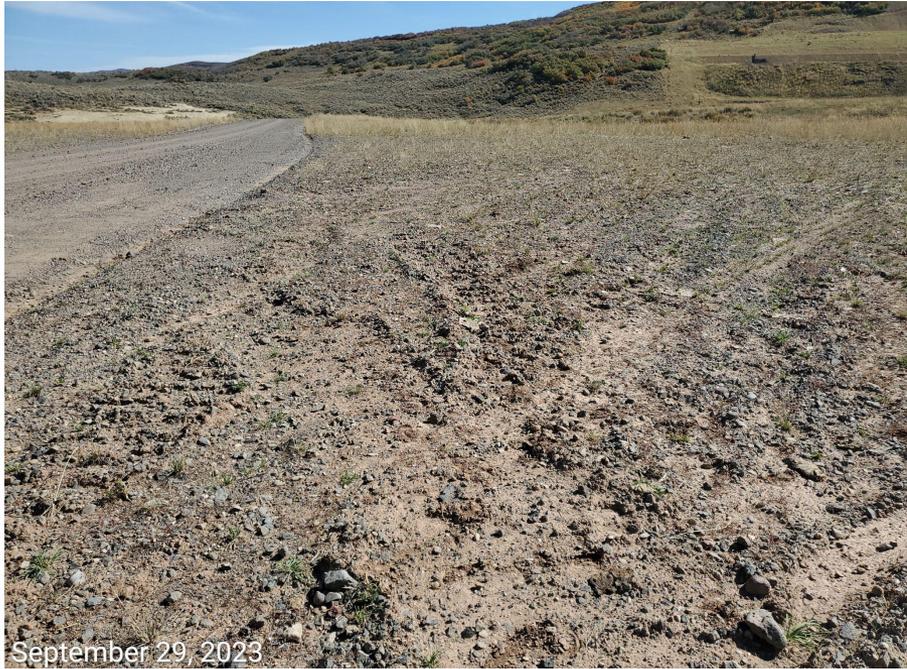
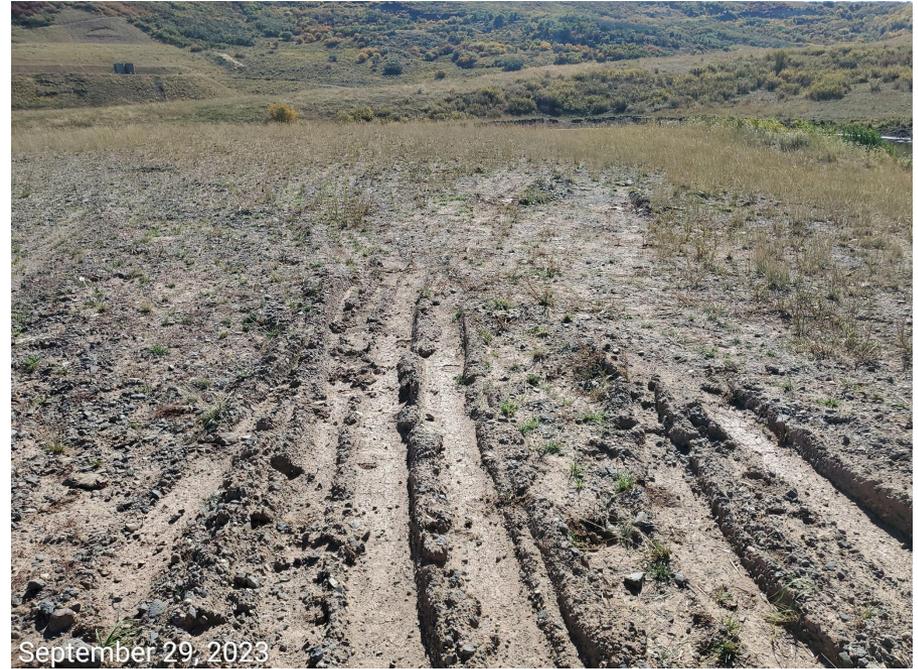
Photo 1: Photos taken from the southwest end of the Location, facing northwest and southwest. Photos show areas of the Location where gravel/road base remains on site. Desirable vegetation establishment within the graveled areas is sparse. Unable to find evidence that compaction alleviation (cross ripping to a minimum depth of 18 inches) had been performed. Additionally, photo right also shows vehicles appear to have traveled over the reclamation, resulting in degradation.

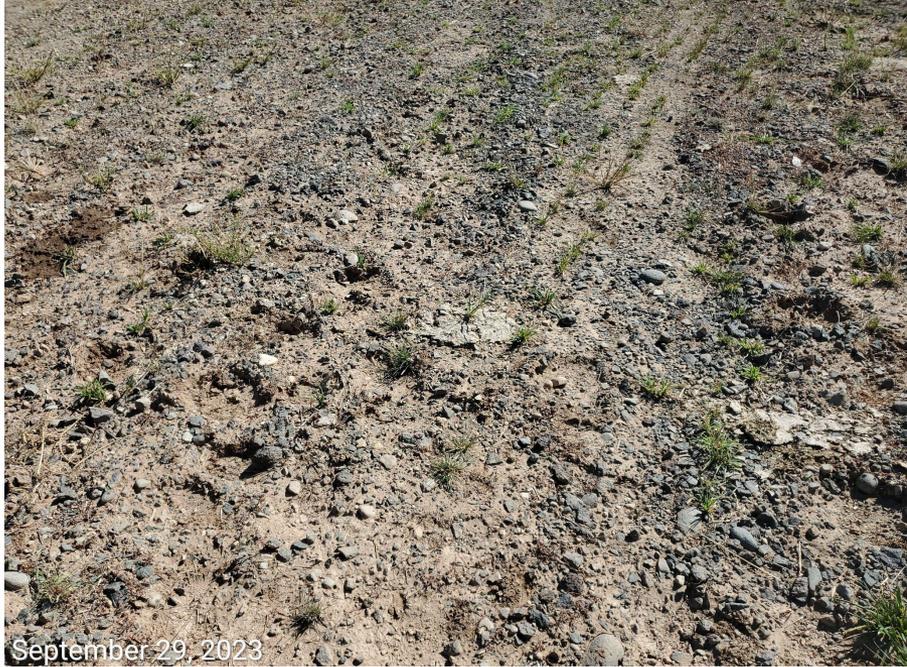
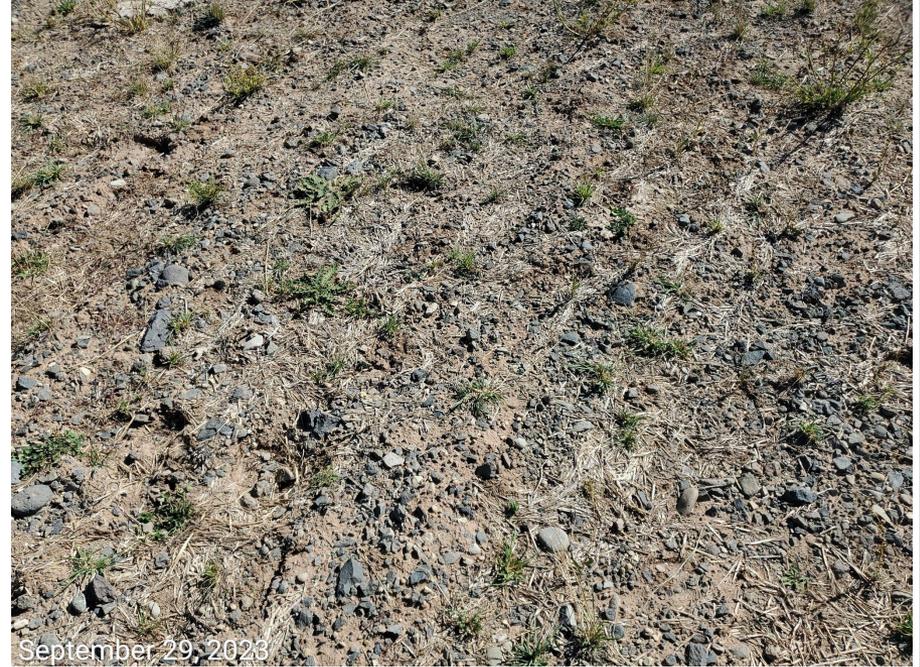
Photo 2: Photos taken from the central areas of the Location. Photos show gravel/road base remains on site. Desirable vegetation establishment within the graveled areas is sparse and not progressing towards 1004 standards.

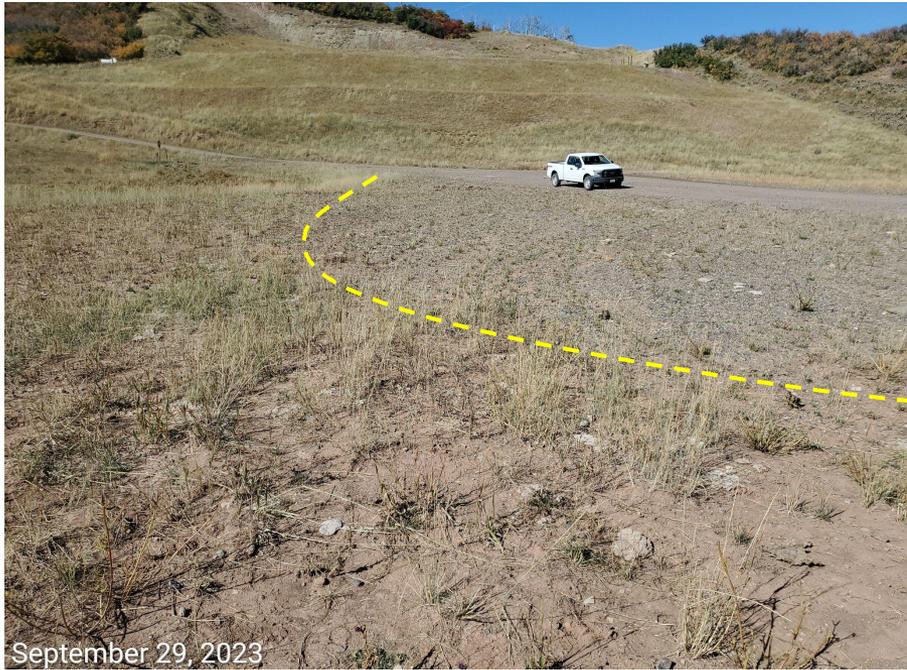
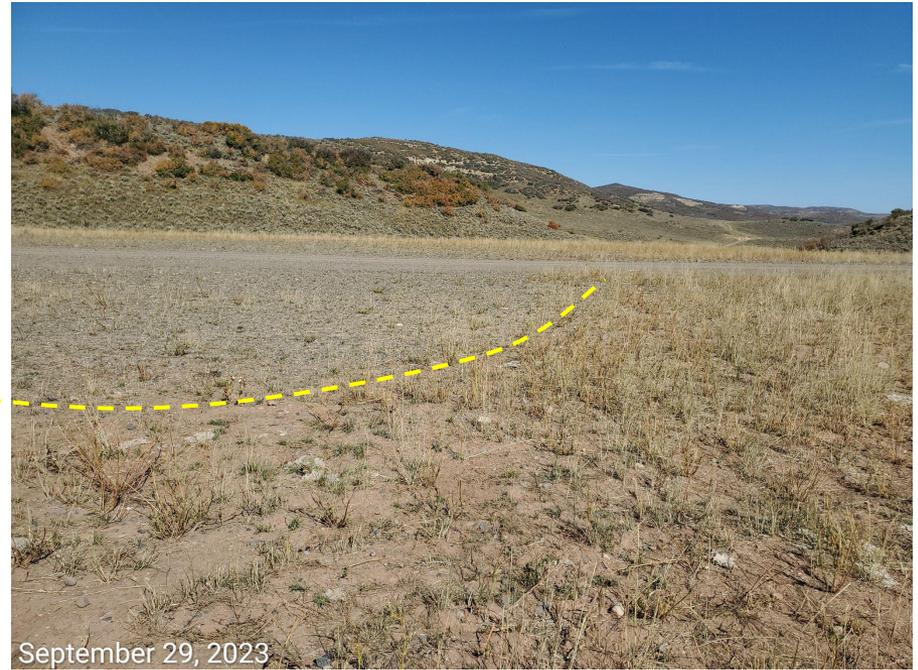
Photo 3: Photos taken from the south end of the Location, facing northwest and northeast. See comments under photo 1. Areas above the dotted line are where gravel/road base remains on Location.

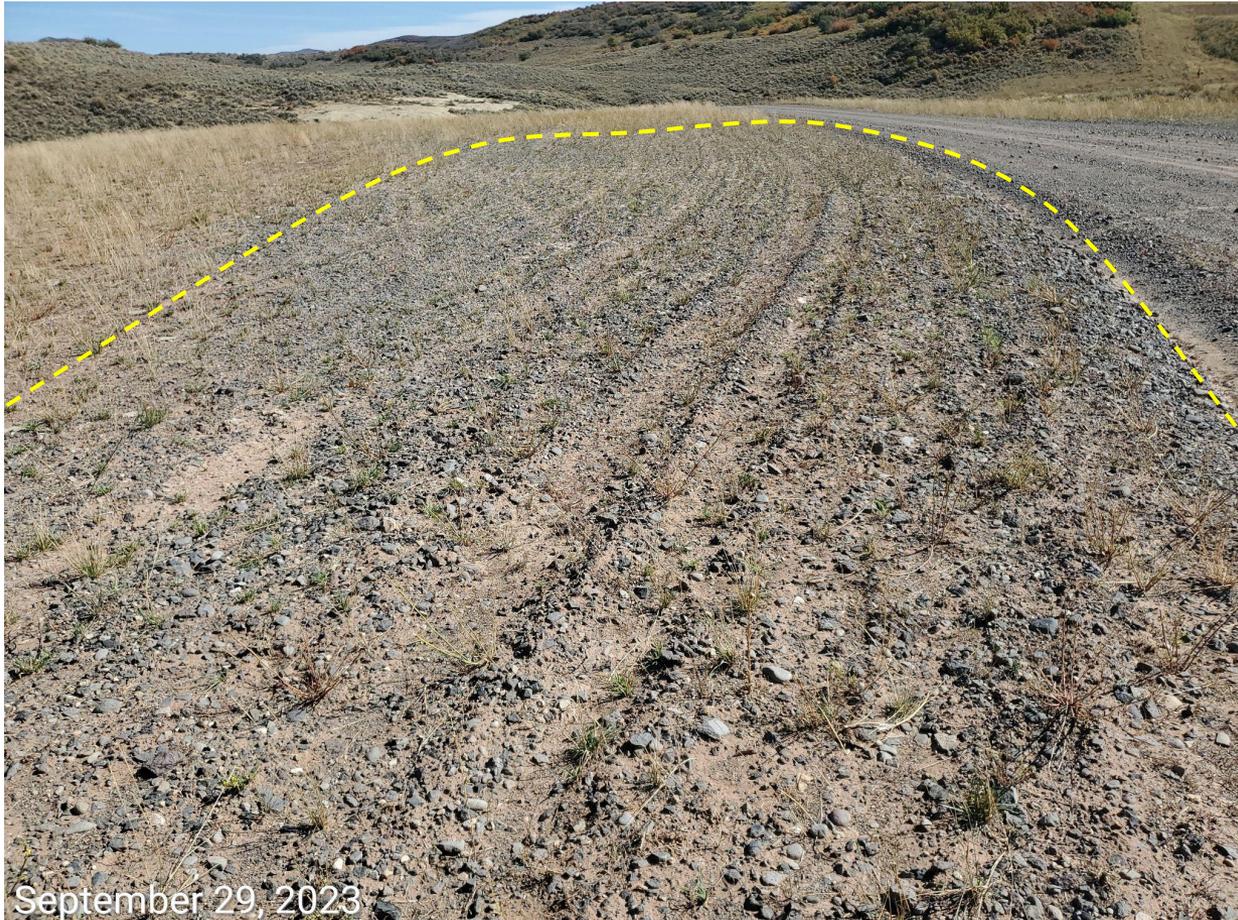
Photo 4: Photo taken from the northwest end of the Location, facing east. See comments under photo 1.

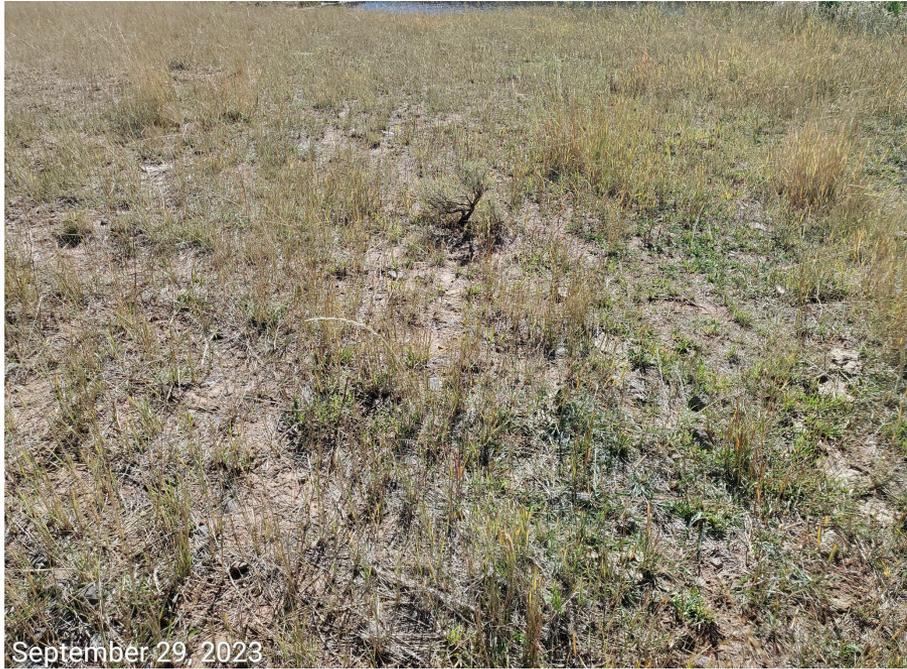
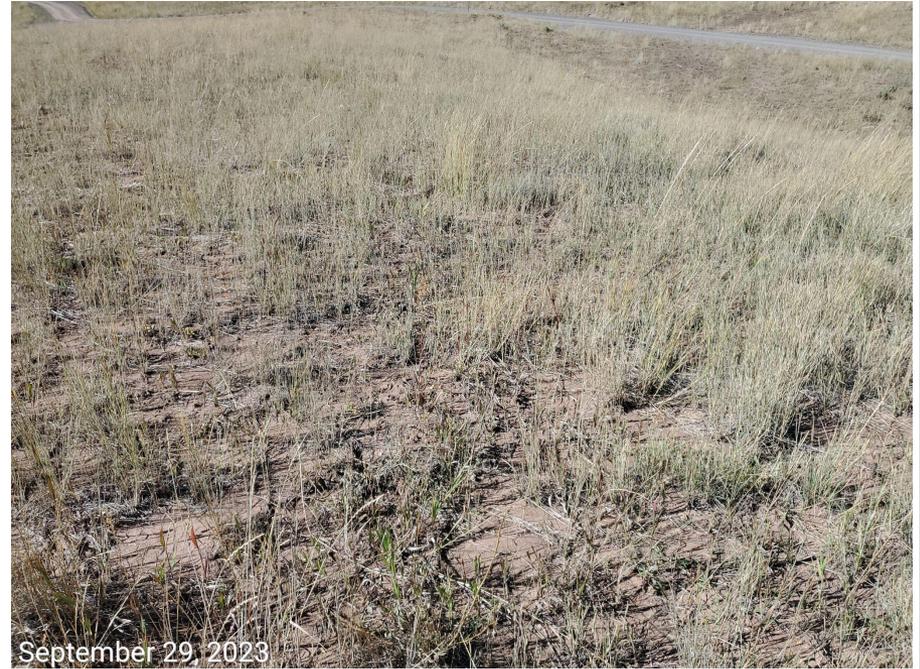
Photo 5: Photos taken from perimeter areas of the Location where gravel has been removed, and vegetation is progressing towards 1003 standards.

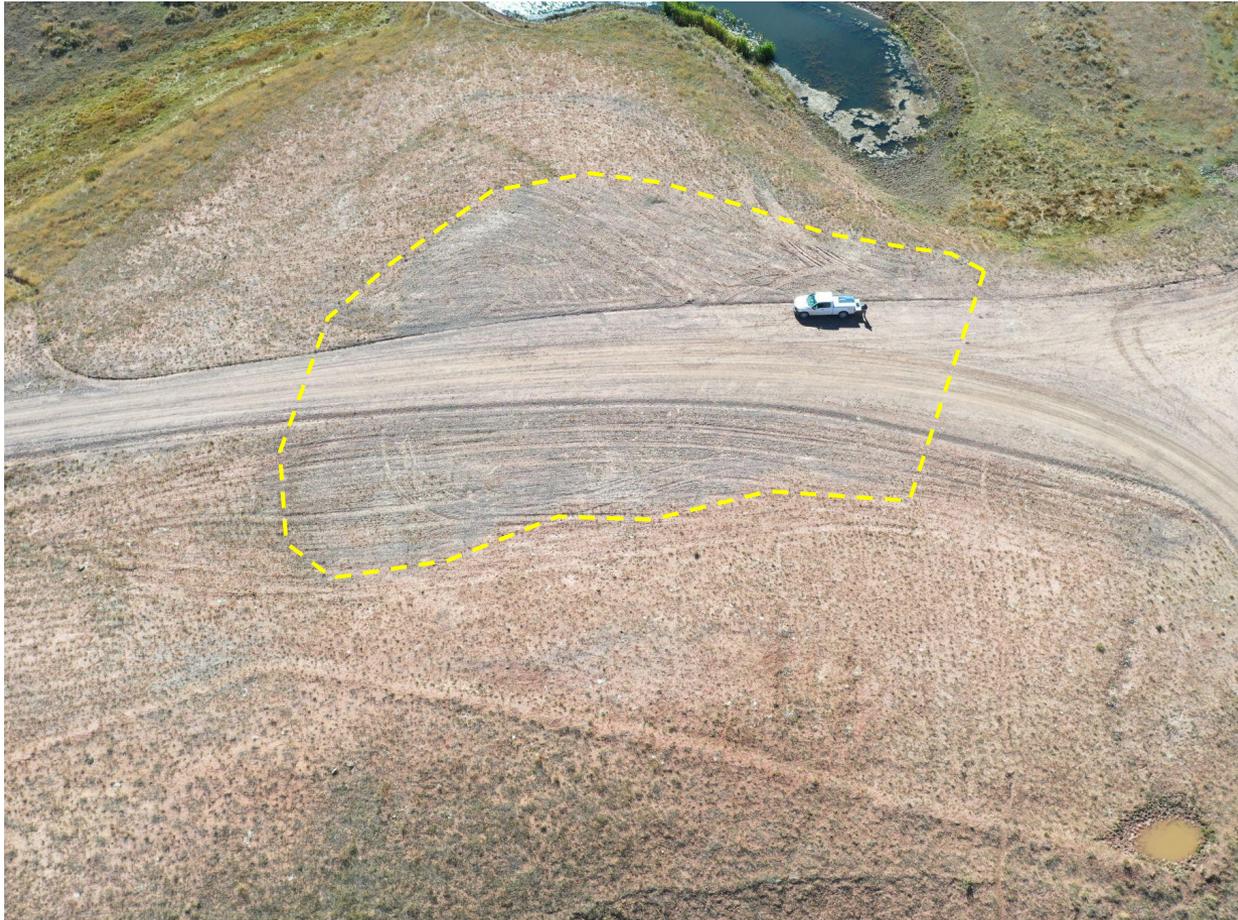
Photo 6: Photo taken with use of a sUAS. Yellow polygon represents areas where gravel/road base remain, and where reclamation is not progressing towards 1004 standards

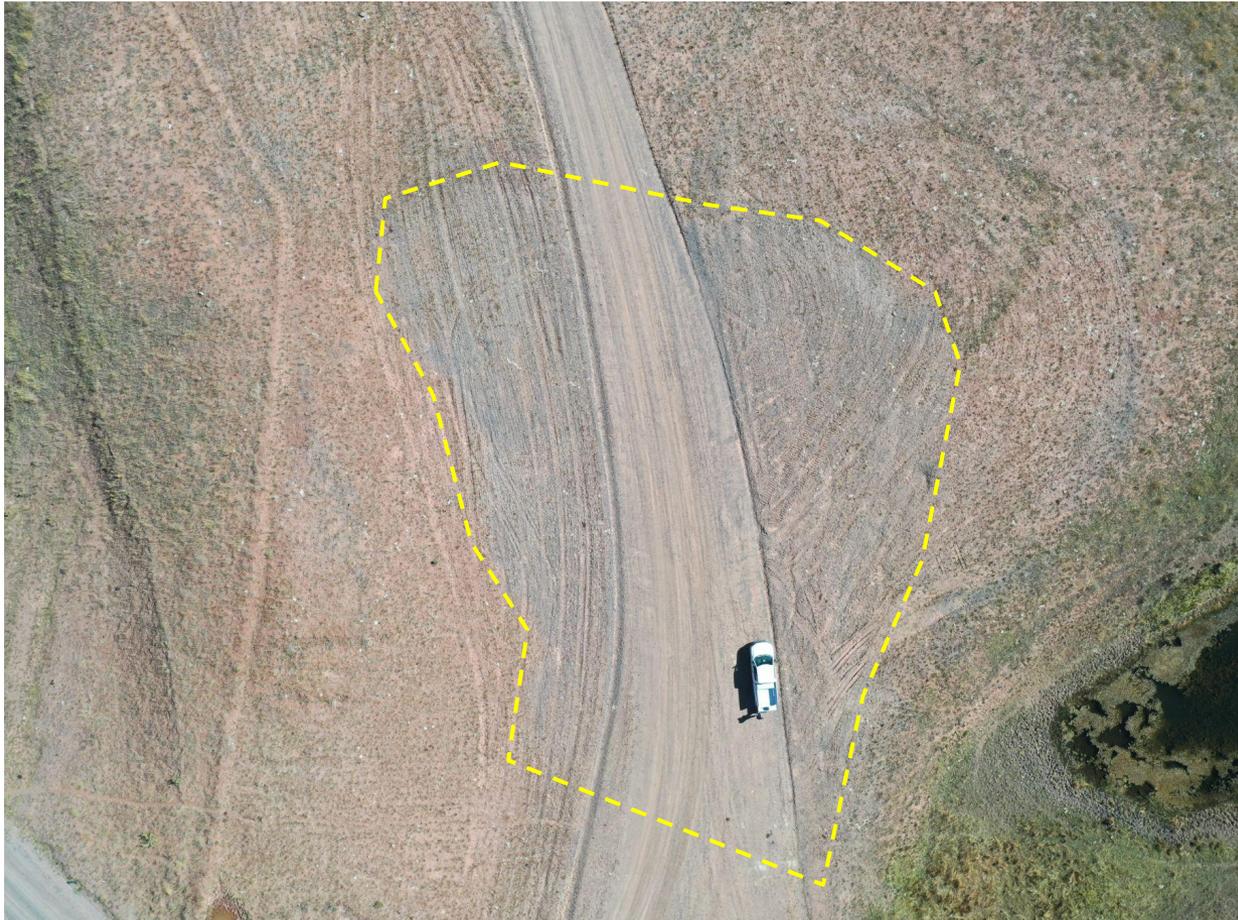
Photo 7: Photo taken with use of a sUAS. Yellow polygon represents areas where gravel/road base remain, and where reclamation is not progressing towards 1004 standards
