Inspection Photos

Loc: 379485

Operator: RENEGADE OIL & GAS COMPANY LLC

Inspection Date: 10/5/2023

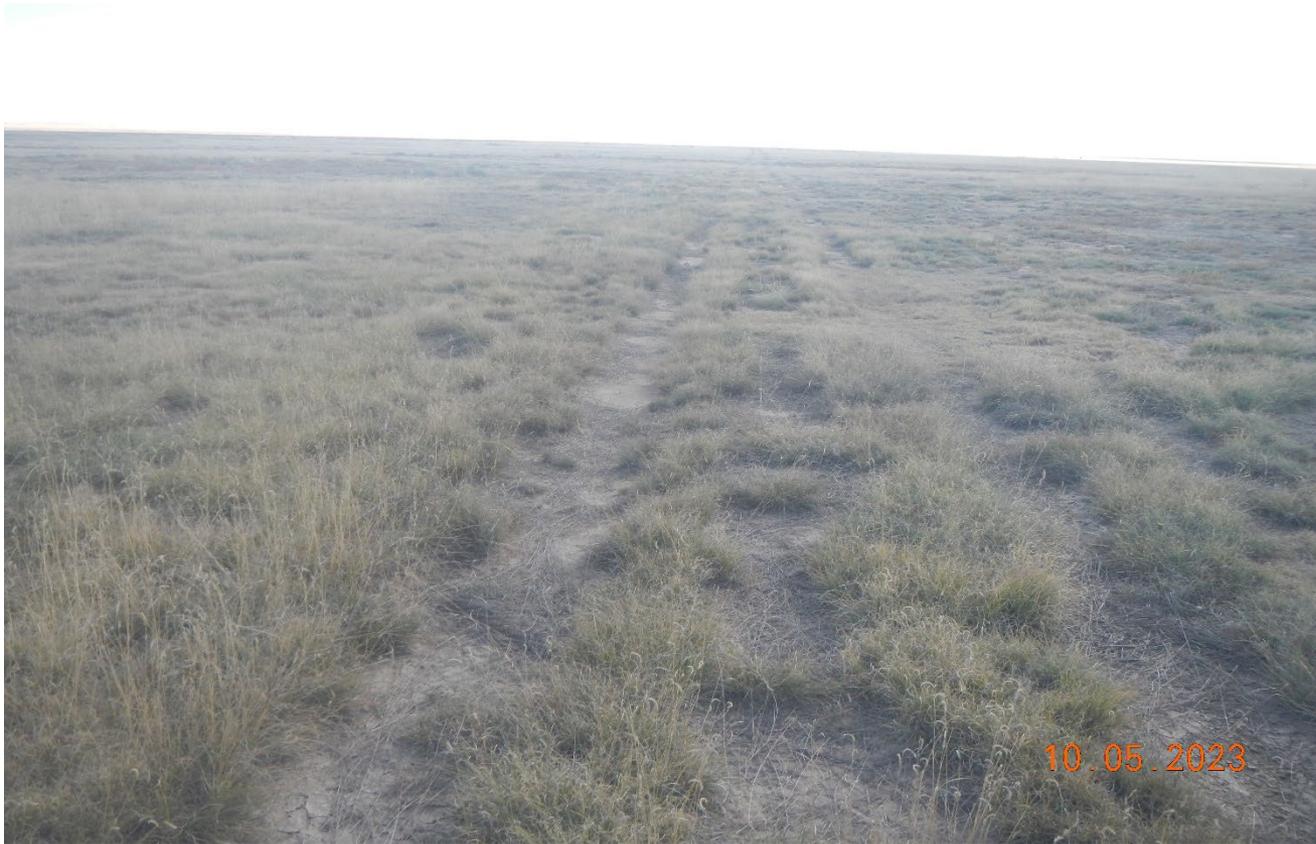
Photo 1. Facing south along the access road. The two track road remains but vegetation appears to have mostly re-established along the former access road.

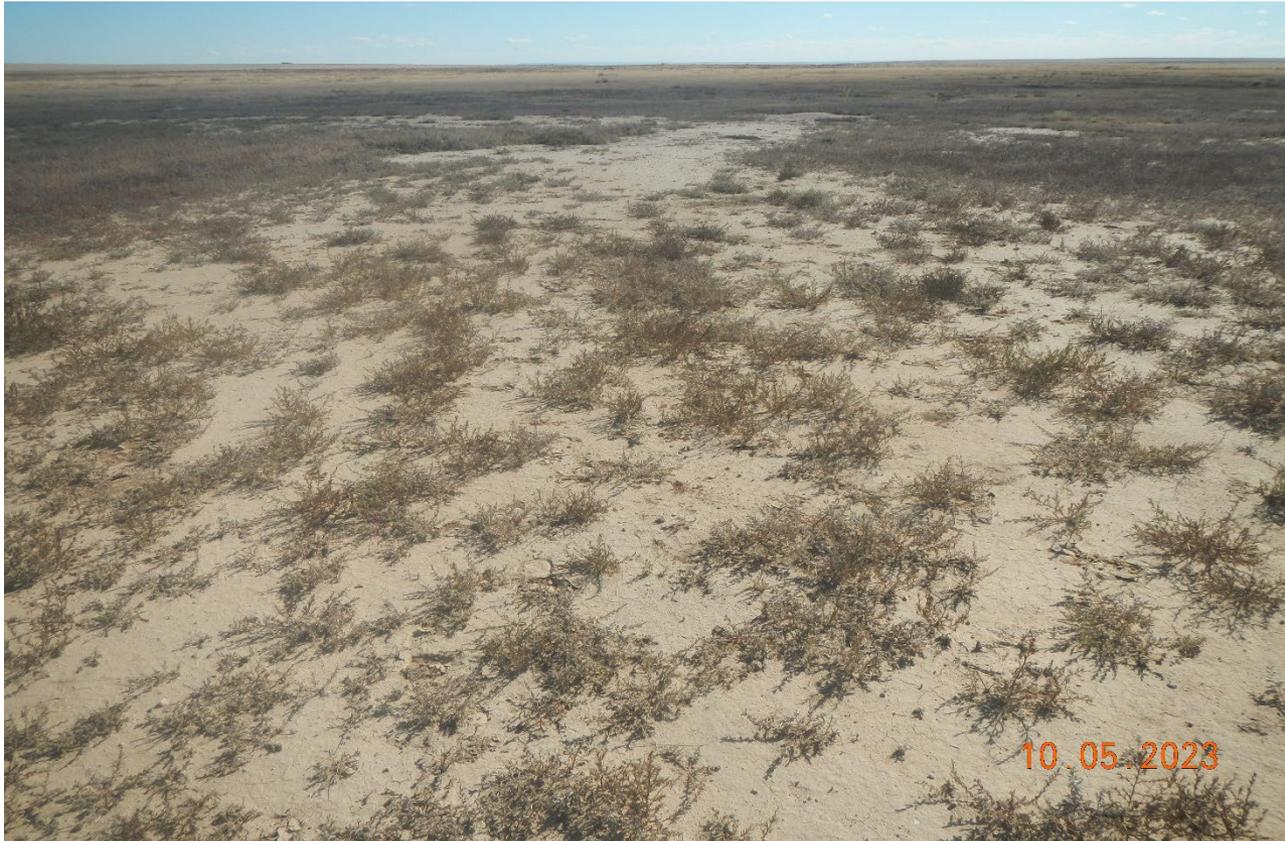
Photo 2. Facing south toward the location. The location consists primarily of undesirable weeds (*Kochia* sp.) and bare soil. The location has not reestablished a uniform vegetation cover of 80% of reference area levels.

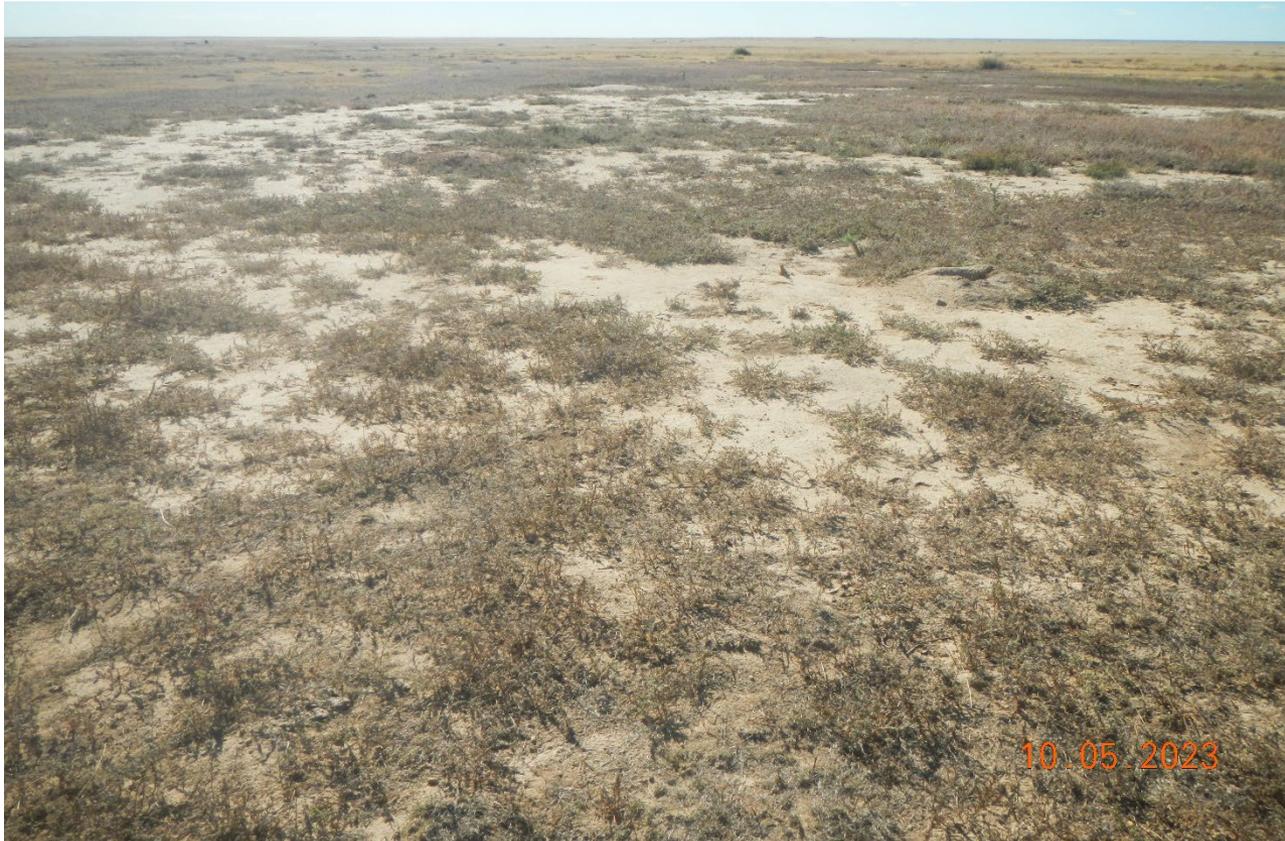
Photo 3. Facing southwest toward the location. The location consists primarily of undesirable weeds (*Kochia* sp.) and bare soil. The location has not reestablished a uniform vegetation cover of 80% of reference area levels.

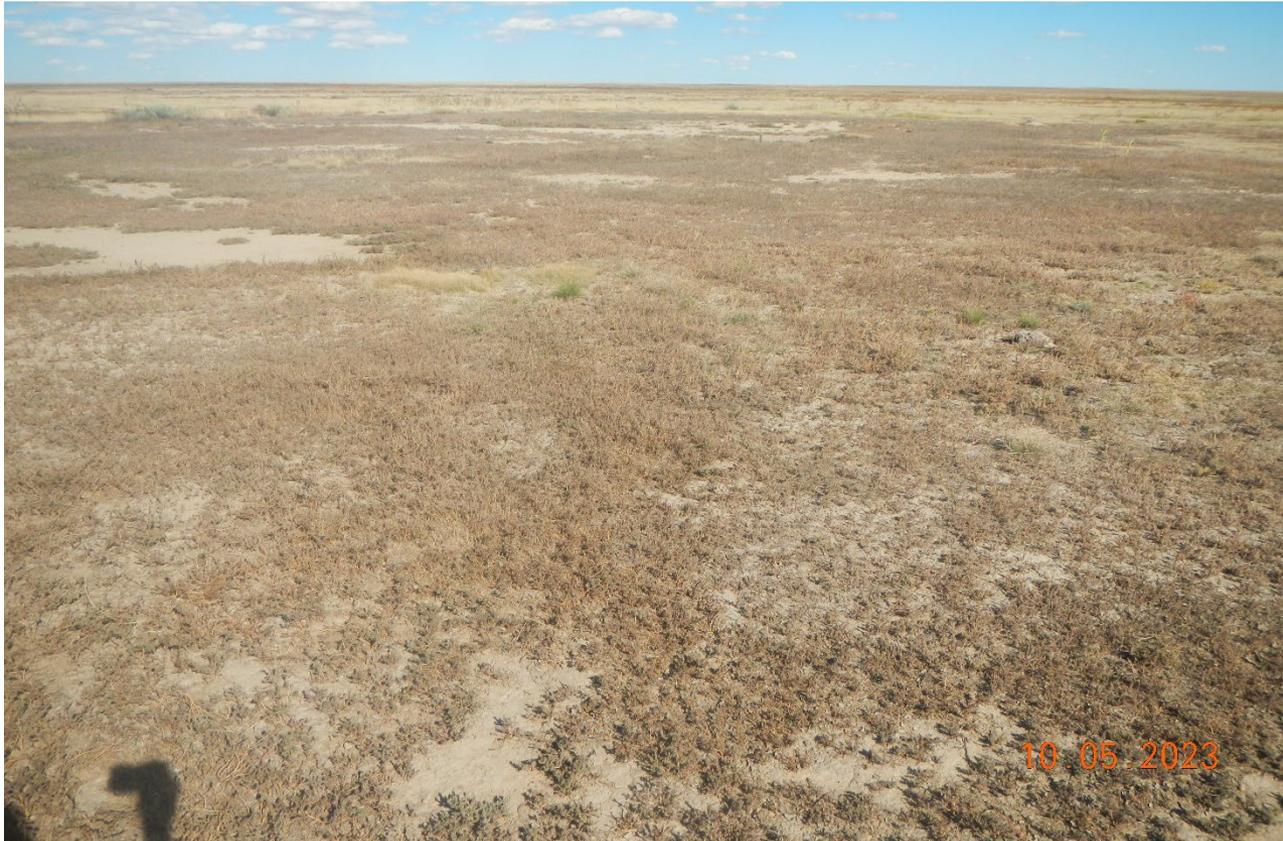
Photo 4. West side of the location facing east. The location consists primarily of undesirable weeds (*Kochia* sp.) and bare soil. The location has not reestablished a uniform vegetation cover of 80% of reference area levels.

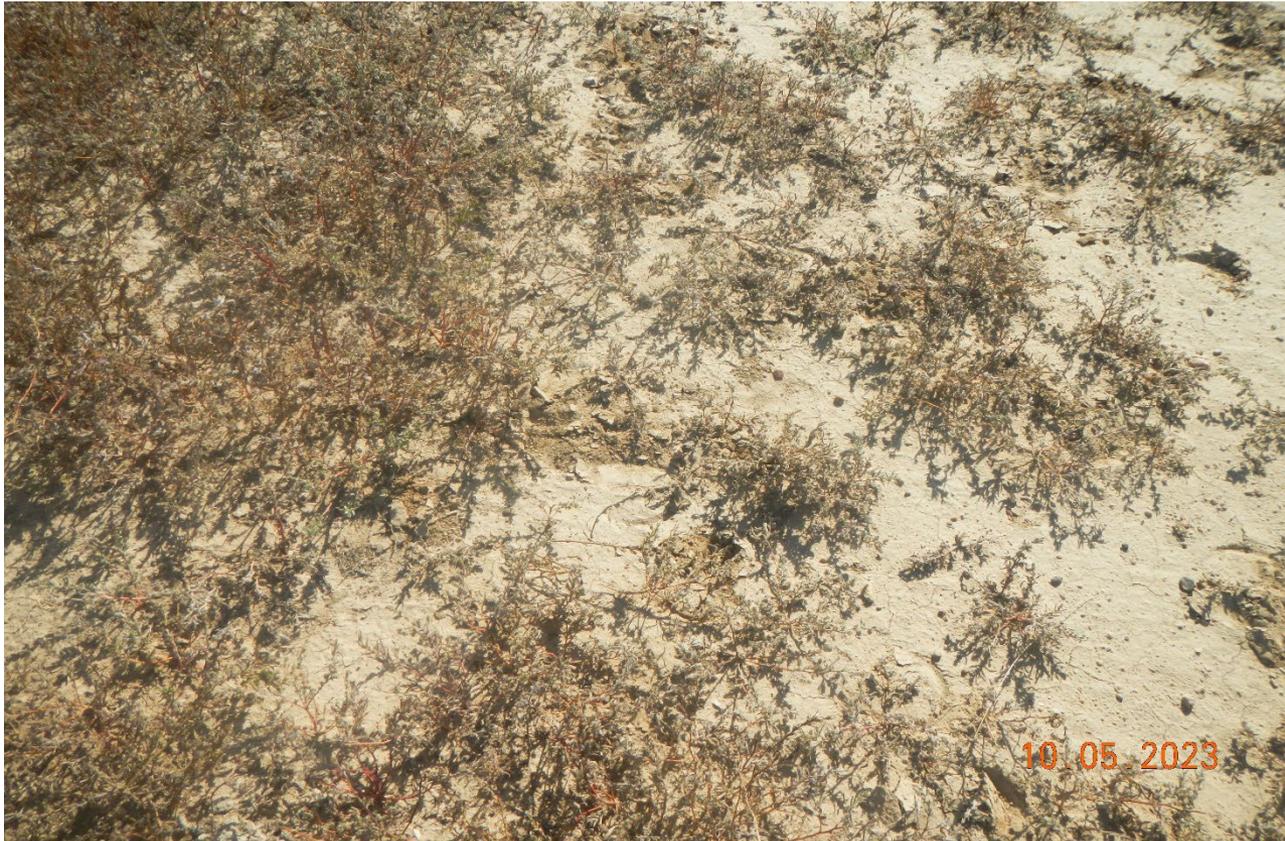
Photo 5. View of groundcover shows undesirable weeds which are found throughout the location. (Kochia sp)

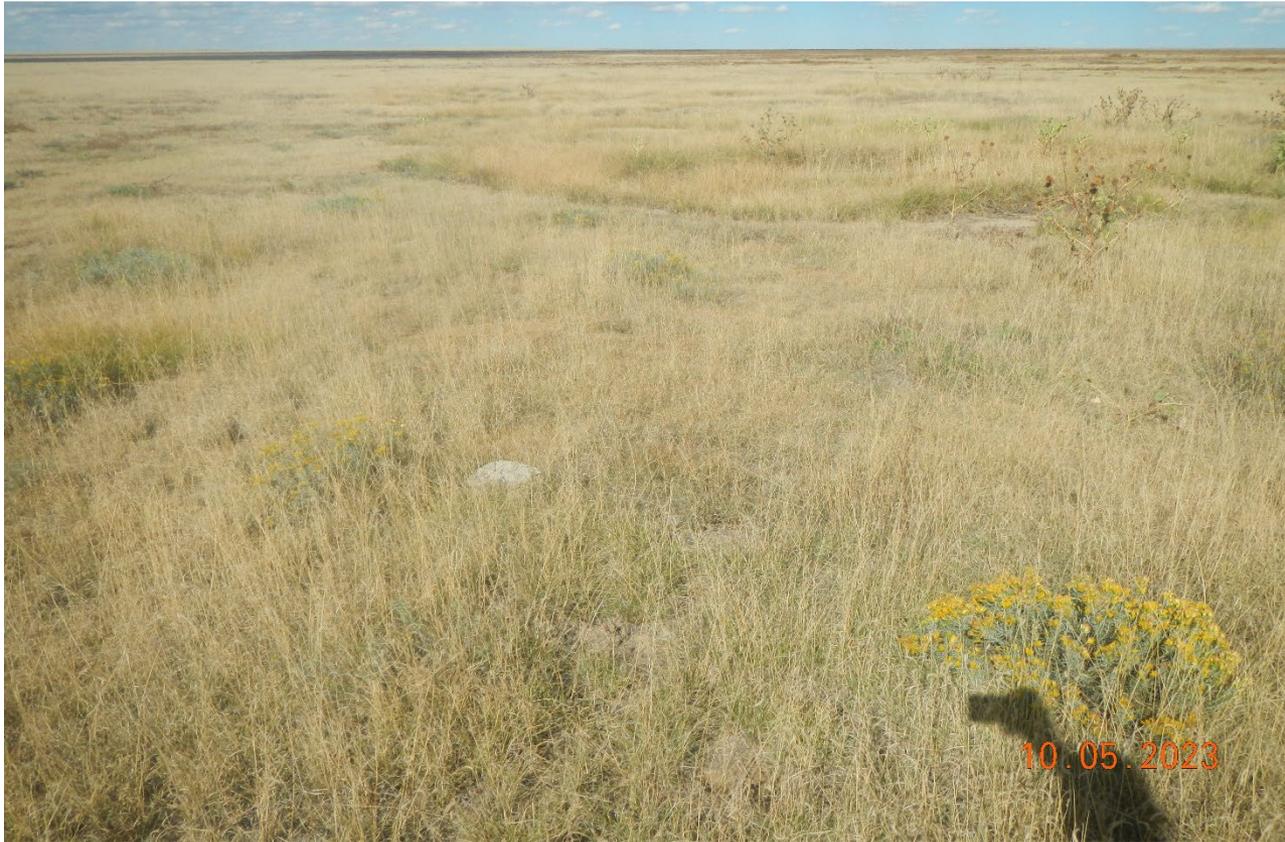
Photo 6. Facing northeast toward the surrounding undisturbed reference areas which consists of Blue grama, Sand dropseed, Buffalo grass among other native species.

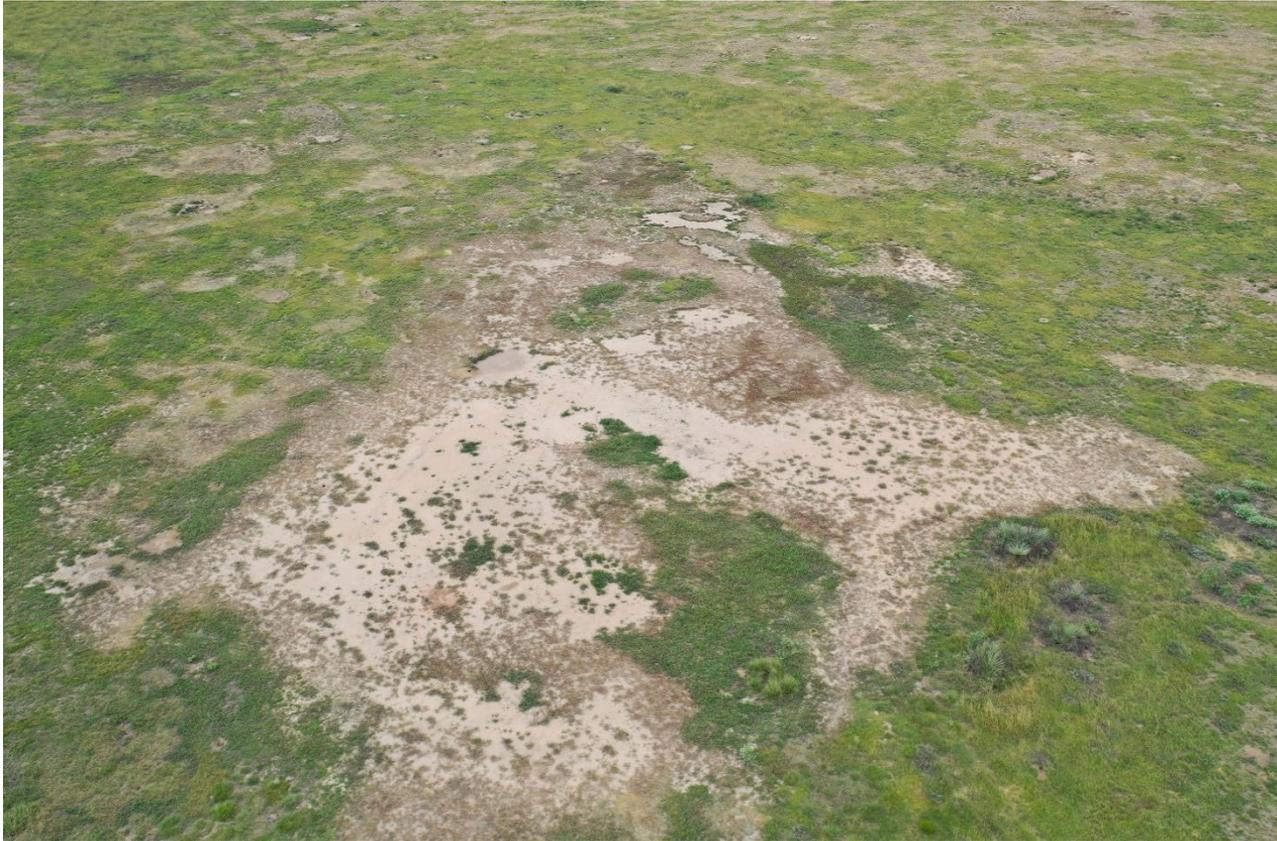
Photo 7. Drone aerial photo (taken 8/9/23) facing west down toward the location. There are areas bare vegetation which appear to be impacted from the wellsite operations.

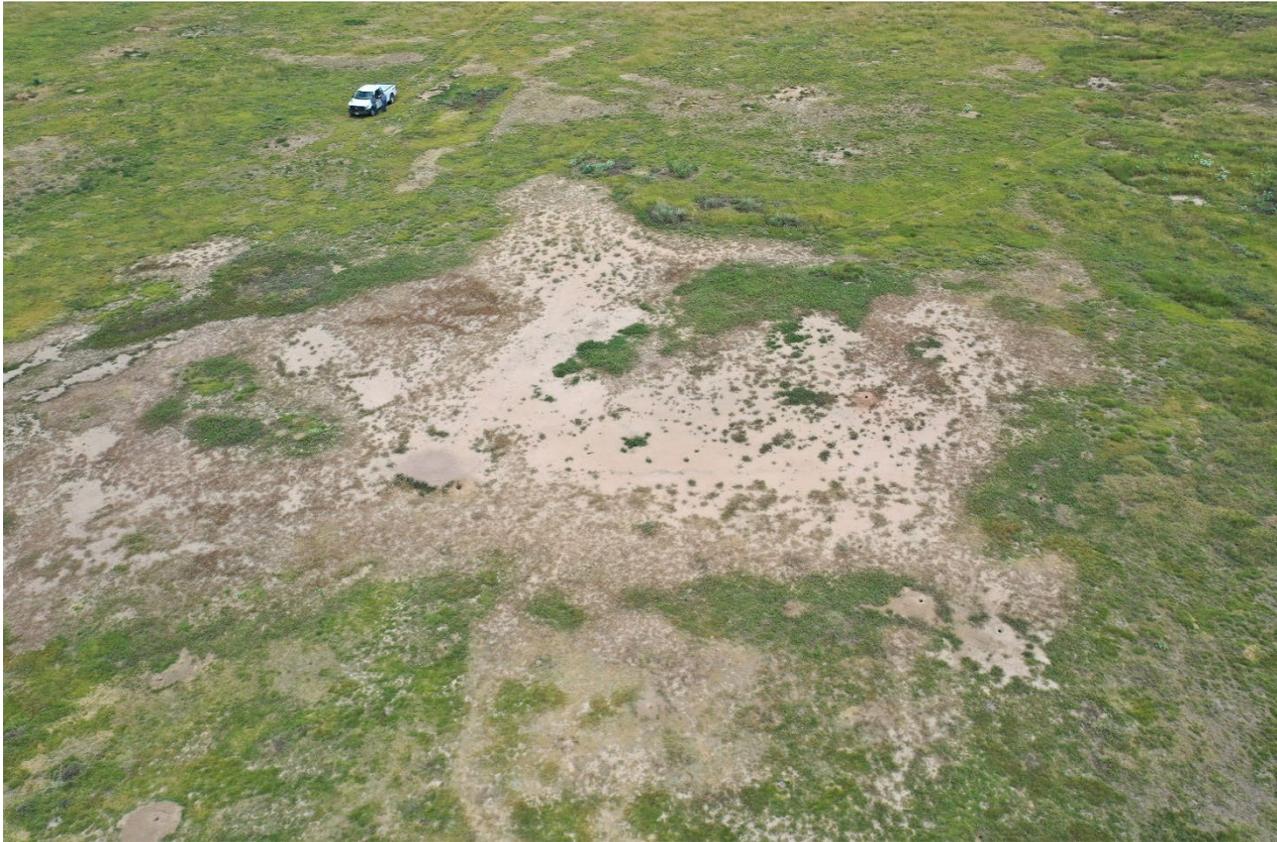
Photo 8. Drone aerial photo (taken 8/9/23) facing north down toward the location. The inspectors truck is shown in the upper left for scale.

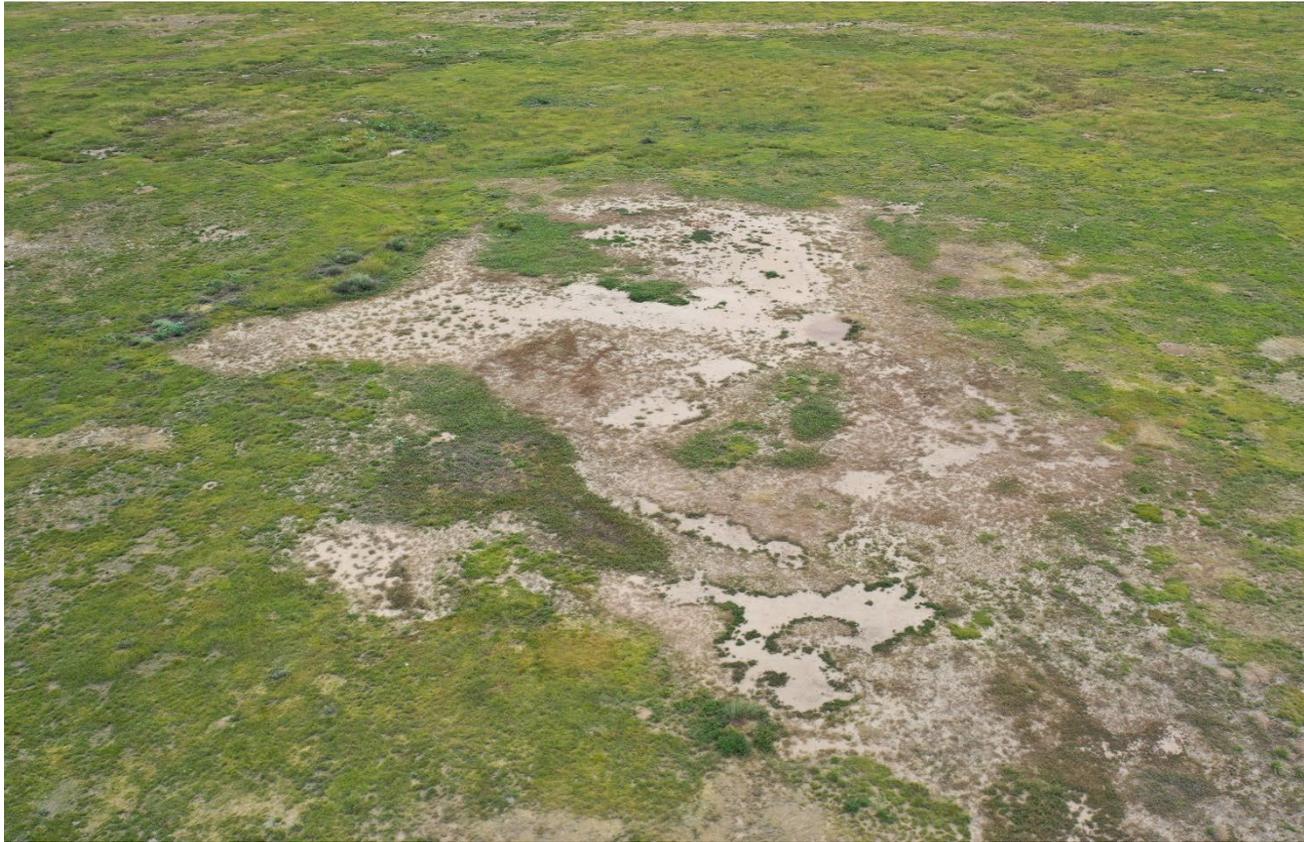
Photo 9. Drone aerial photo (taken 8/9/23) facing east down toward the location. There are areas bare vegetation which appear to be impacted from the wellsite operations.

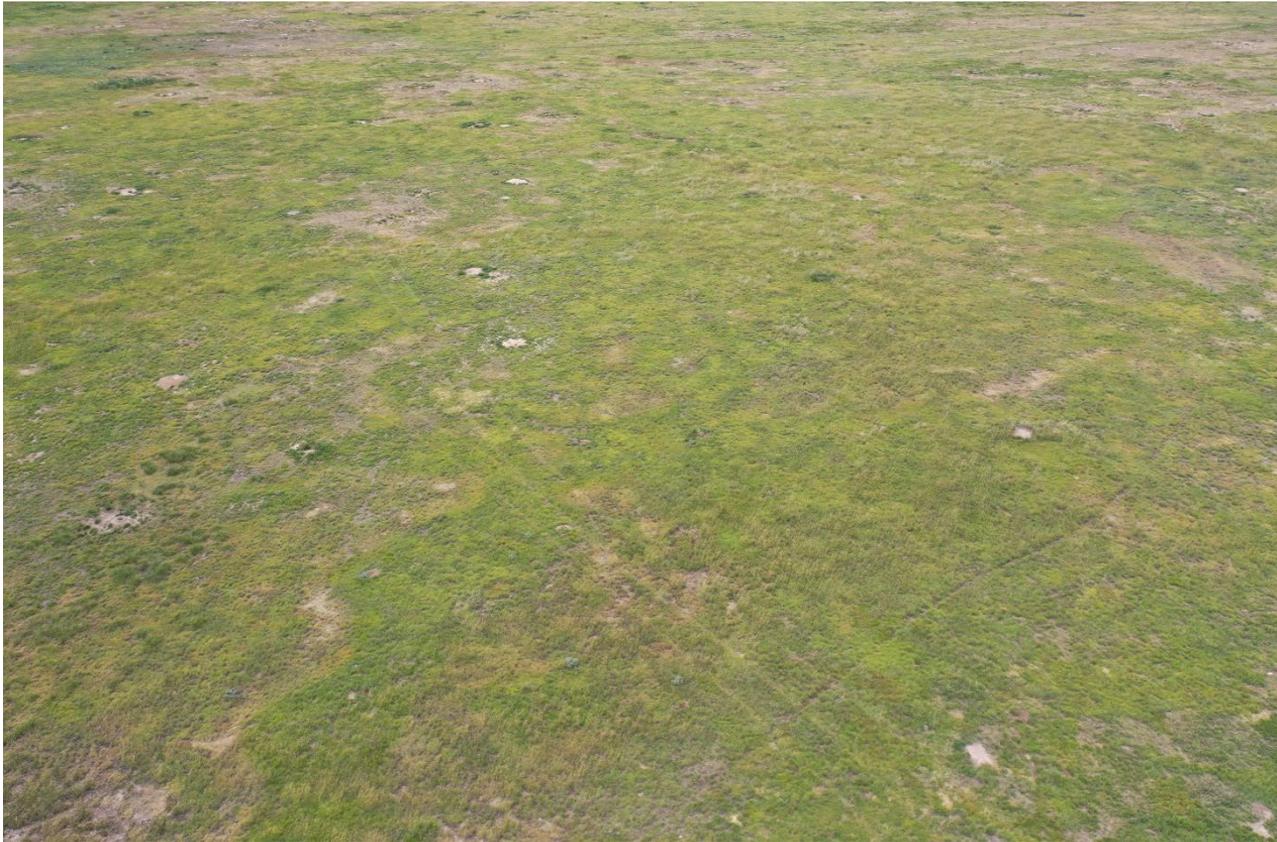
Photo 10. Drone aerial photo (taken 8/9/23) facing southeast toward the surrounding undisturbed reference area which has a uniform perennial vegetation cover.
