Final Reclamation and Stormwater Inspection

Operator: H&M PETROLEUM CORPORATION - 10032

Location ID: 312312

Inspection Document #: 708200601

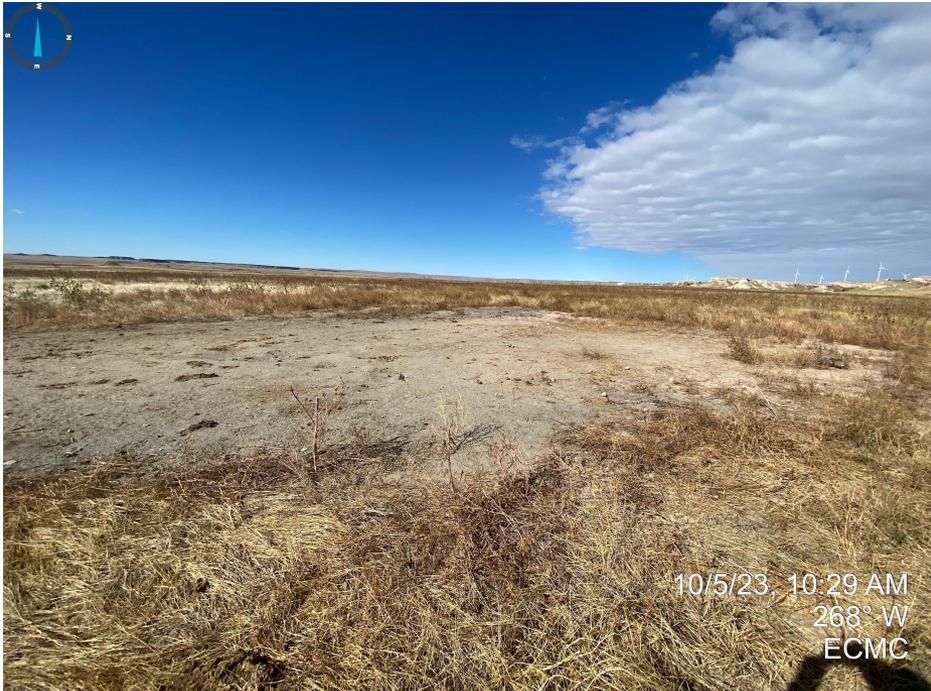
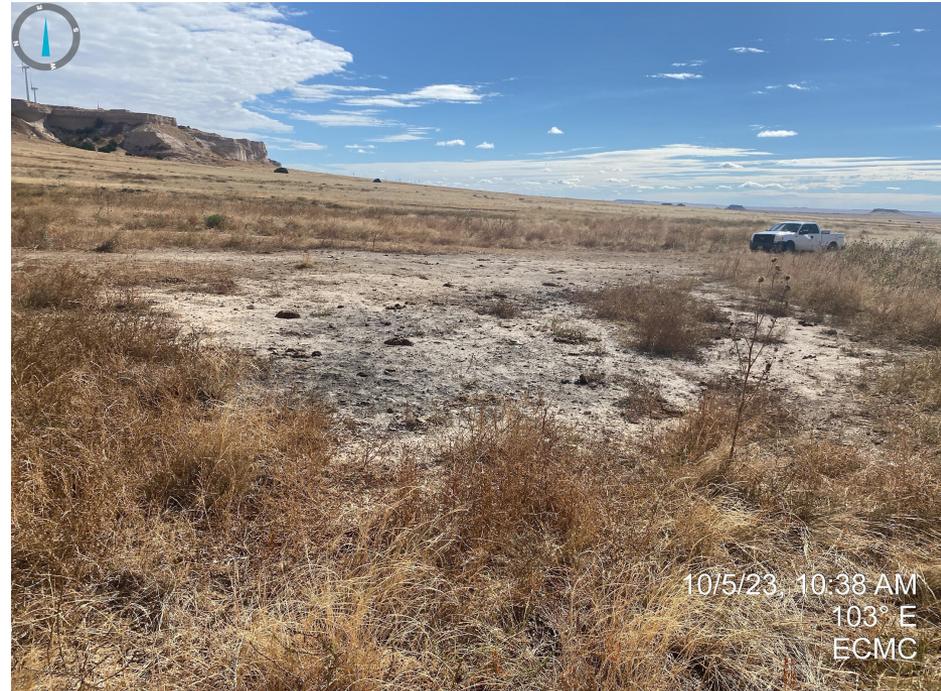
Photos 1 & 2. Taken from the southern portion of the location. Photo illustrates non-uniform vegetative cover resulting in areas of bare/exposed soils. Additional revegetation activities are required in order to meet Rule 1004 standards and regulations.

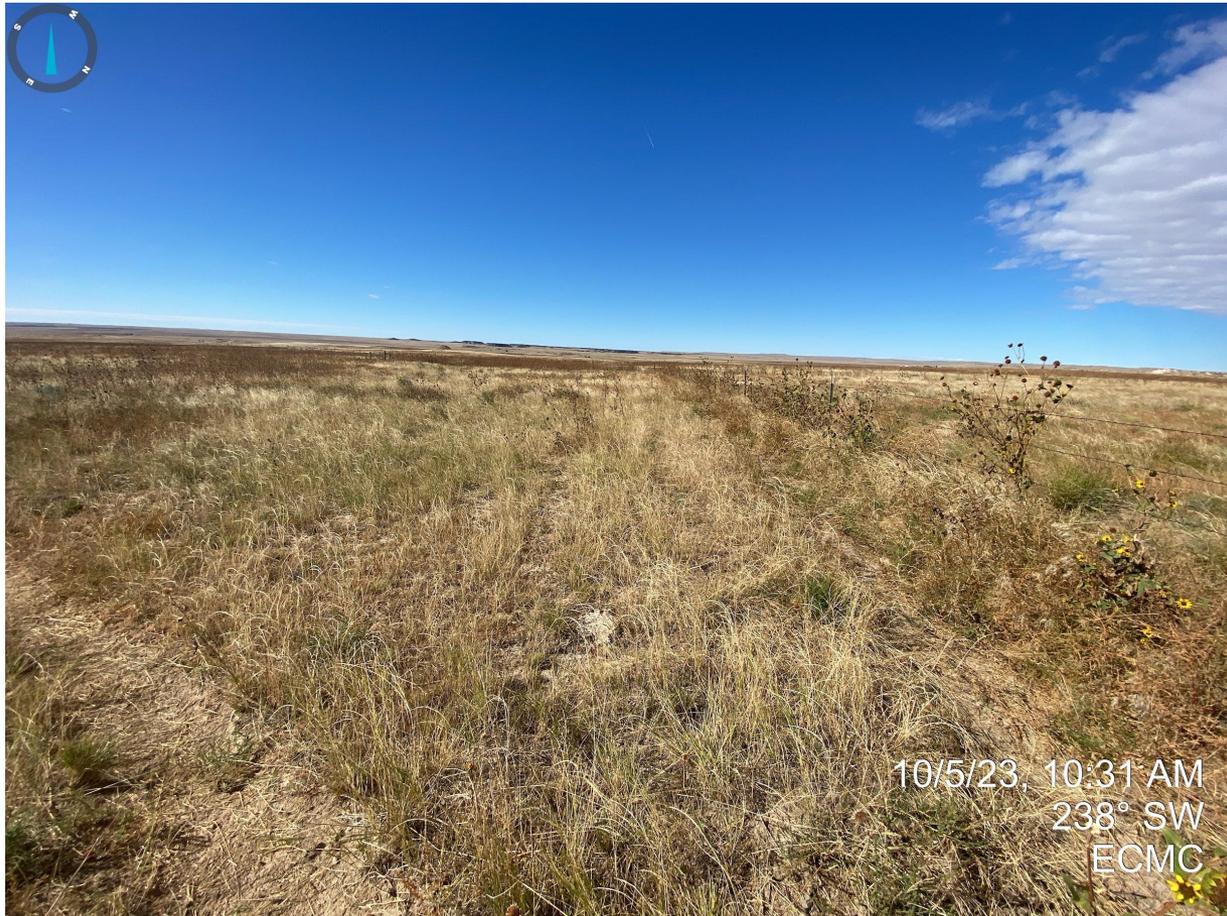
Photo 3. Taken from the northeast corner of the location. The former tank battery location appears to be progressing towards Rule 1004 vegetation standards with the presence of desirable vegetation observed.

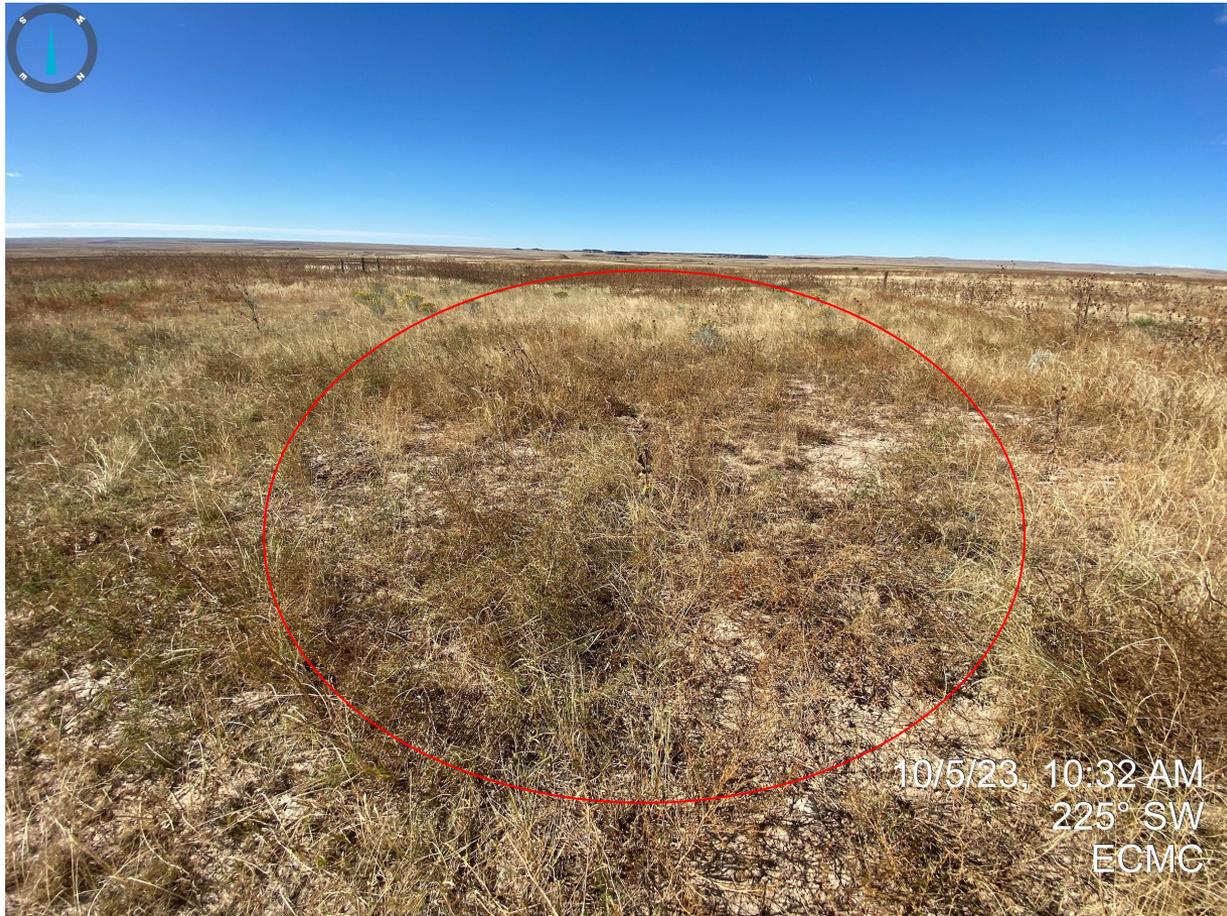
Photo 4. Taken between the former tank battery and pit area. Undesirable vegetation (e.g. kochia and russian thistle) was observed in portions of the reclaimed area.

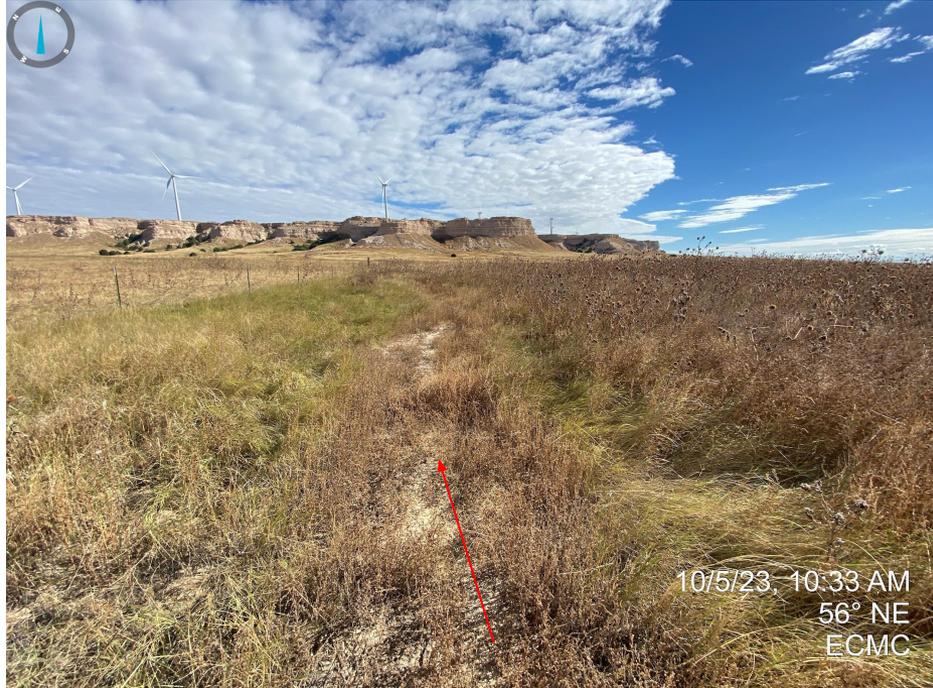
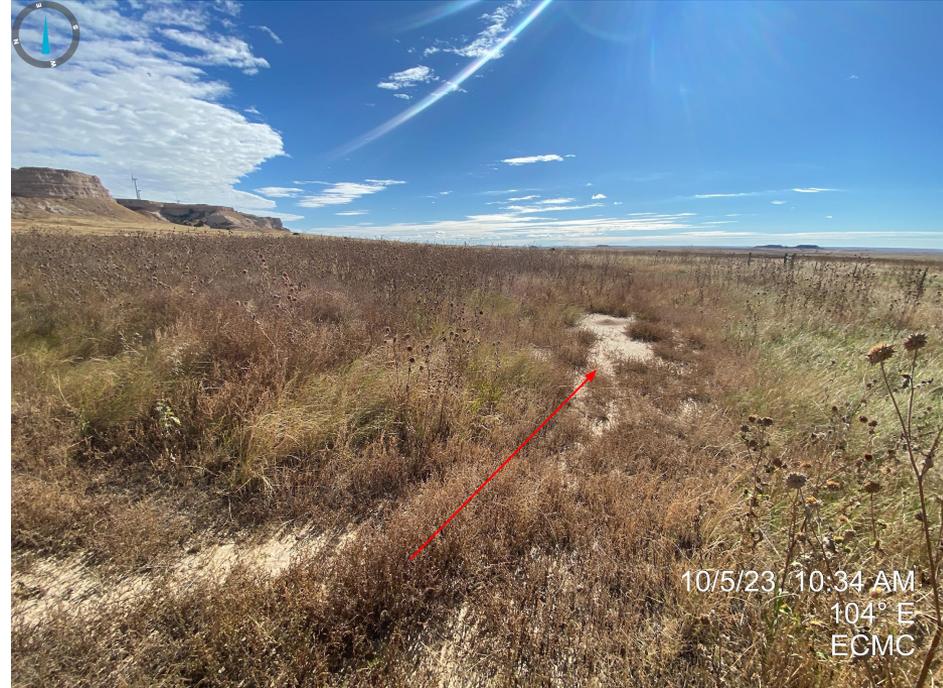
Photo 5 & 6. Taken from the northwest corner of the former pit. Photo illustrates that the former pit walls/berms have not been de-compacted, have soil suitability issues, or both; resulting in areas of bare and exposed soils and undesirable vegetation.

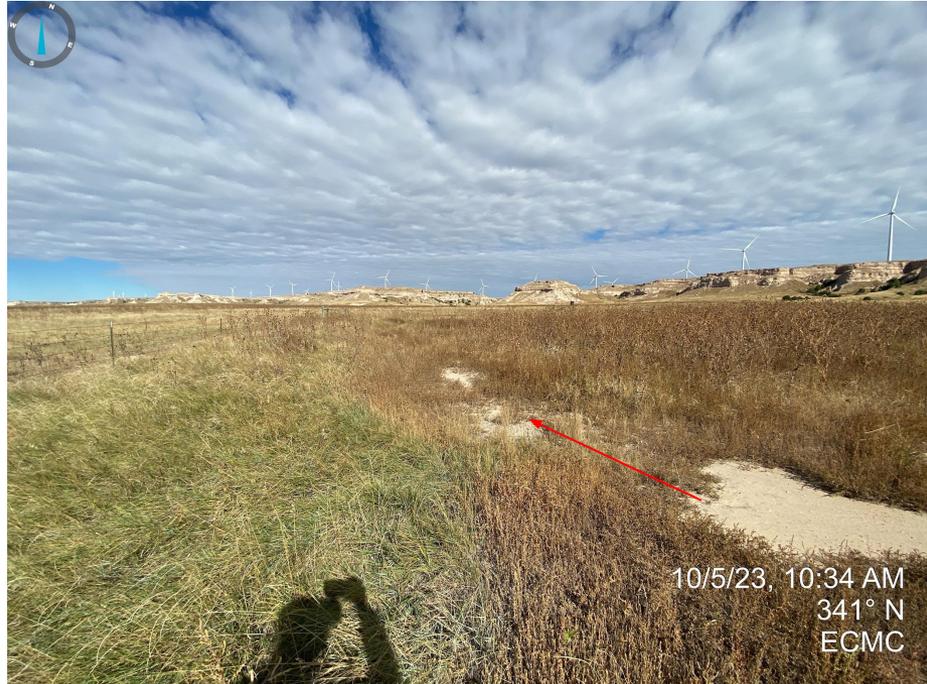
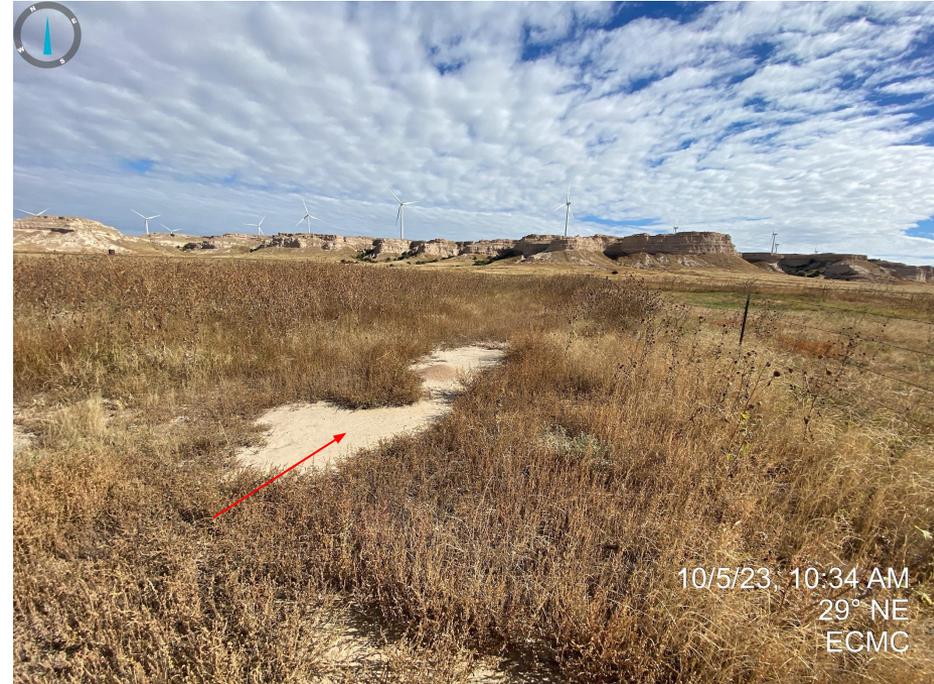
Photos 7 & 8. Taken from the southwestern corner of the pit; see comments in Photos 5 & 6.

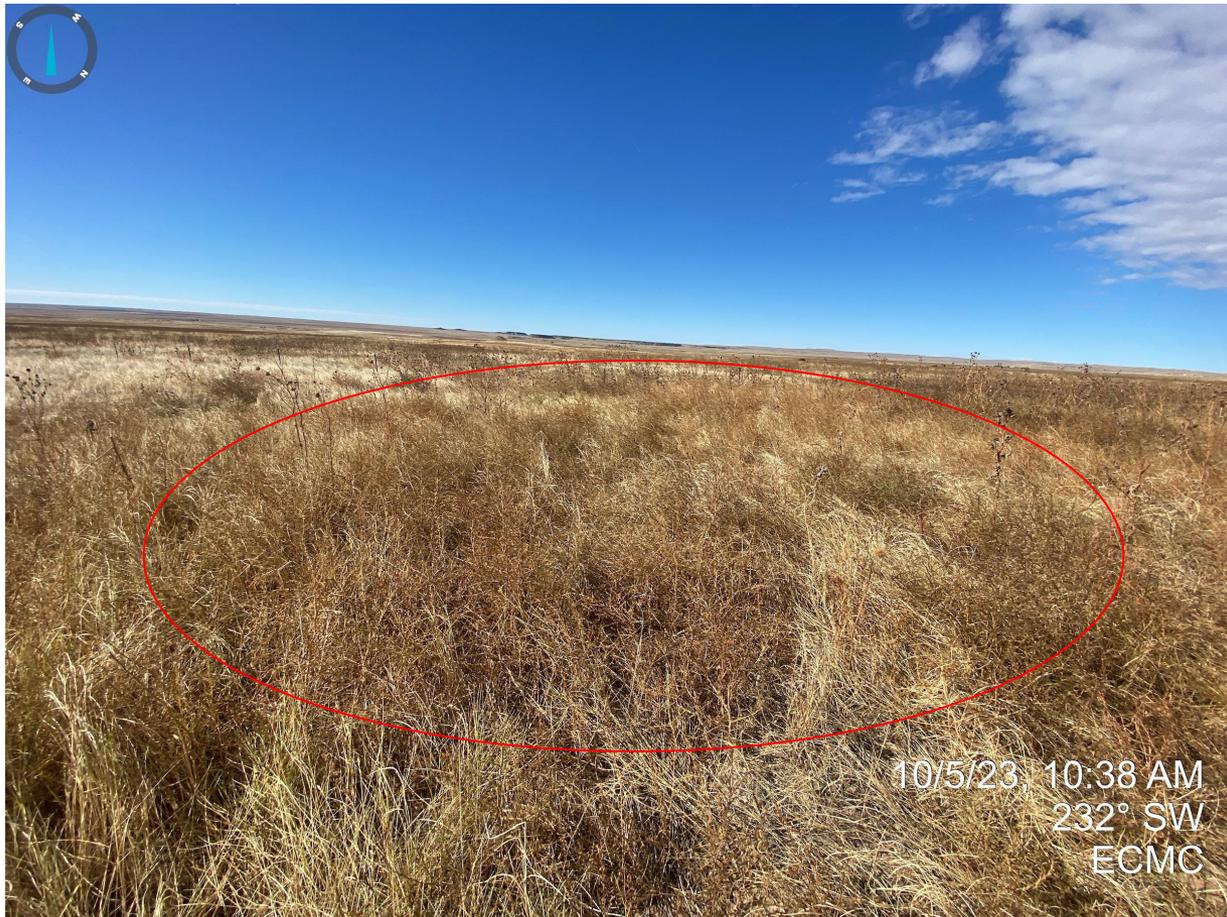
Photo 9. Taken from the center portion of the location. Photo illustrates undesirable vegetation (e.g. russian thistle) infestation within the reclaimed area. Additional management and/or revegetation activities are required in order to meet Rule 1004 vegetation standards.
