Storm Water Management and Erosion control
Location Name: TEP Rocky Mountain LLC LAST DANCE 9-3 Pad
Location # 324247

**Location Overview: Location is within High
Priority/Density/Black Bear Habitat areas.**

Section/Township/Range: 34 6S92W

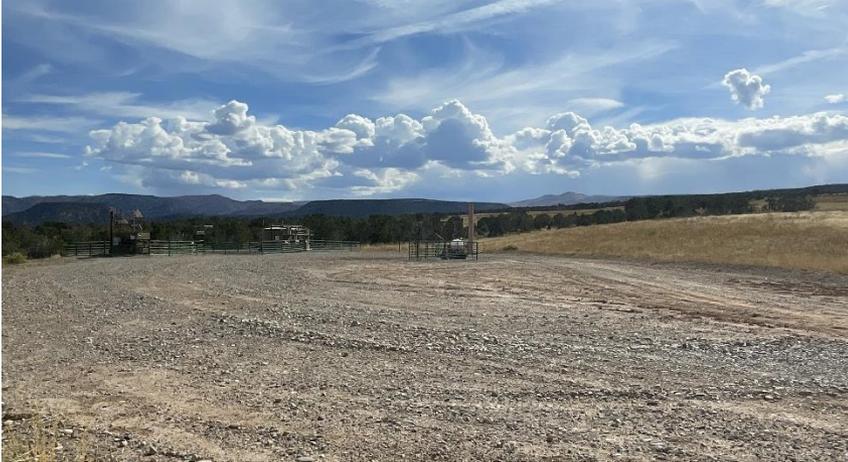
North West corner of location.

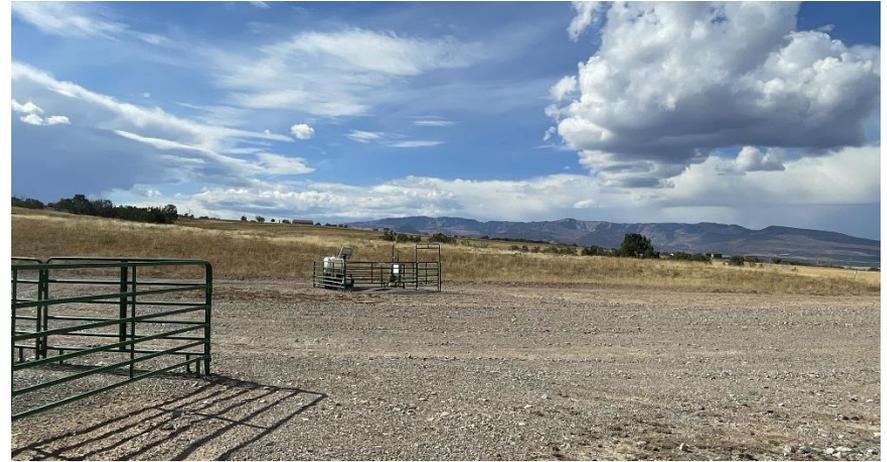
North East corner of location.

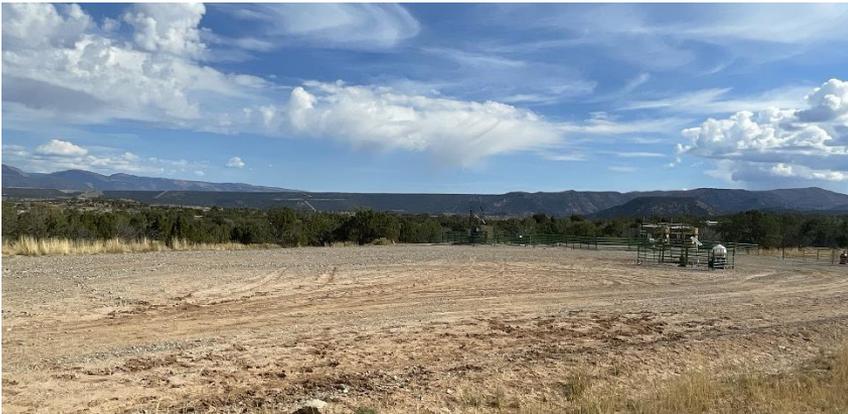
South West corner of location.

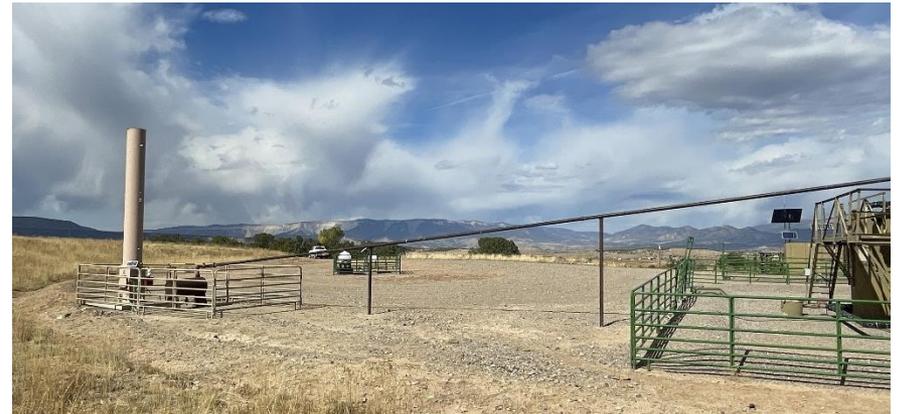
South East corner of location.

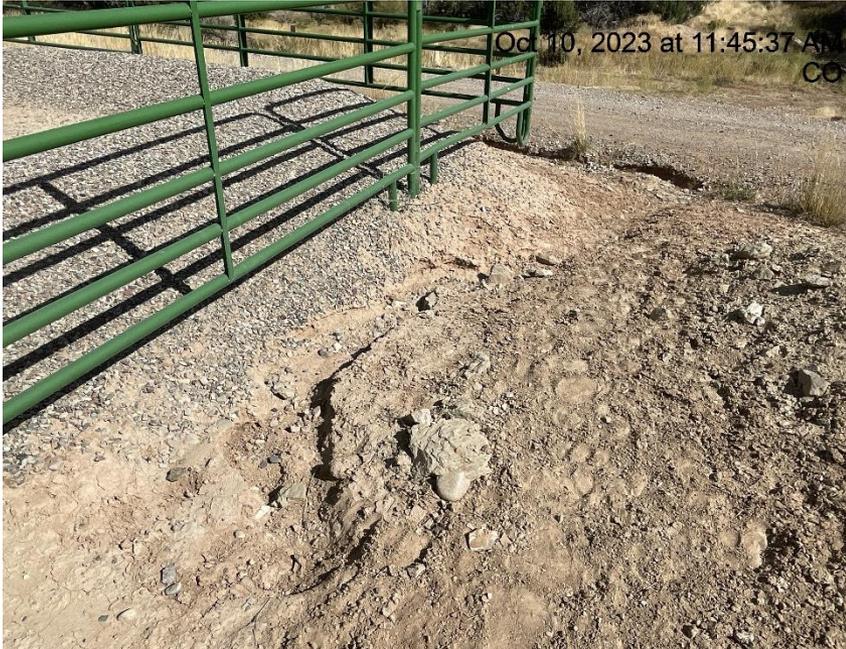
Photo # 2220 Erosion & transport of sediment off location/insufficient BMP's (SE corner of location near tank battery containment)

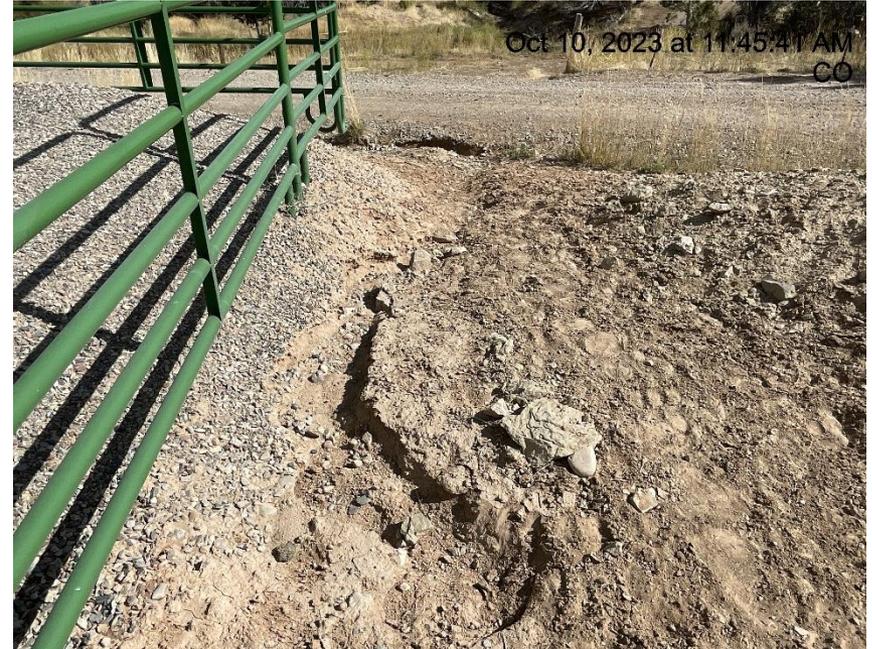
Photo # 2221 Erosion & transport of sediment off location/insufficient BMP's (SE corner of location near tank battery containment)

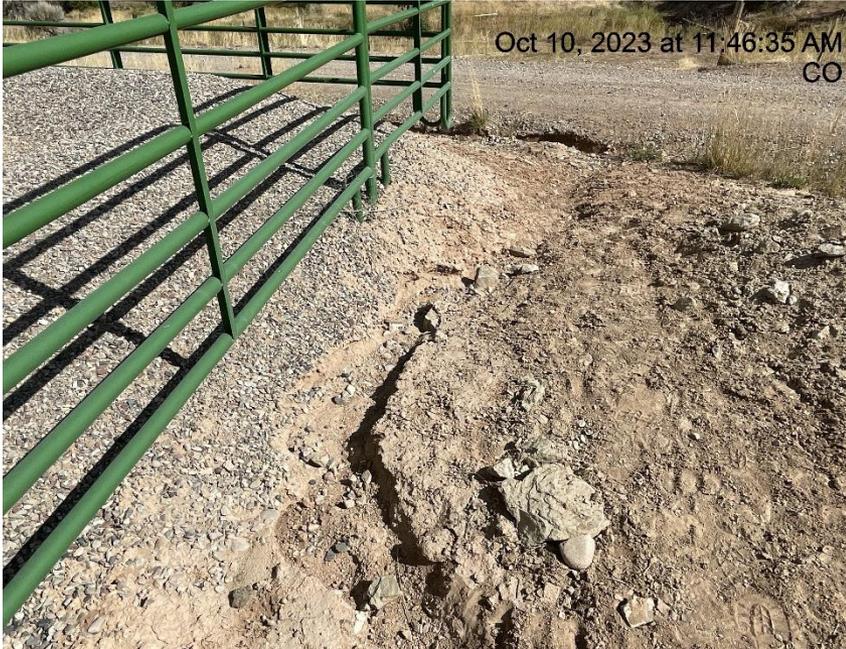
Photo # 2222 Erosion & transport of sediment off location/insufficient BMP's (SE corner of location near tank battery containment)

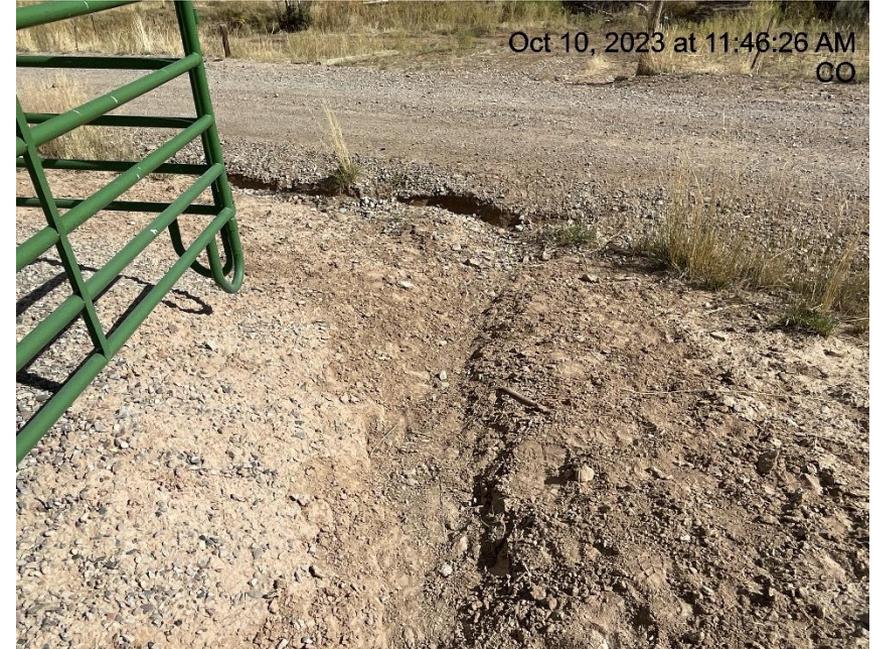
Photo # 2223 Erosion & transport of sediment off location/insufficient BMP's (SE corner of location near tank battery containment)

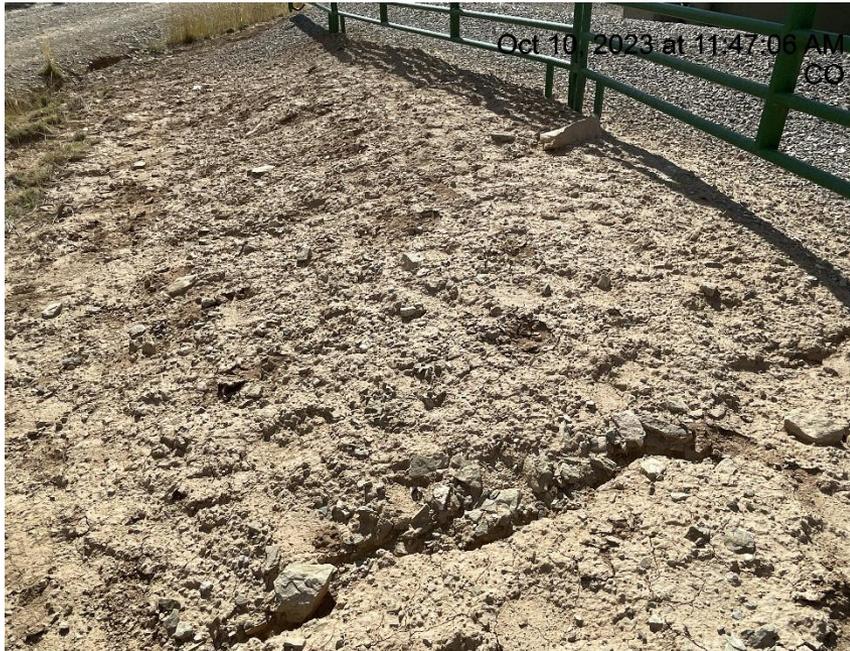
Photo # 2224 Erosion & transport of sediment on slope (SE side of location behind tank battery containment)

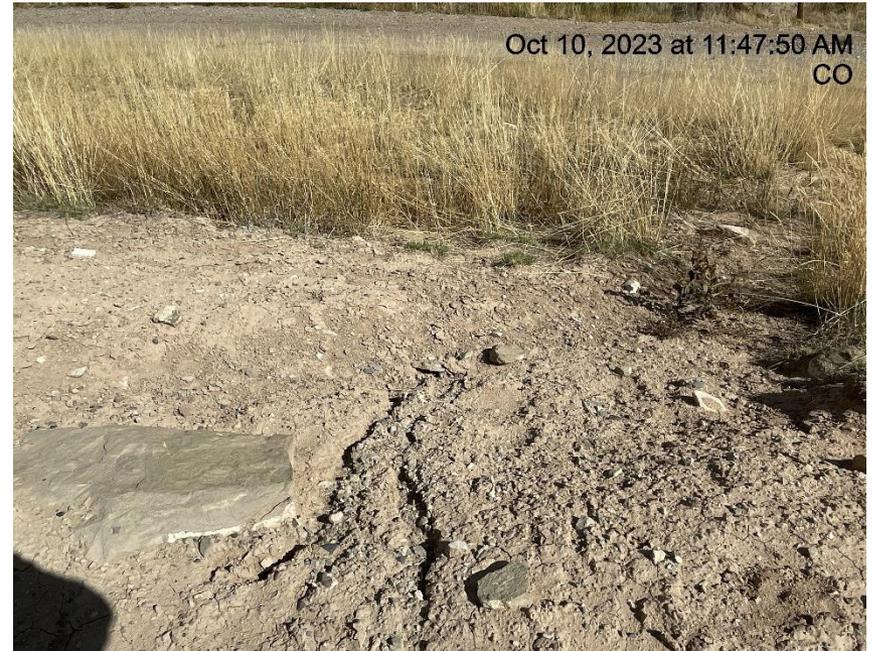
Photo # 2225 Erosion & transport of sediment off location/insufficient BMP's (SE side of location behind tank battery containment)

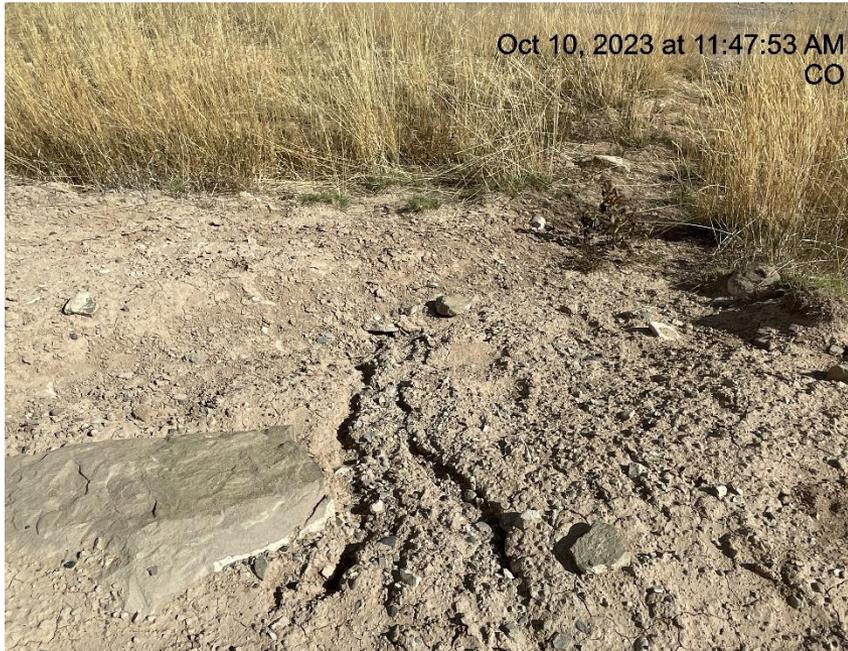
Photo # 2226 Erosion & transport of sediment off location/insufficient BMP's (SE side of location behind tank battery containment)

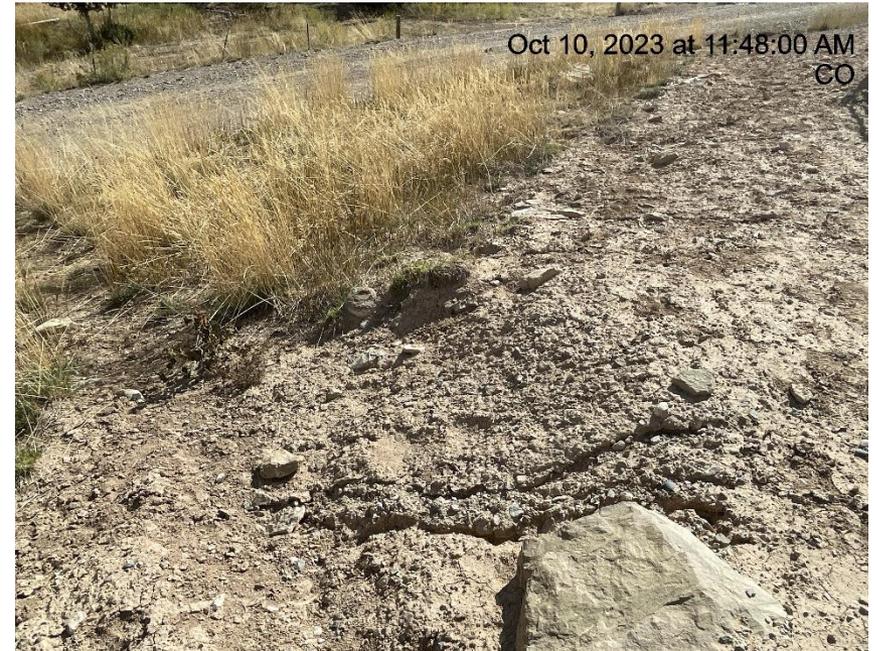
Photo # 2227 Erosion & transport of sediment off location/insufficient BMP's (SE side of location behind tank battery containment)

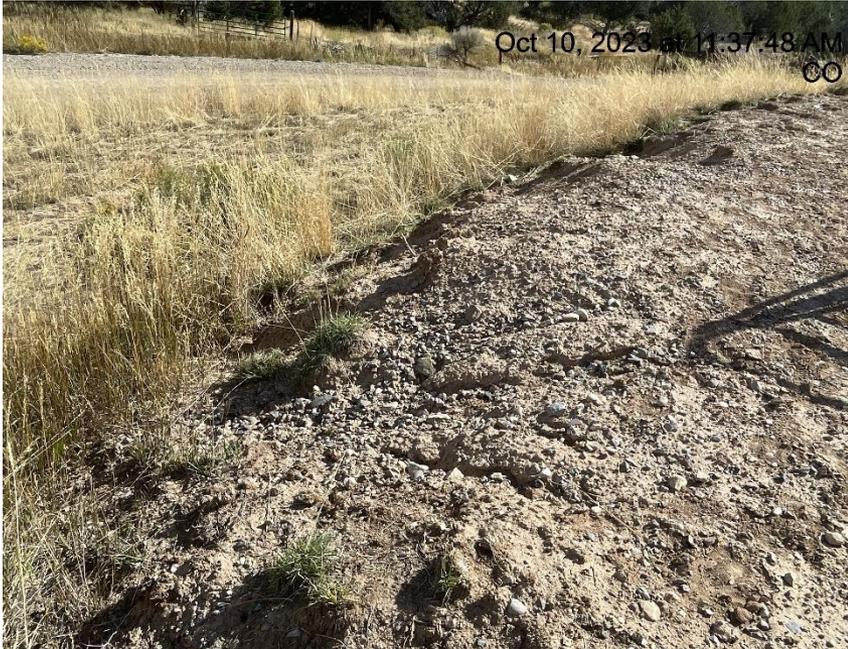
**Photo # 2228 Erosion & transport of sediment off location
(N/NE side of location in multiple areas)**
