Final Reclamation and Stormwater Inspection

Location ID: 330786

Inspection Document #: 708200617

Inspection Photos
Location Name: Hill 31 9-11
Location ID: 330786

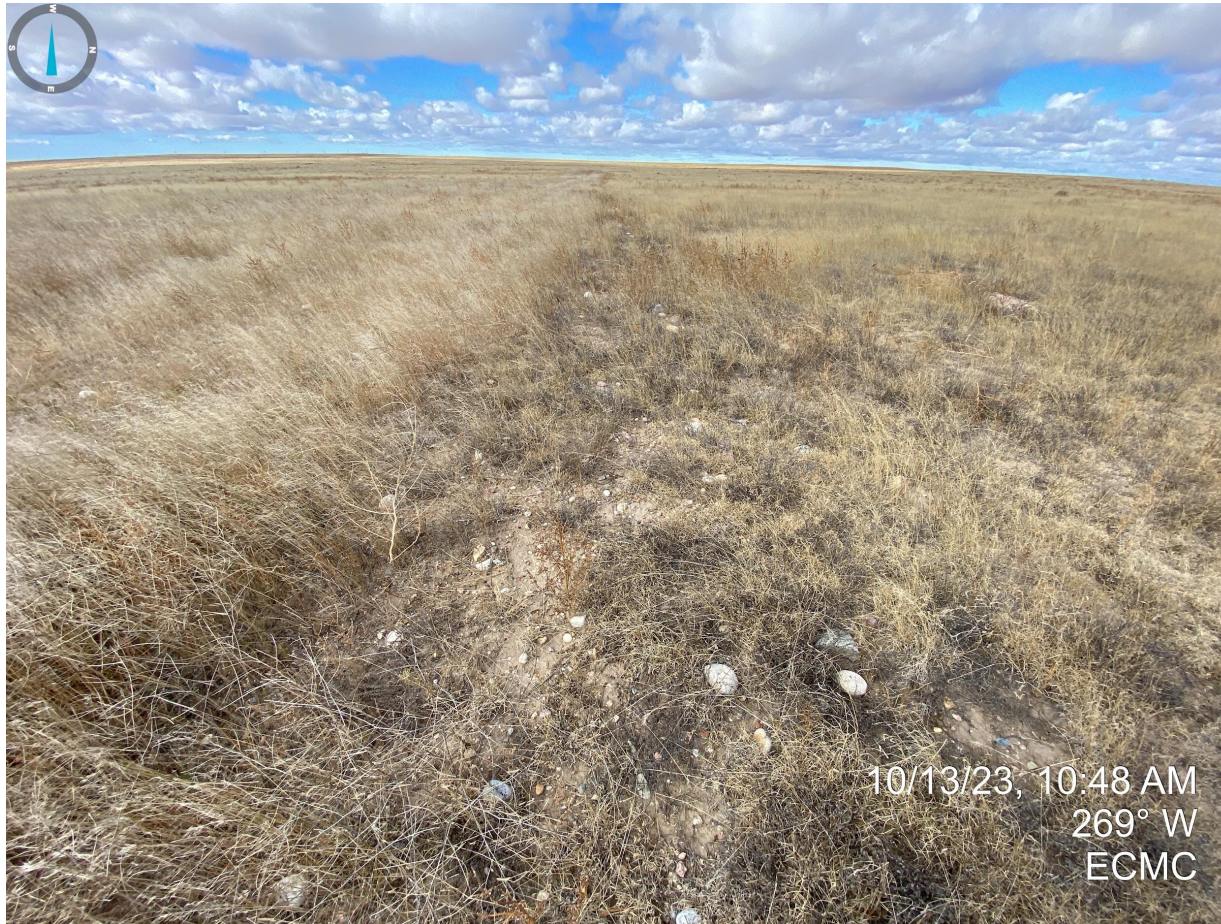
Photo 1. Taken from the access road. Road base material and cobble remain throughout the access road and requires removal. Photo is only an example as cobble and road base was observed throughout the entire access road.

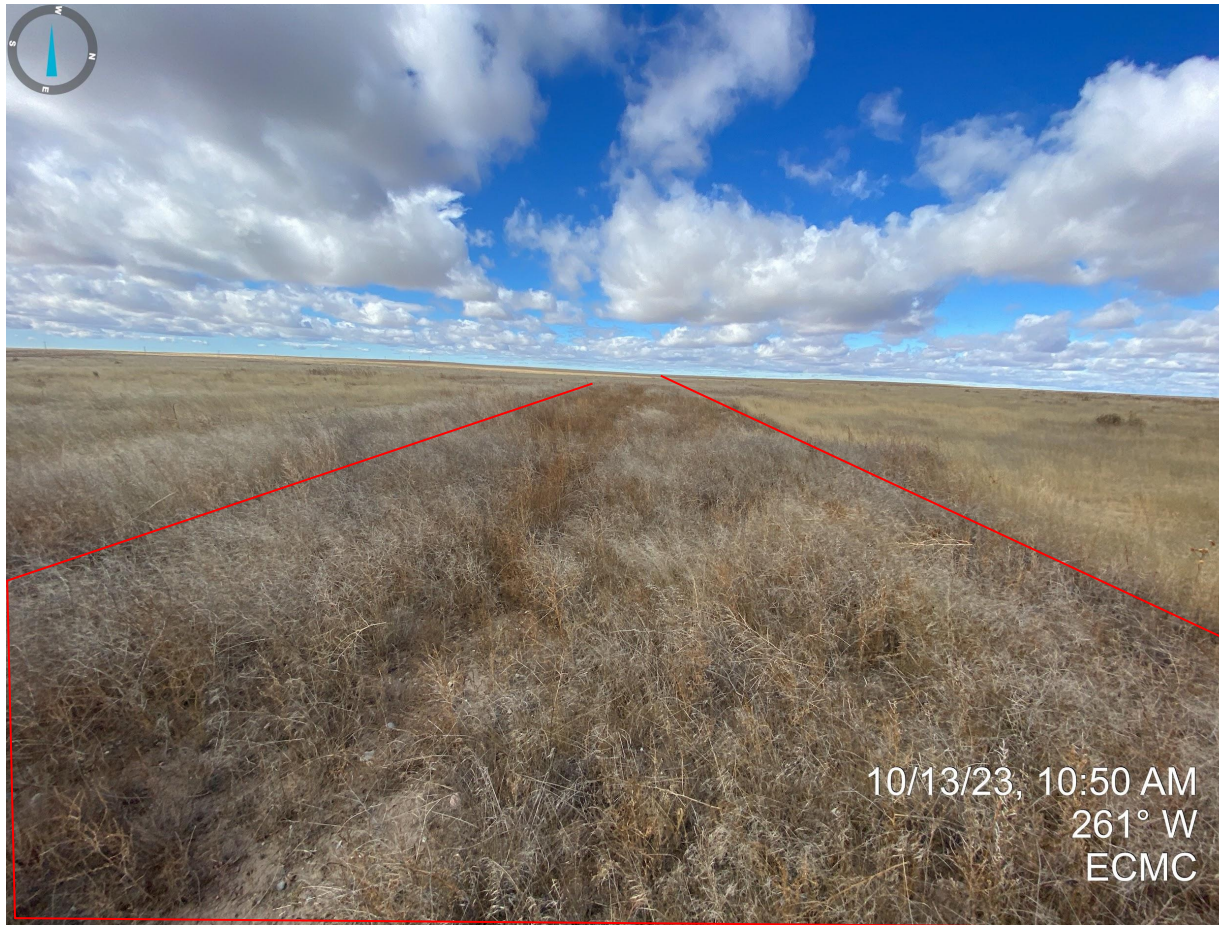
Photo 2. The access road and location are predominantly undesirable vegetation (e.g. CO List C Noxious Weed- Cheatgrass, and kochia). Weed management and revegetation activities are required.

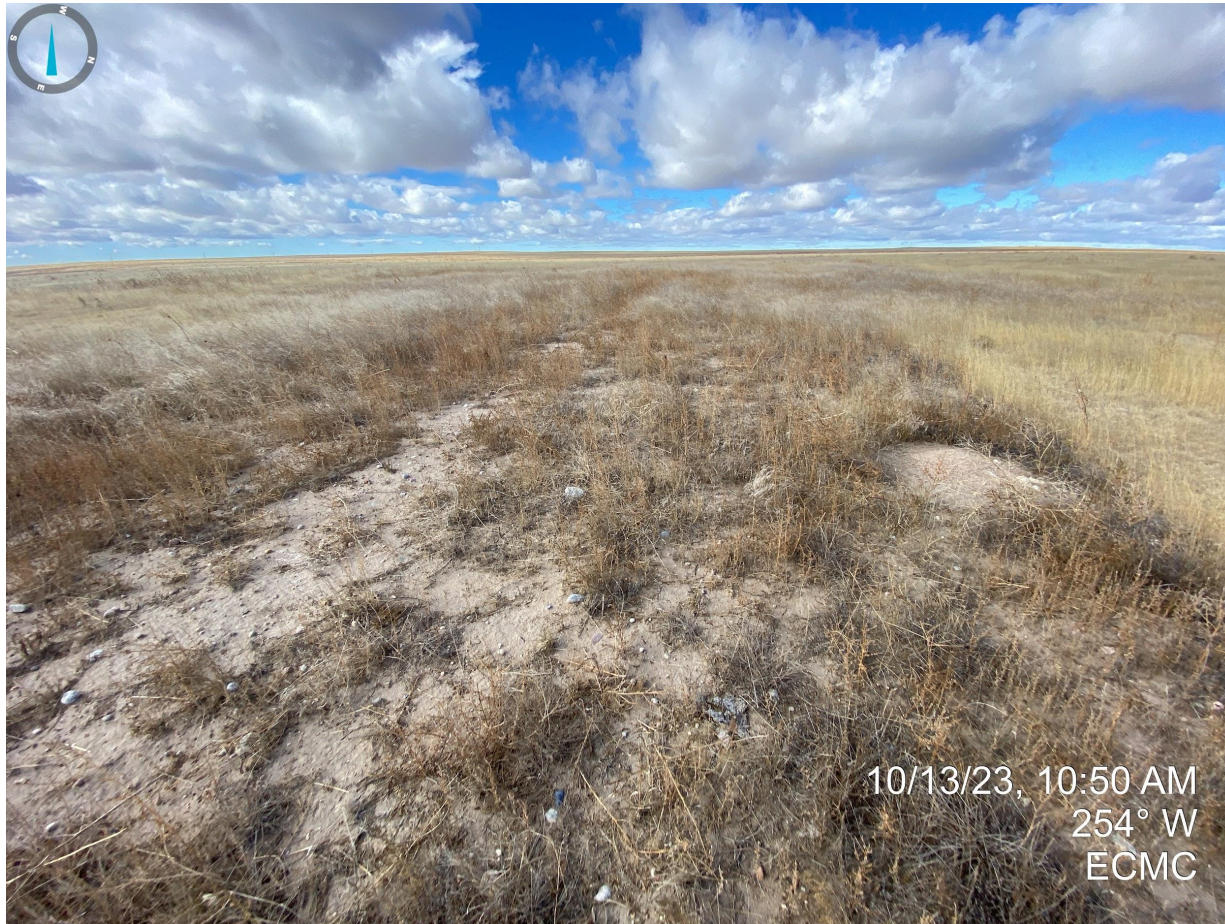
Photo 3. Taken from the access road, east of the well location. Areas of bare and exposed soils observed along the access road and former well location.

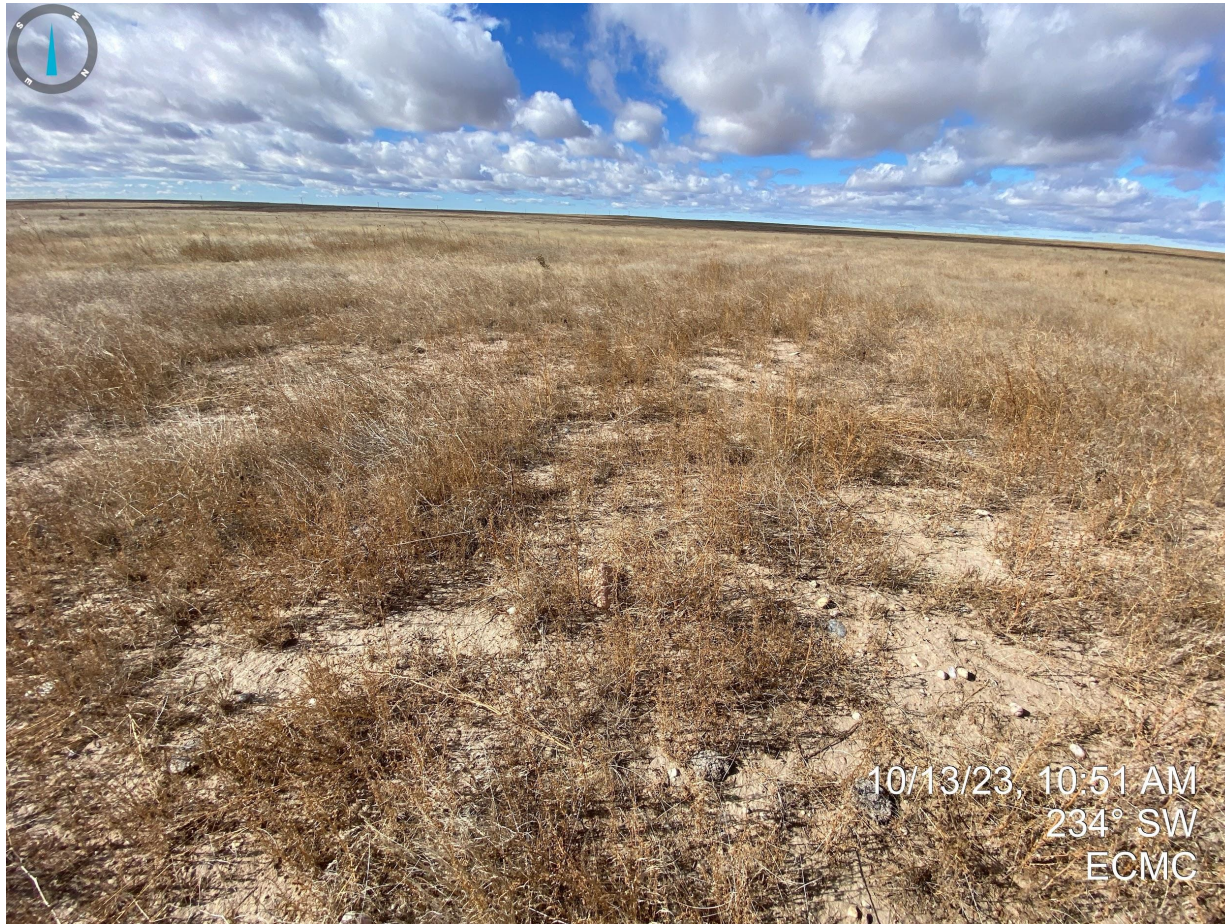
Photo 4. Taken from the well location. See comments in Photo 2 & 3.

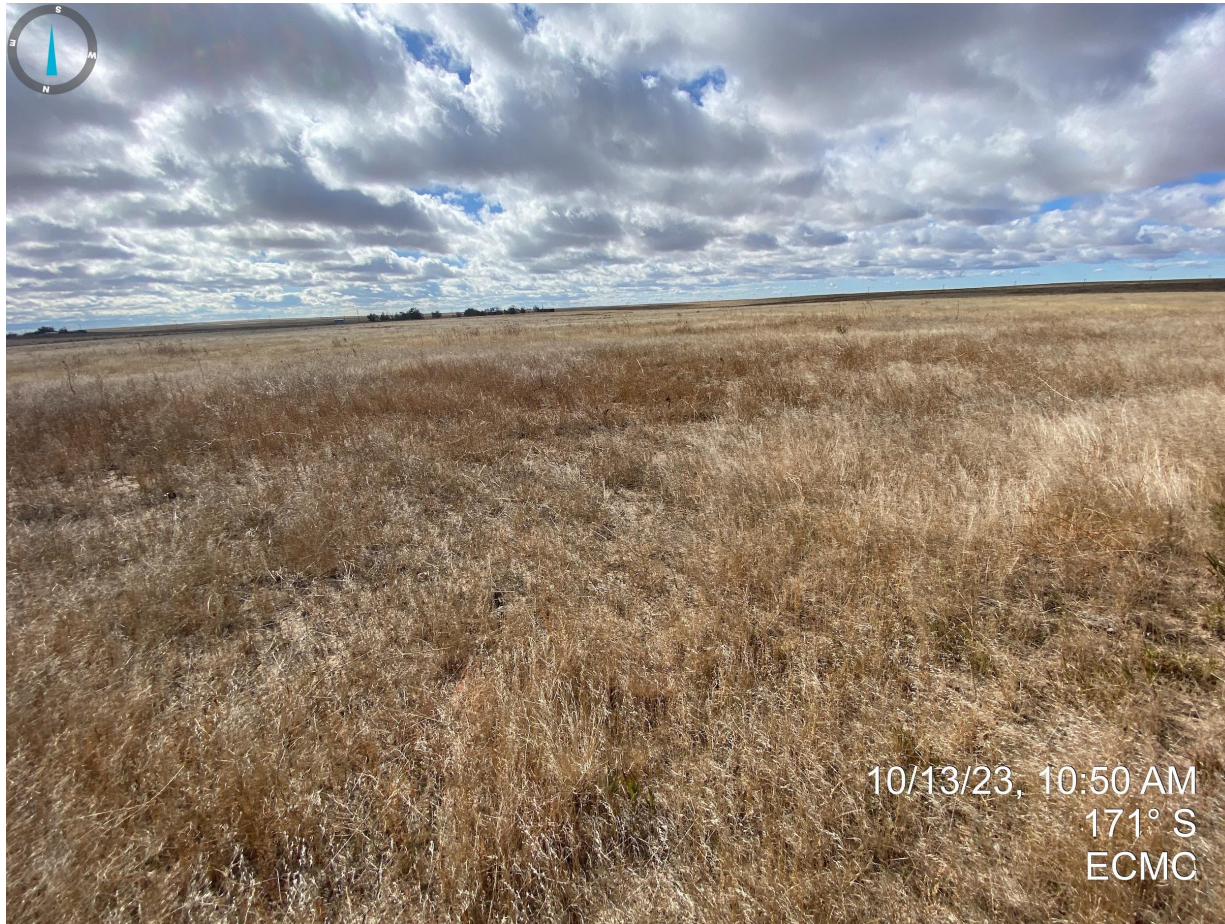
Photo 5. Taken from the northwest corner of the well location. Colorado List C Noxious Weed- Cheatgrass- and kochia was observed throughout.
