WELL NAME: HILL RANCH 32-8, API #: 071-08062, INSP. # 695108689

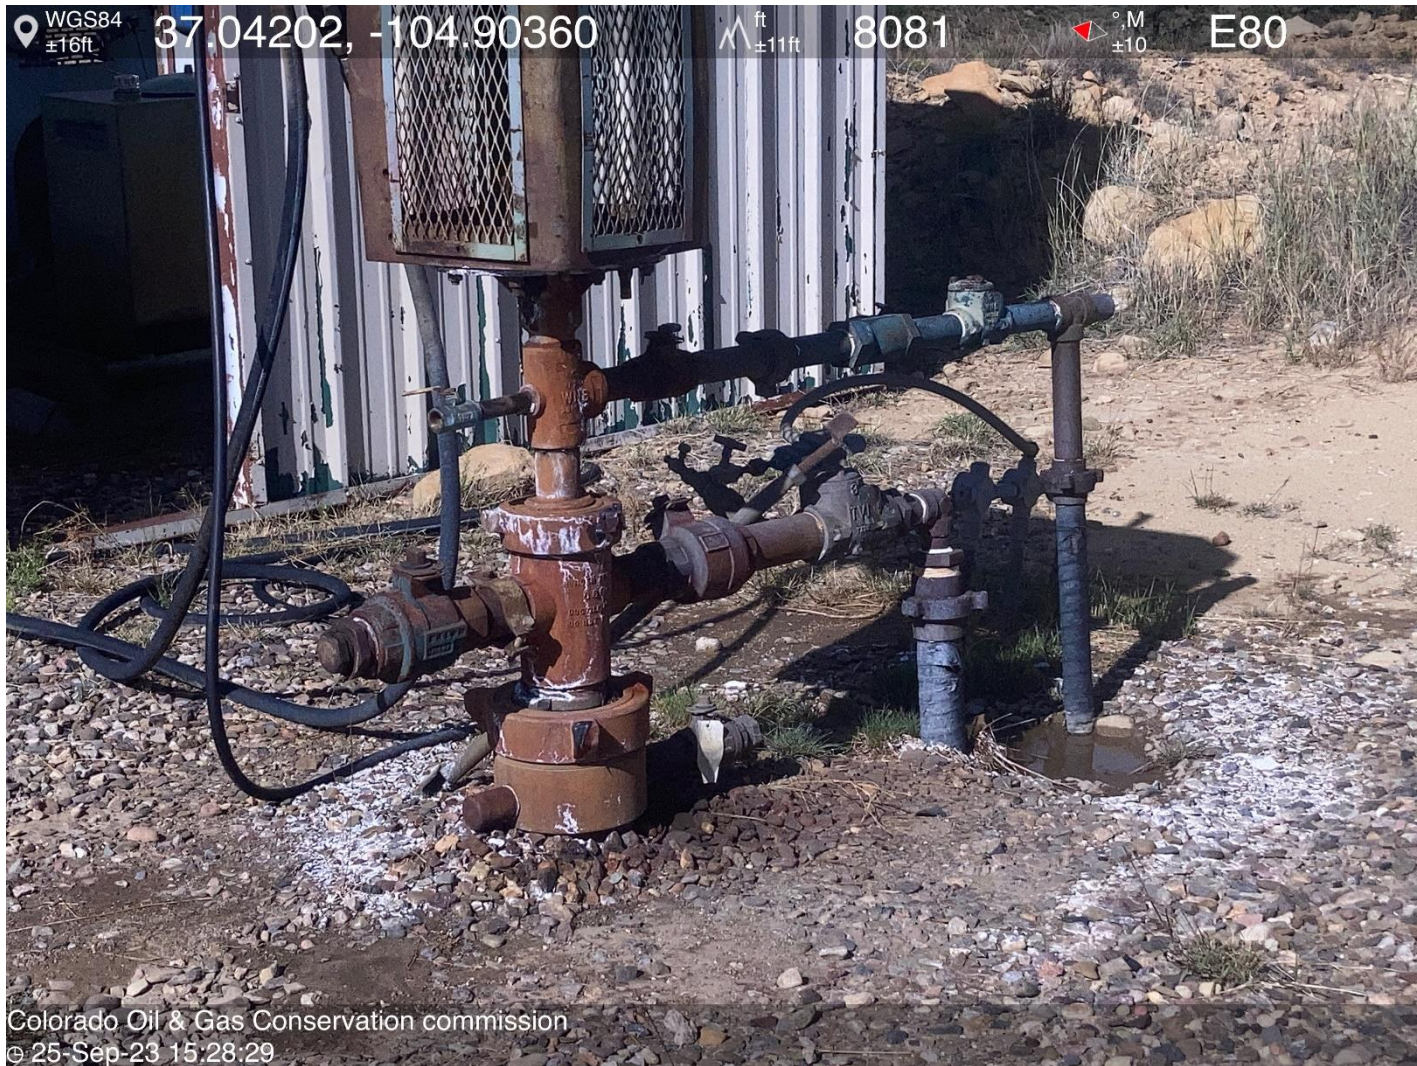
**PHOTO 4: Signs of recent slow leak from wellhead. Salt/mineral buildup is evident on the wellhead and ground around wellhead. Securely fasten all valves, pipes, fittings, and Production Facilities to ensure good mechanical condition, inspect at regular intervals, remove salt/mineral buildup, maintain in good mechanical condition remove and dispose of impacted material per Rule 608.e. ca date 11-20-2-23.**

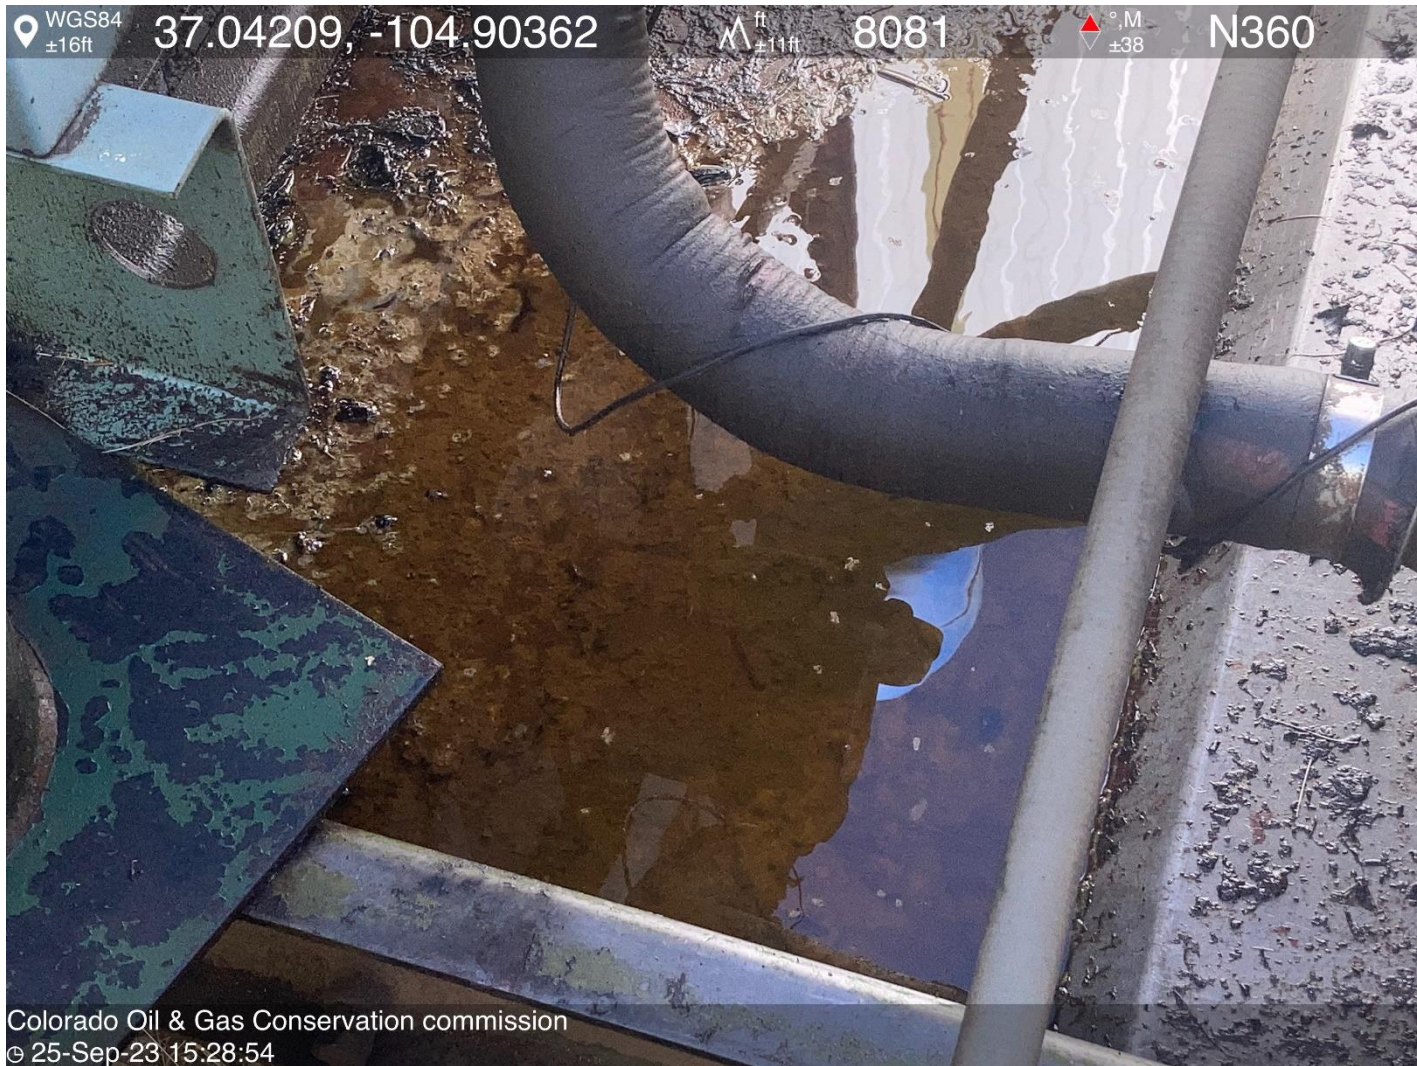
**PHOTO 5: OILY WASTE IN ENGINE SKID. COMPLY WITH RULE 1002.f.(2)B, Comply with general provisions of the oil and gas act for wildlife protection AND SB-181. ca date 10-23-2023.**
