Operator: HIGHPOINT OPERATING CORPORATION

Location Name: Dutch Lake Pad 16-24H

Loc ID: 422838

Inspection: 696305334

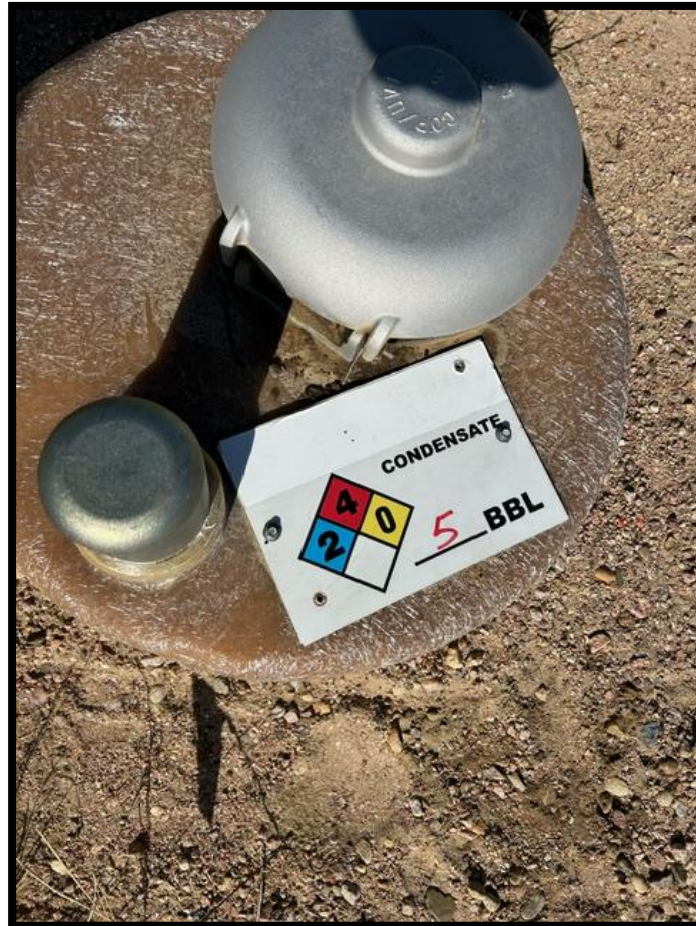
Exhibit A

CA: Vault East of Separators missing Labels - Content, Capacity and NFPA; See photos. Install sign to comply with Rule 605.h.

CA Resolution: Labels regarding Content, Capacity, and NFPA has been updated and installed to comply with Rule 605.h.

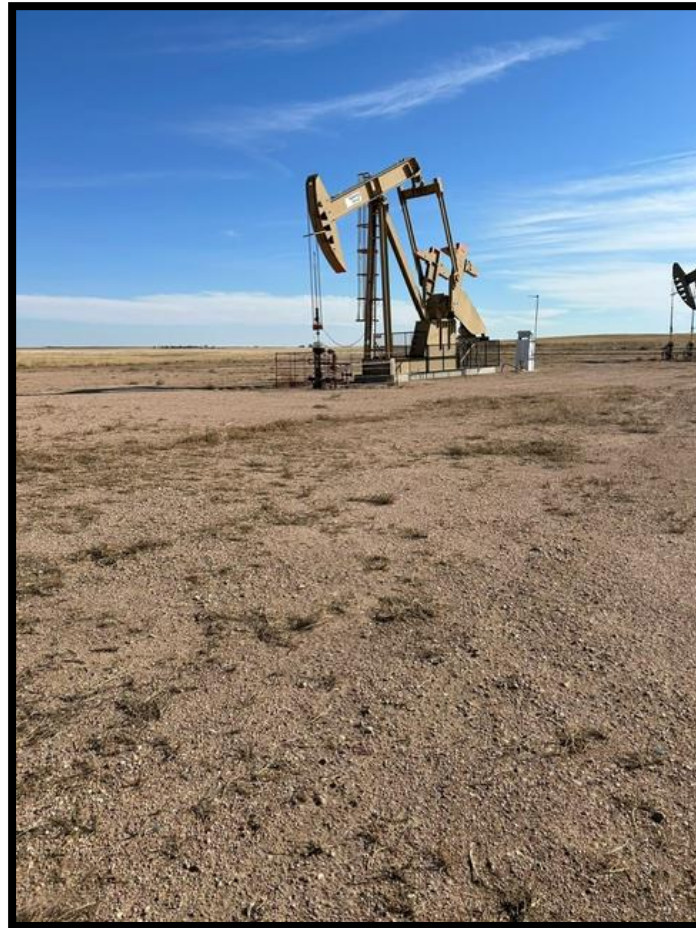
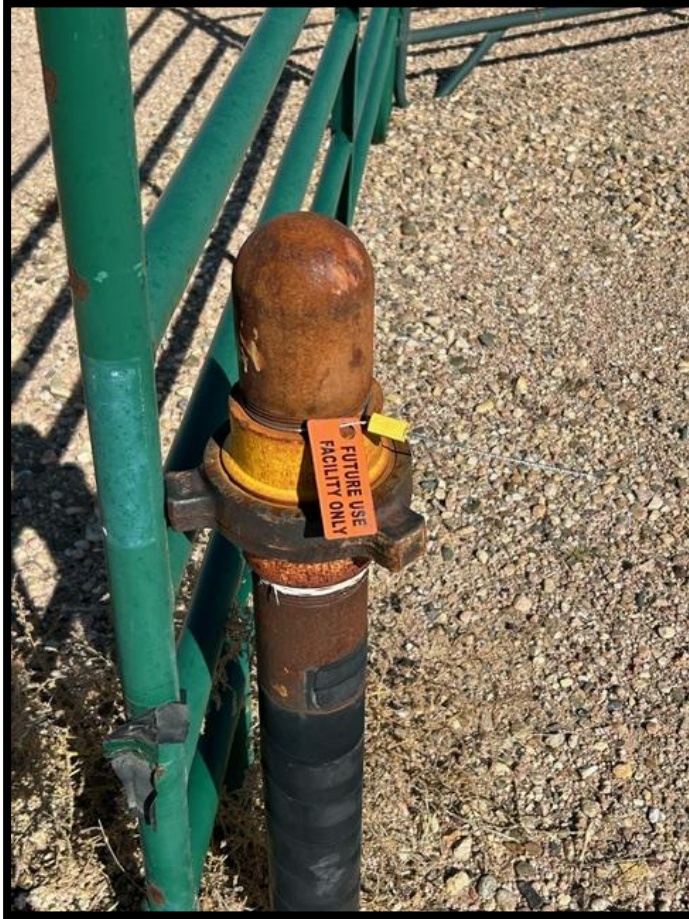
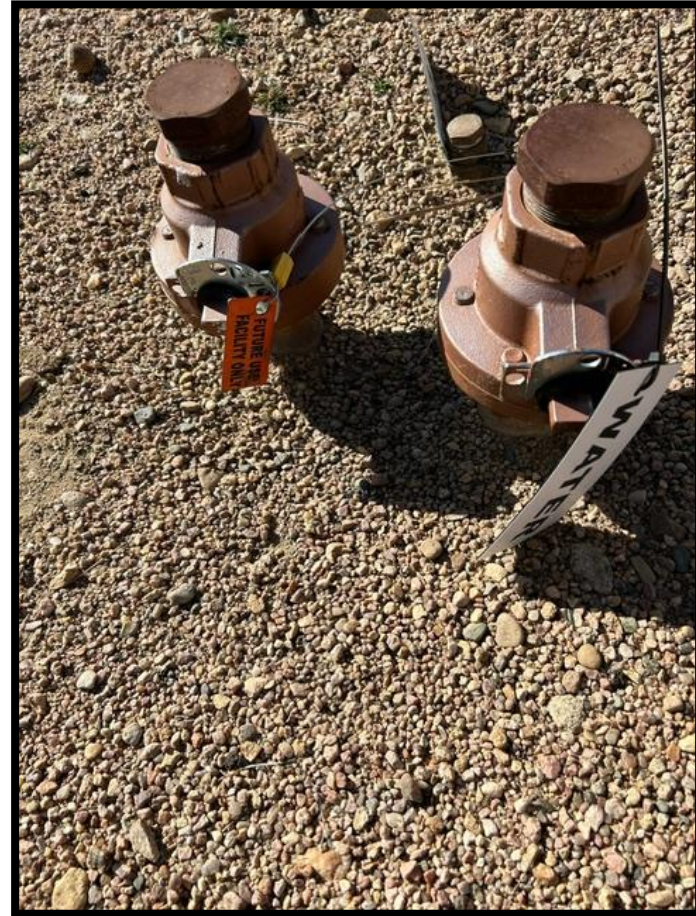
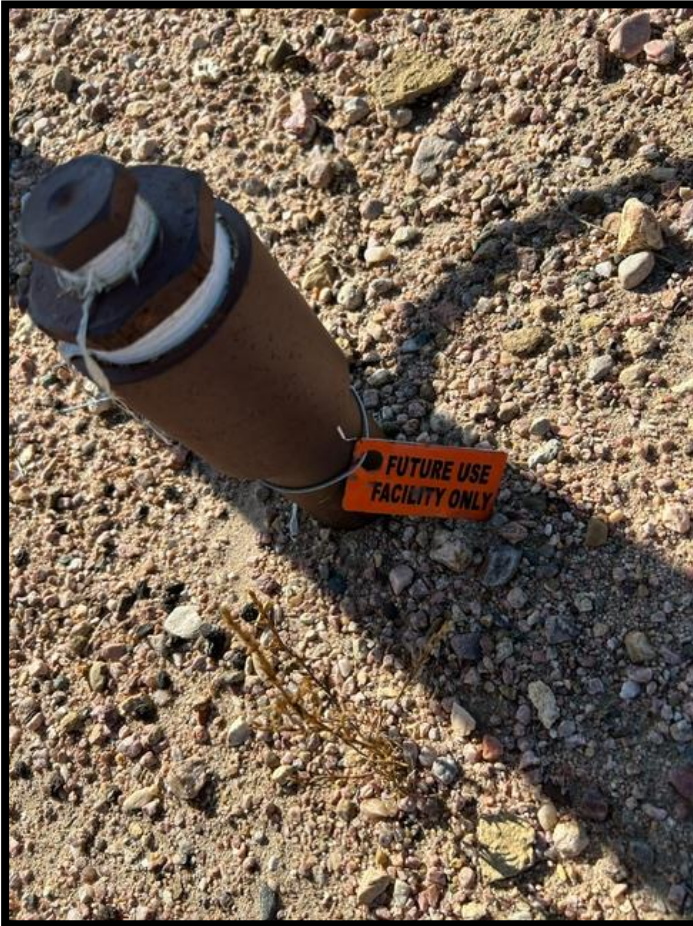
Exhibit A

CA: Overgrown Vegetation on Location; see photos. Comply with Rule 606.

CA Resolution: Operator has addressed and cleared overgrown vegetation and weed debris from location to comply with Rule 606.

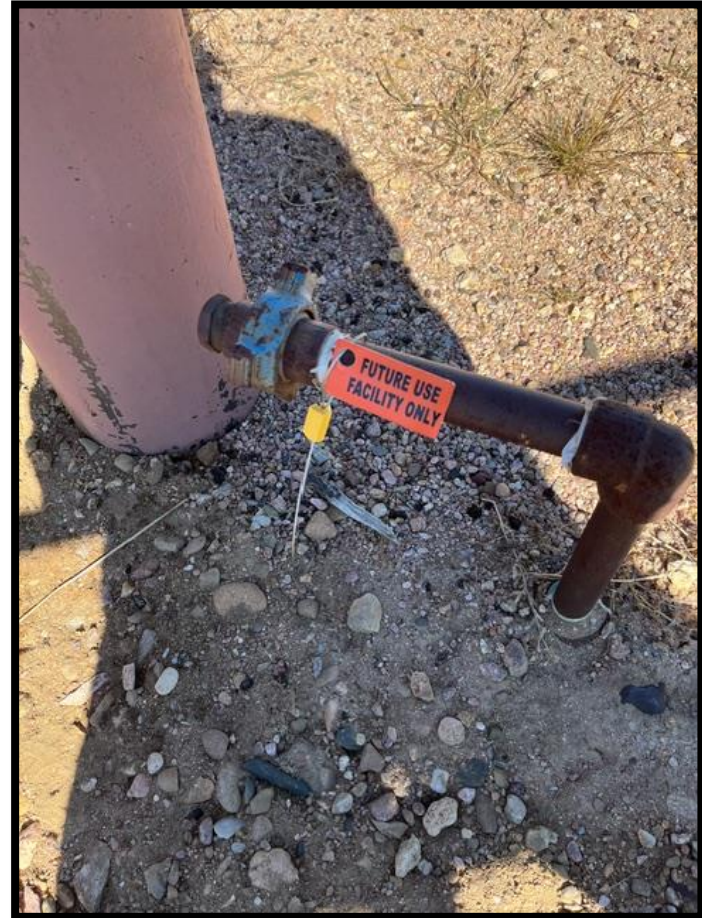
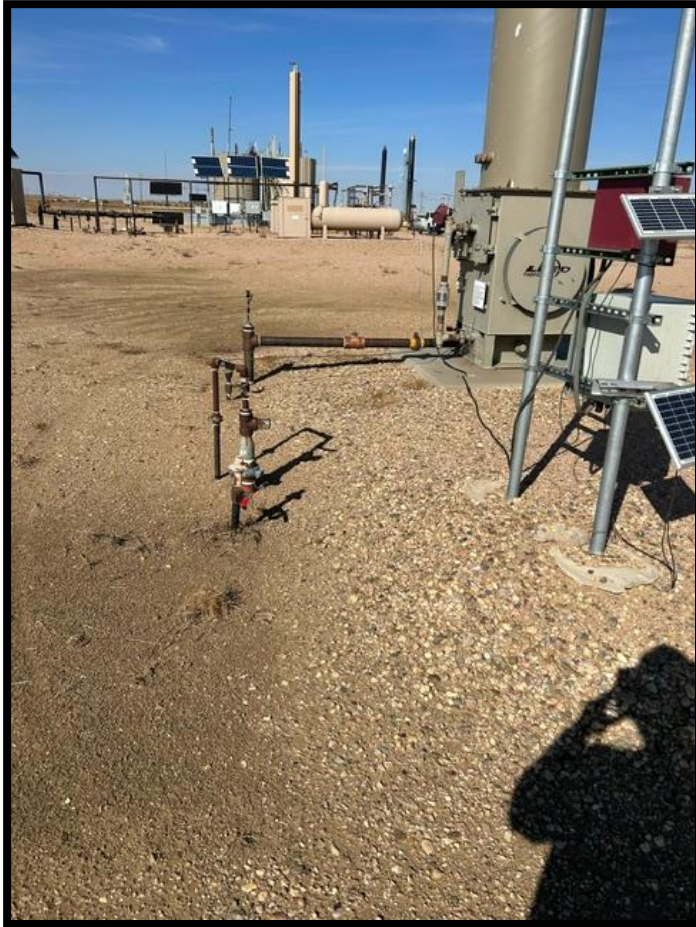
Exhibit D

CA: Unmarked Risers at ECD, in between Separators and East of Separators; see photos. Comply with Rule 606.

CA Resolution: Operator has marked the identified risers to comply with Rule 606.

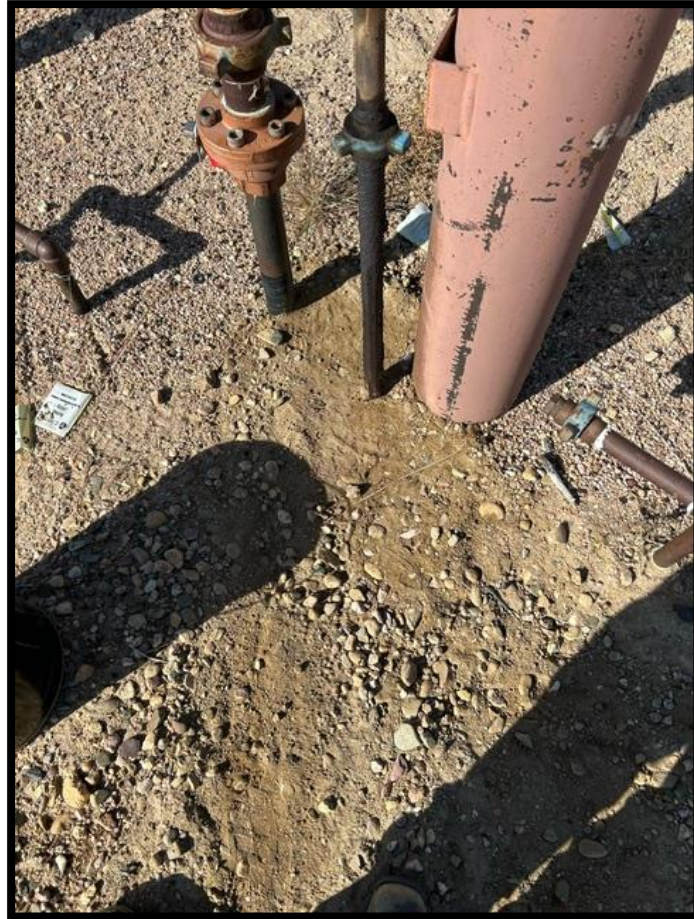
Exhibit B

CA: Stained Soil at Riser Area East of Separators; see photos. For localized stained soils or oily waste - "Properly dispose of oily waste in accordance with 905.e."

CA Resolution: Operator has appropriately addressed and cleaned identified areas of stained soil to comply with Rule 905.e.
