Operator: HIGHPOINT OPERATING CORPORATION

Location Name: CB Rudd 6-61-18_19 SW7

Inspection: 696305339

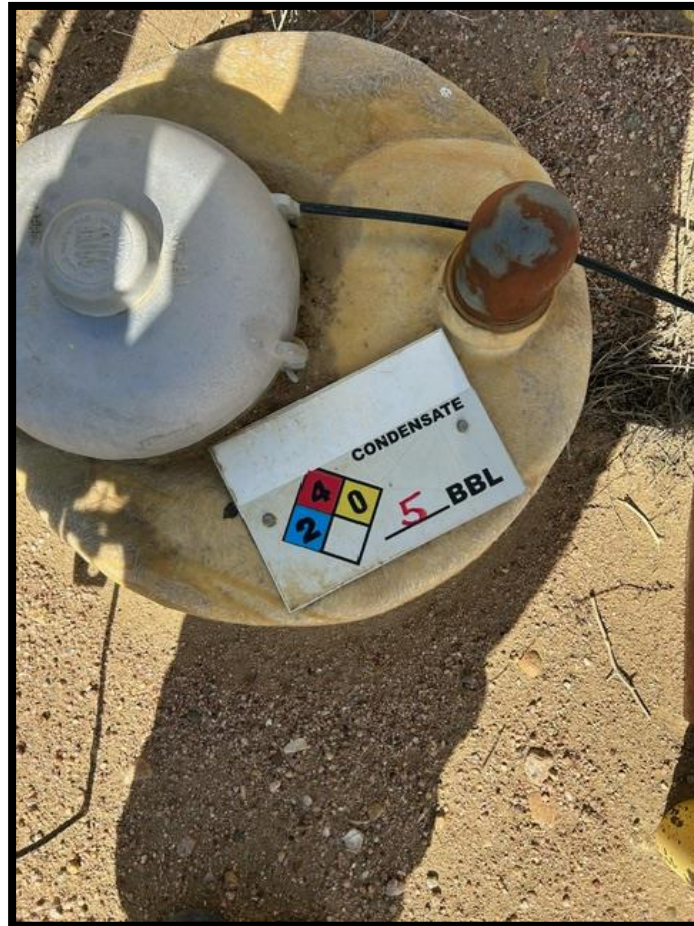
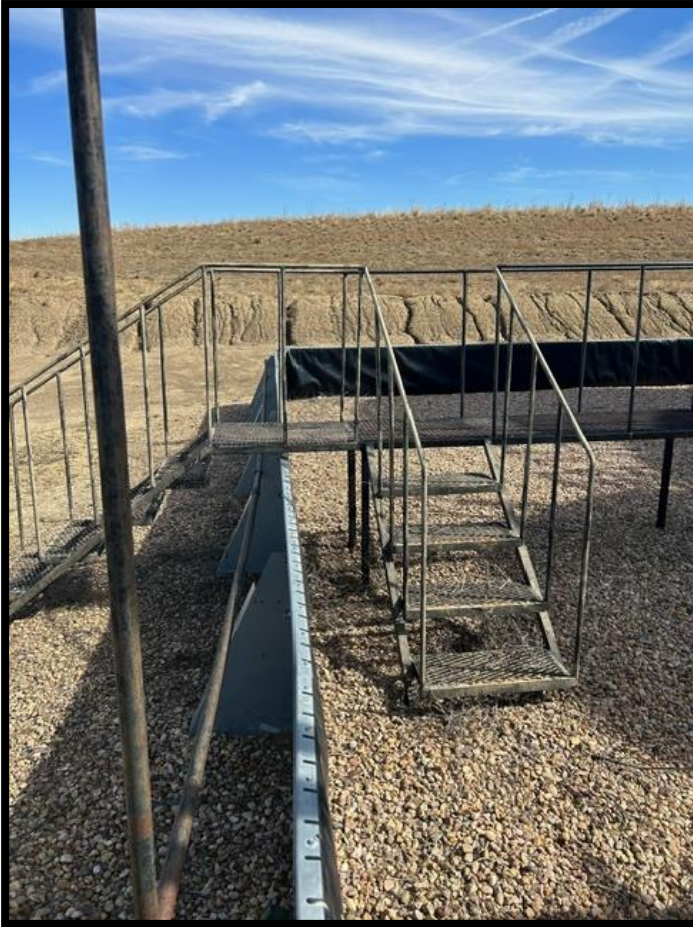
Exhibit A

CA: Condensate Vault at VRU missing Capacity Label; see photos. Install sign to comply with Rule 605.h.

CA Resolution: Labels regarding Content, Capacity, and NFPA has been updated and installed to comply with Rule 605.h.

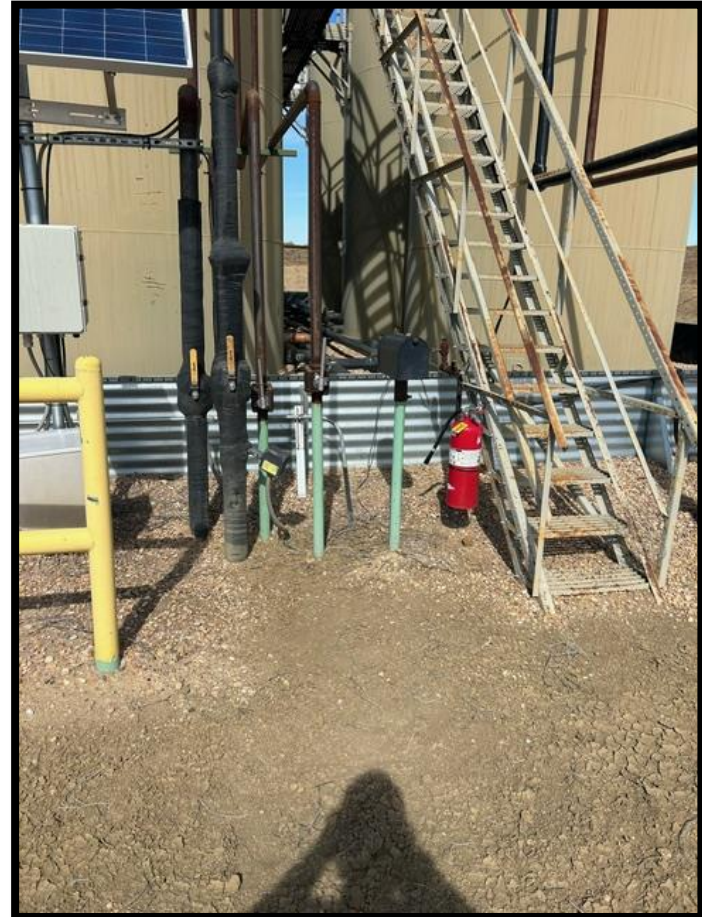
Exhibit D

CA: Tumbleweeds around Tank Berm; see photos. Comply with Rule 606.

CA Resolution: Operator has addressed and cleared tumbleweeds and other weed debris from location to comply with Rule 606.
