Third Party Flowline Abandon in place Verification Letter

Owen Brothers 13-32

Client: Crestone Peak Resources Operating LLC

Location: Sec32, T3N, R67W

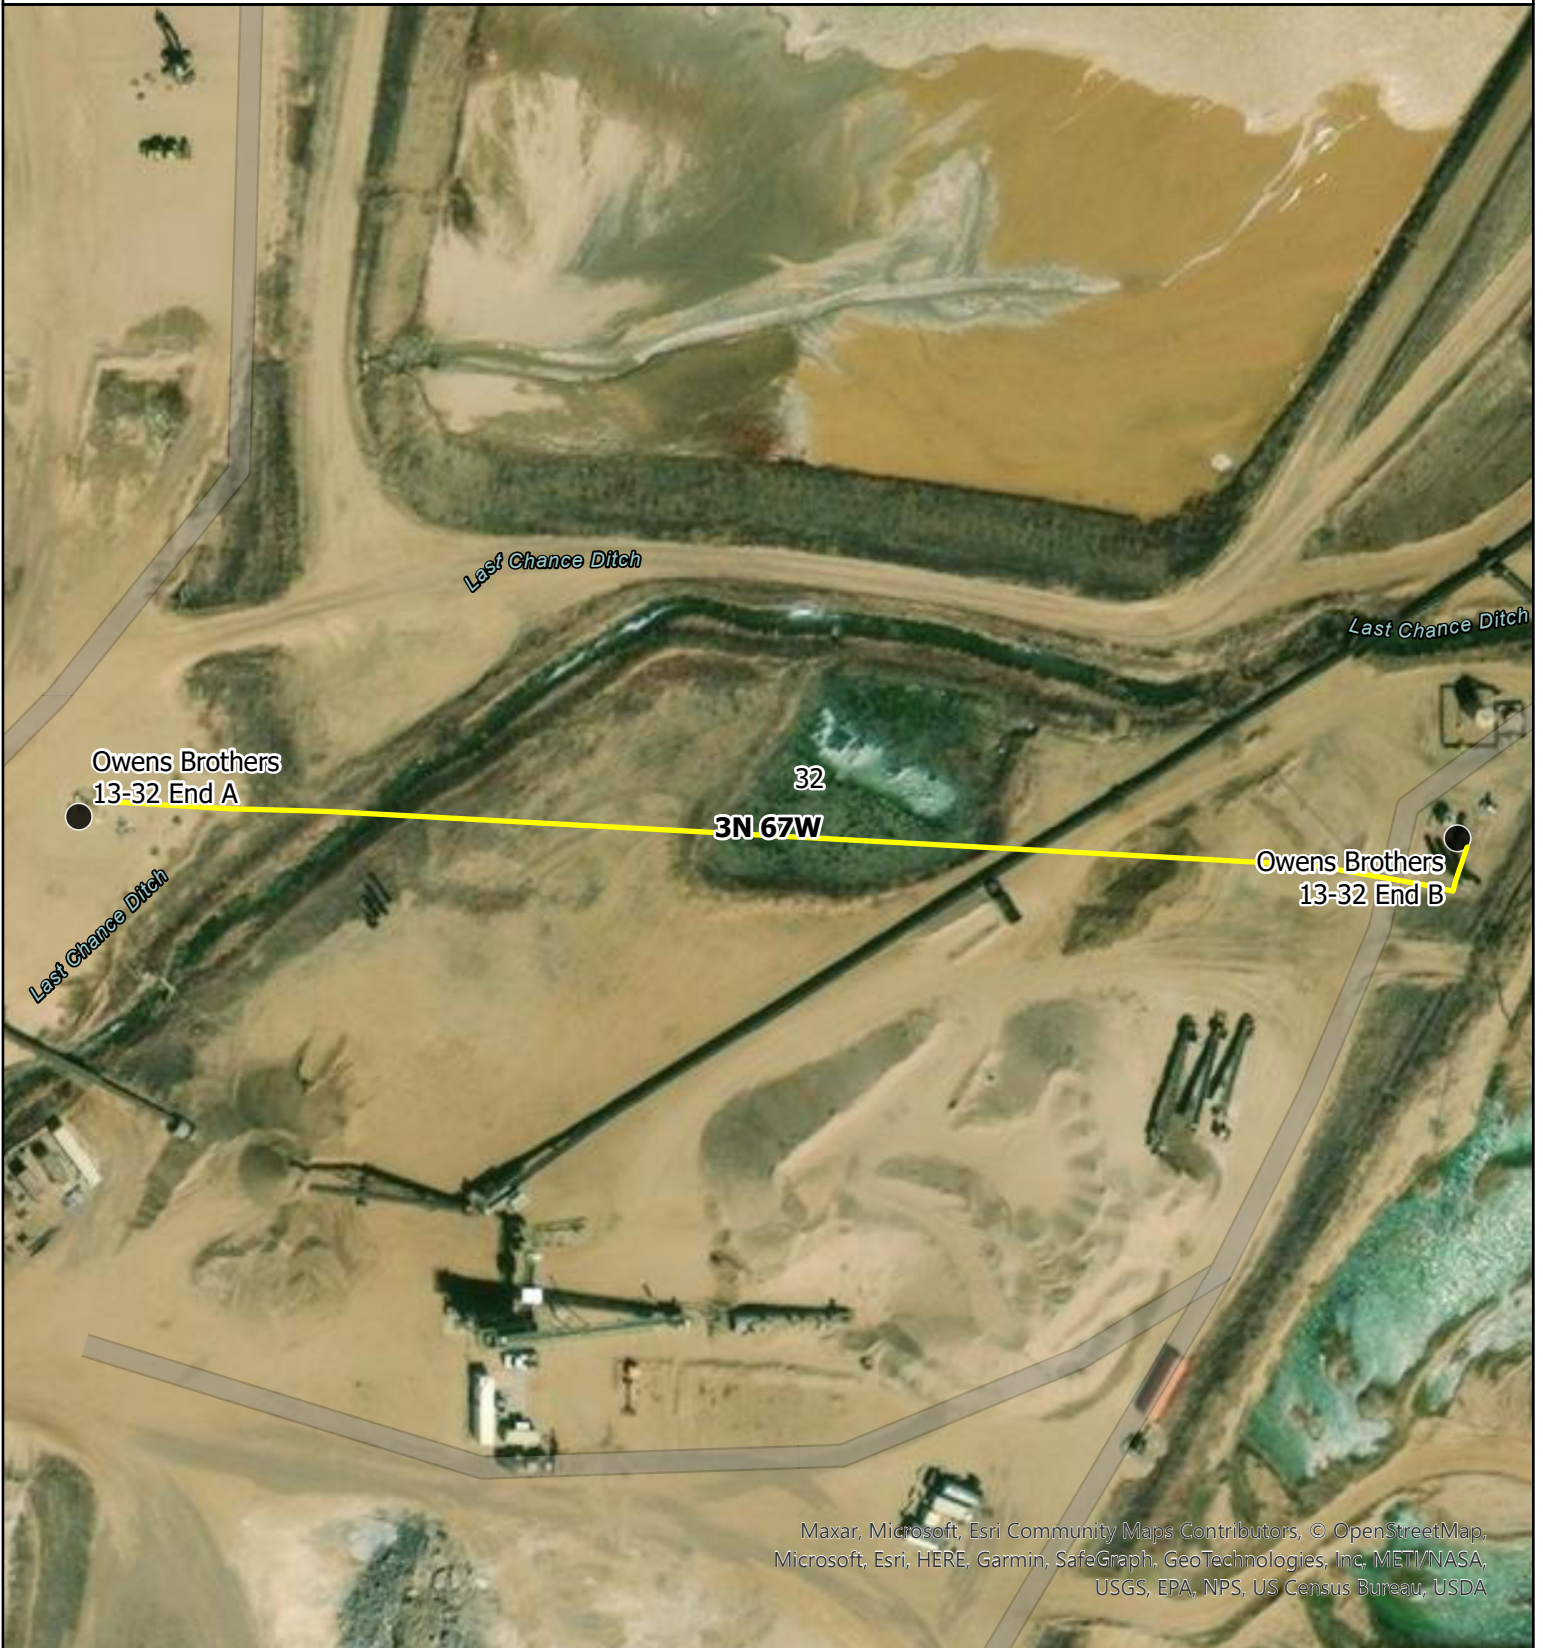
**FLOWLINE
ABANDON-IN-PLACE
MAP**

The ABiP work on this location included one (1) steel flowline with fusion bond coating. The Owen Brothers 13-32 flowline has a diameter of 2.0 inches. The flowline runs east from the wellhead (End A) to the Owen Brothers 13-32 oil and gas location. Approximately 820 linear feet was ABiP from the Owen Brothers 13-32 wellhead to the separator at the facility (End B).

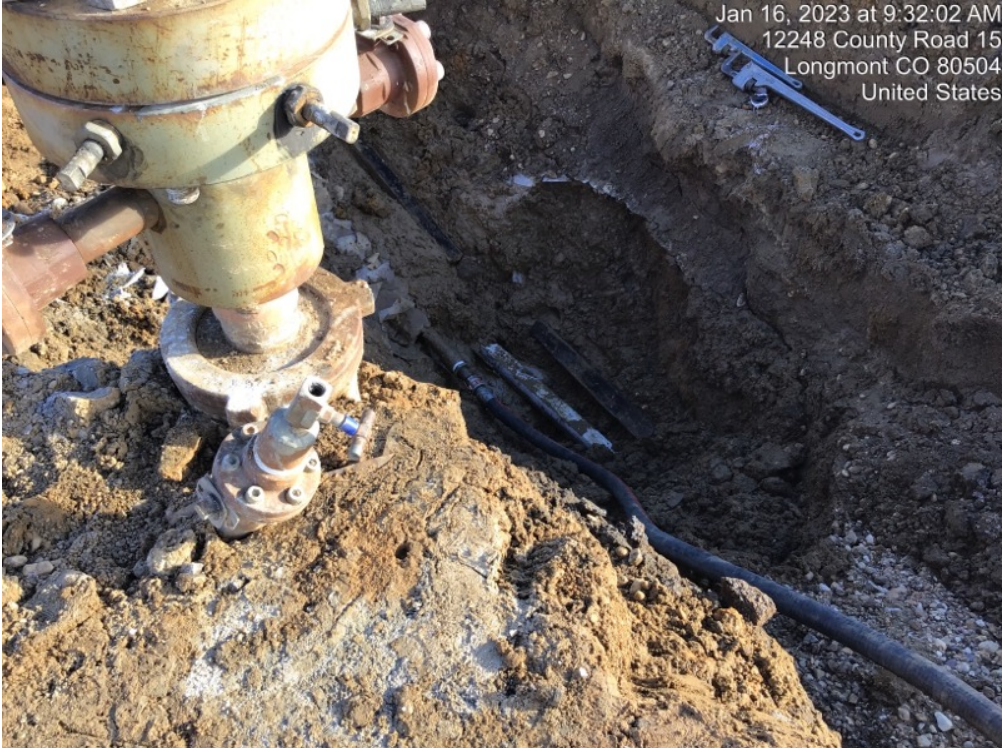
Information		Photo
Photo #: Location: Description:	1 End A End A prior to flushing activity

Prior to flushing operations, end A was uncapped at 9:01 AM and end B was uncapped at 9:01 AM per attached report, and released to atmospheric pressure. Upon fluid evacuation described above, the hydrovac hoses and valve sets were safety removed allowing the flanged pipe ends full exposure to normalize to atmospheric pressure.

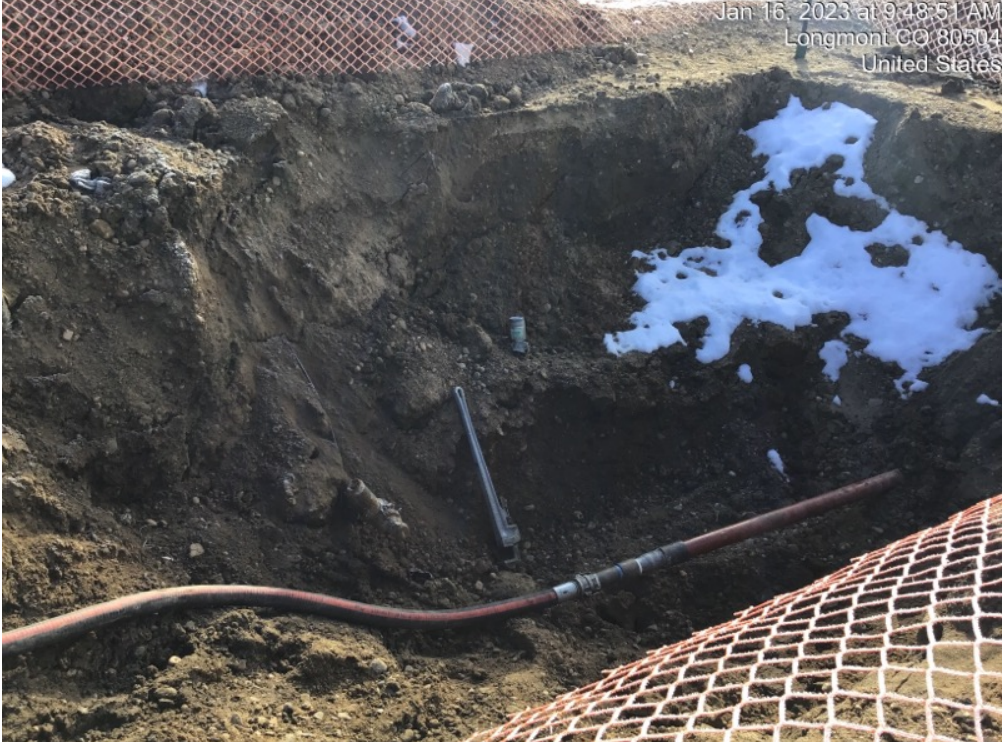
<p>Jan 16, 2023 at 9:32:02 AM 12248 County Road 15 Longmont CO 80504 United States</p>
Photo #: Location: Description:	2 End B End B during flushing activity

The line was flushed using two hydrovac trucks. A total of 18.6 barrels of freshwater was used to flush and evacuate the flowline. All water and fluids from the pipe were removed from the site and properly disposed of.

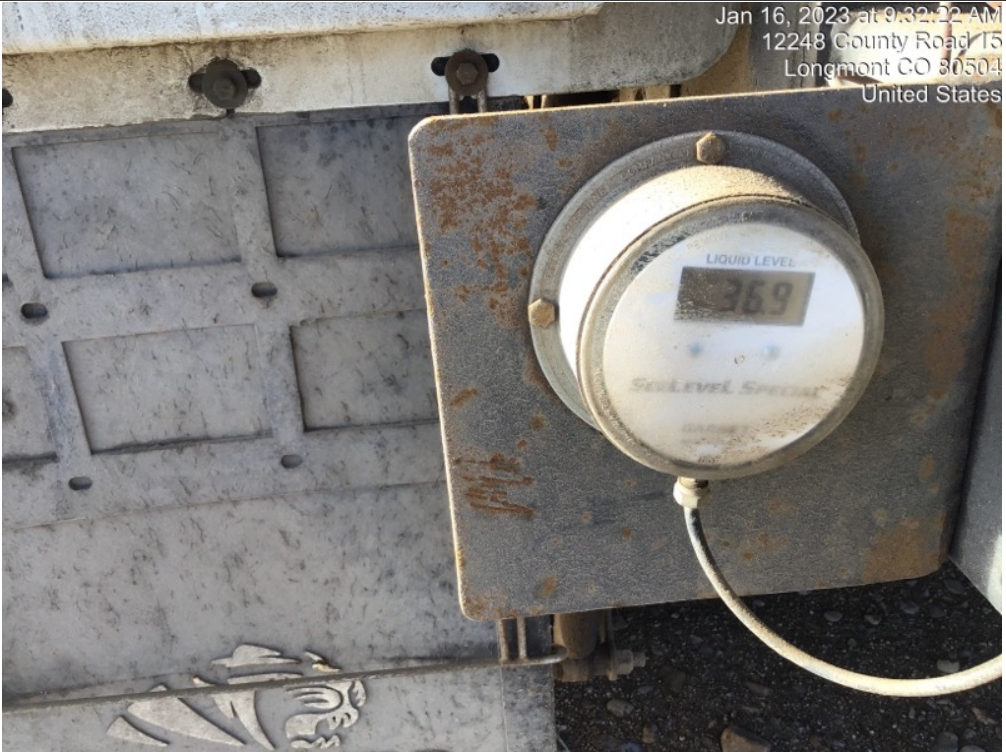
Information		Photo
Photo #: Location: Description:	3 Meter at End A Meter prior to flushing activity

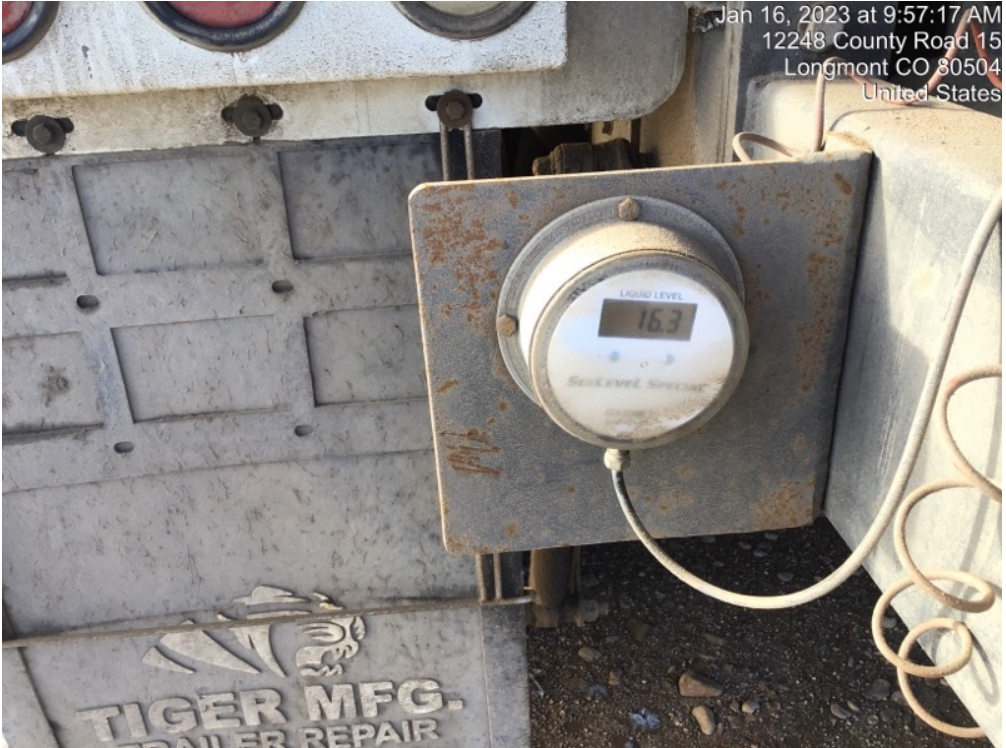
<p>Jan 16, 2023 at 9:32:12 AM 12248 County Road 15 Longmont CO 80504 United States</p>
Photo #: Location: Description:	4 Meter at End A Meter post flushing activity

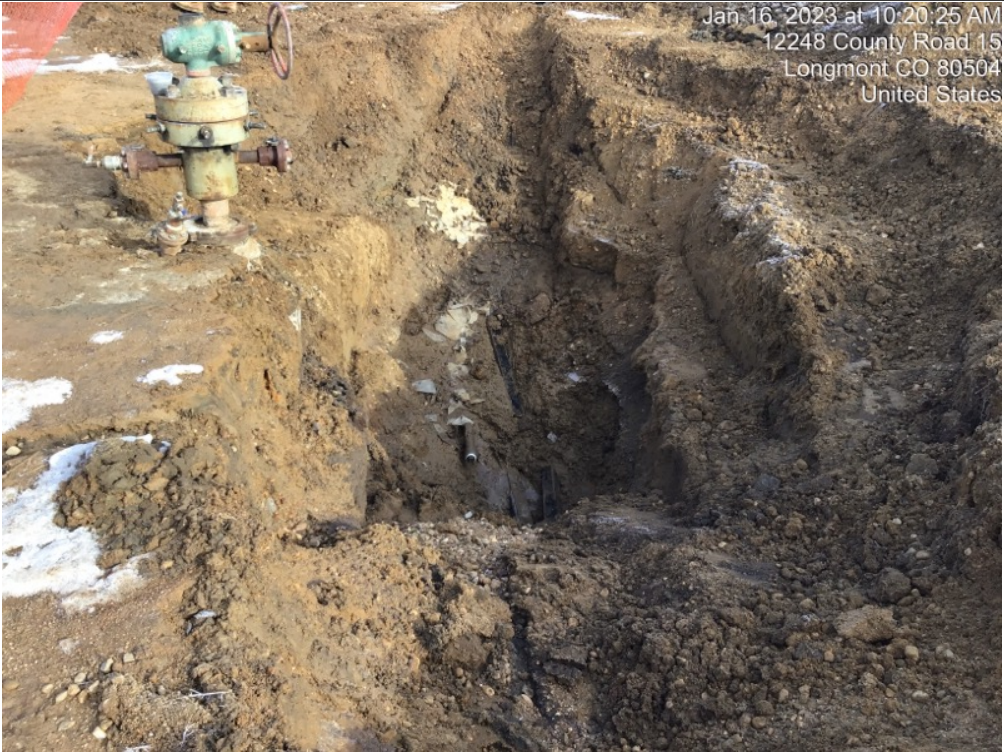
Information		Photo
Photo #: Location: Description:	5 End A End A post flushing activity

The flowline was cut 6.5 feet below ground surface at End A. At End B, the flowline was cut 4.0 feet below ground surface. End point coordinates were documented at both ends of the flowline.

The flowline was threaded, wrapped with white tape and capped at End A and End B as shown in the attached report.

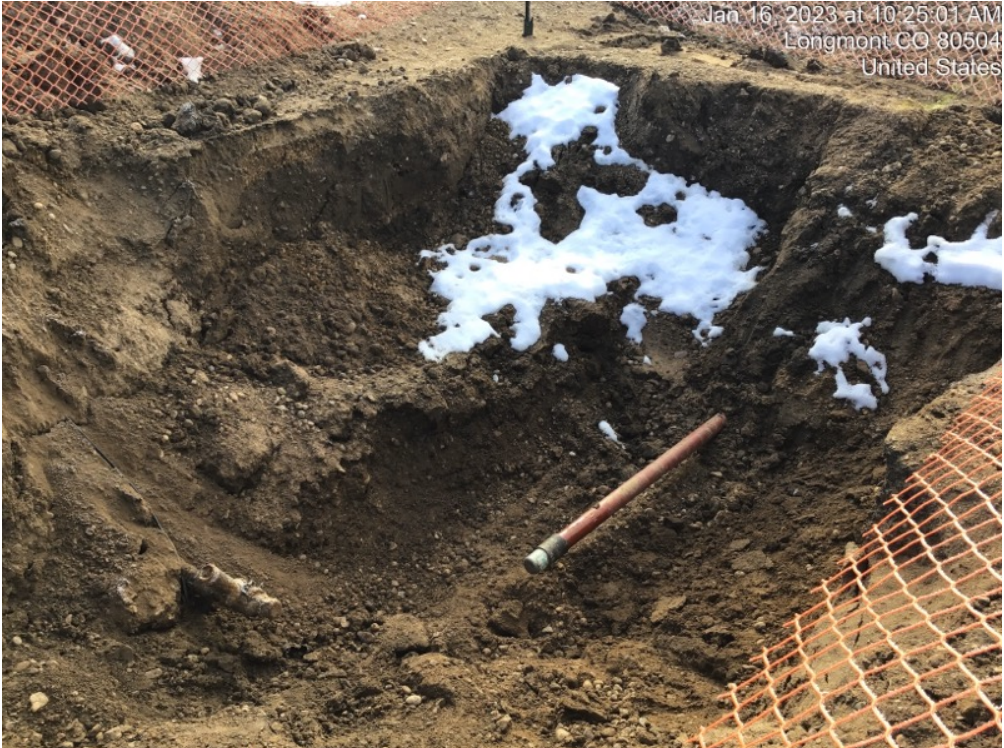
<p>Jan. 16, 2023 at 10:20:25 AM 12248 County Road 15 Longmont CO 80504 United States</p>
Photo #: Location: Description:	6 End B End B post flushing activity
