Annual Reclamation Assessment Report (2023)

ECMC Location Name (ID)	MATT-64N67W /24NWSW (331001)
Operator Location Name	Matt 1 Well Pad & Facility
ECMC Operator Name (ID)	PDC ENERGY, INC (69175)
Legal Description	NWSW Sec. 24 T4N-R67W
Well Pad Geographic Coordinates (WGS84)	40.295627/ -104.846841
Facility Pad Geographic Coordinates (WGS84)	40.294865/-104.848239

Introduction

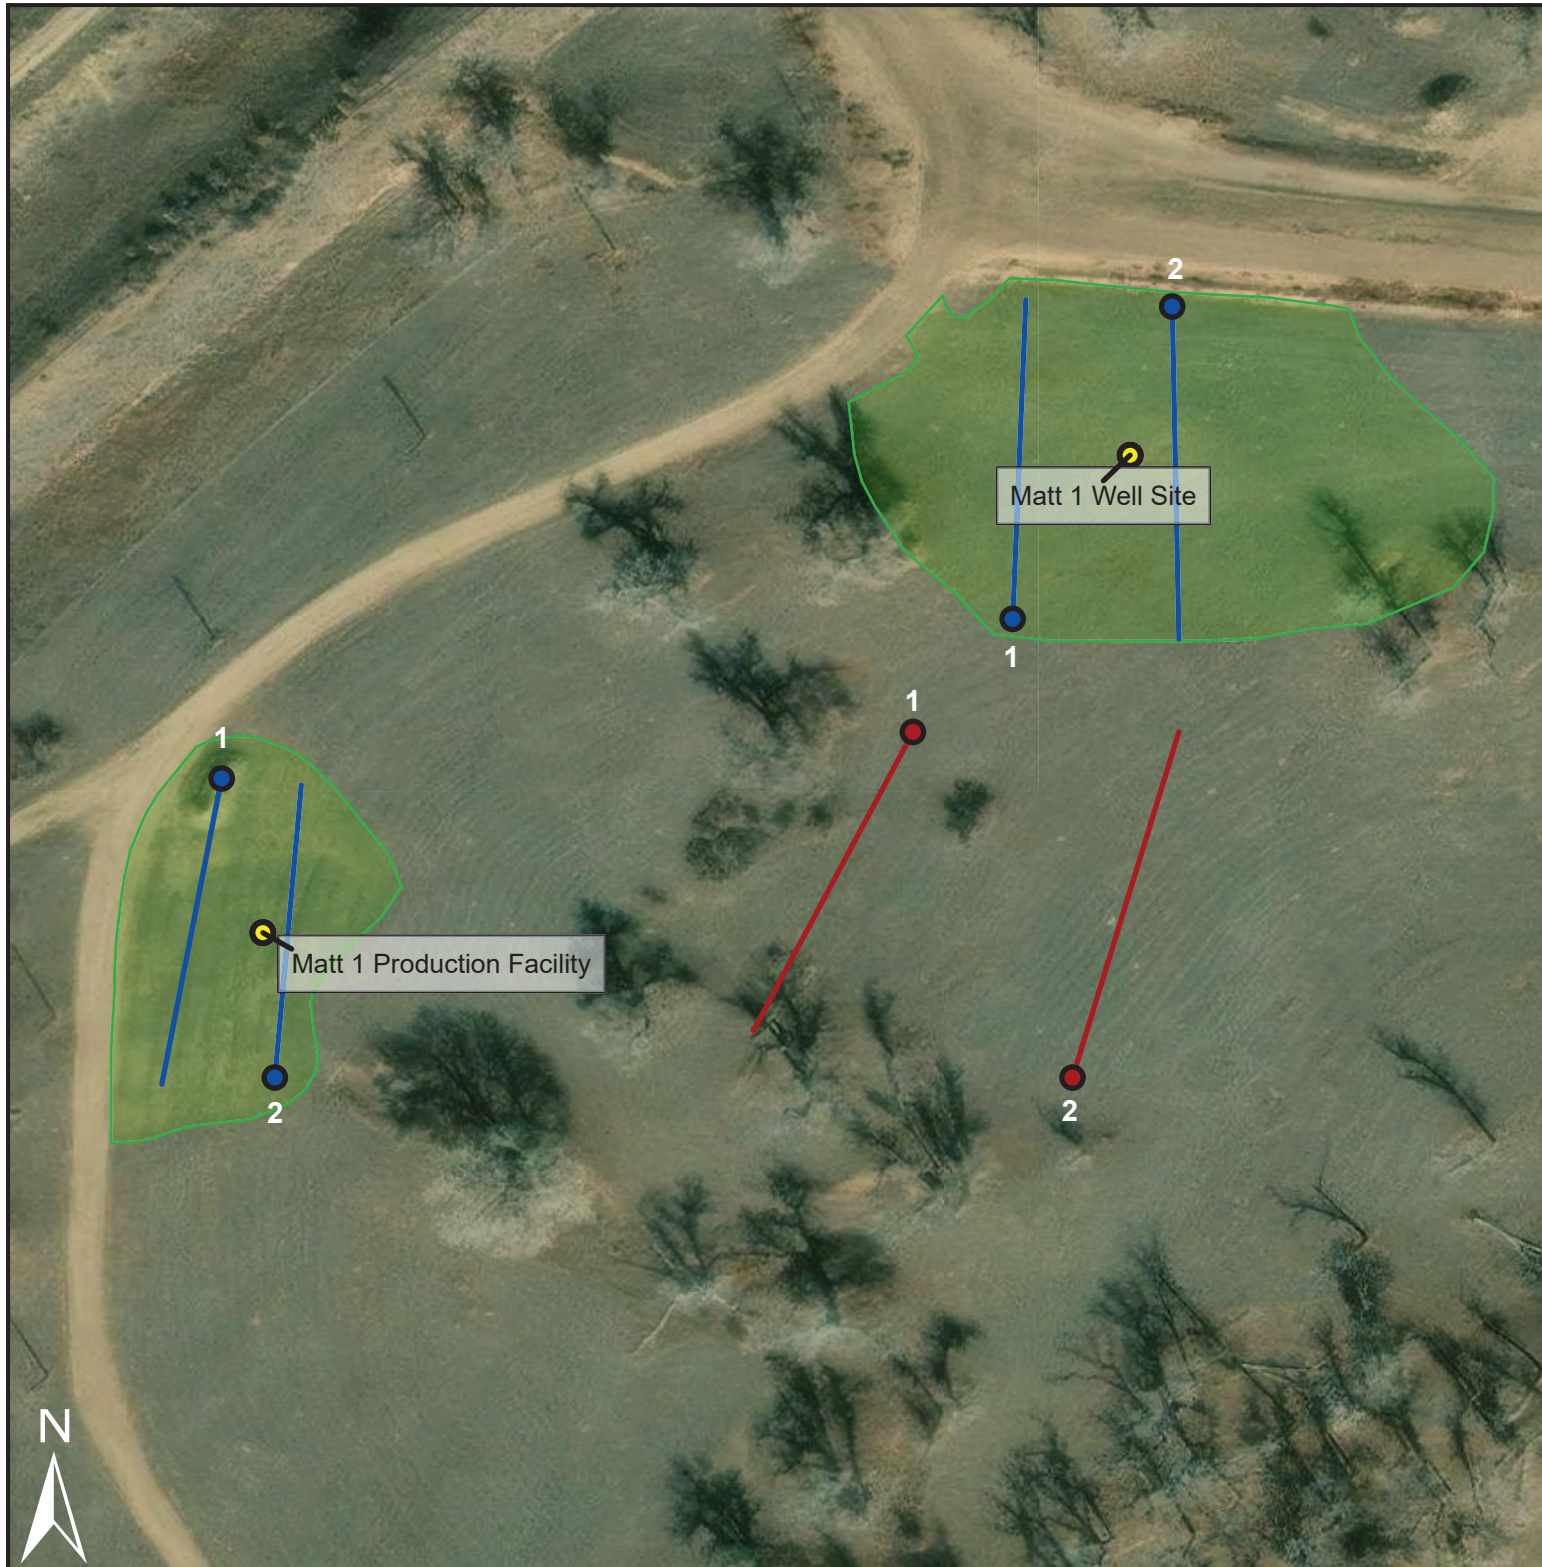
Matt 1 Flow Analysis Site Overview

A flow analysis of the upgradient drainage basin found that 373 acres contribute stormwater and suspended sediment to the reclaimed Locations. The Locations are directly downgradient of the basin and fall within the floodplain and filled oxbow of the South Platte River. An abandoned

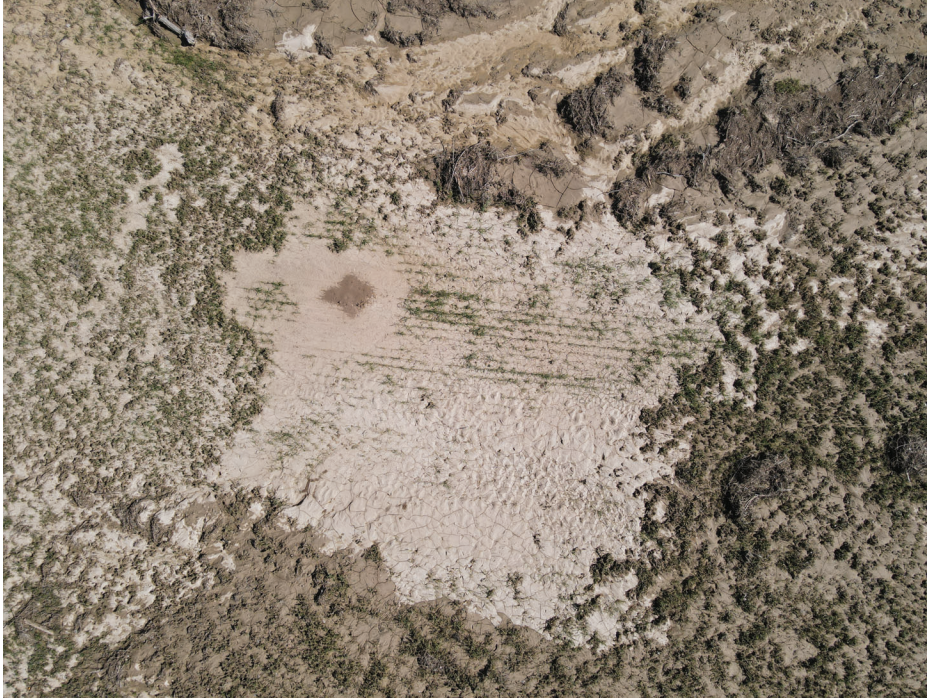
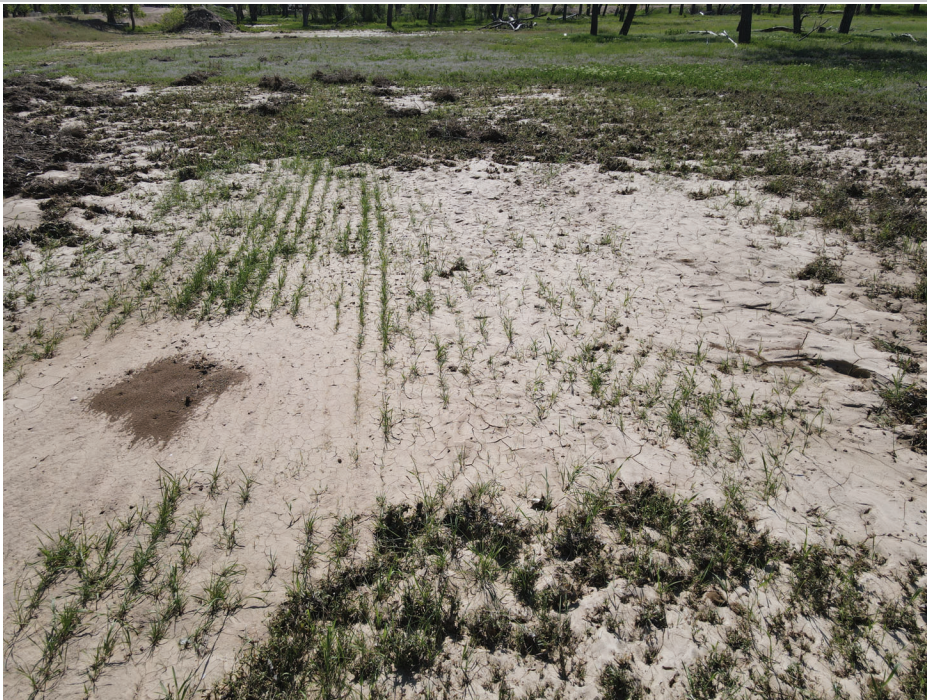
SECONDARY SITE RECOMMENDATION: Maintenance

Secondary Recommendation: Maintenance	Rationale: Subsidence observed within the reclaimed disturbance.	Description: The 600 square feet surrounding the former well head is below grade despite evidence of previous subsidence repair and reseeding. Confluence recommends subsidence repair during potential sediment removal operations.
---	--	--

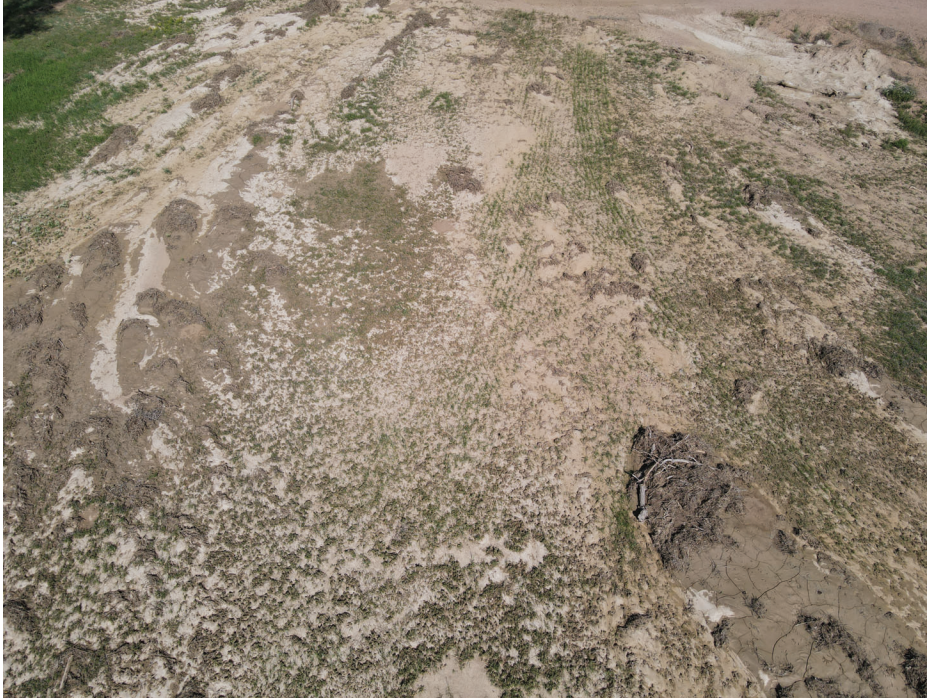
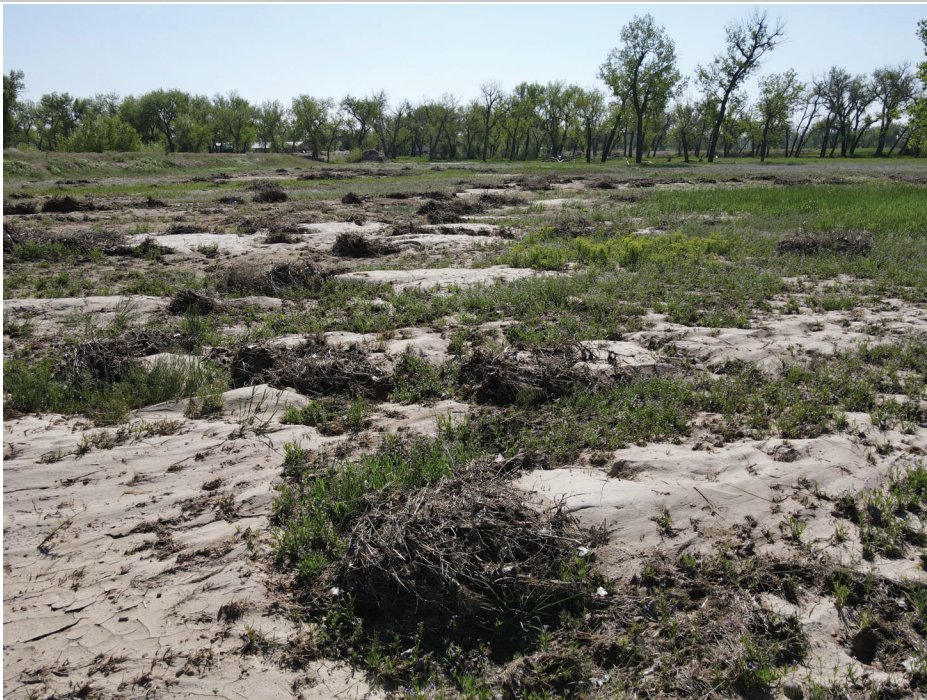
TERTIARY SITE RECOMMENDATION: Maintenance

Tertiary Recommendation: Maintenance	Rationale: Weeds are over-represented within the reclaim when compared to the reference.	Description: Listed noxious weed and undesirable weeds are overrepresented within the reclaimed surface. Confluence recommends weed management to suppress undesirable vegetation encroachment.
--	--	---

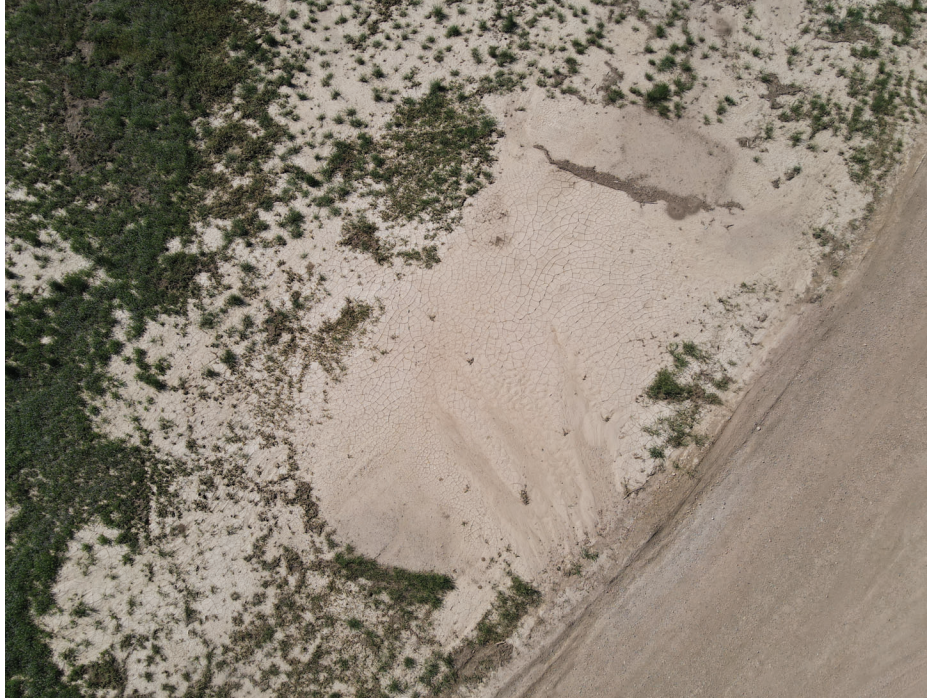
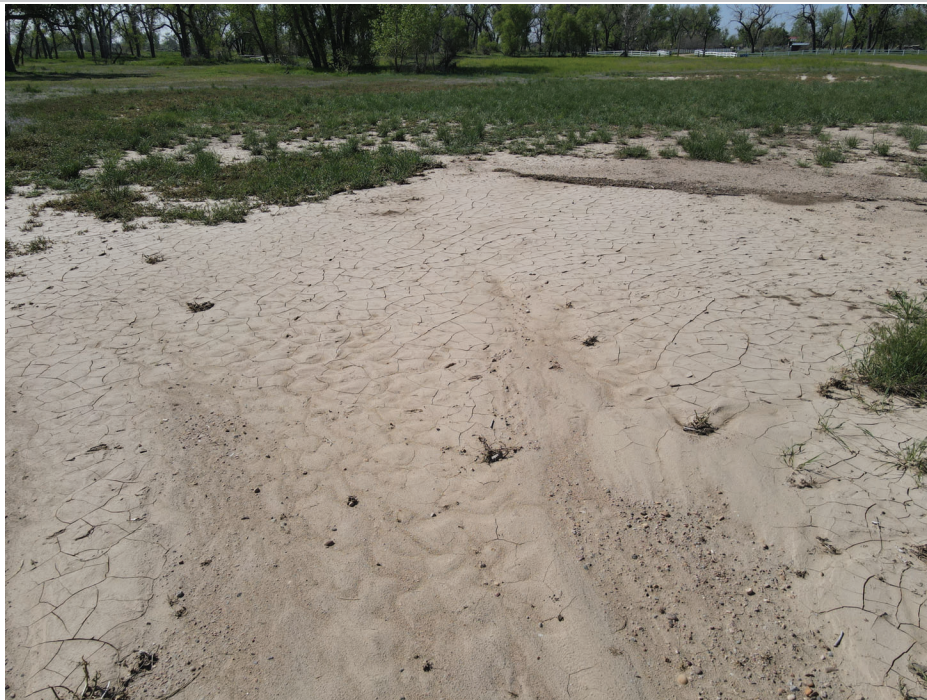
PRIMARY SITE RECOMMENDATION: Maintenance

Primary Recommendation:	Rationale:	Description:
Maintenance	Subsidence present within the reclaimed surface.	The southern portion of the surface disturbance is below grade and exhibits evidence of ponding with poor vegetation establishment. Confluence recommends infilling the below grade region and interseeding.
Maintenance Contract Type:	3	
Square Foot Estimate:	3410	
Secondary Recommendation:	Rationale:	Description:
Maintenance	Bare regions present within the reclaimed surface.	The surface disturbance previously housed a road base stockpile. This has been removed by the surface owner. The area beneath the former stockpile is bare. Confluence recommends seedbed preparation and seeding for the bare area.
Maintenance Contract Type:	NA	
Square Foot Estimate:	2687	
Tertiary Recommendation:	Rationale:	Description:
Maintenance	Weeds are over-represented within the reclaim when compared to the reference.	Undesirable and listed noxious weeds are over represented in the reclaim. Confluence recommends coordinating weed management activities with the surface owner.

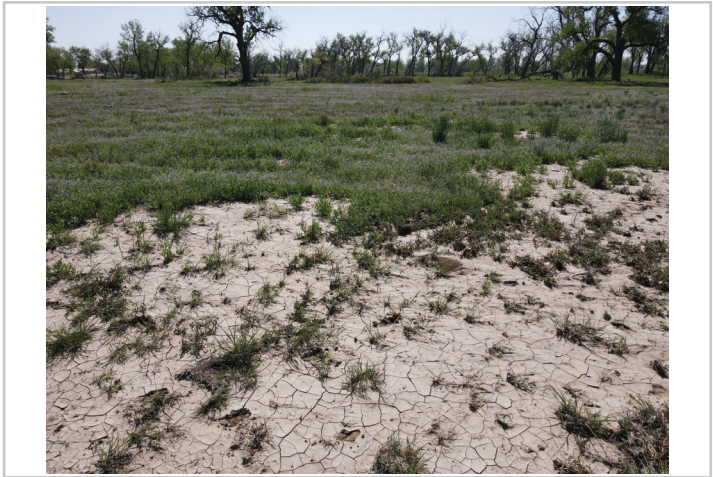
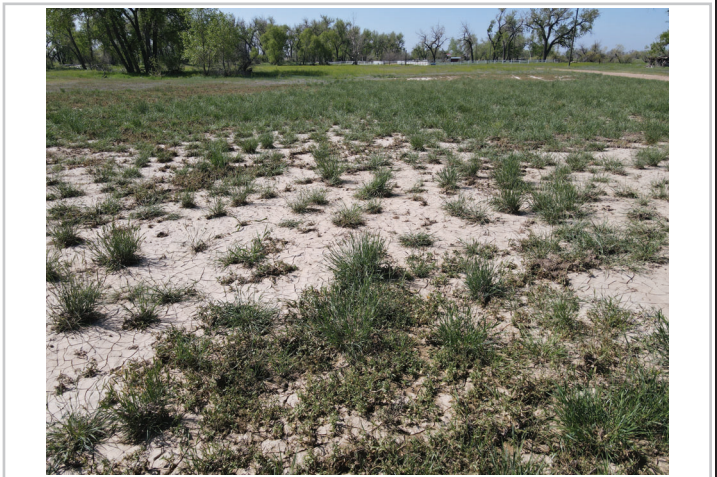
Stressed vegetation and bare areas
