# Inspection Photos

**Operator:** POC-I LLC - 10386

**Location ID:** 312756

**Inspection Doc:** 696205344

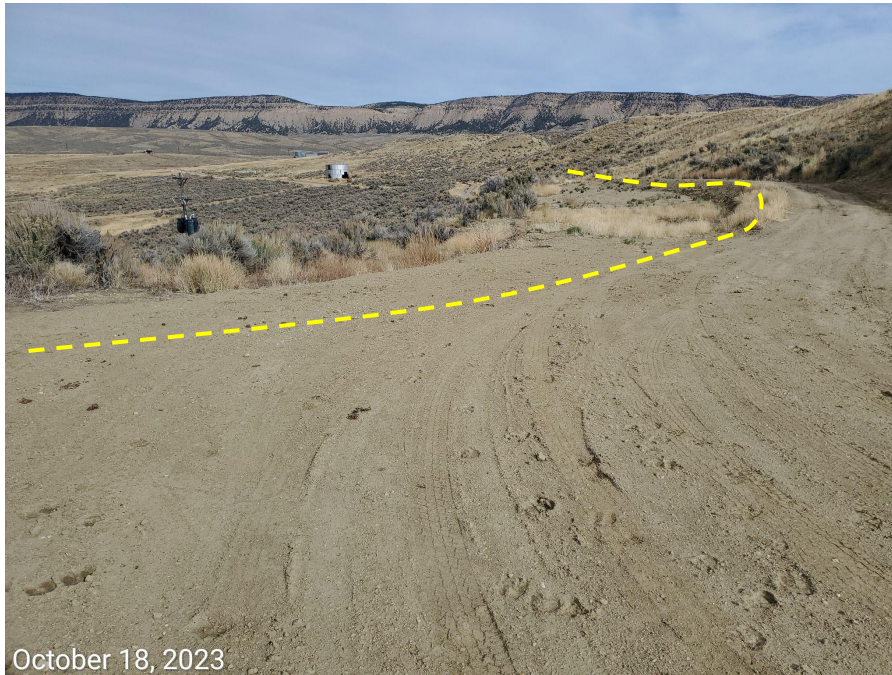
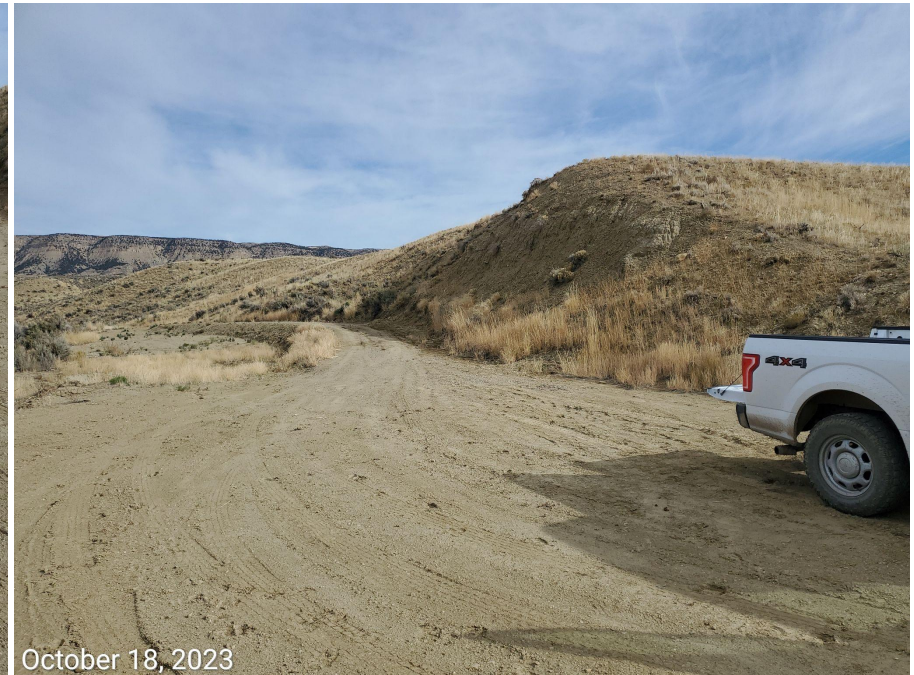
**Photo 1:** Photos taken from the south end of the Location, facing north and northeast. Photos provide an overview of the Location. Areas left of the yellow line in the left photo require reclamation. Access road travels past the location and remains in use by the surface owner.

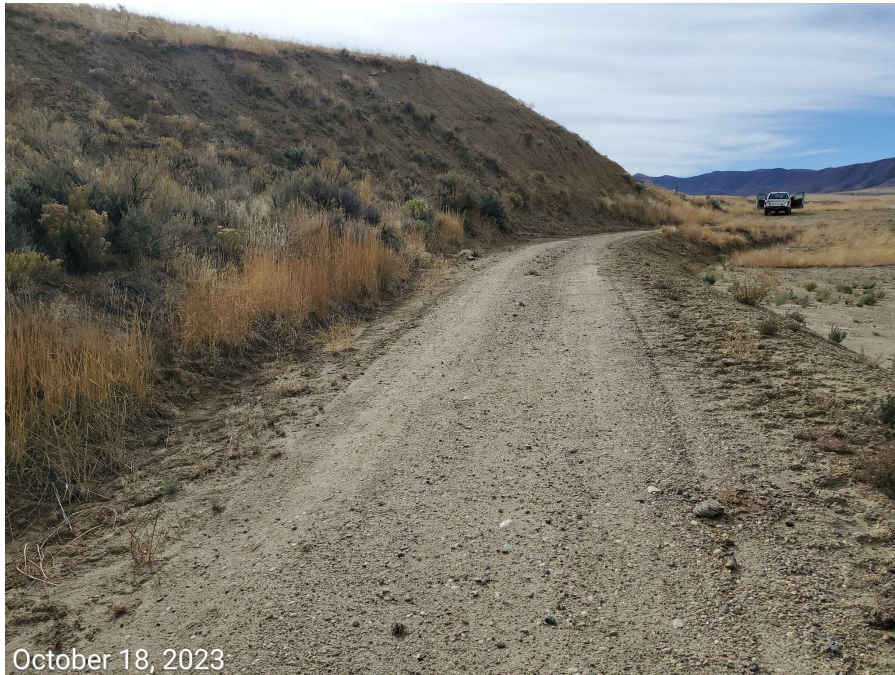
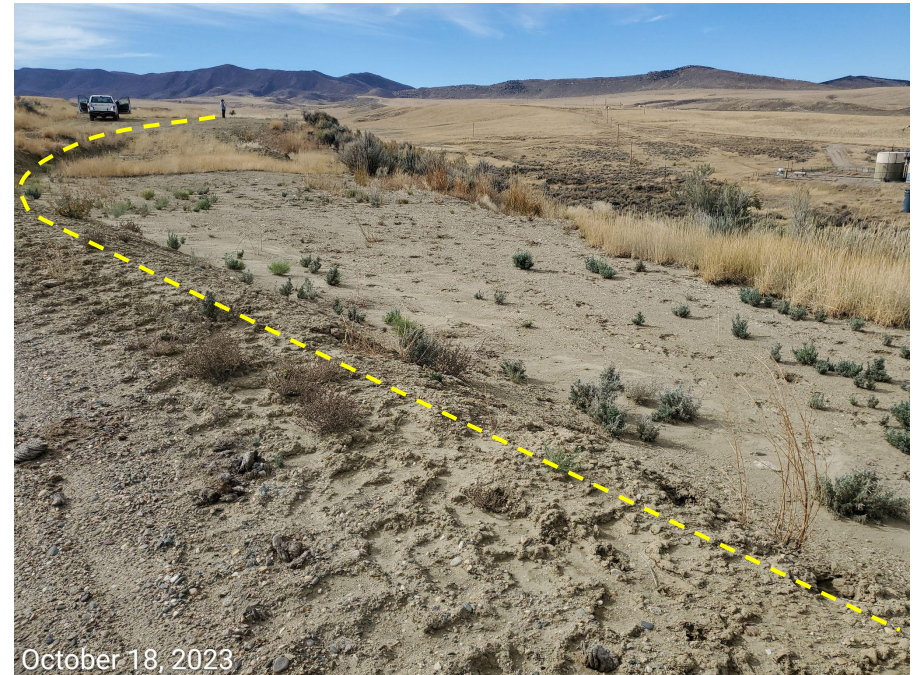
**Photo 2:** Photos taken from the north end of the Location, facing south and northwest. Photos provide an overview of the Location. Areas right of the yellow line in the right photo require reclamation. Access road travels past the location and remains in use by the surface owner.

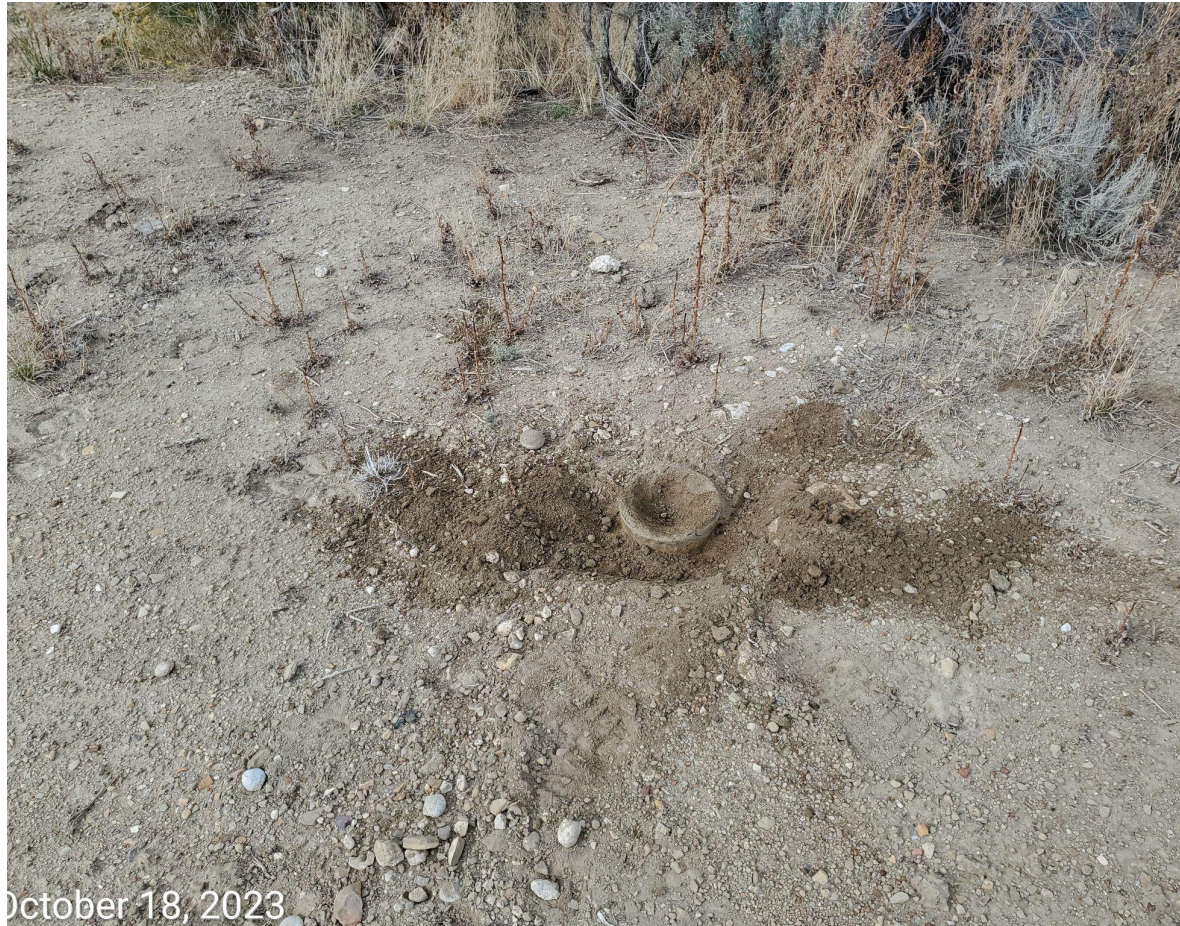
**Photo 3:** Photo taken from the west end of the Location. Photo shows pipe that remains apparent at the pad surface. Operator appears to have cut the pipe at the surface, and backfilled with soil.

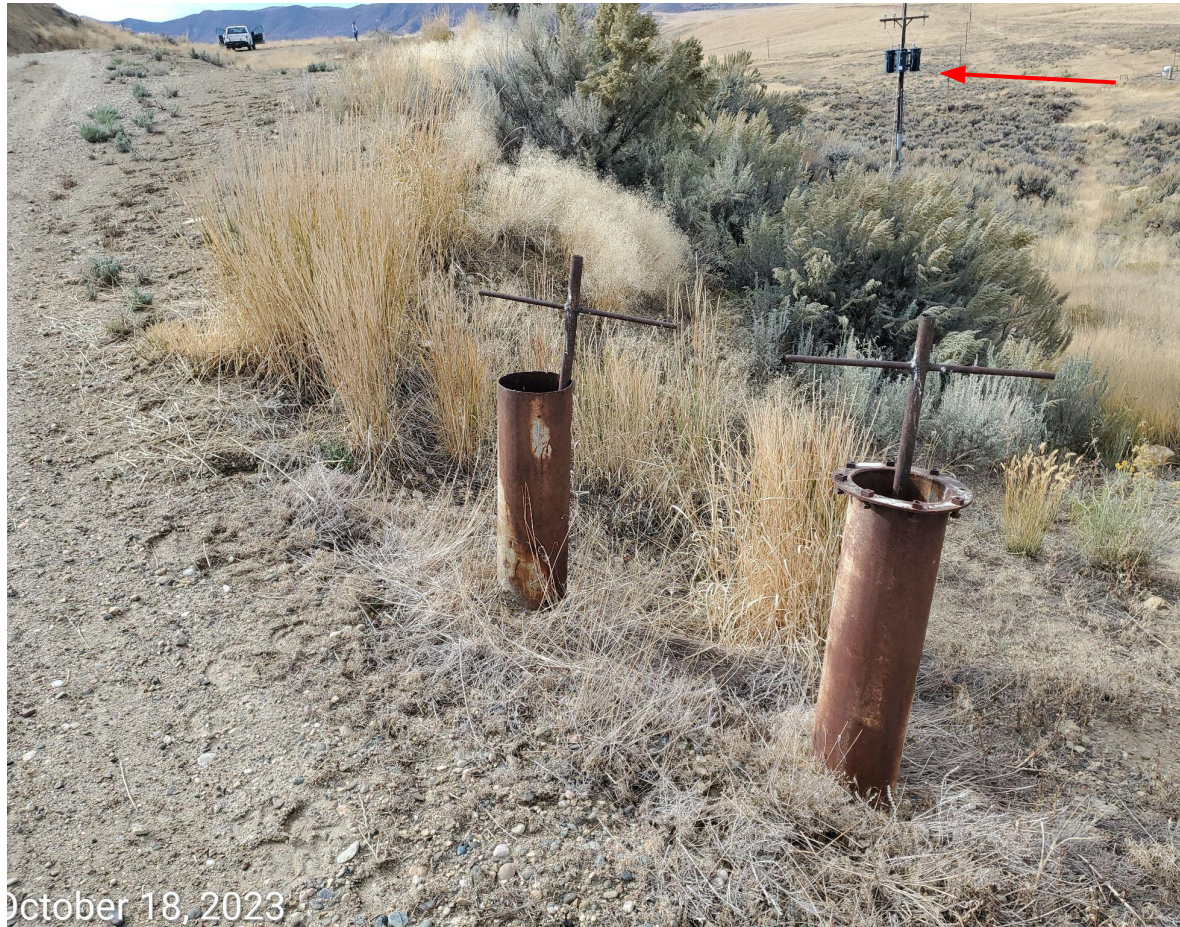
**Photo 4:** Photo taken from the north end of the Location, facing south. Photo shows pipe equipment remaining on the Location. Arrow also shows Utility Pole remaining. Equipment require removal.

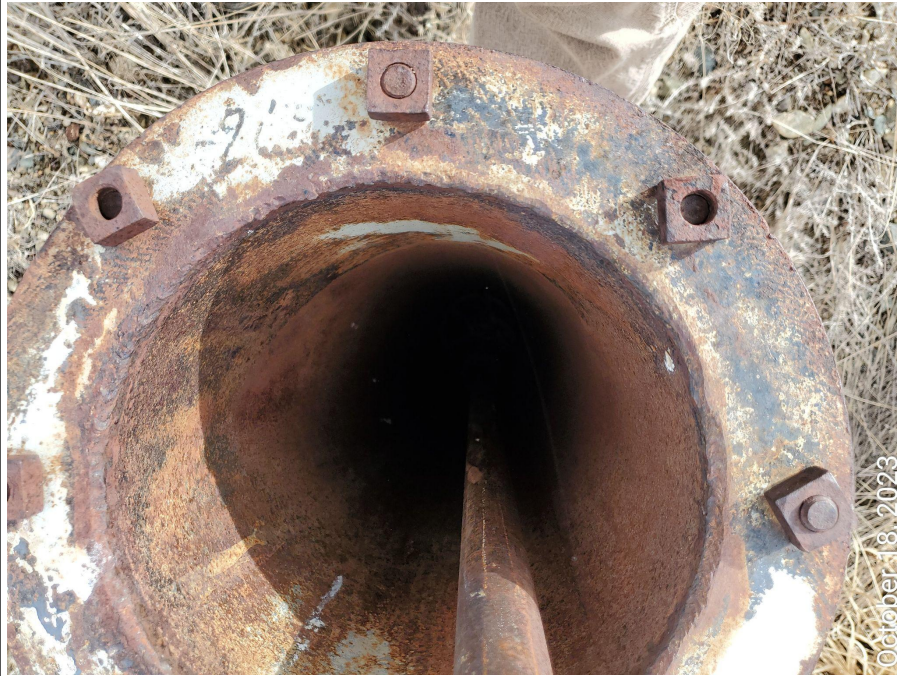
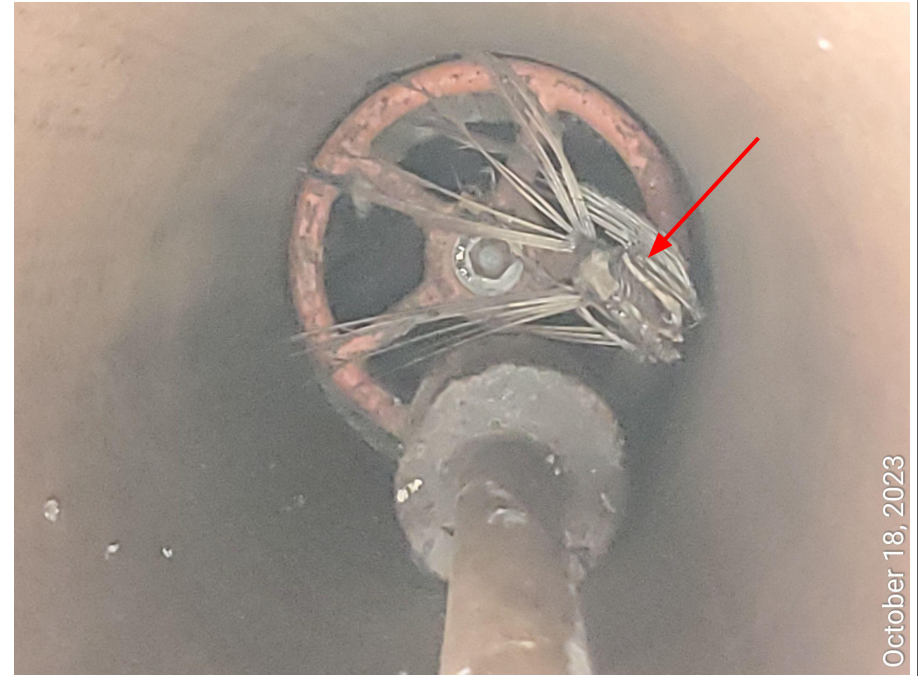
**Photo 5:** Continued from photo 4. Photo shows pipe on the north end of the Location has not been properly covered, resulting in bird mortality.

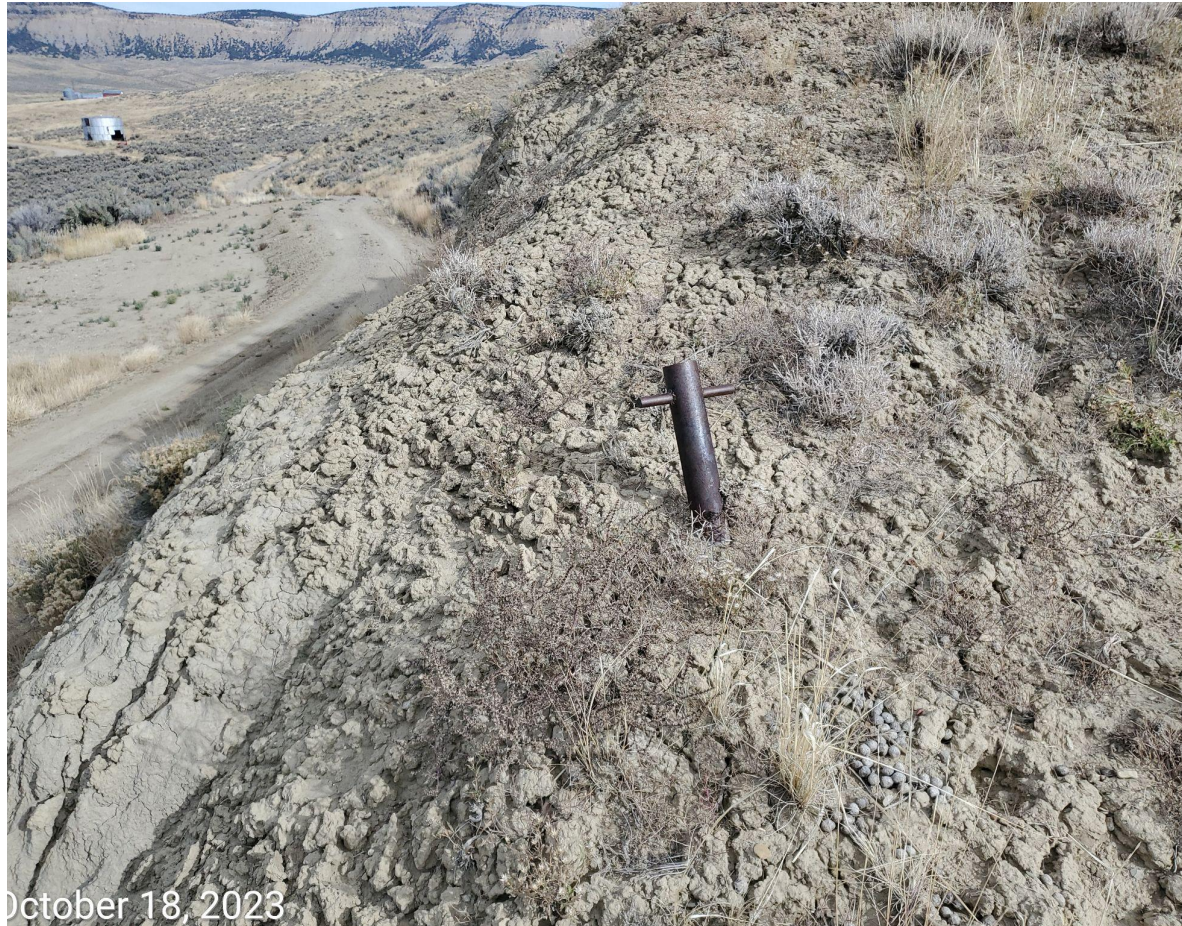
**Photo 6:** Photo shows anchor remaining on the southeast end of the Location.

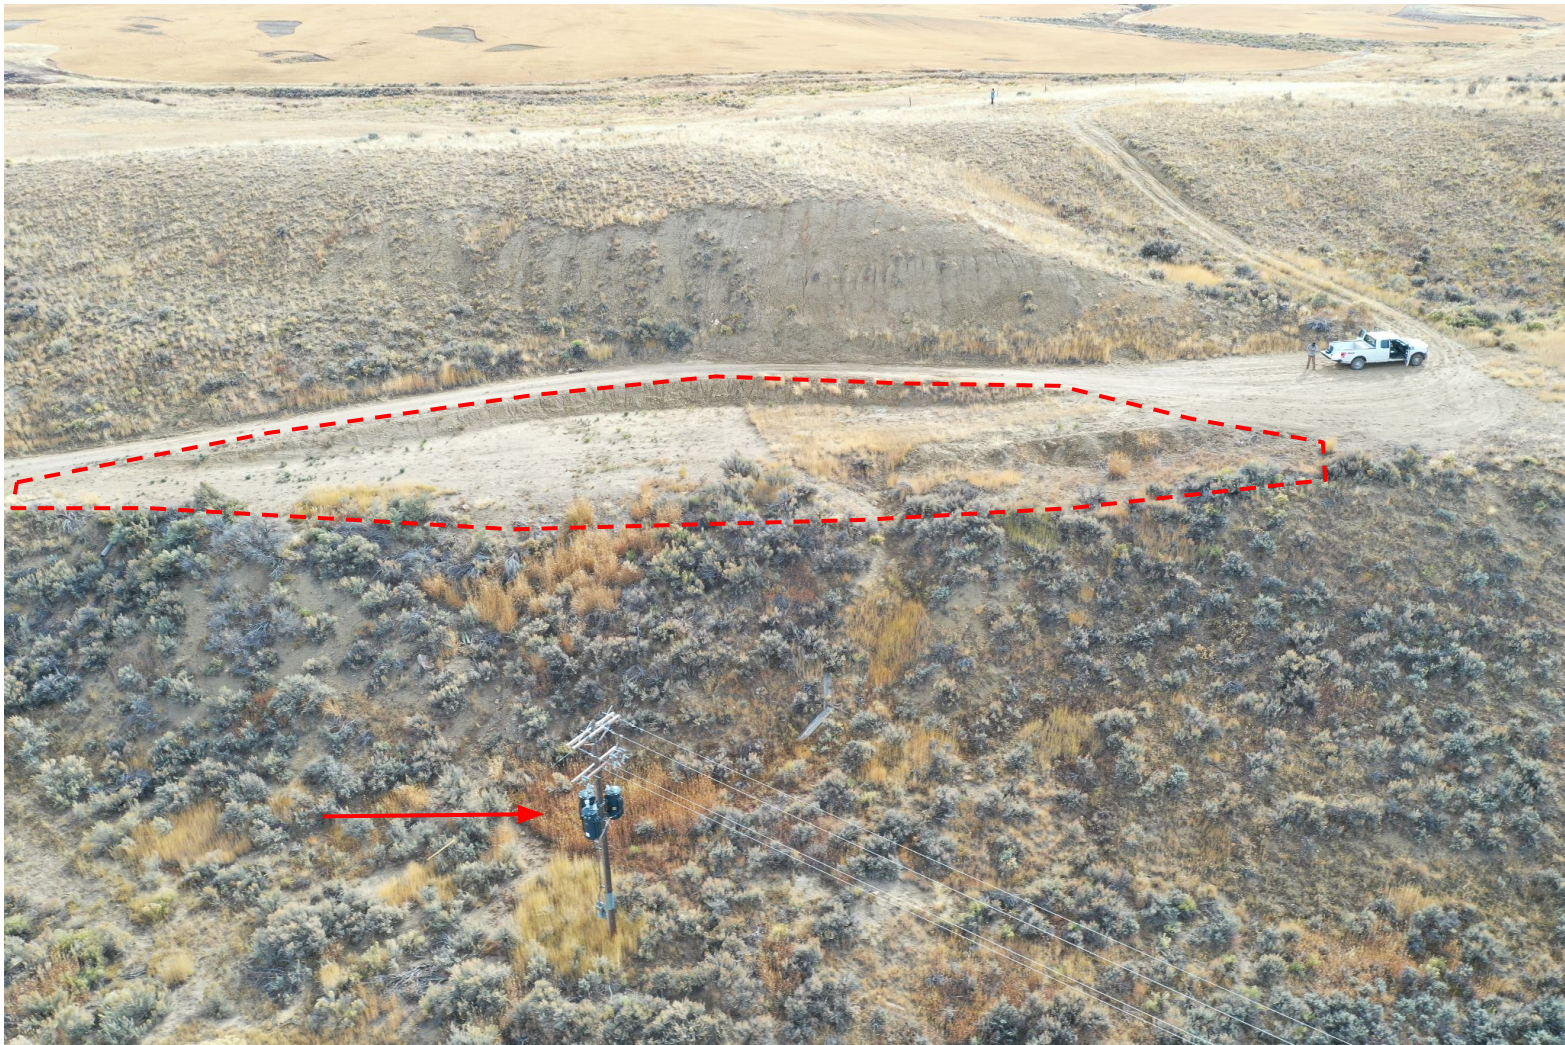
**Photo 7:** Photo taken with use of a sUAS. Photo shows access road travels through the Location and is in use by the Surface Owner; areas beyond the road require reclamation (red polygon). Photo also shows utility equipment requiring removal.
