Inspection Photos

Loc: 321141

Operator: **LORENTZ OIL & GAS LLC**

Inspection Date: 10/31/2023

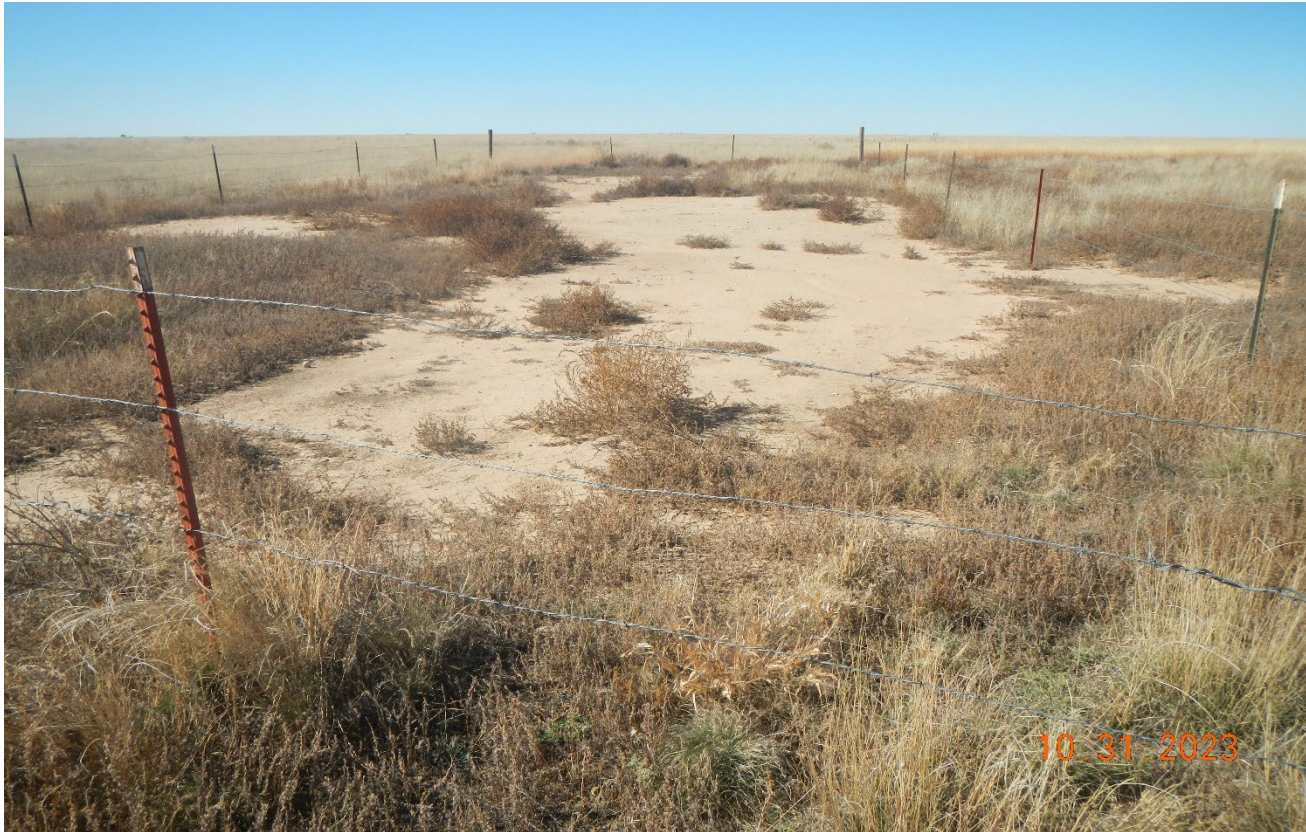
Photo 1. Facing west toward the location. The location is fenced and desirable vegetation has not reestablished.

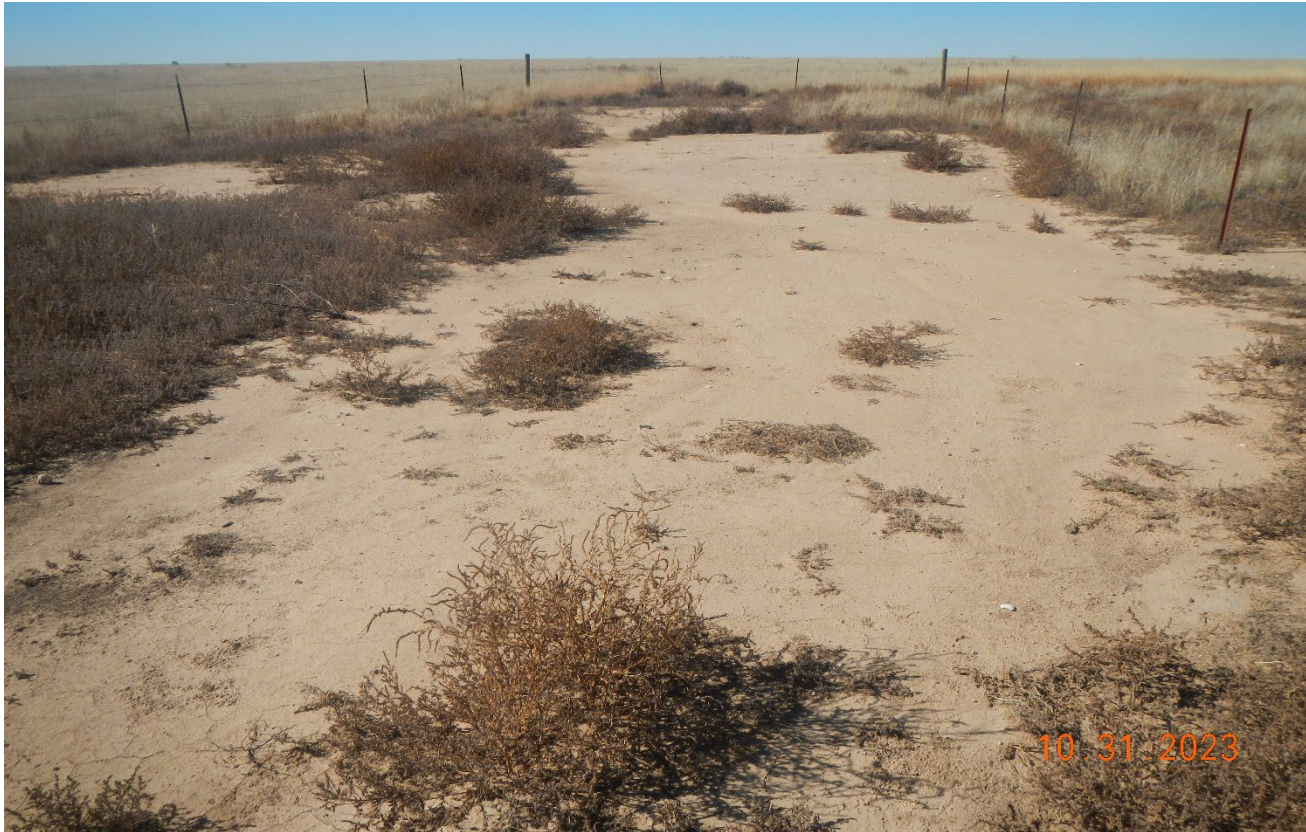
Photo 2. Facing west at the location. This area with insufficient vegetation is approximately 120'x60'. There are likely impacted soils preventing vegetation growth.

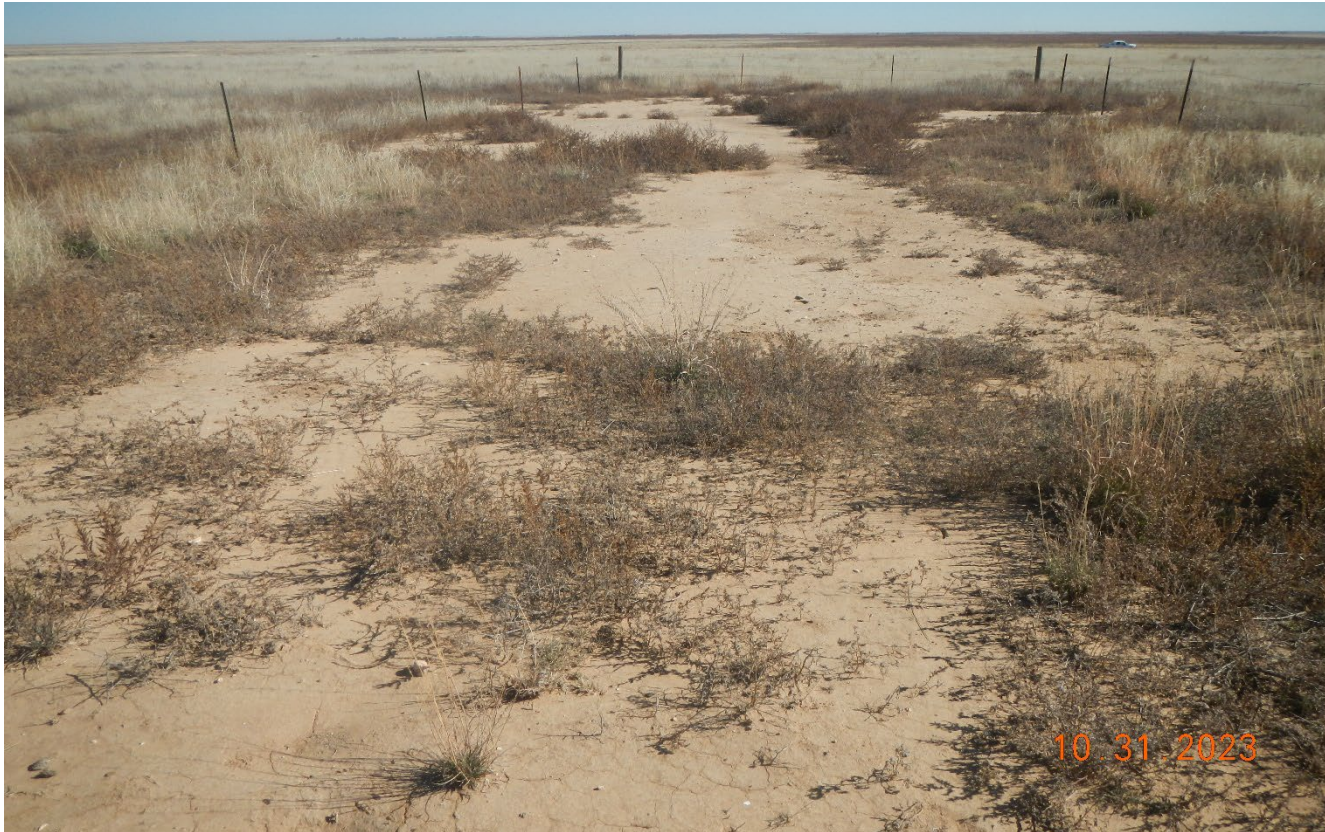
Photo 3. Facing east at the location. This area with insufficient vegetation is approximately 120'x60'. There are likely impacted soils preventing vegetation growth.

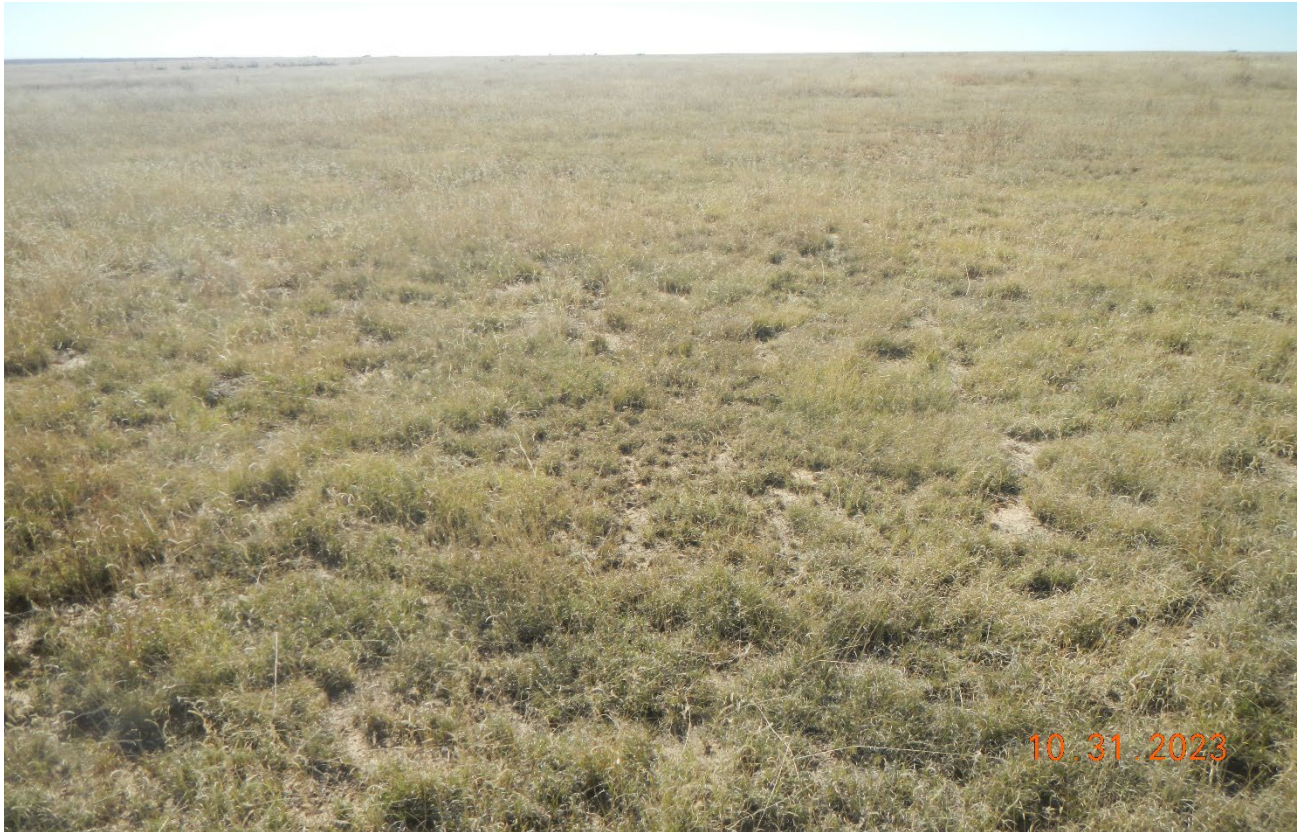
Photo 5. Facing south toward the surrounding reference area which consists of native Blue grama, Sand drpseed, Buffalo grass ect.
