Inspection Photos

Operator: TEP ROCKY MOUNTAIN LLC #96850
/ NONSUCH NATURAL GAS INC #10163

Location ID: 322524 (TEP), 453726 (Nonsuch)

Inspection Doc: 696205408

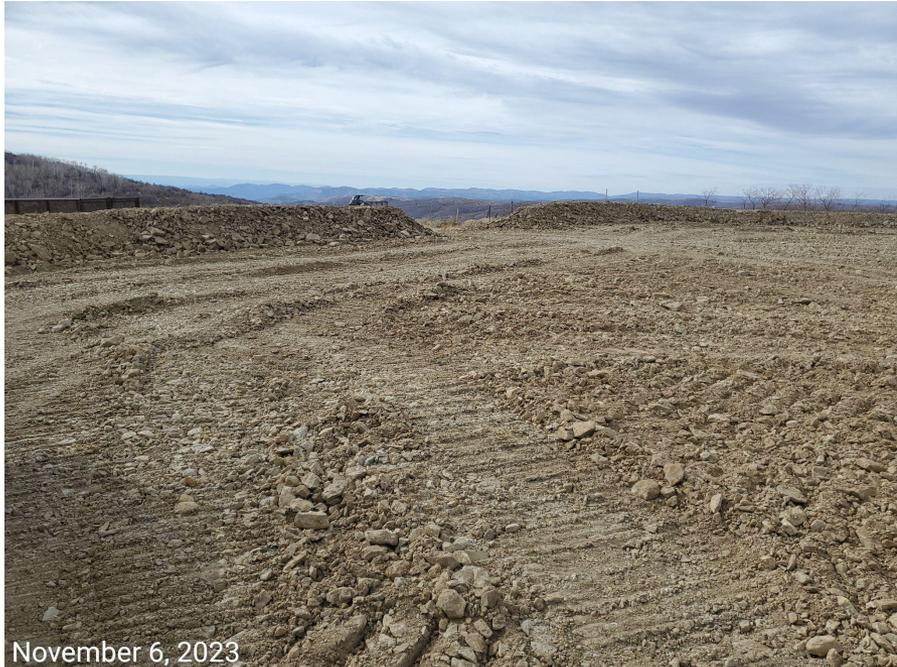
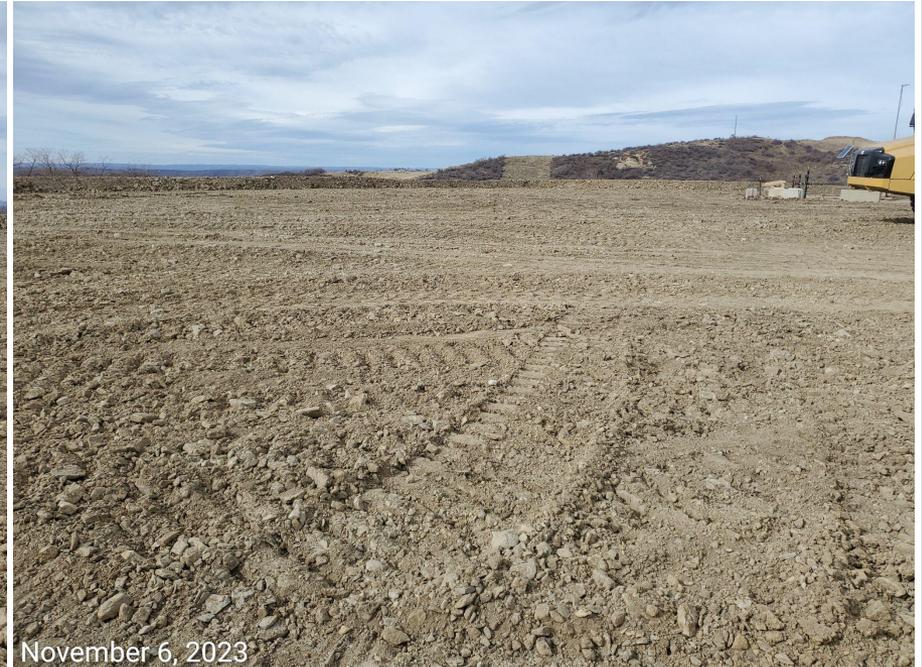
Photo 1: Photos 1-2 taken from the east end of the working pad surface. Photos provide an overview of the Location from south, southwest northwest to north.

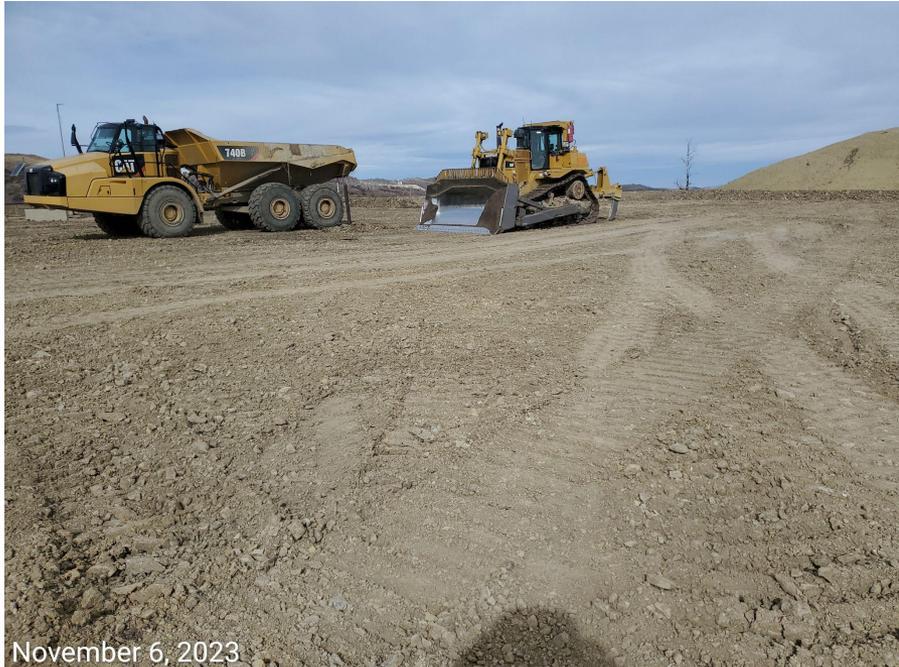
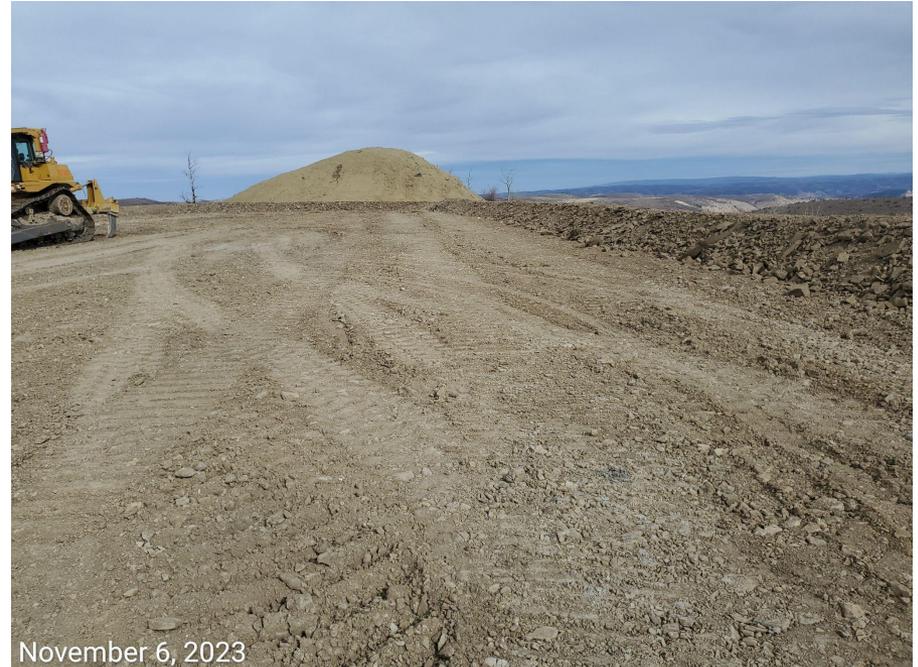
Photo 2: See comments under photo 1.

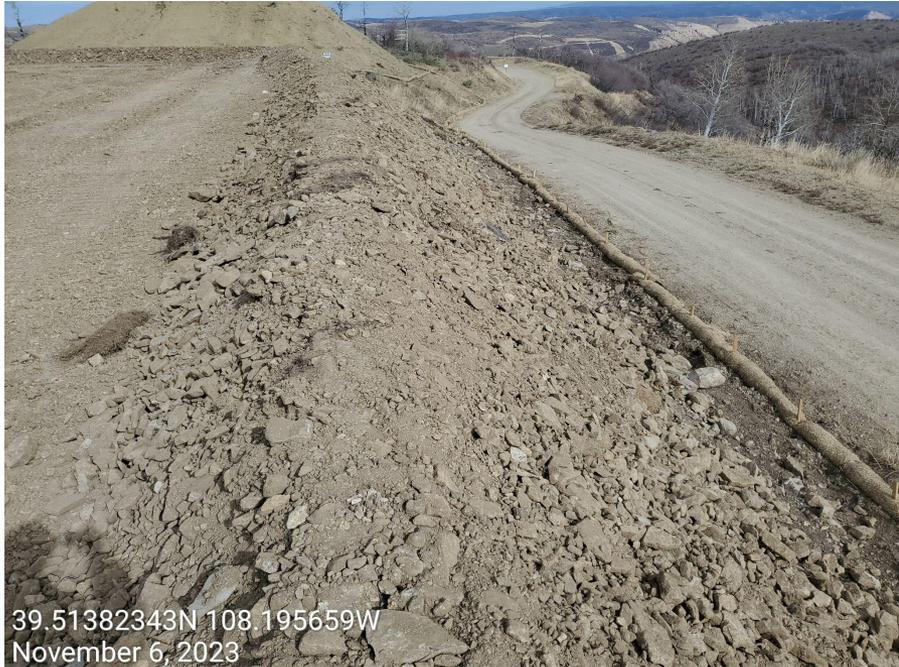
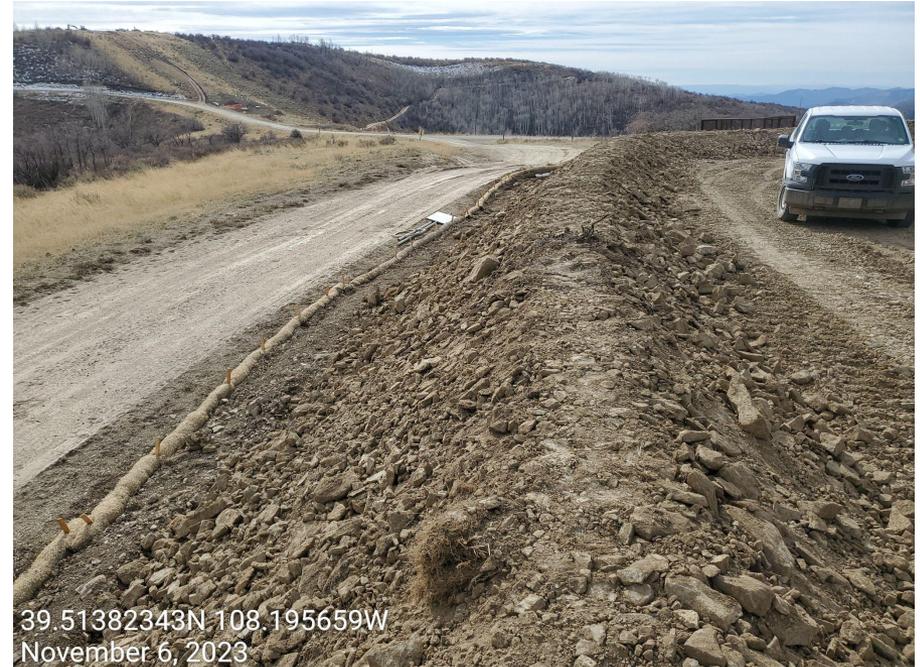
Photo 3: Photos examples showing berm constructed along the perimeter of the WPS; erosion logs implemented along the Locations disturbance.

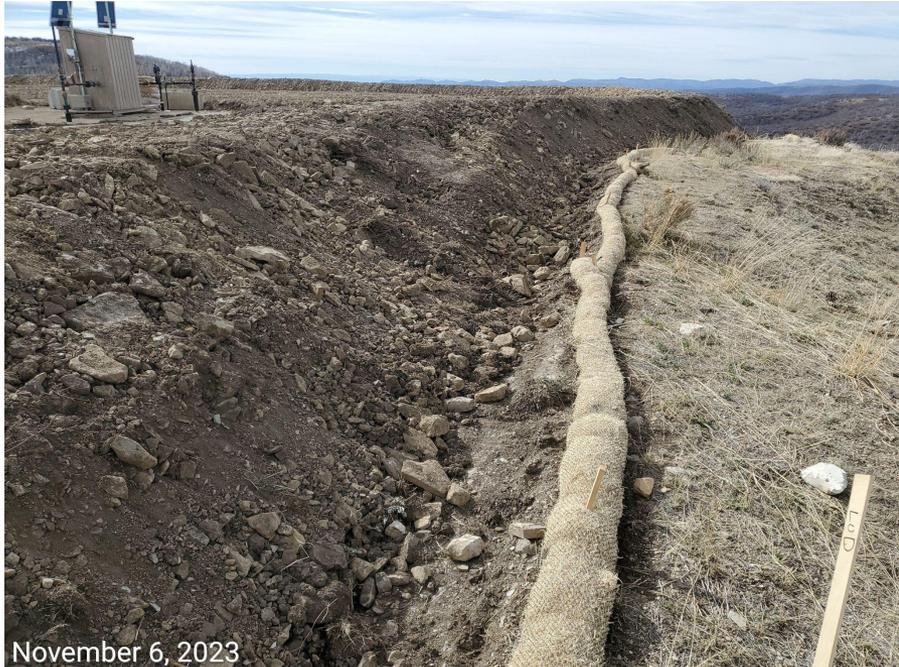
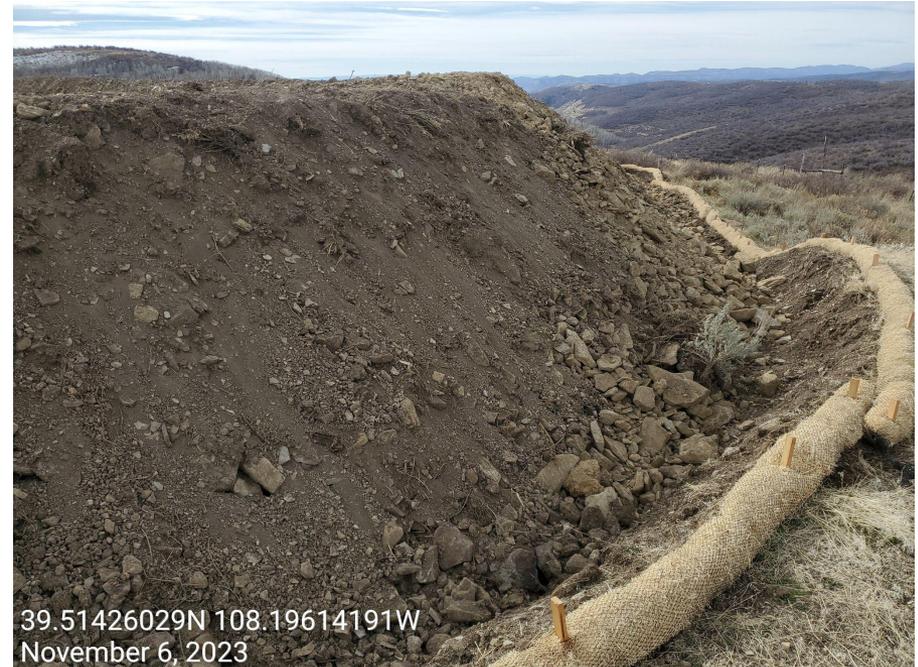
Photo 4: Photos examples showing slopes of the Location are bare, lack stabilization and are at risk to wind and water erosion; stormwater and erosion control measures inadequate.

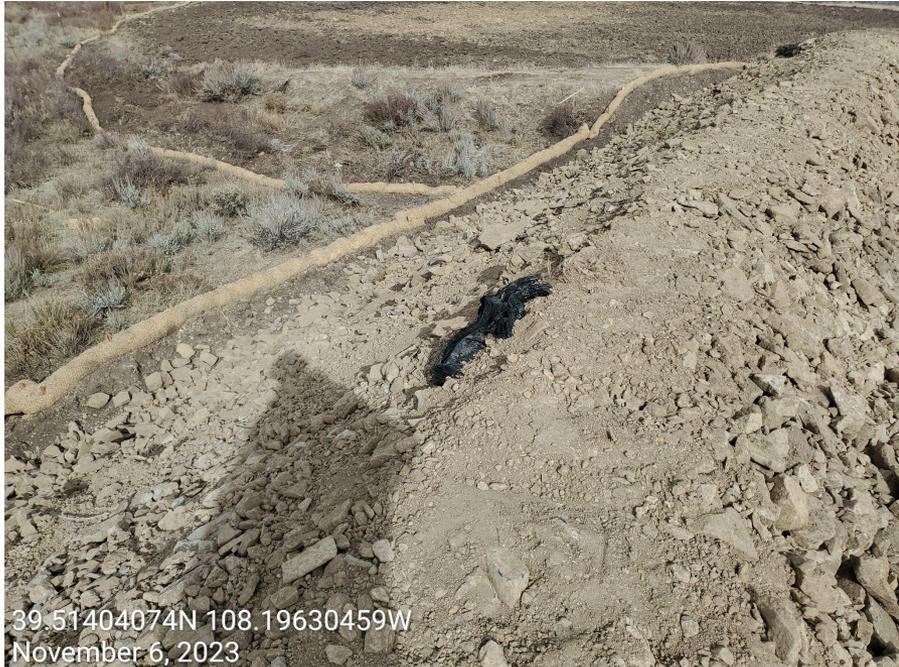
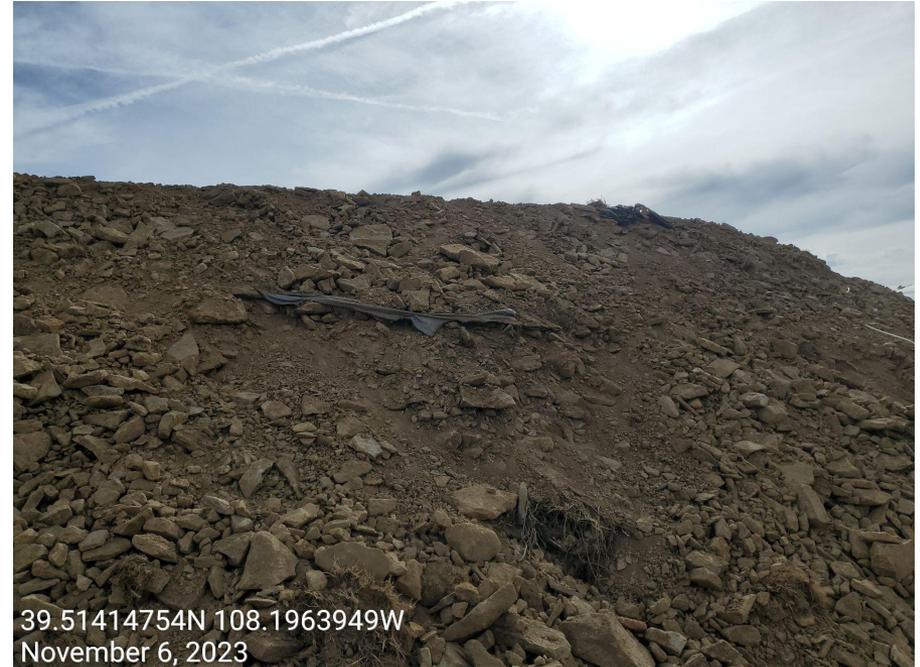
Photo 5: Photos show examples of trash debris observed along the slopes and berm of the Location.

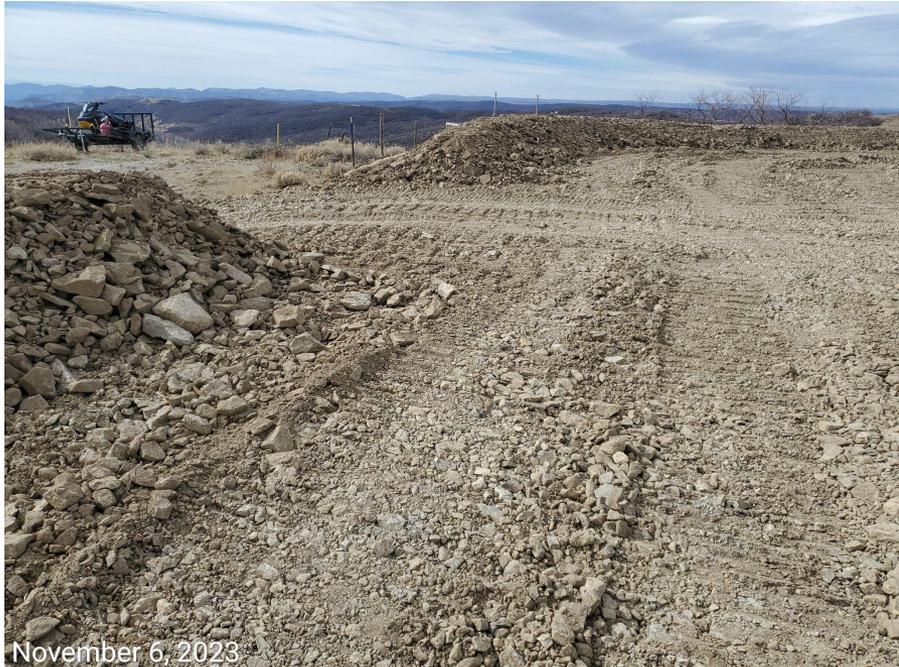
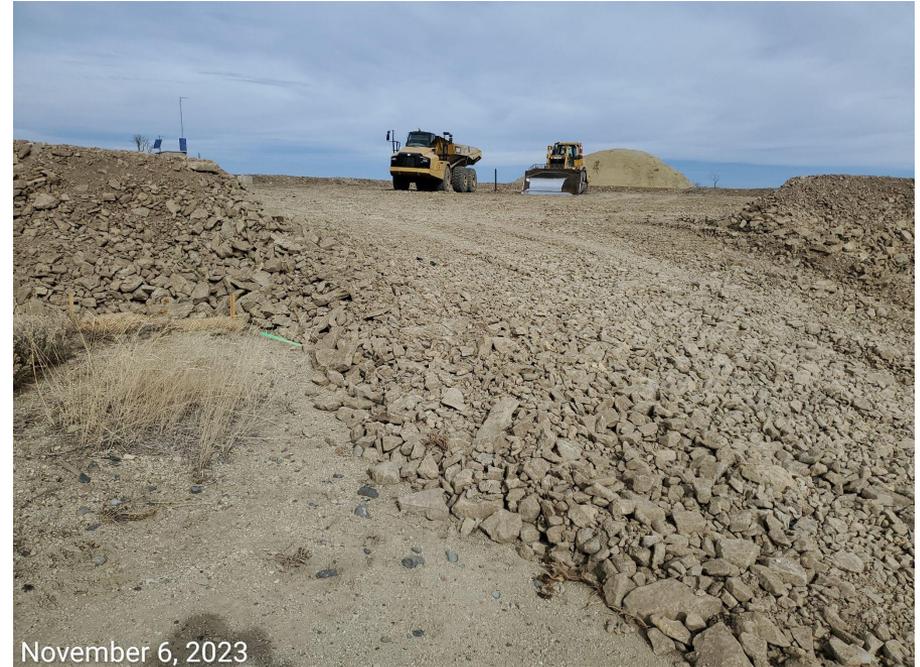
Photo 6: Photos taken from the Location entrance. “Drive Over Berm” to manage runoff has not been constructed per Operator’s documents attached to the Form 4.

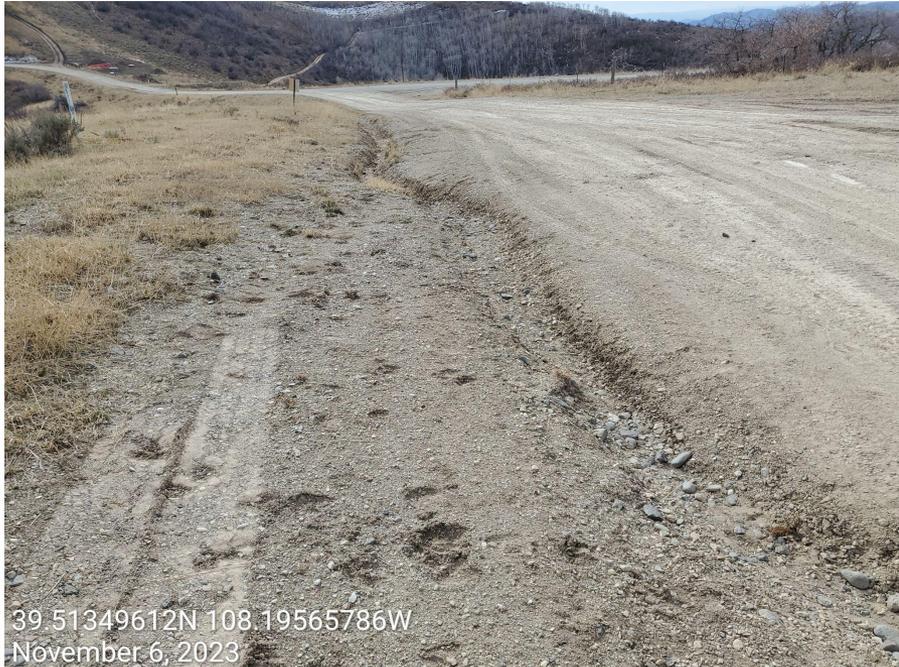
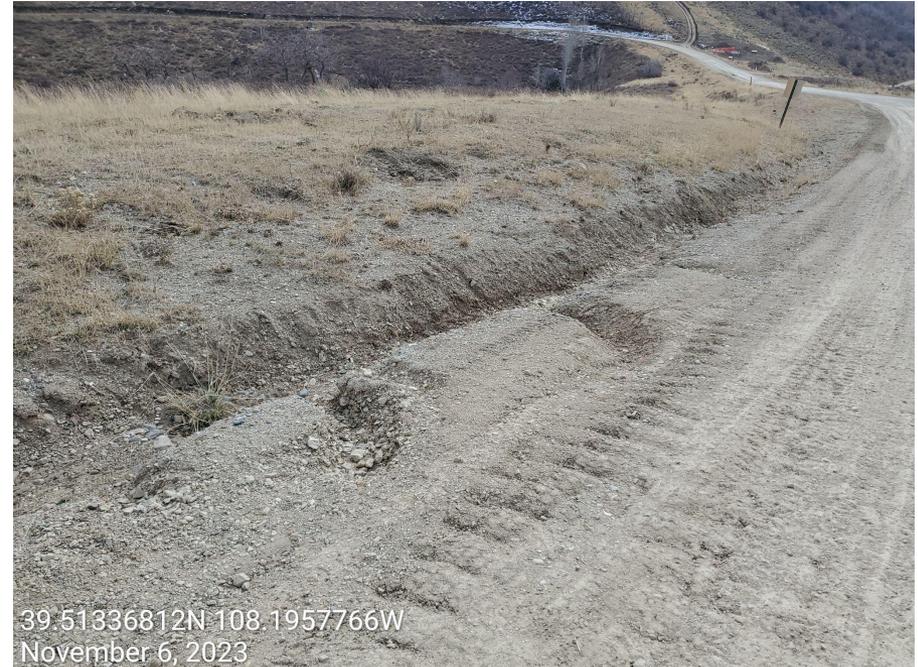
Photo 7: Photos taken from the access road. Previous inspection observed that stormwater runoff from the Location has resulted in degradation the Location's entrance and access road. The Location entrance has been re-constructed, however erosion degradation along the access road remains apparent.

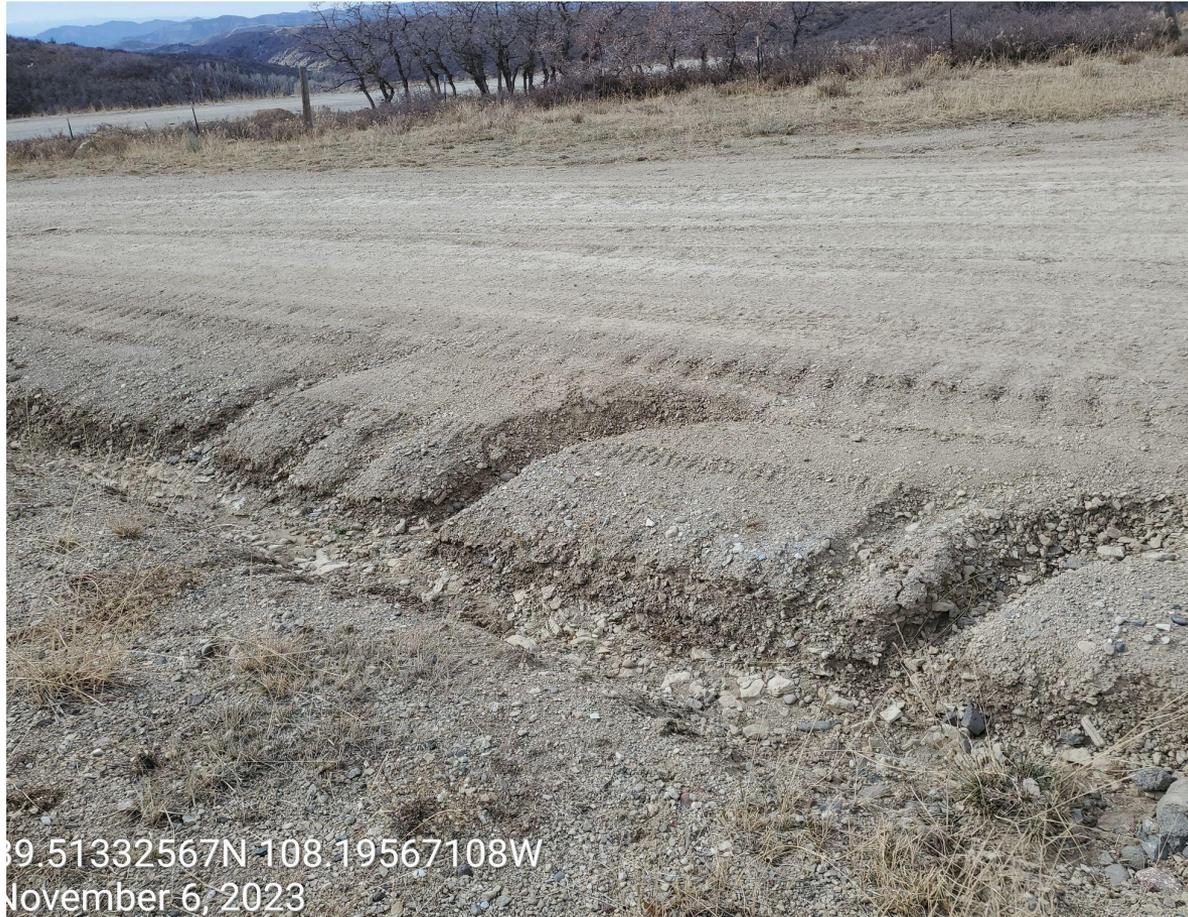
Photo 8: See comments under photo 7.

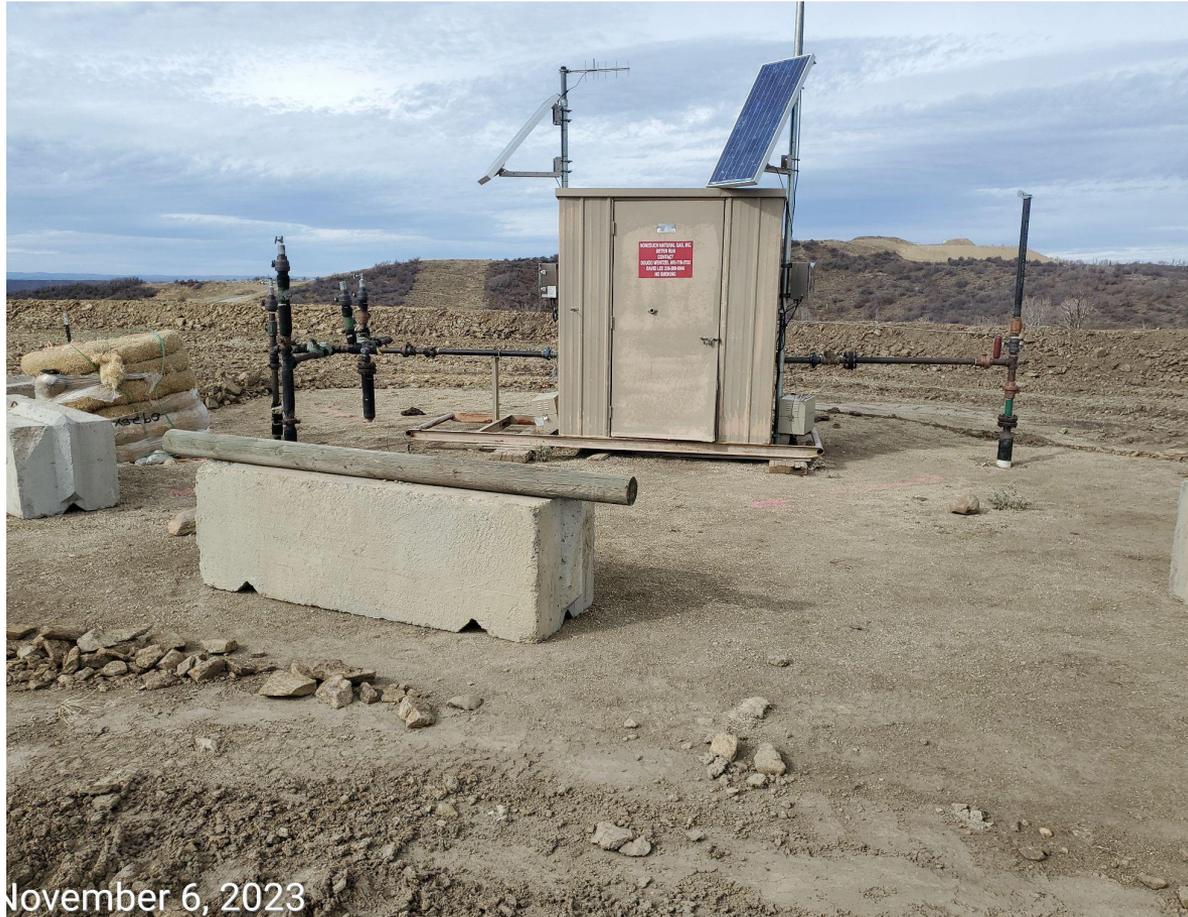
Photo 9: Photo shows Nonsuch equipment associated with the CSOC 697-14 Tank Battery Facility remains on the Location.
