# Inspection Photos

**Operator:** NONSUCH NATURAL GAS INC

**Location ID:** 324169

**Inspection Doc:** 696205408

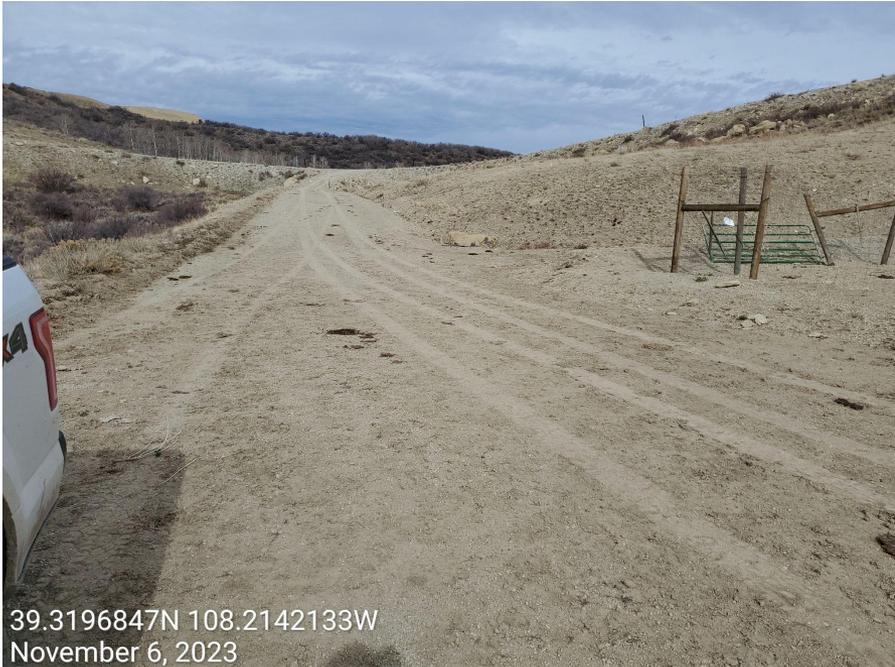
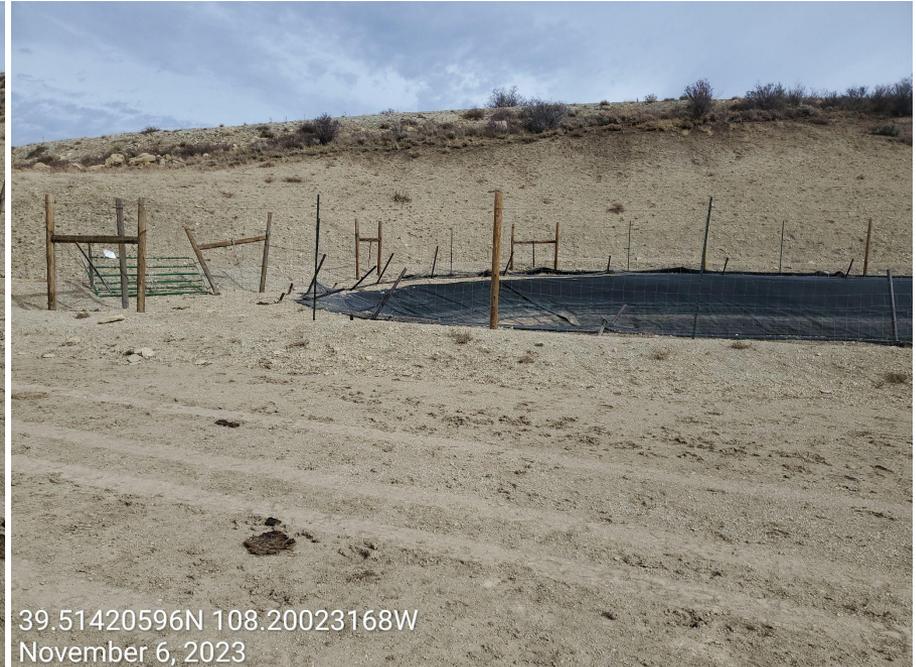
**Photo 1:** Photos 1-2 taken from the west end of the working pad surface. Photos provide an overview of the Location from north, northeast, southeast to south.

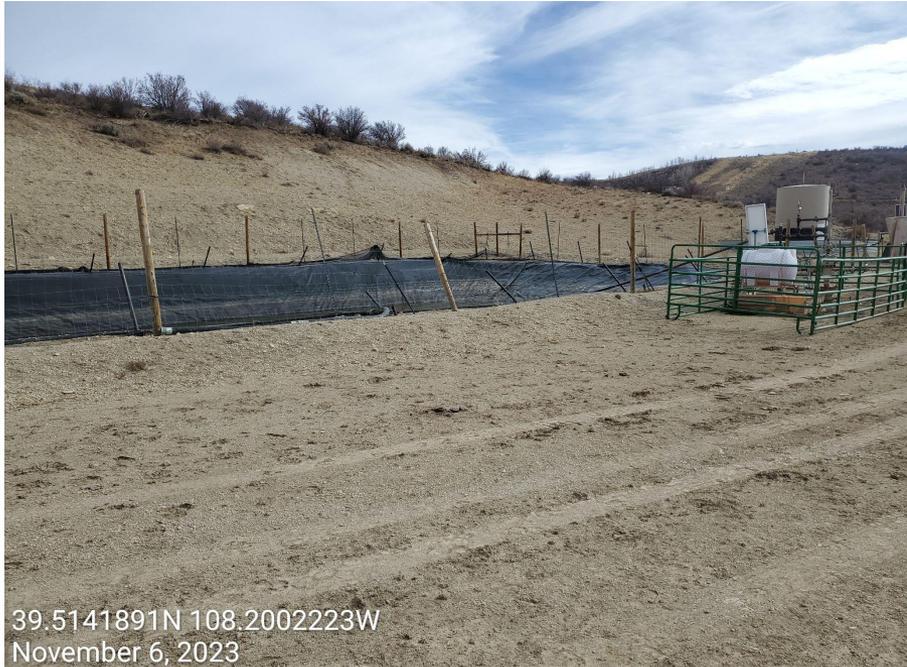
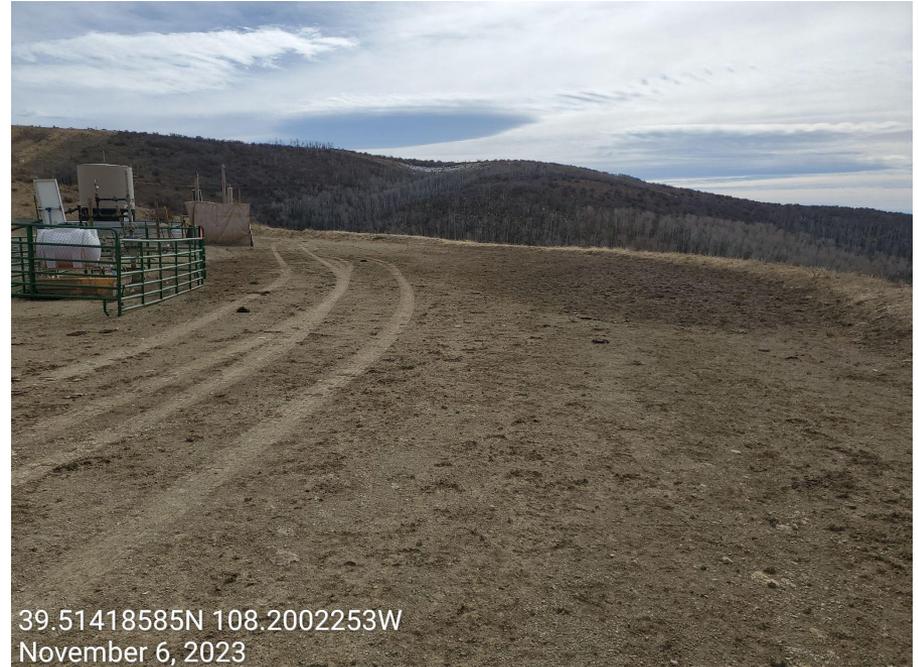
**Photo 2:** See comments under photo 1.

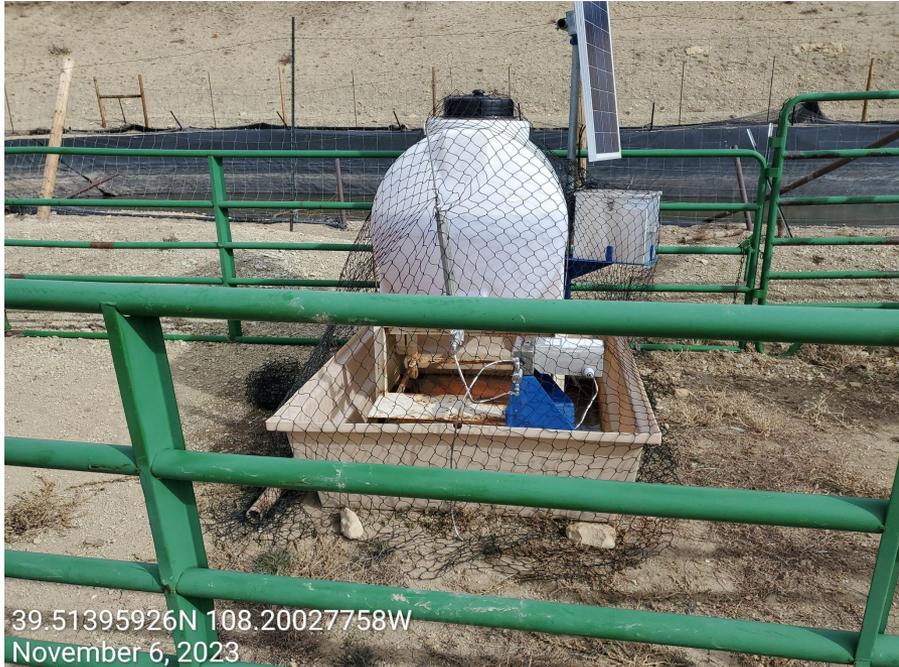
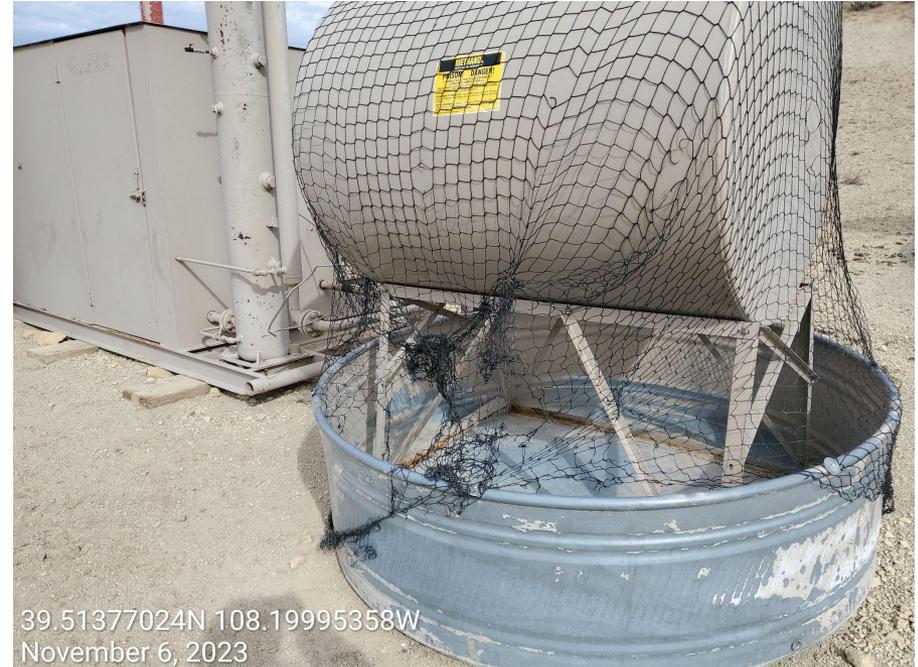
**Photo 3:** Photos show the two methanol tanks on Location. Photo left show BMPs (netting) to mitigate wildlife access to the containment BMP has been installed. Photo right shows BMP (netting) remains in disrepair.

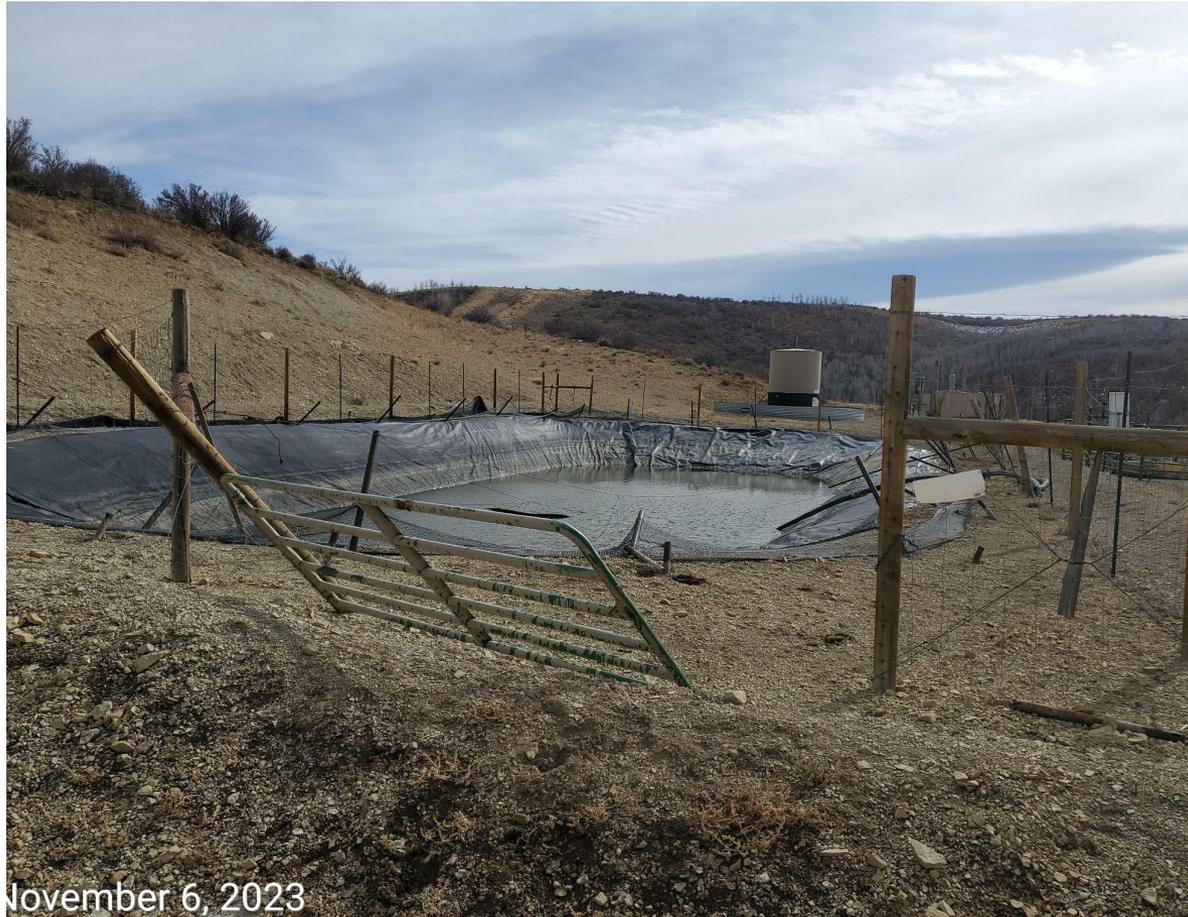
**Photo 4:** Photo shows perimeter fence at the pit remains in disrepair.

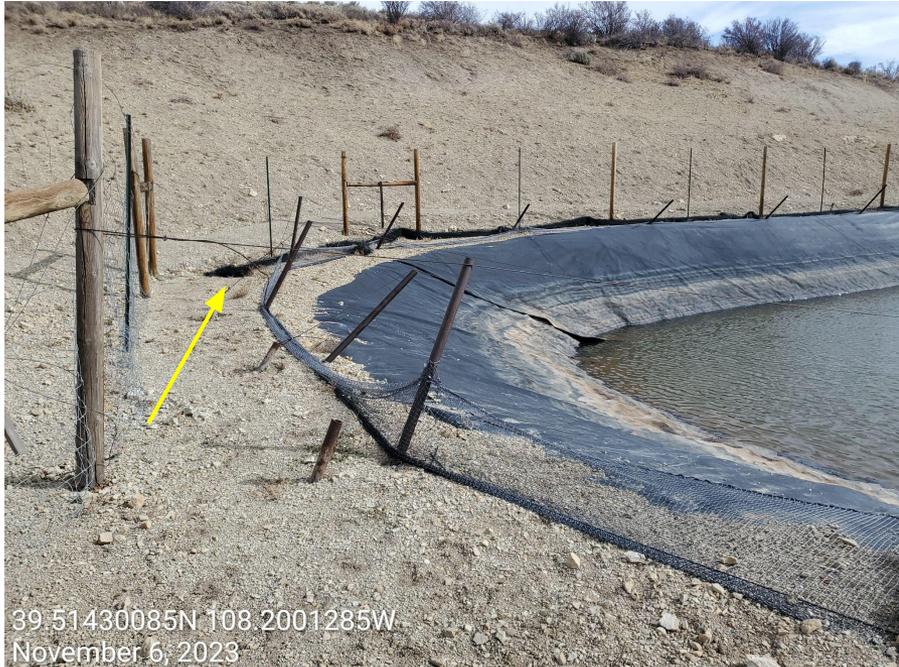
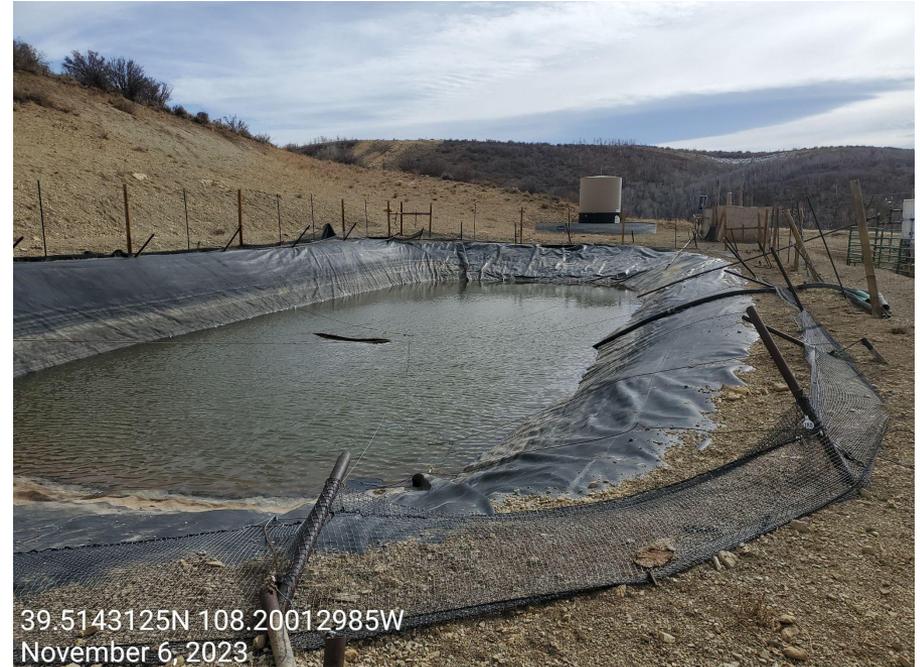
**Photo 5:** Photos show netting (arrow) has not been replaced over the pit.

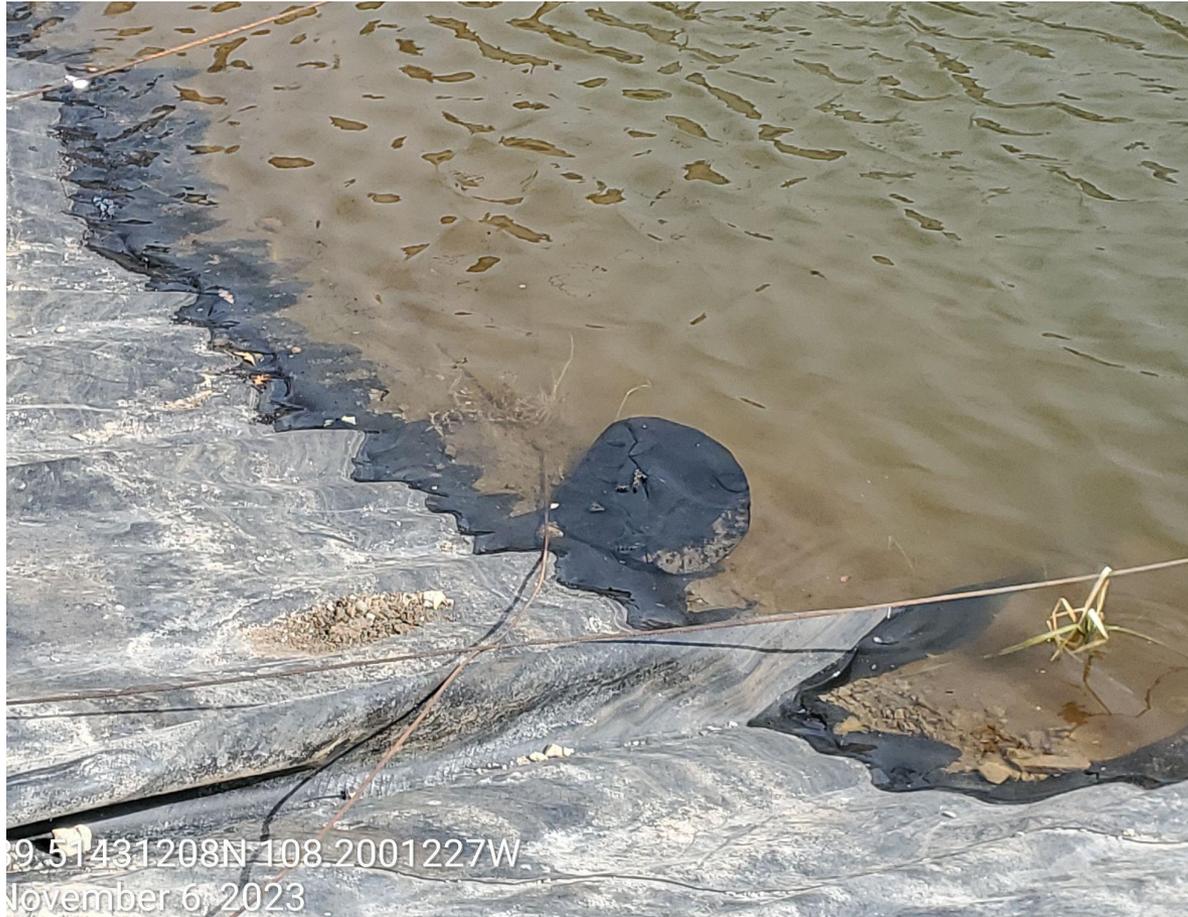
**Photo 6:** Photo shows what appears to be a patch observed floating within the pit; patch appears to have detached from the liner at some unknown point.

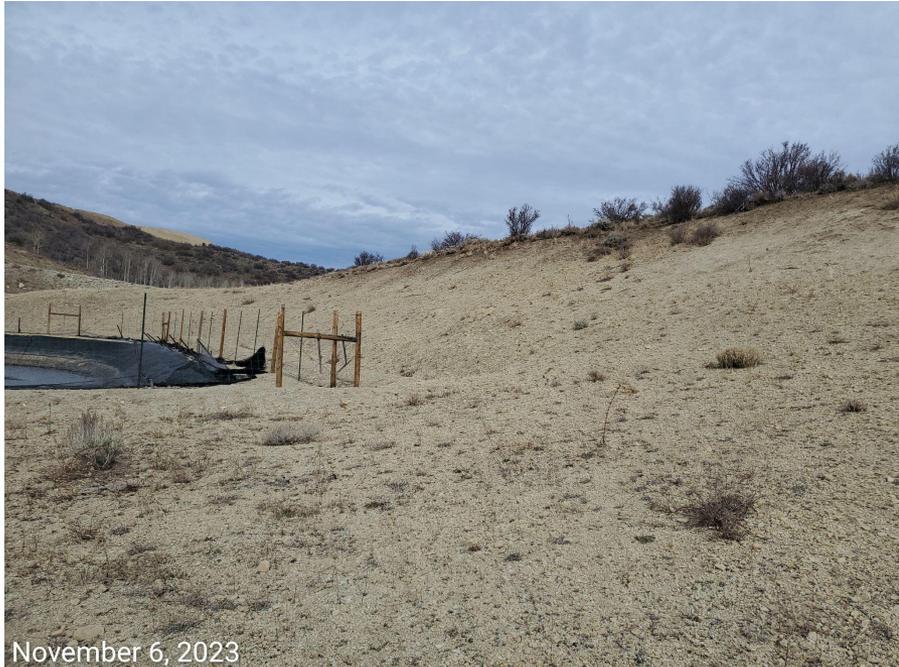
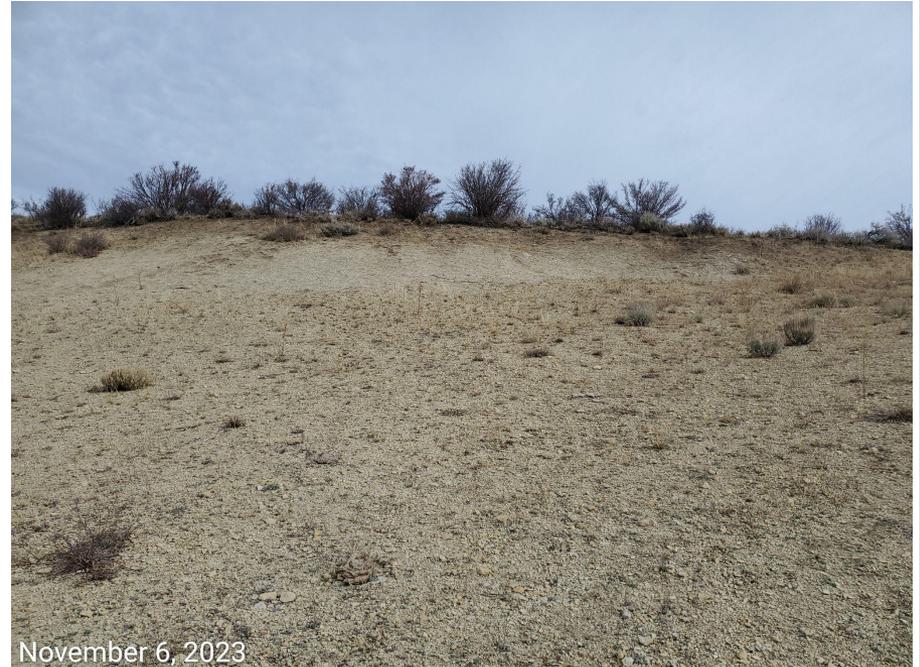
**Photo 7:** Photos taken from the interim areas on the east end of the Location. Unable to find evidence that reclamation has been performed per CAs and 1003 rules. Photos also examples showing control measures to manage runoff, and to minimize erosion, degradation and sediment transport remains missing or insufficient.

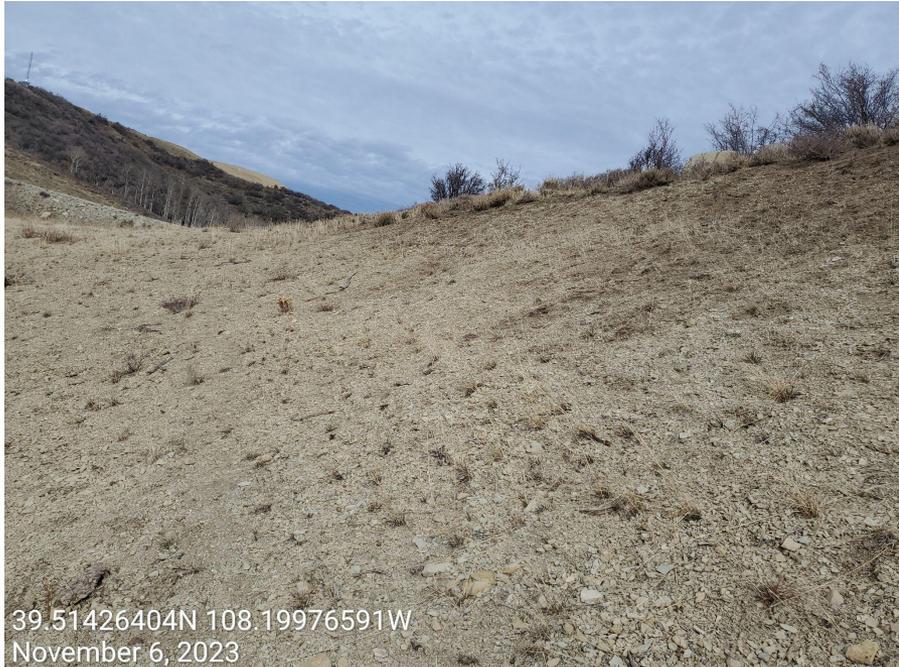
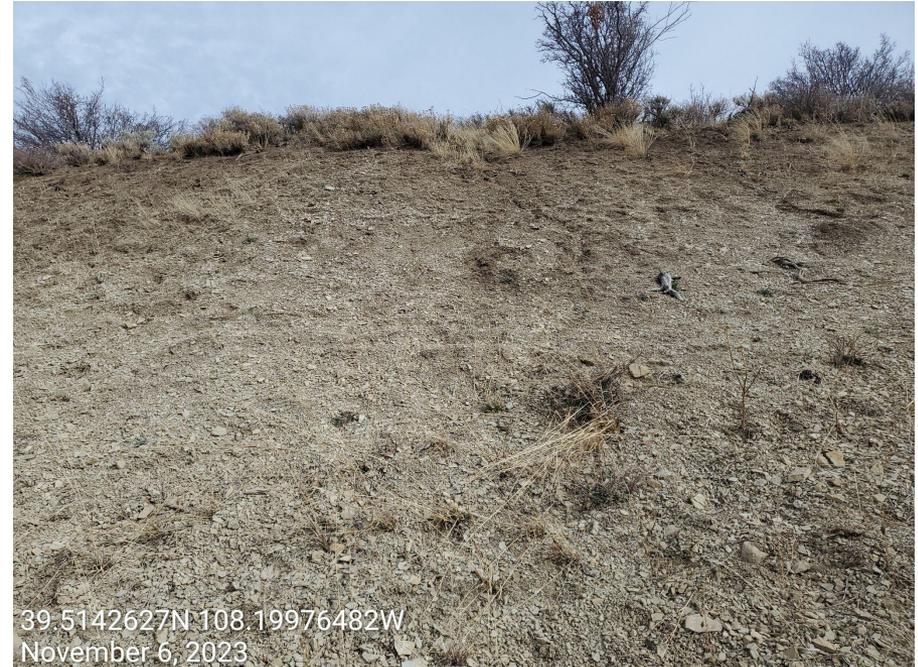
**Photo 8:** Photos taken from the interim areas on the east end of the Location. Unable to find evidence that reclamation has been performed per CAs and 1003 rules. Photos also examples showing control measures to manage runoff, and to minimize erosion, degradation and sediment transport remains missing or insufficient.

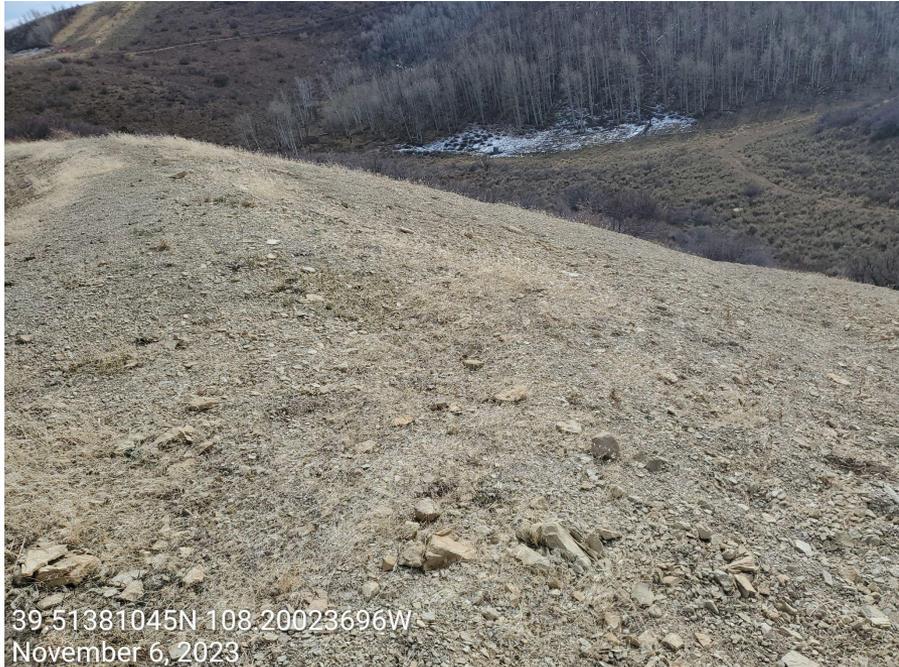
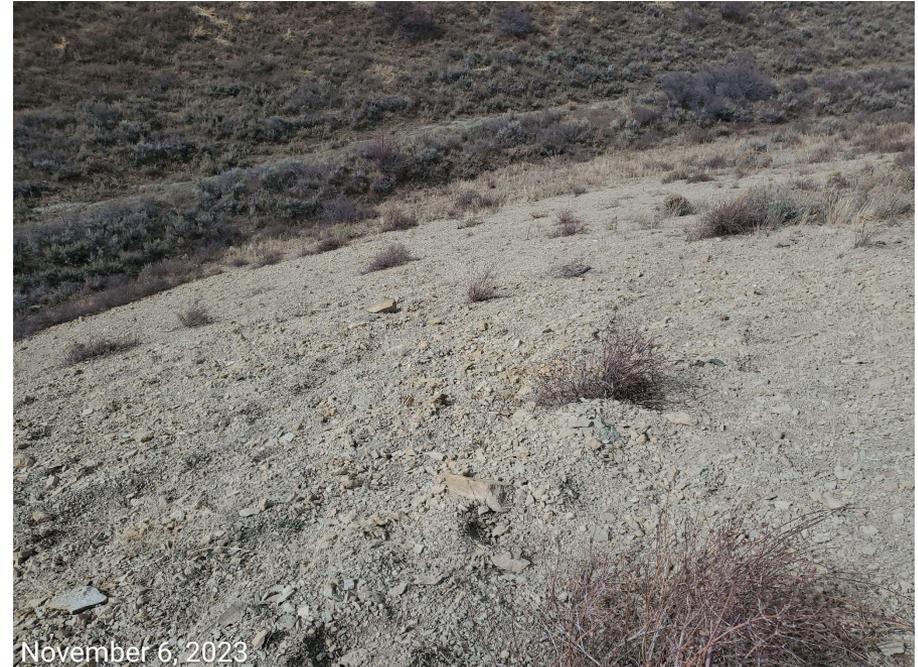
**Photo 9:** Photos taken from the interim areas on the west end of the Location. Unable to find evidence that reclamation has been performed per CAs and 1003 rules. Photos also examples showing control measures to manage runoff, and to minimize erosion, degradation and sediment transport remains missing or insufficient.

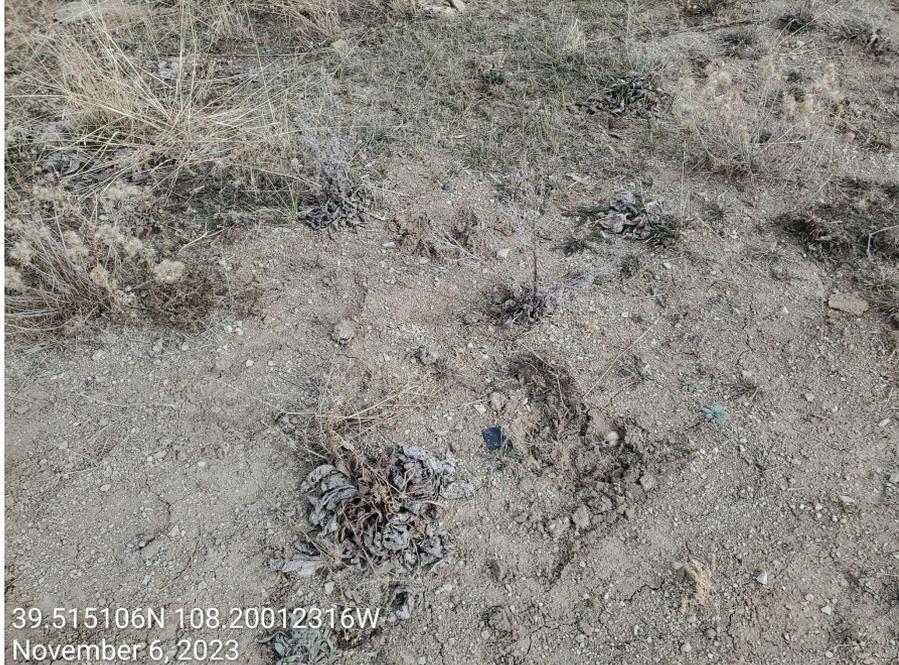
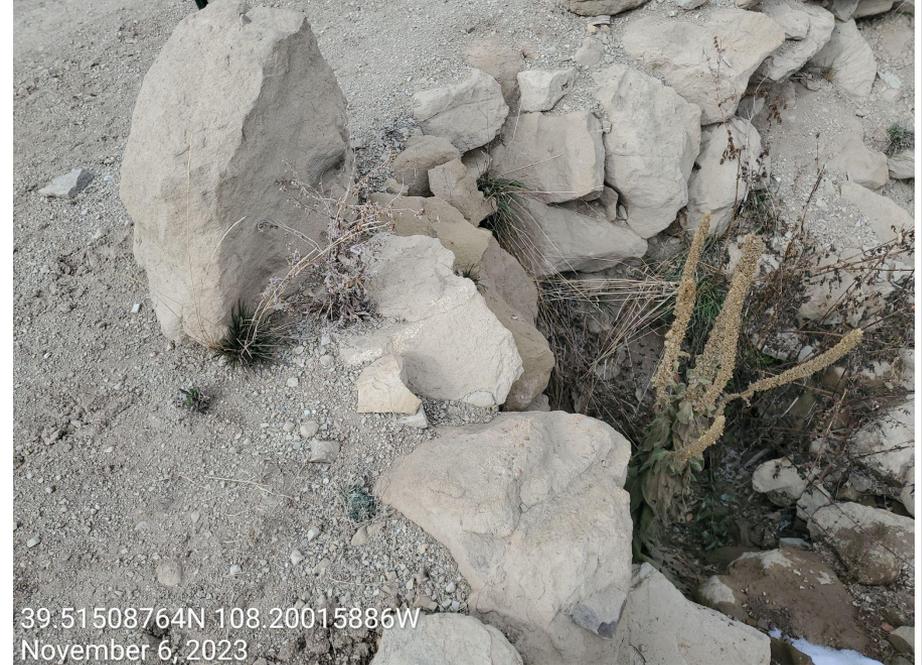
**Photo 10:** Photos example showing Noxious Weeds (hounds tongue, common mullein) observed on the Location. Weeds observed had reached maturity.

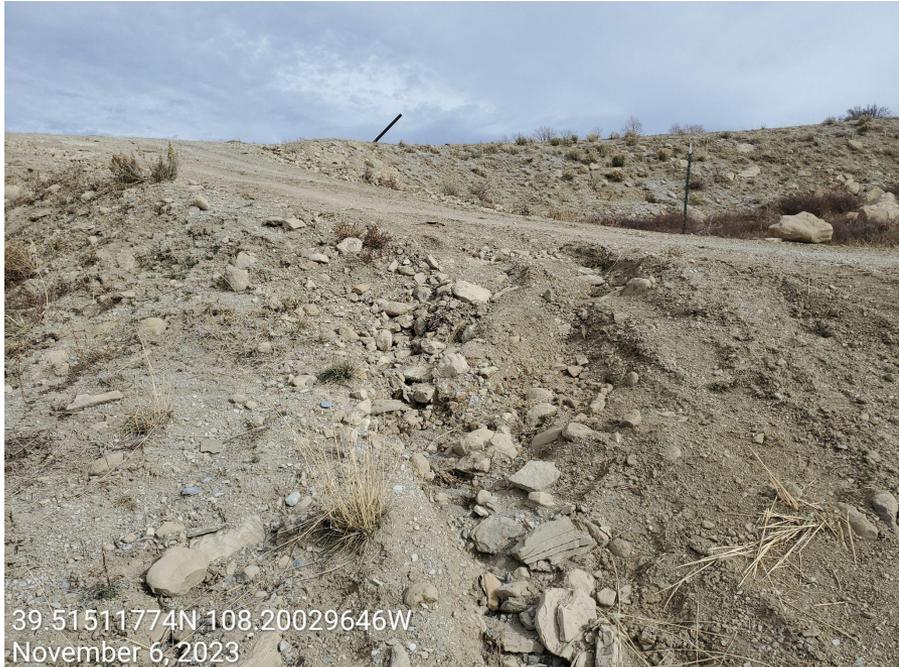
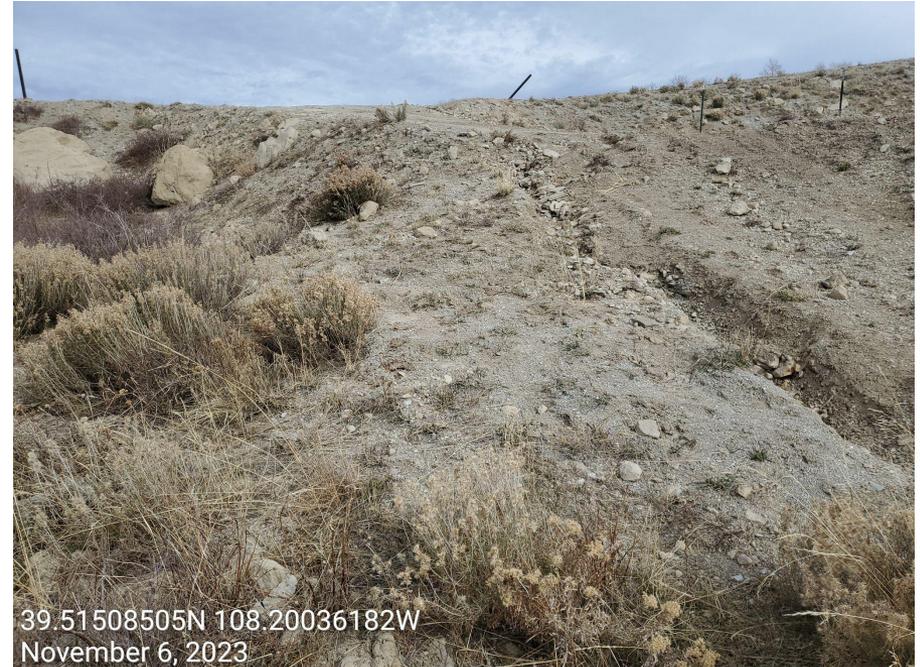
**Photo 11:** Photos taken from the access road. Stormwater and erosion control measures to manage runoff at road remain missing or insufficient, resulting in persisting off-site sediment transport and degradation (photo right).
