SITE-SPECIFIC QUALITY ASSURANCE & QUALITY CONTROL AUDIT

PERMIT CLOSURE REPORT – DESIGNATION LAND USE CHANGE

Location ID - 321522

Location Name – GREEN MA-61S68W 17NWNE

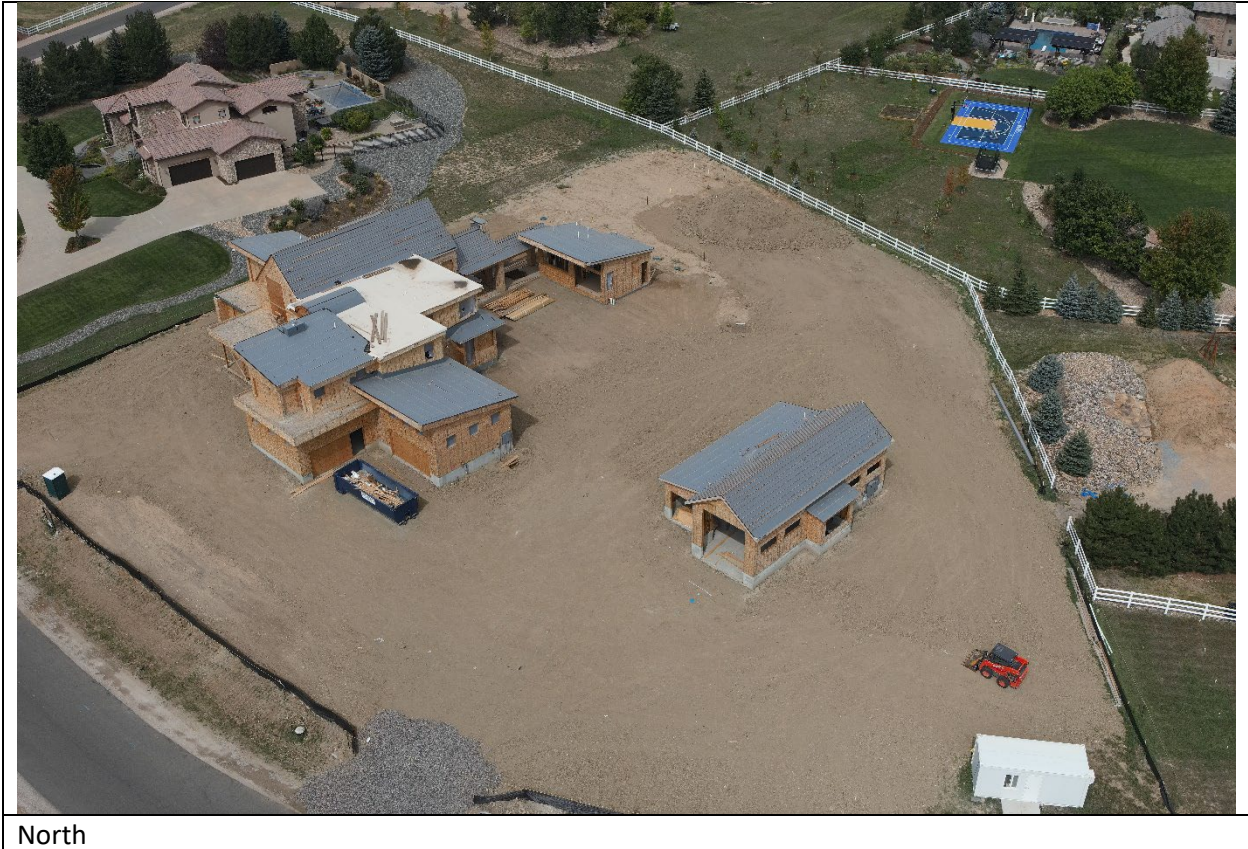
North

Cardinal directional and ground perspective photos of the site

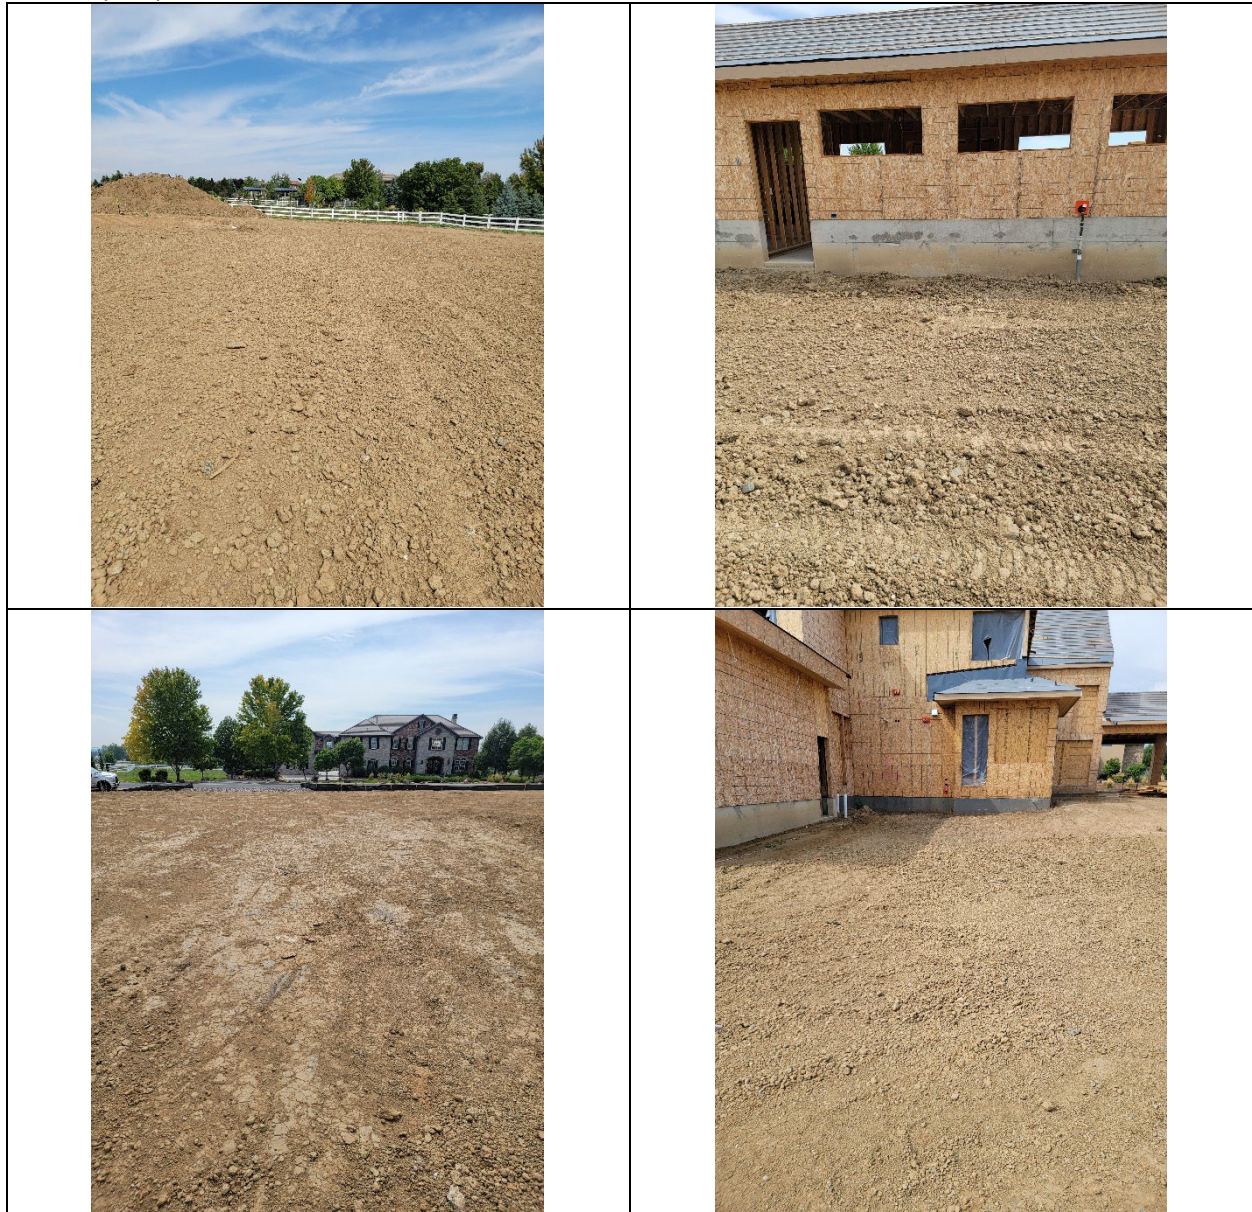
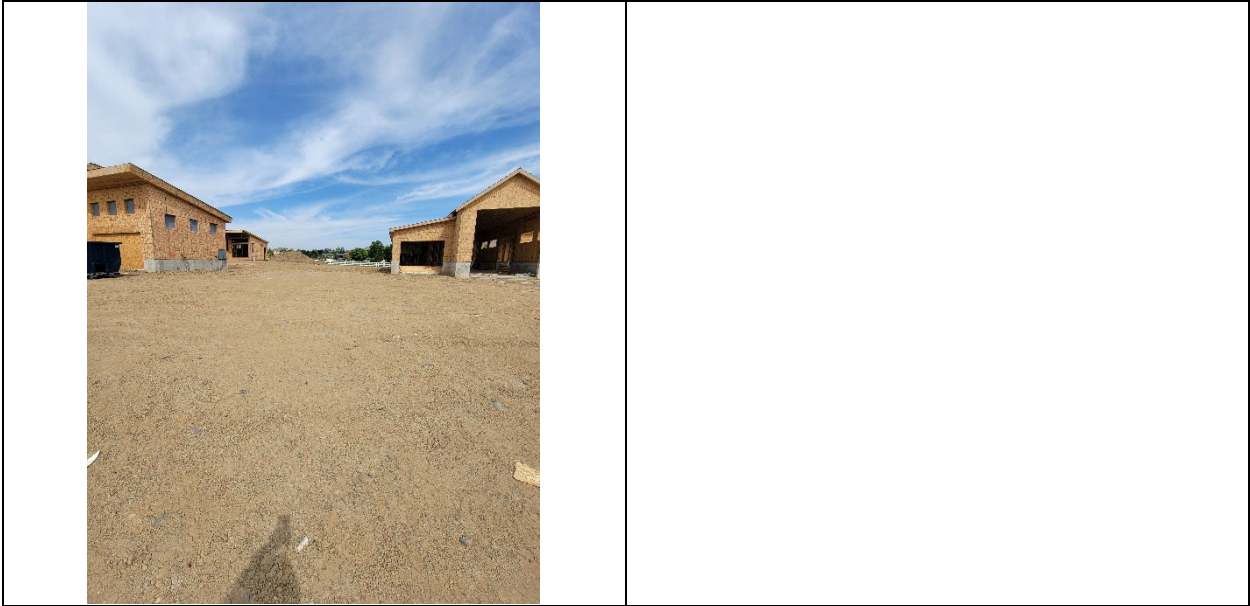
Ground perspective of the well site locations

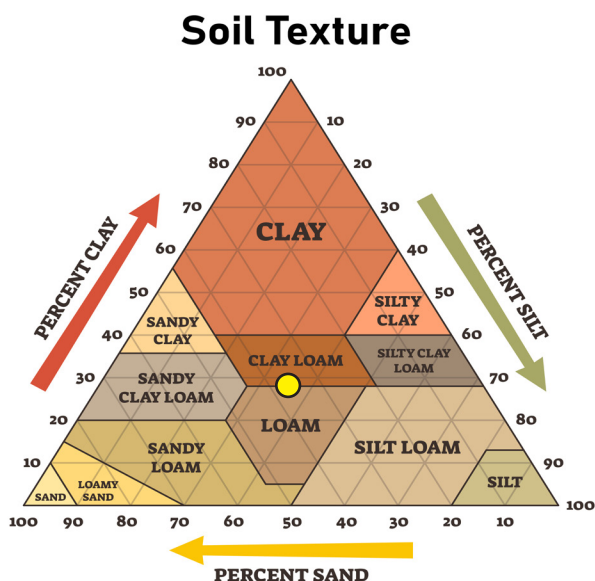
This soil is formed from mixed eolian deposits over tertiary aged alluvium derived from igneous, metamorphic and sedimentary rock. Landform is interfluvies, with the Loamy Plains Ecological Site. Soils are well drained with a moderate water holding capacity, and slope 0-3 percent.

Depth (in)	Physical			Chemical			
	Texture	Bulk Density	Partical Size Percent sand, silt, clay	pH	EC	SAR	OM%
0-10	Loam	1.39	38-35-27	7.4	0.5	0.0	1.50
10-20	Clay	1.36	30-30-40	7.6	0.5	0.0	1.50
20-30	Loam	1.55	44-32-24	8.3	0.5	0.0	0.68
30-40	Sandy Clay Loam	1.55	61-19-20	8.5	0.5	0.0	0.50
40-50	Sandy Clay Loam	1.58	61-19-20	8.5	0.5	0.0	0.50
50 +	Sandy Clay Loam	1.58	61-19-20	8.5	0.5	0.0	0.50

Soil Texture Triangle reflect the 0-10 in depth

- K Factor, Whole soil - .43. Values of K range from 0.02 to 0.69. Other factors being equal, the higher the value, the more susceptible the soil is to sheet and rill erosion by water.
- Wind Erodibility Group – 5. The soils assigned to group 1 are the most susceptible to wind erosion, and those assigned to group 8 are the least susceptible.

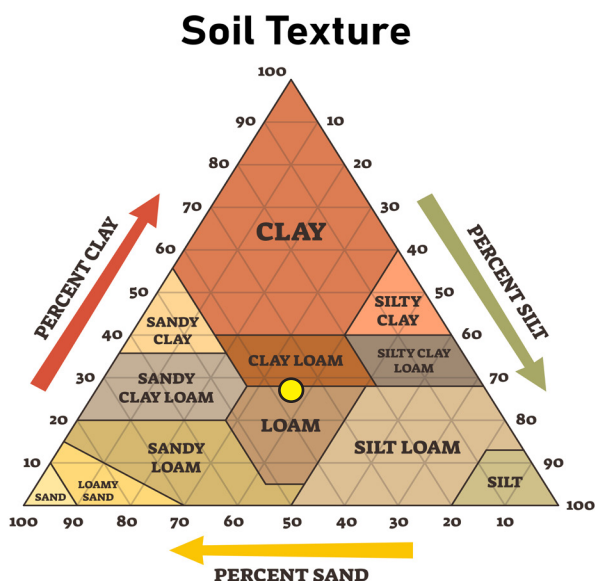
This soil is formed from mixed eolian deposits over calcareous tertiary alluvium. Landform is interfluvial, with the Loamy Plains Ecological Site. Soils are well drained with a moderate water holding capacity, and slope 3-5 percent.

Physical			Chemical			
Depth (in)	Texture	Bulk Density	Partial Size Percent sand, silt, clay	pH	EC	SAR	OM%
0-10	Loam	1.44	38-35-27	7.4	0.5	0.0	1.06
10-20	Clay	1.36	30-30-40	7.6	0.5	0.0	1.00
20-30	Clay Loam	1.55	44-31-25	8.3	0.5	0.0	0.68
30-40	Sandy Clay Loam	1.55	64-17-19	8.5	0.4	0.0	0.50
40-50	Sandy Loam	1.59	69-15-16	8.5	0.1	0.0	0.50
50 +	Sandy Loam	1.59	69-15-16	8.5	0.1	0.0	0.50

Soil Texture Triangle reflect the 0-10 in depth

- K Factor, Whole soil - .37. Values of K range from 0.02 to 0.69. Other factors being equal, the higher the value, the more susceptible the soil is to sheet and rill erosion by water.
- Wind Erodibility Group – 5. The soils assigned to group 1 are the most susceptible to wind erosion, and those assigned to group 8 are the least susceptible.

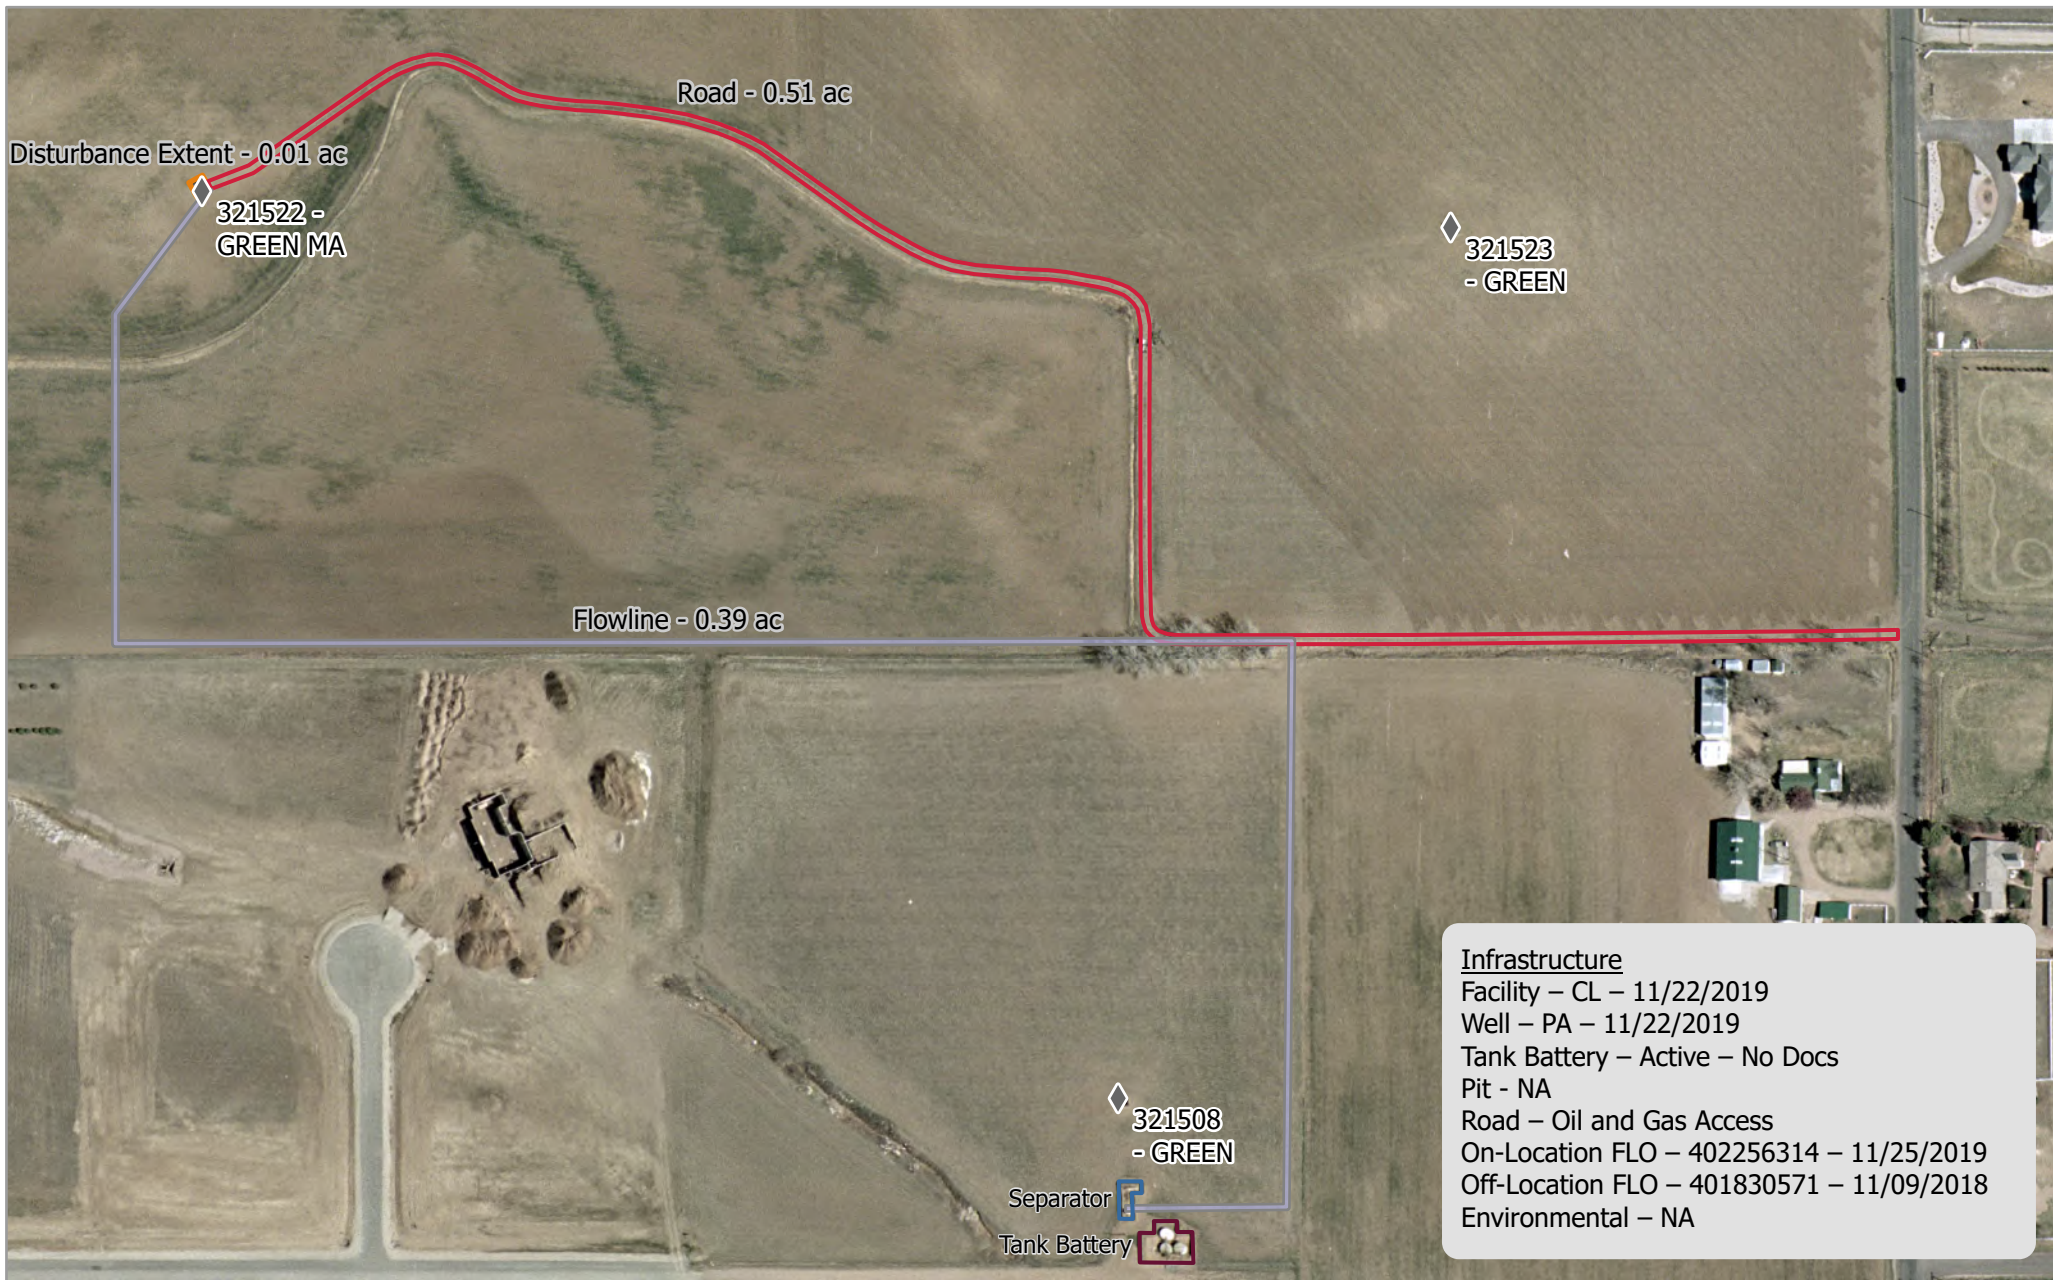
CIV - 321522- GREEN MA Map Extent - DRCOG 2002

Imagery: DRCOG
 Imagery Date: 2002
 Map Date: 08 Nov 2022
 Datum: NAD_1983_UTM_Zone_13N
 POC: Soil Sage

Overall Disturbance:
 0.91 Acres
 Scale: 1:2,500

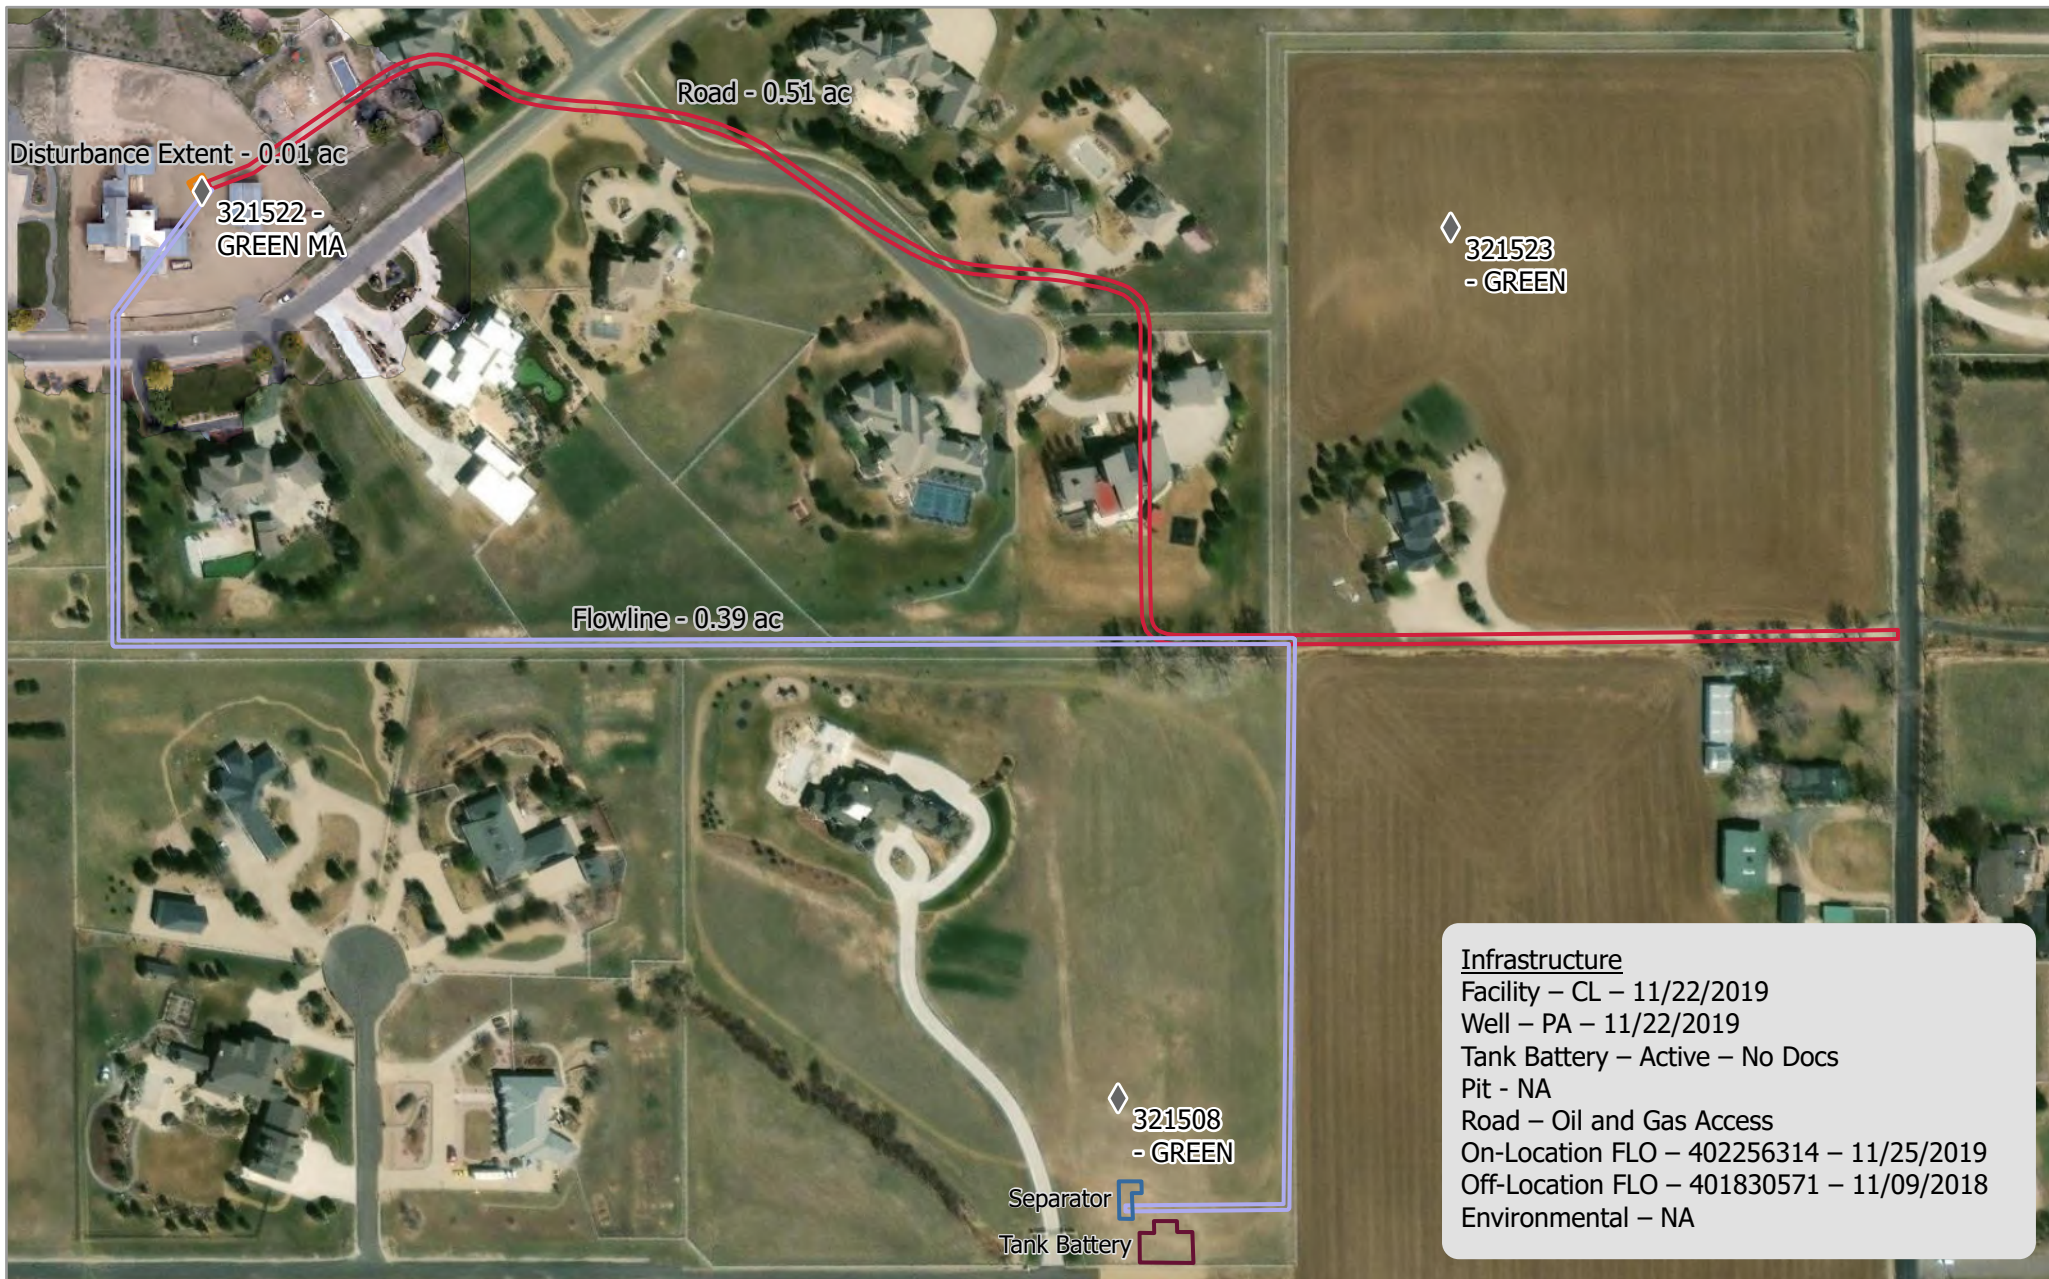
CIV - 321522- GREEN MA Map Extent - Overview

Imagery: RS Orthomosaic & ESRI Basemap Maxar
 Imagery Date: 13 Sep 2022, 22 Apr 2022
 Map Date: 09 Nov 2022
 Datum: NAD_1983_UTM_Zone_13N
 POC: Soil Sage

Overall Disturbance:
 0.91 Acres
 Scale: 1:2,500

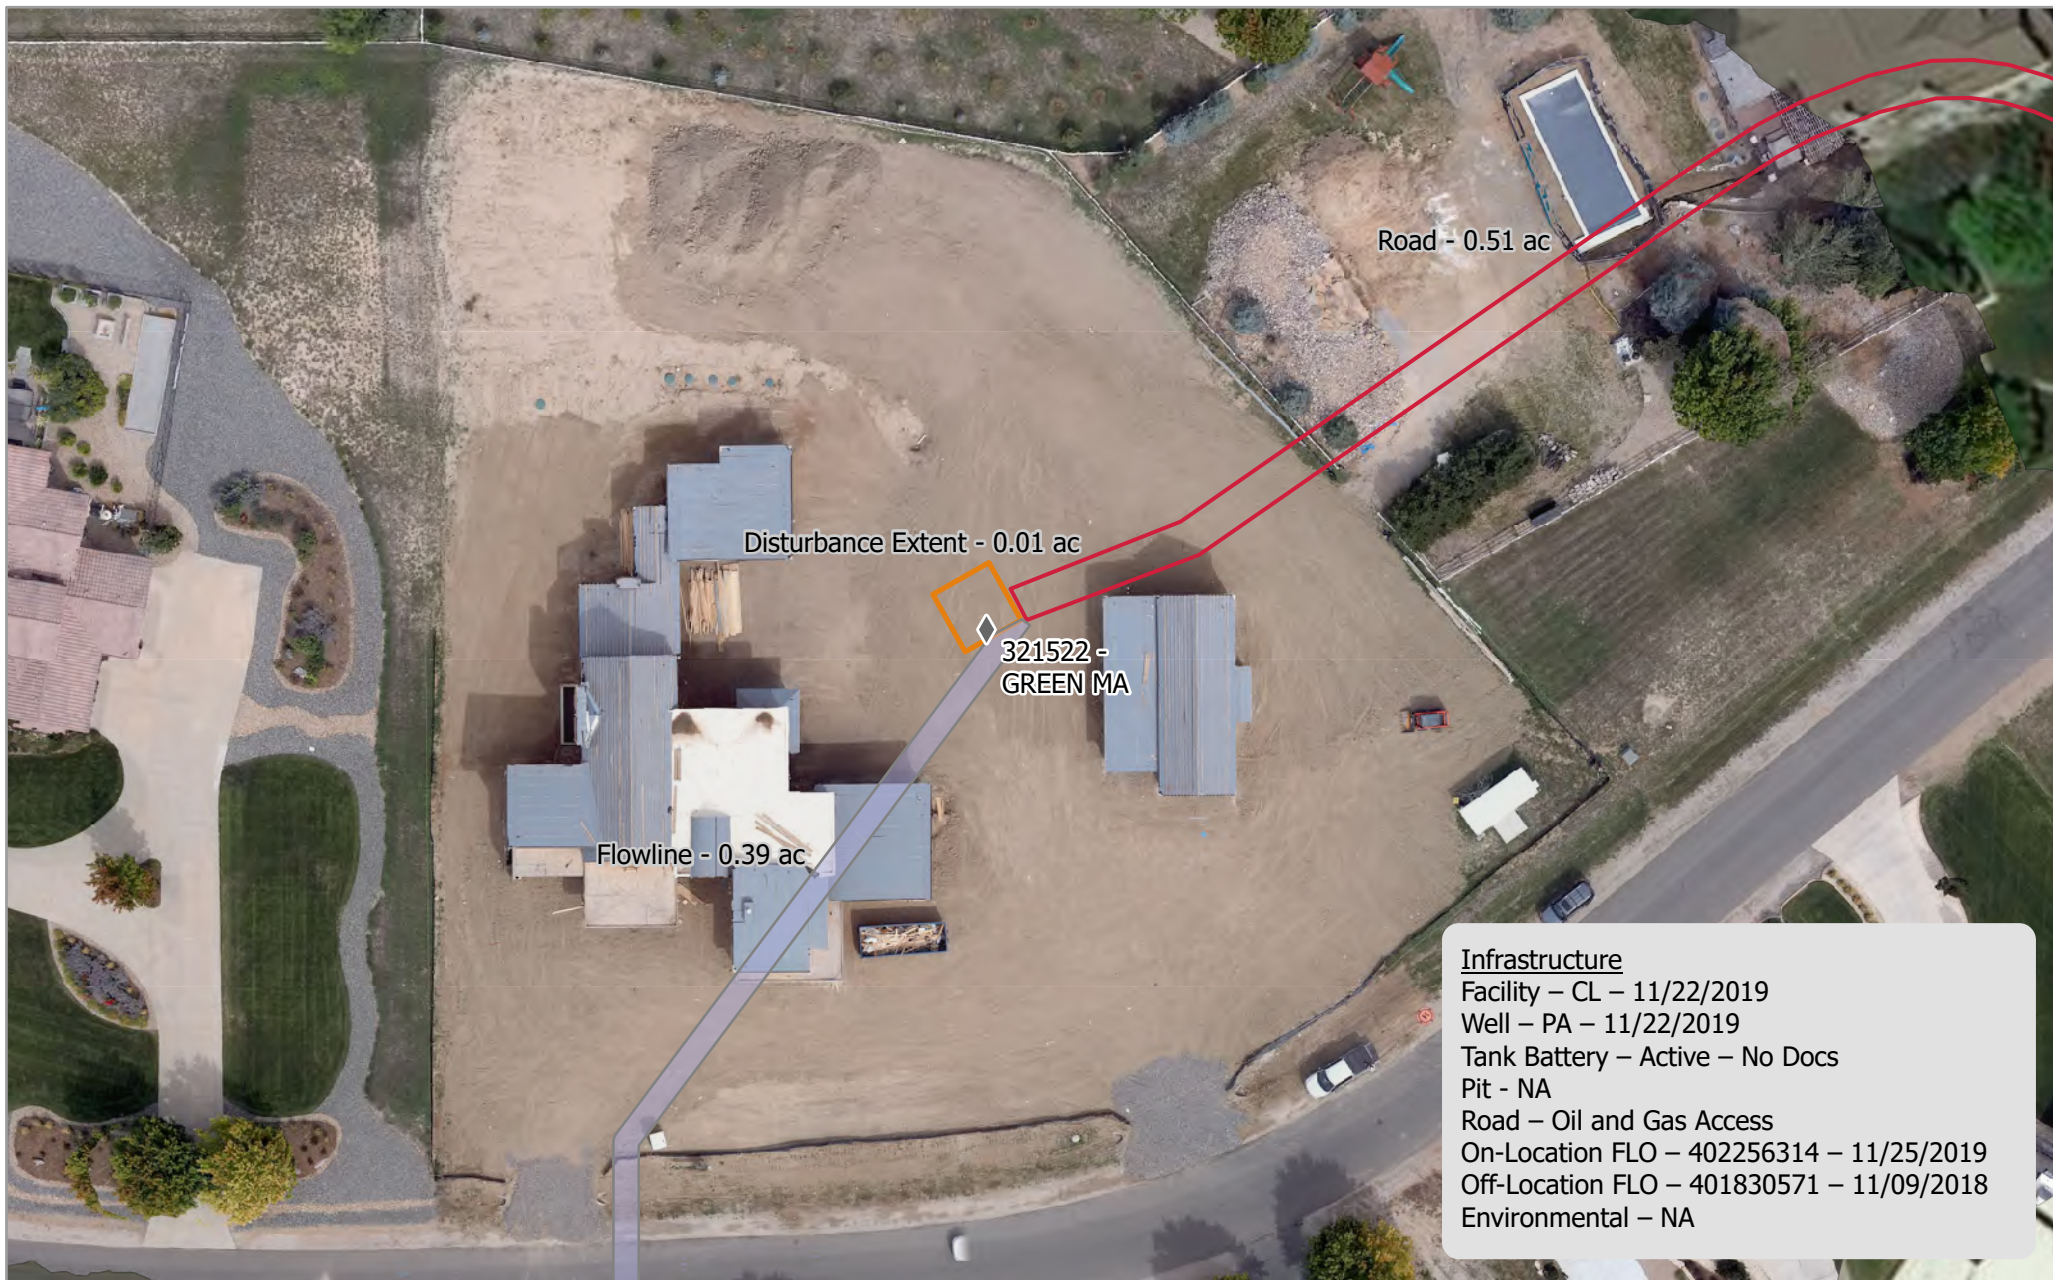
CIV - 321522- GREEN MA **Map Extent - Overview**

Infrastructure
 Facility – CL – 11/22/2019
 Well – PA – 11/22/2019
 Tank Battery – Active – No Docs
 Pit - NA
 Road – Oil and Gas Access
 On-Location FLO – 402256314 – 11/25/2019
 Off-Location FLO – 401830571 – 11/09/2018
 Environmental – NA

Imagery: RS Orthomosaic & DSM
 Imagery Date: 13 Sep 2022
 Map Date: 08 Nov 2022
 Datum: NAD_1983_UTM_Zone_13N
 POC: Soil Sage

Overall Disturbance:
 0.91 Acres
 Scale: 1:600

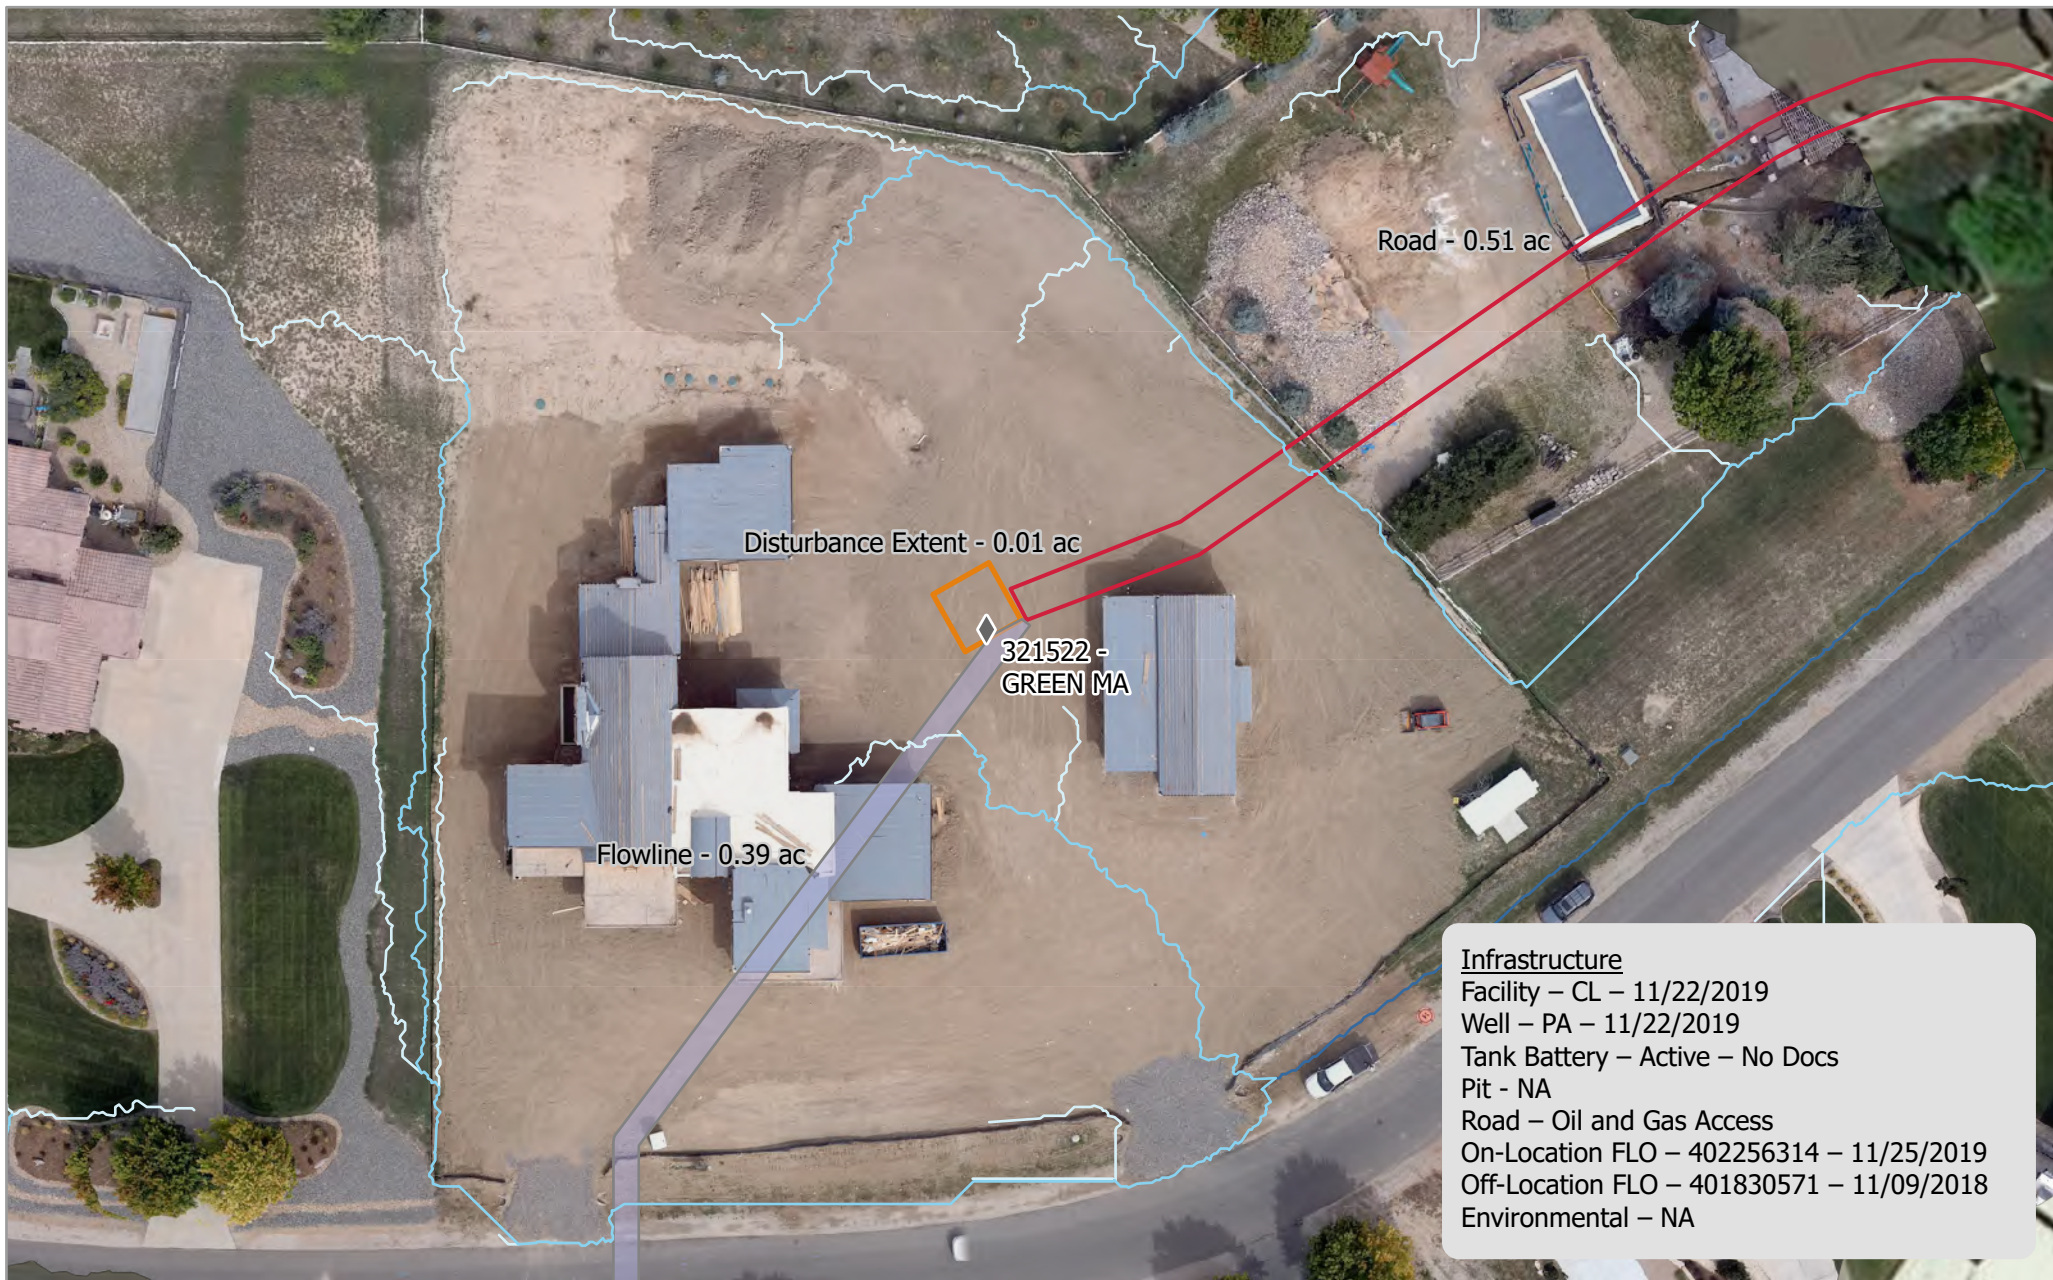
CIV - 321522- GREEN MA
Map Extent - Hydrology

Infrastructure
 Facility – CL – 11/22/2019
 Well – PA – 11/22/2019
 Tank Battery – Active – No Docs
 Pit – NA
 Road – Oil and Gas Access
 On-Location FLO – 402256314 – 11/25/2019
 Off-Location FLO – 401830571 – 11/09/2018
 Environmental – NA

Imagery: RS Orthomosaic & DSM
 Imagery Date: 13 Sep 2022
 Map Date: 08 Nov 2022
 Datum: NAD_1983_UTM_Zone_13N
 POC: Soil Sage
