SITE-SPECIFIC QUALITY ASSURANCE & QUALITY CONTROL AUDIT

PERMIT CLOSURE REPORT – RANGELAND

Location ID 320337

Location Name WWC-61S68W9SESE

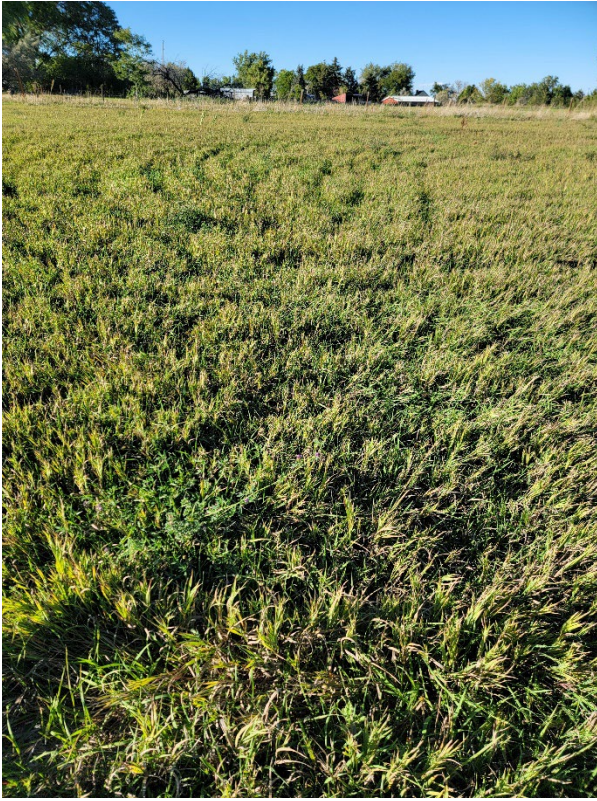
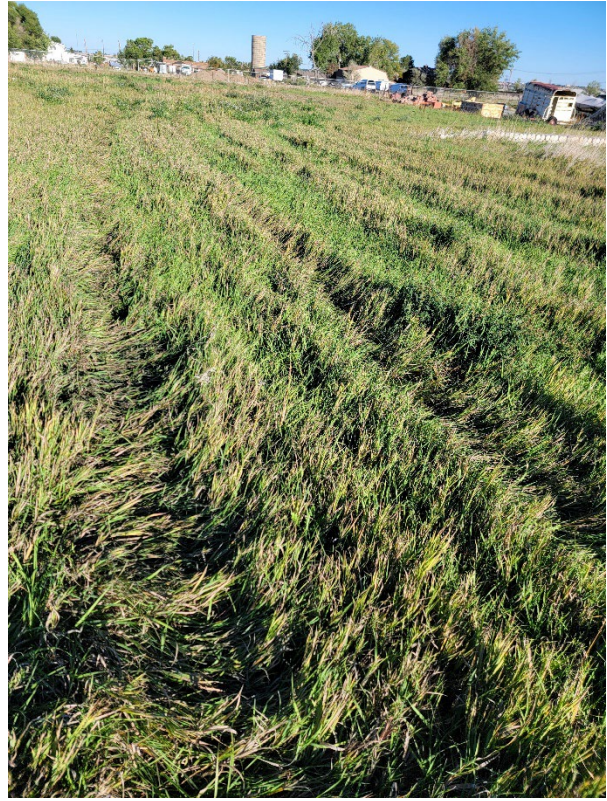
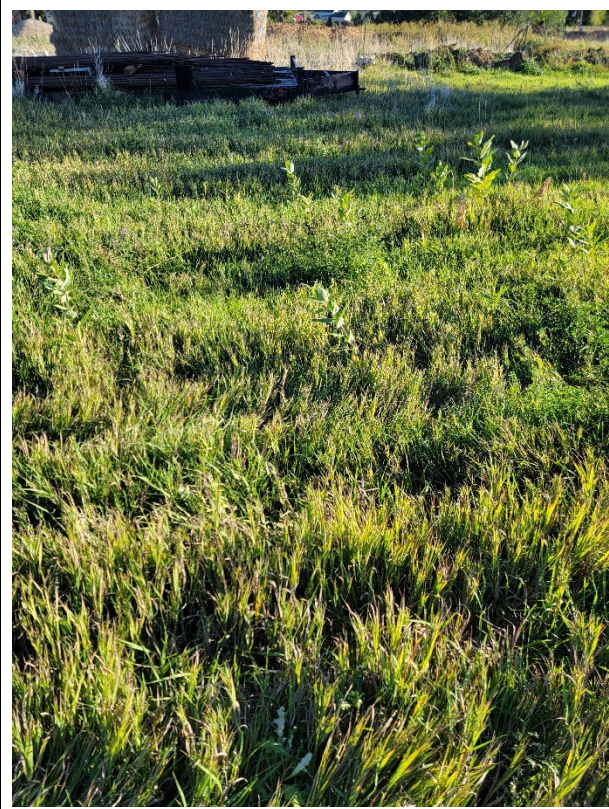
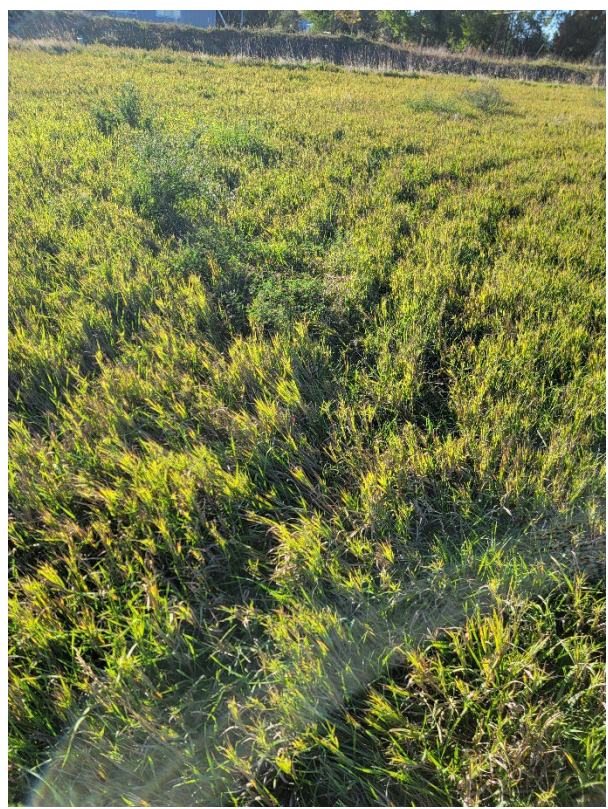
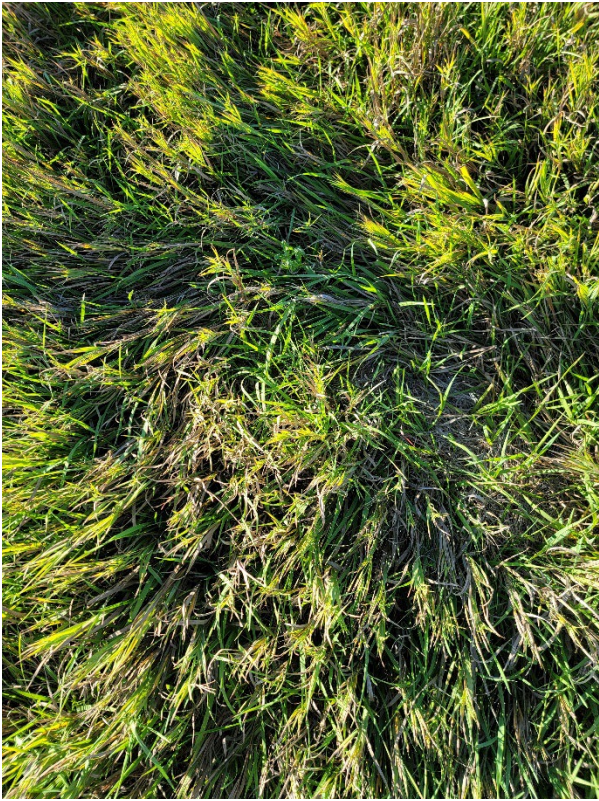
Reference

39.973713, -105.000485

Vegetation - Alfalfa

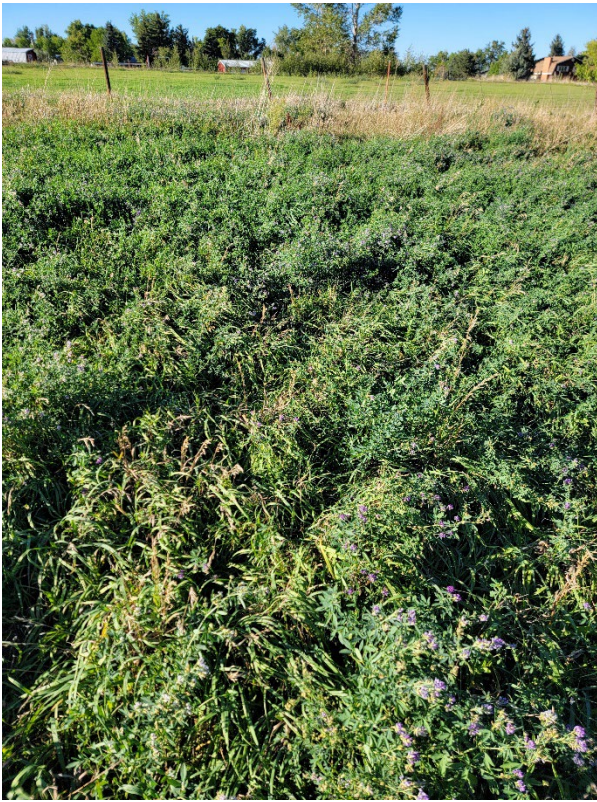
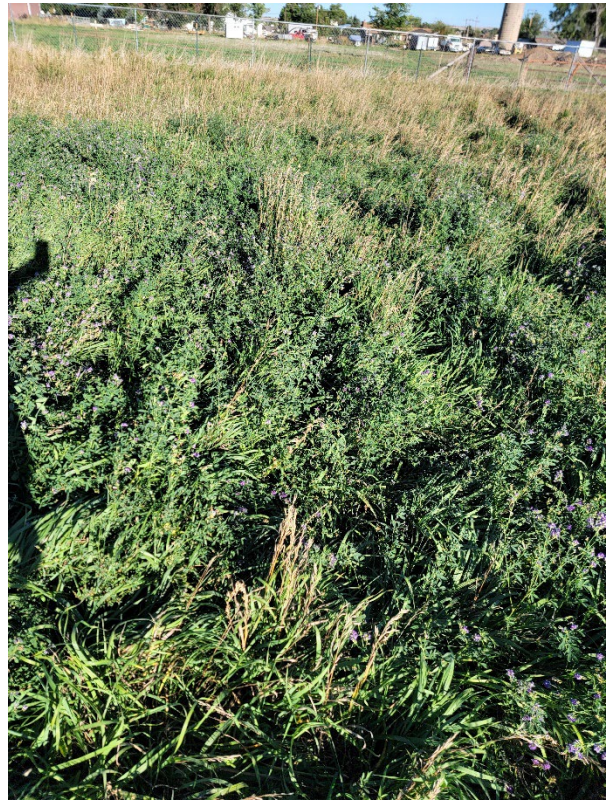
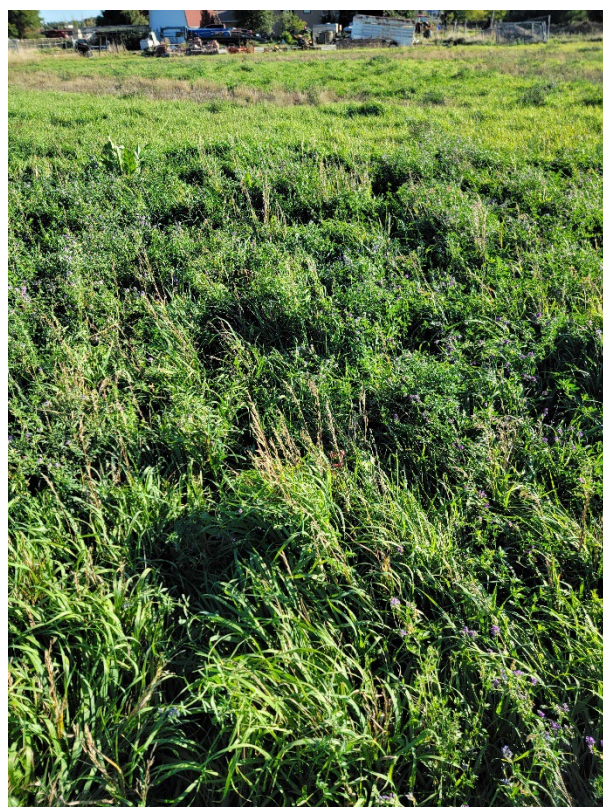
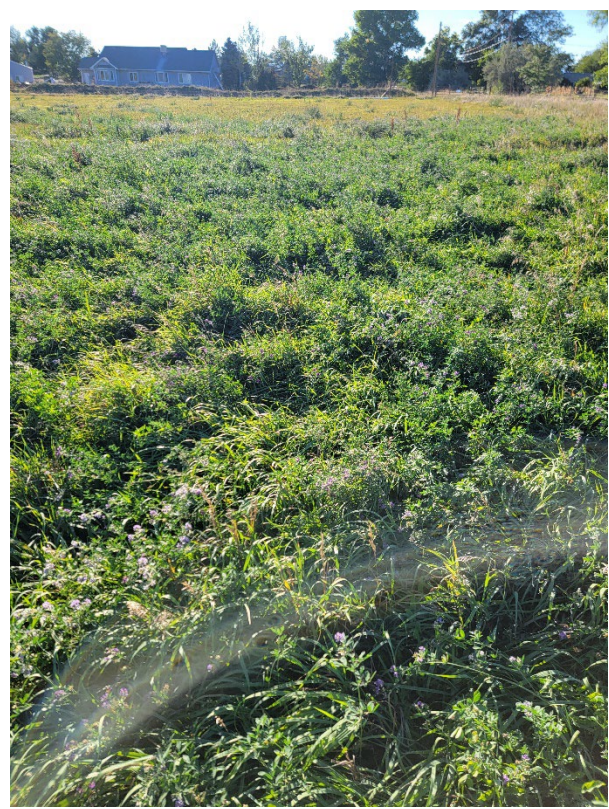
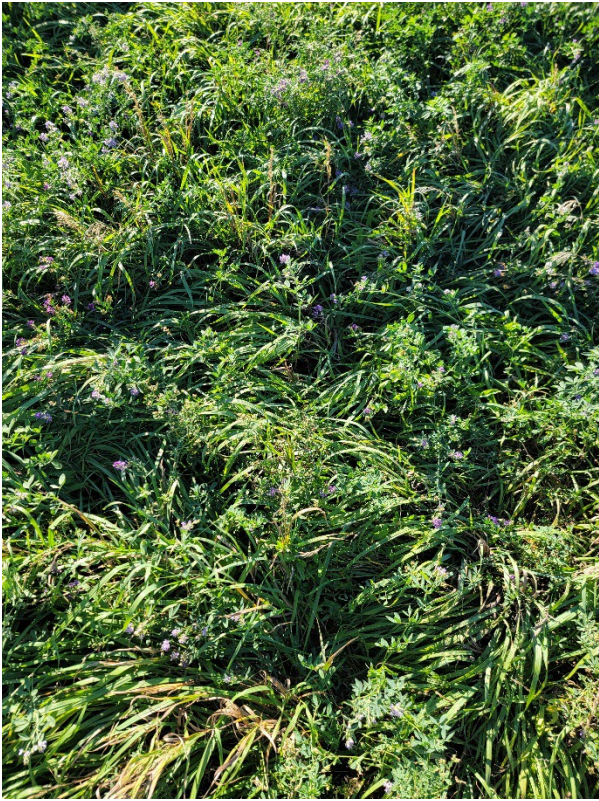
Recovery

39.973807, -104.999836

Vegetation – Alfalfa

This site statically meets the revegetation target rate within the reclaim and road extent. Recommend for permit closure.

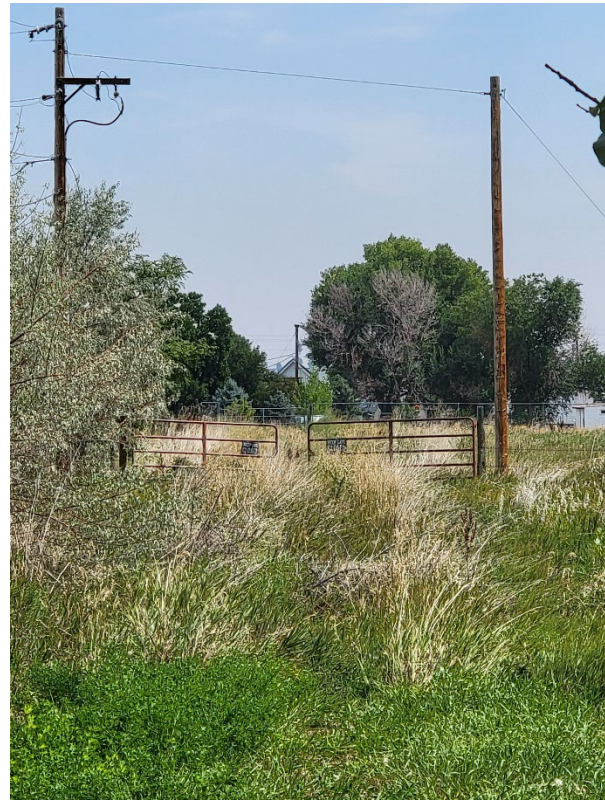
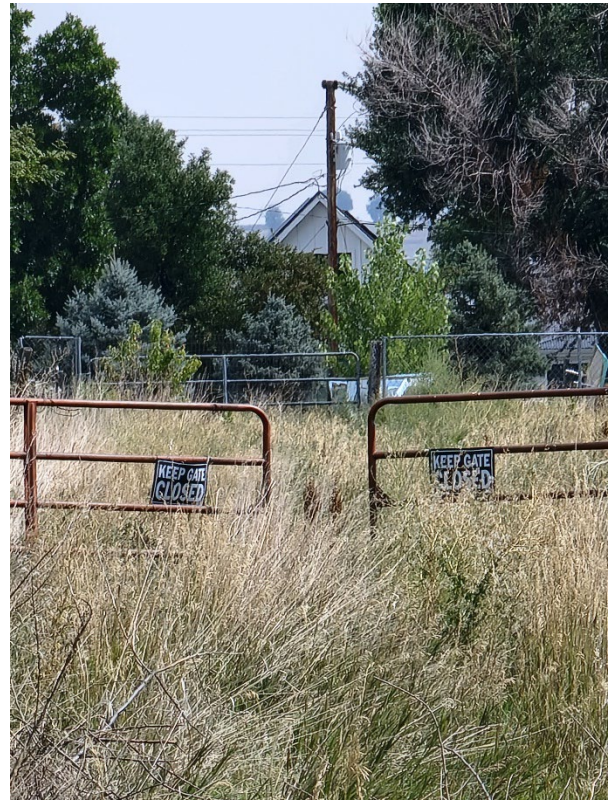
Access Road Recovery

Access Road

Vegetation recovery for the access road was calculated within the reference extent and reflects the same values as the recovery status above.

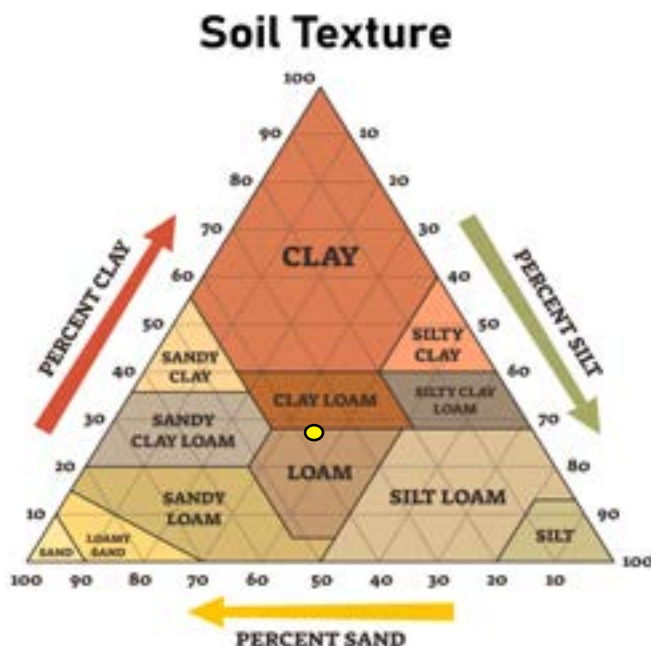
Soil Texture Triangle reflect the 0-10 in depth

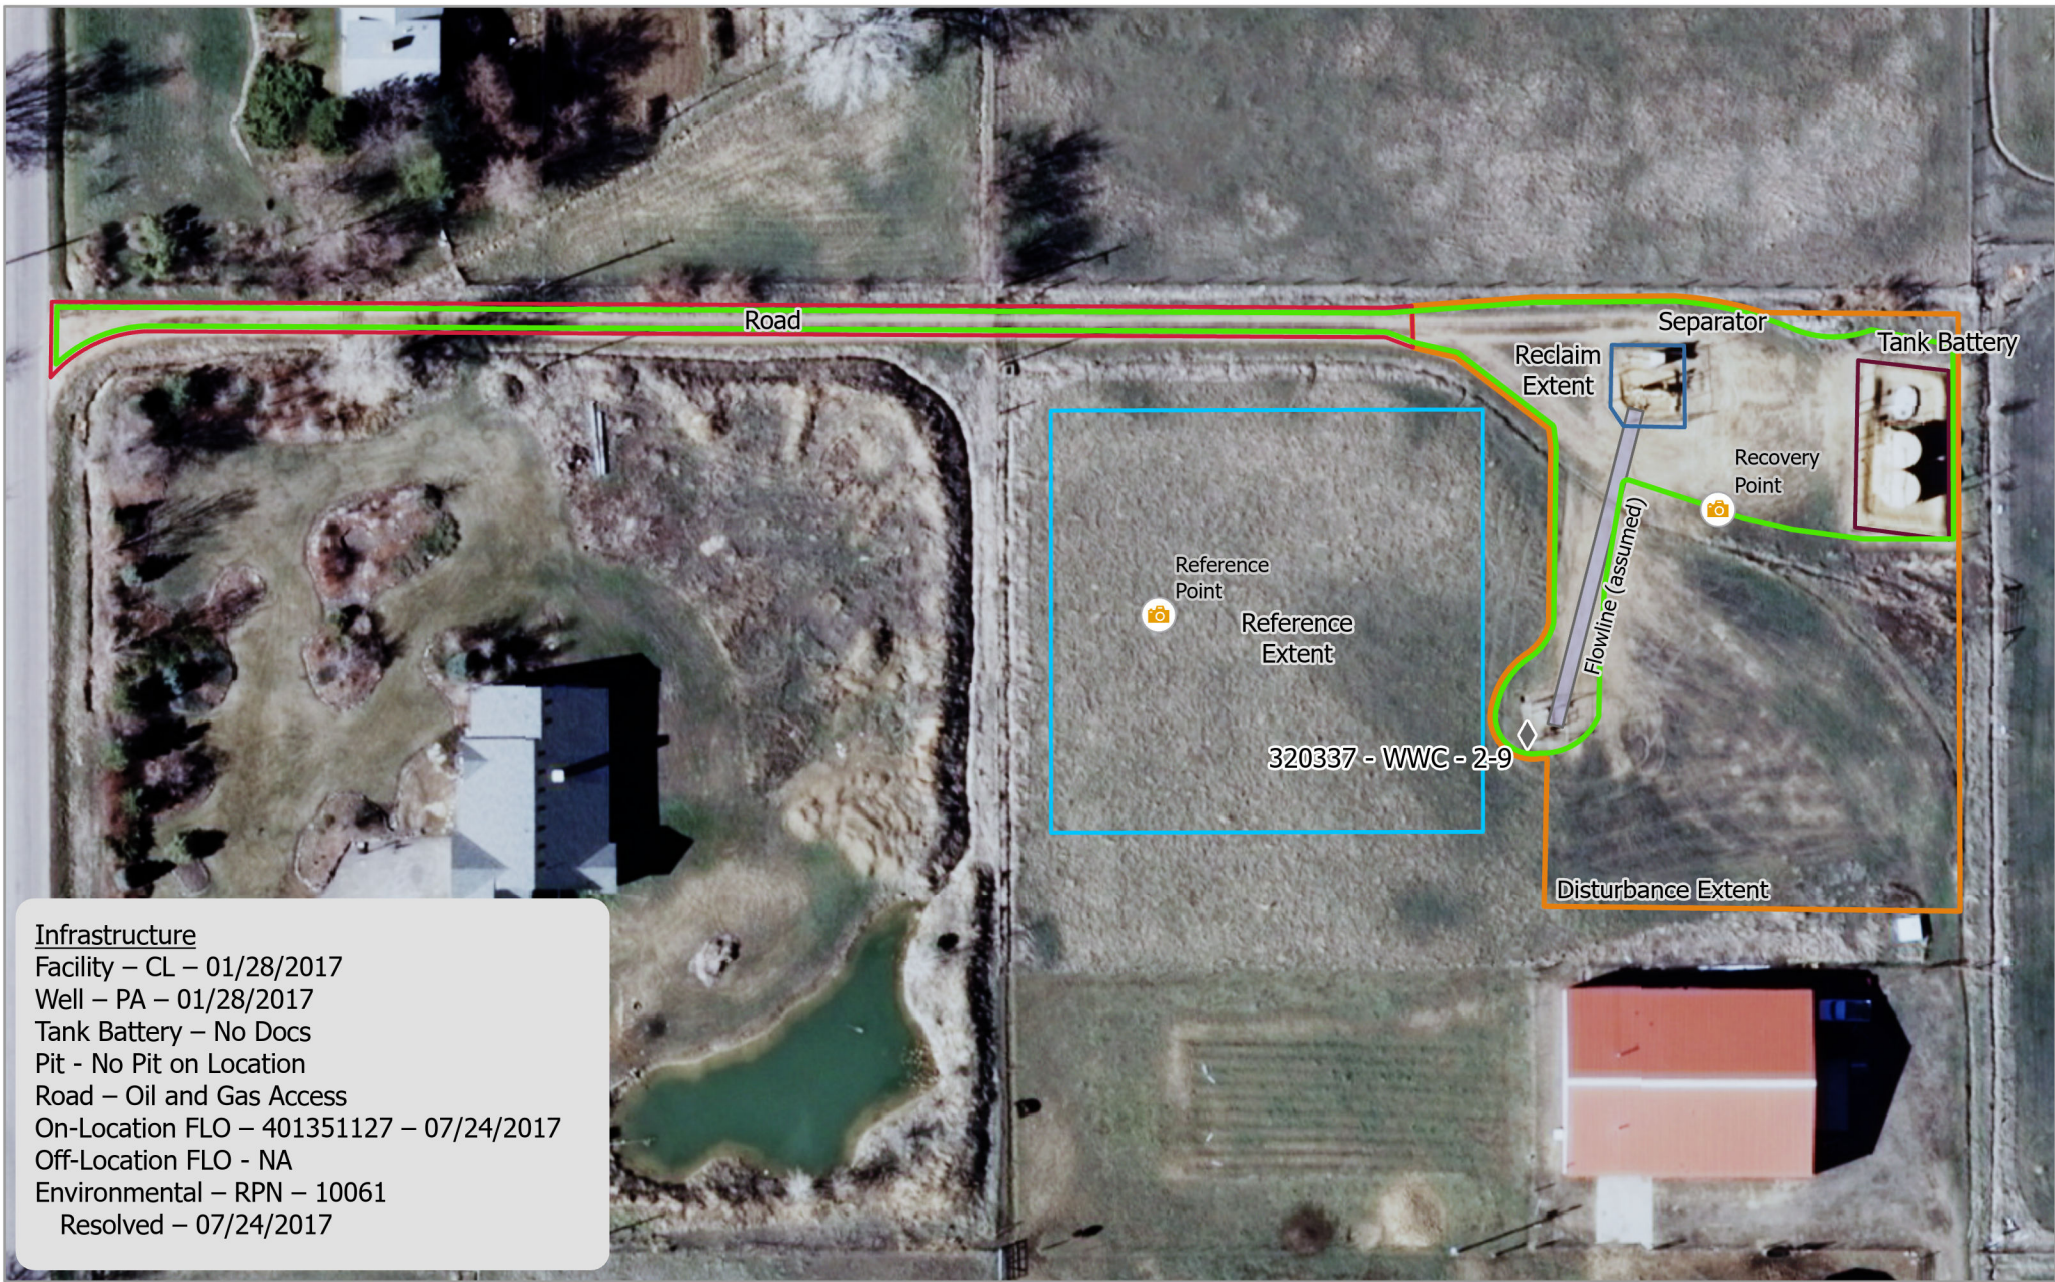
**CIV - 320337- WWC 2-9
Map Extent - DRCOG 2010**

- Landuse mixed used, non-agricultural, disturbance, reclaim and road extent present

Facility – CL – 01/28/2017
 Well – PA – 01/28/2017
 Tank Battery – No Docs
 Pit - No Pit on Location
 Road – Oil and Gas Access
 On-Location FLO – 401351127 – 07/24/2017
 Off-Location FLO - NA
 Environmental – RPN – 10061
 Resolved – 07/24/2017

Imagery: DRCOG
 Imagery Date: 2010
 Map Date: 26 Mar 2023
 Datum: WGS 1984 UTM Zone 13N
 POC: Soil Sage

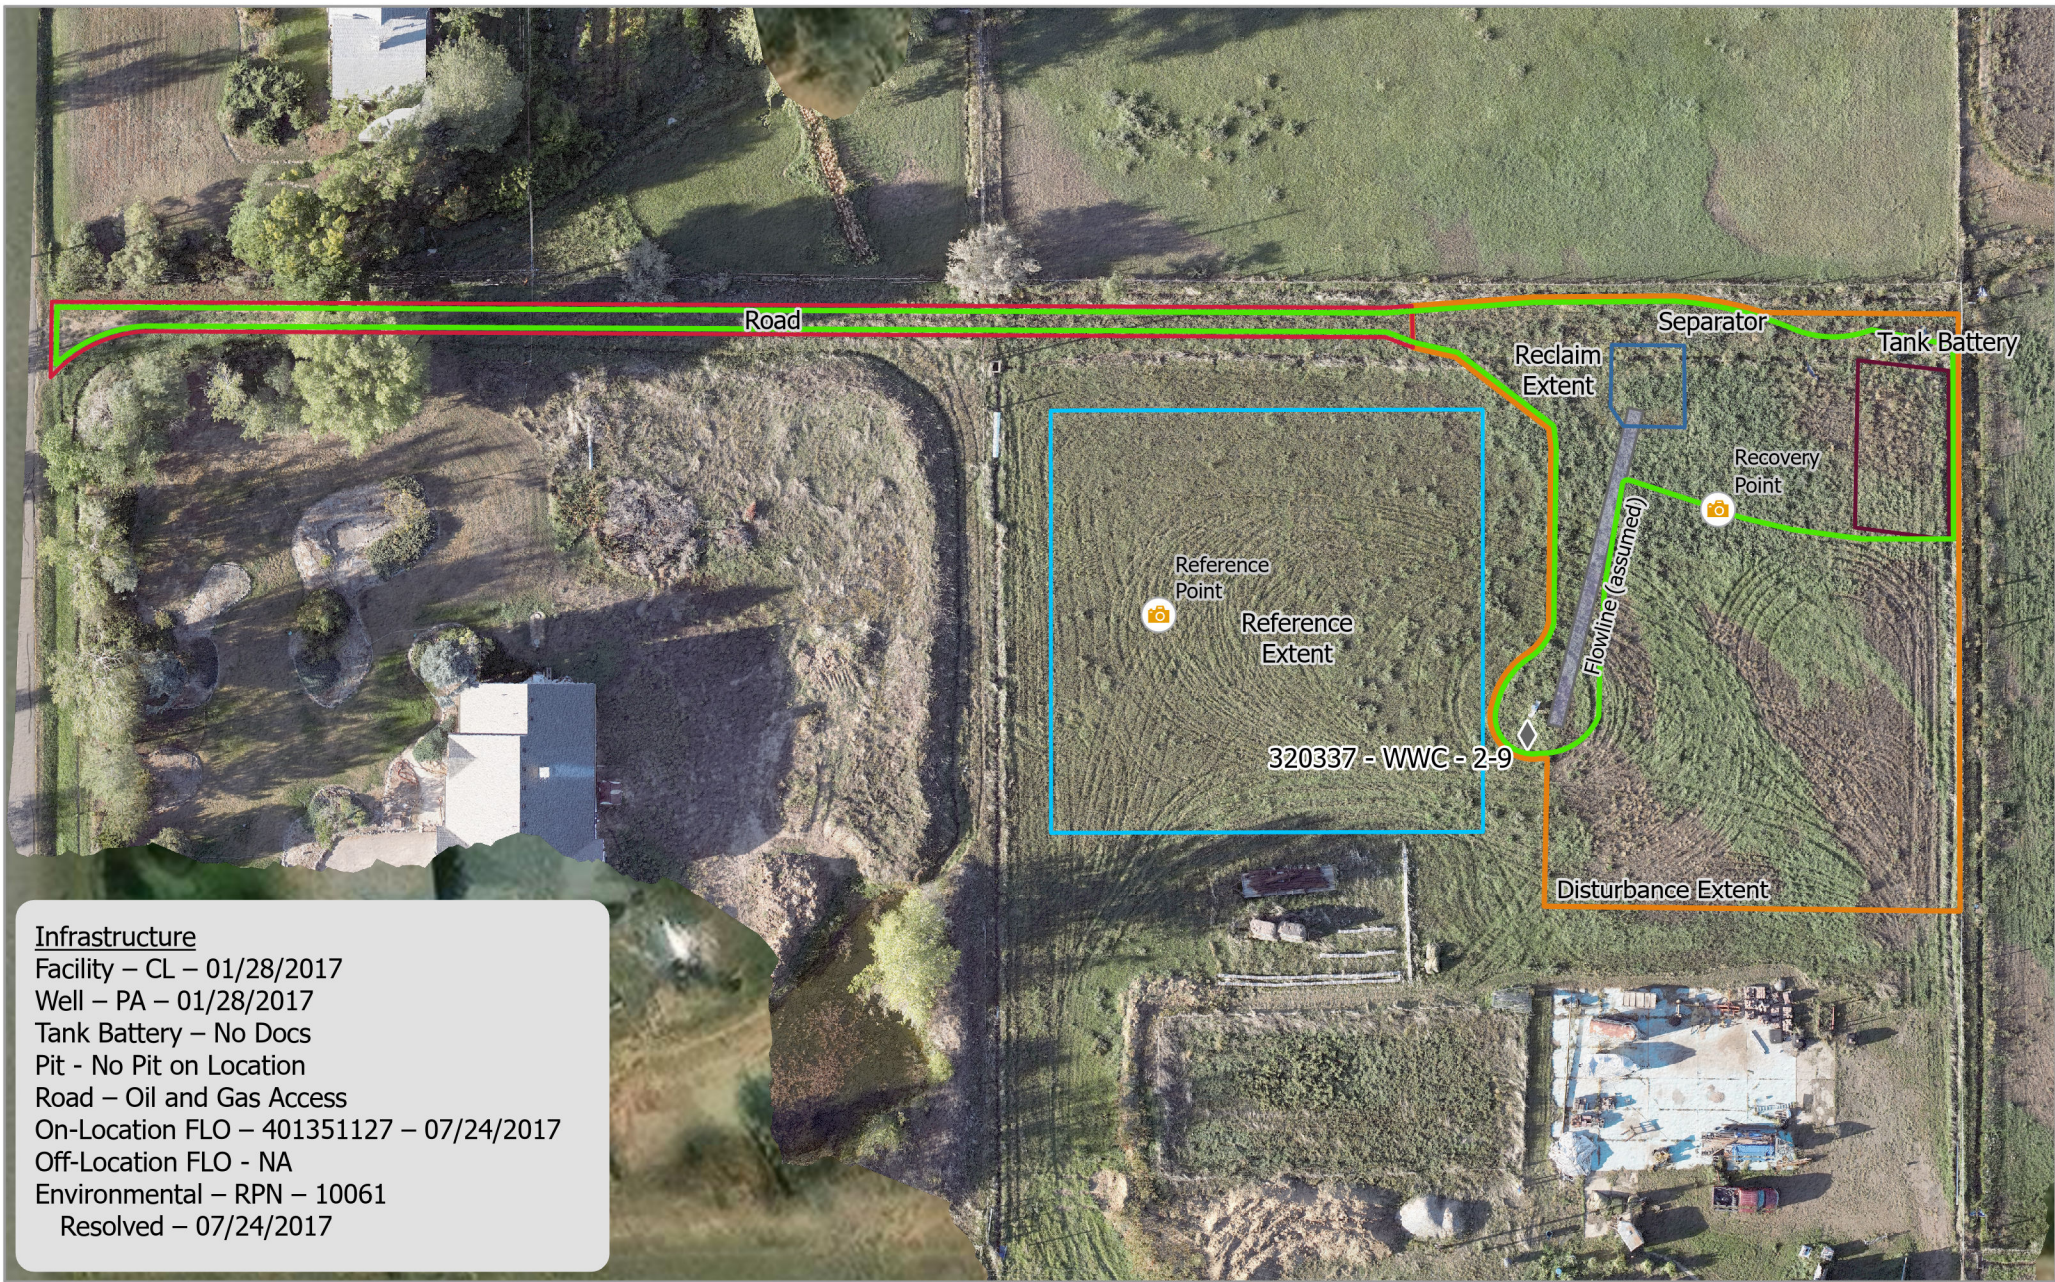
**CIV - 320337- WWC 2-9
 Map Extent - Overview**

- Landuse mixed use, agricultural reclaim extent not visible
-

Infrastructure
 Facility – CL – 01/28/2017
 Well – PA – 01/28/2017
 Tank Battery – No Docs
 Pit - No Pit on Location
 Road – Oil and Gas Access
 On-Location FLO – 401351127 – 07/24/2017
 Off-Location FLO - NA
 Environmental – RPN – 10061
 Resolved – 07/24/2017

Imagery: RS Orthomosaic & DSM
 Imagery Date: 24 Sep 2022
 Map Date: 24 Mar 2023
 Datum: WGS 1984 UTM Zone 13N
 POC: Soil Sage
