# SITE-SPECIFIC QUALITY ASSURANCE & QUALITY CONTROL AUDIT

## PERMIT CLOSURE REPORT – DESIGNATION LAND USE CHANGE

Location ID – 330962

Location Name – ECHEVERRIA-62N67W 2NWSW

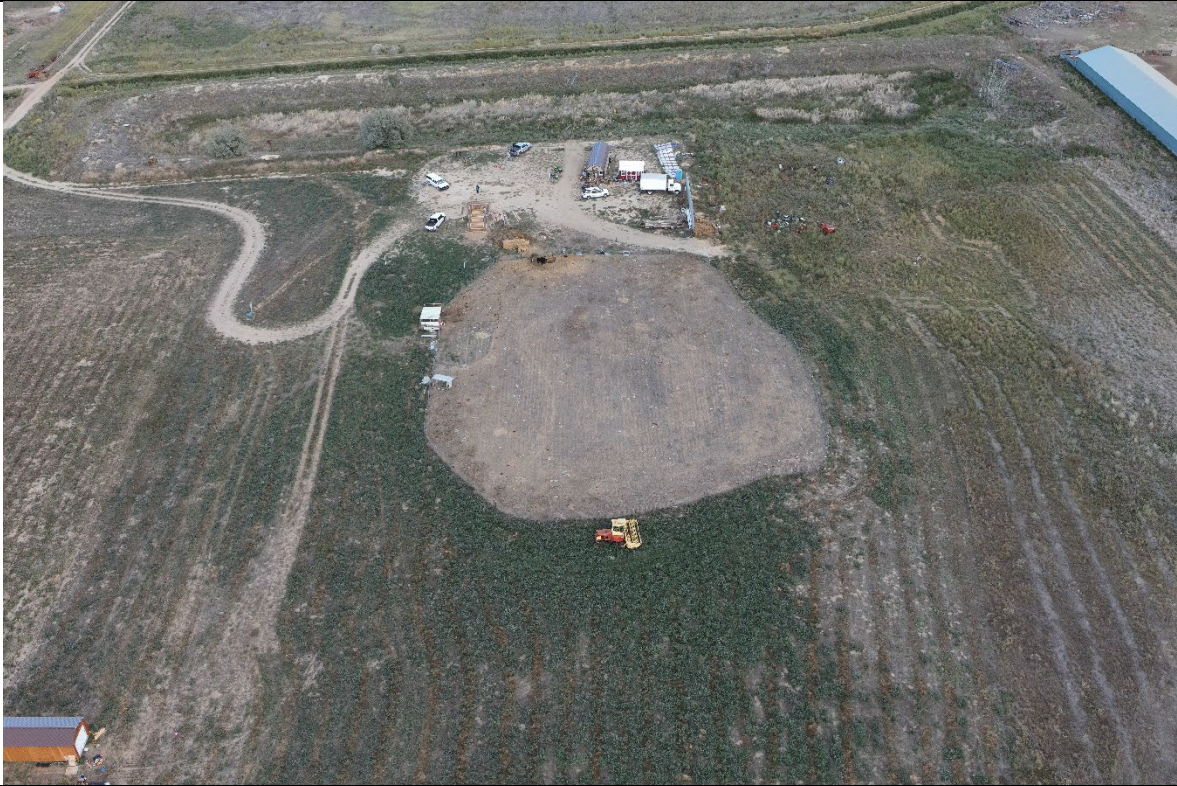
East

Photo locations correspond with the site map.

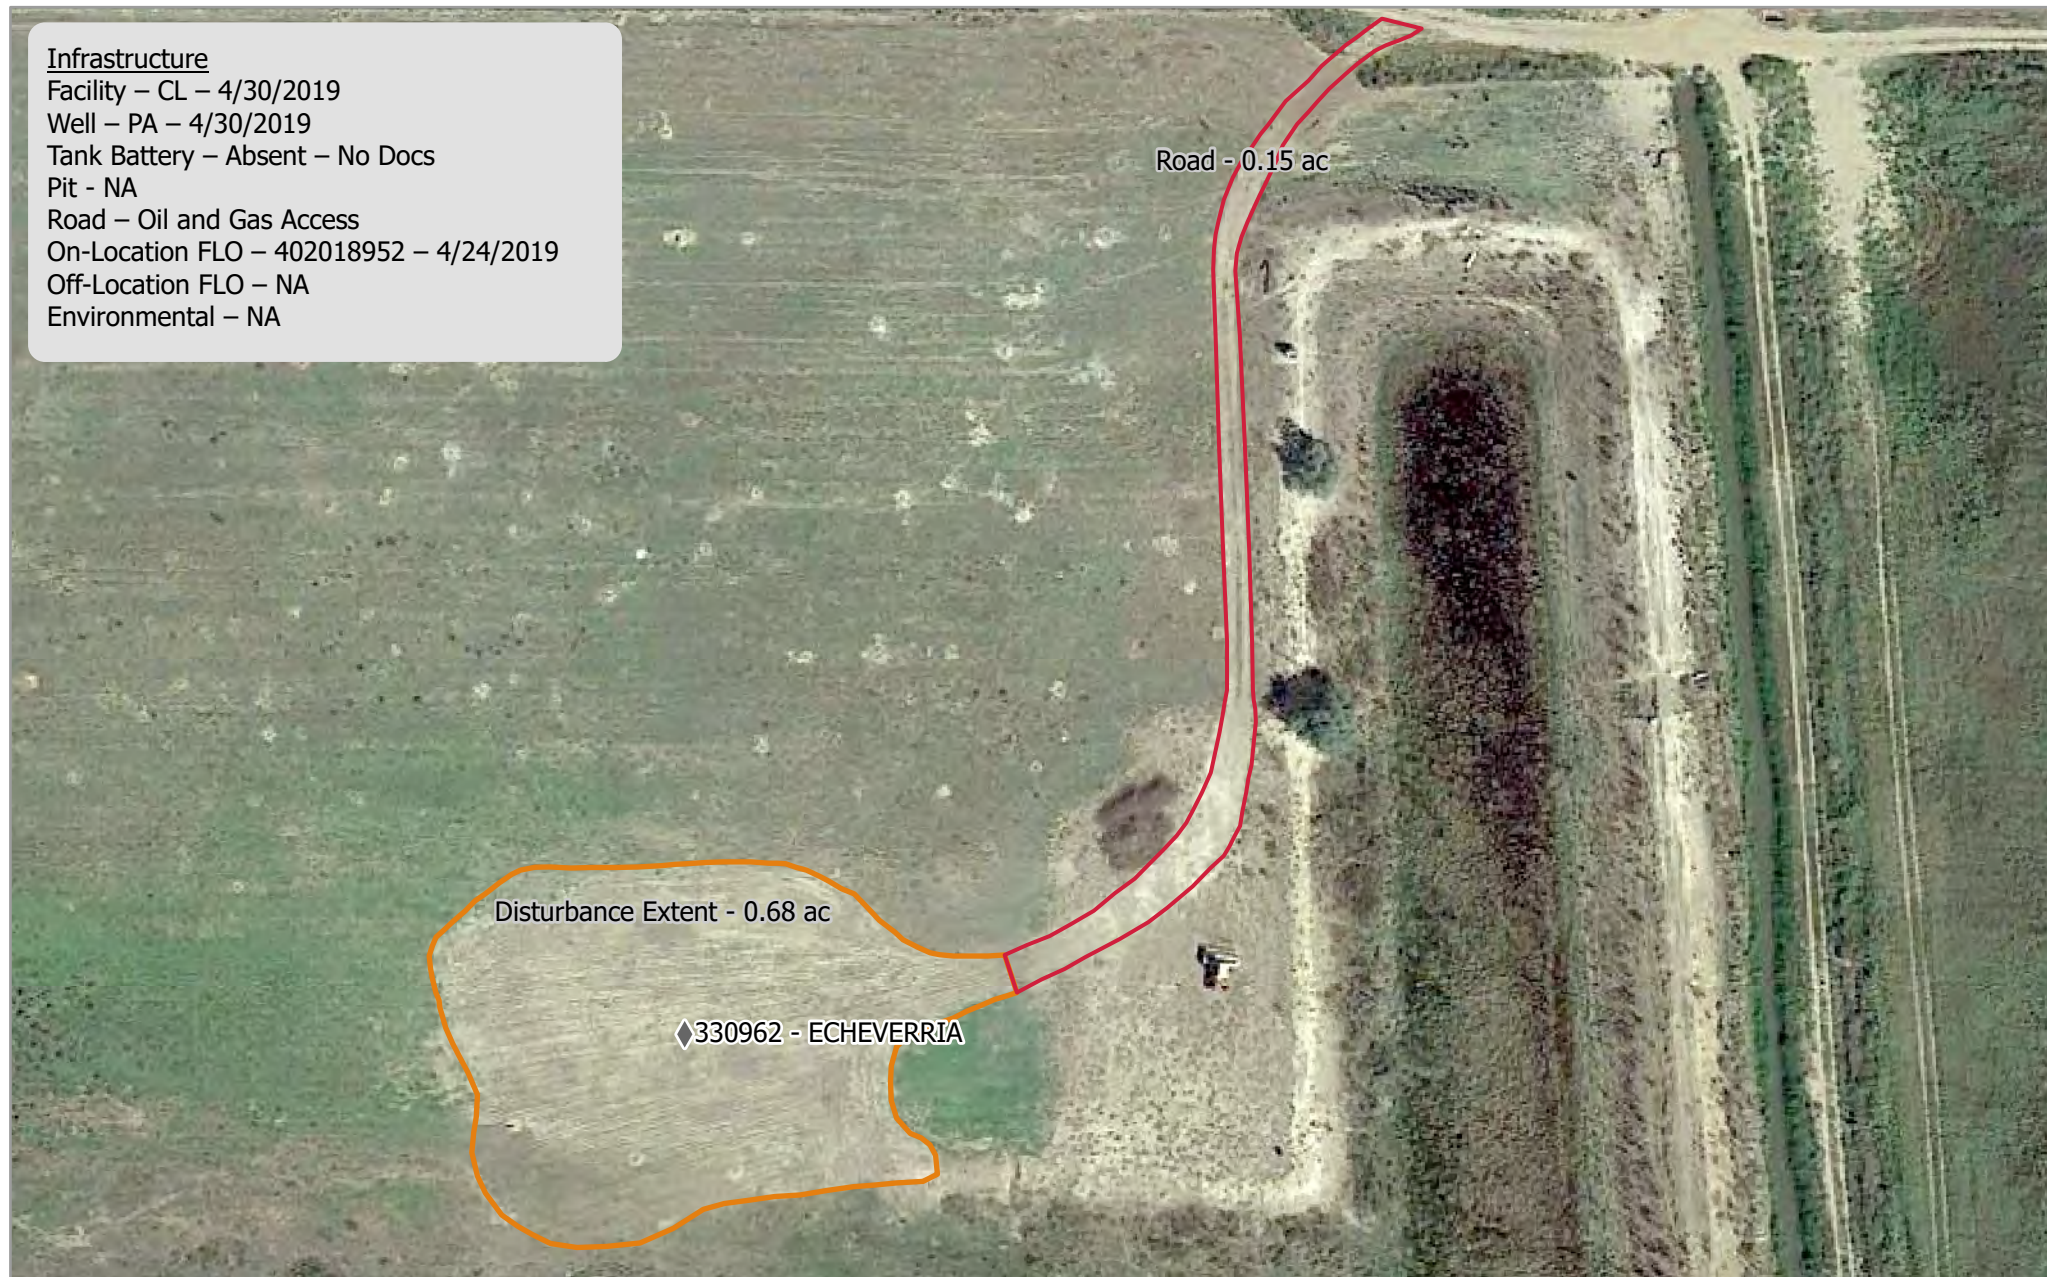
## CIV - 330962 - ECHEVERRIA Map Extent - 2019

Imagery: Landsat Copernicus

Imagery Date: 12 Sep 2019

Overall Disturbance:  
0.83 Acres
