Final Reclamation and Stormwater Inspection

Date: 10/24/23

Location ID: 306037

Inspection Photos
Location Name: Pronghorn 31-9
Location ID: 306037

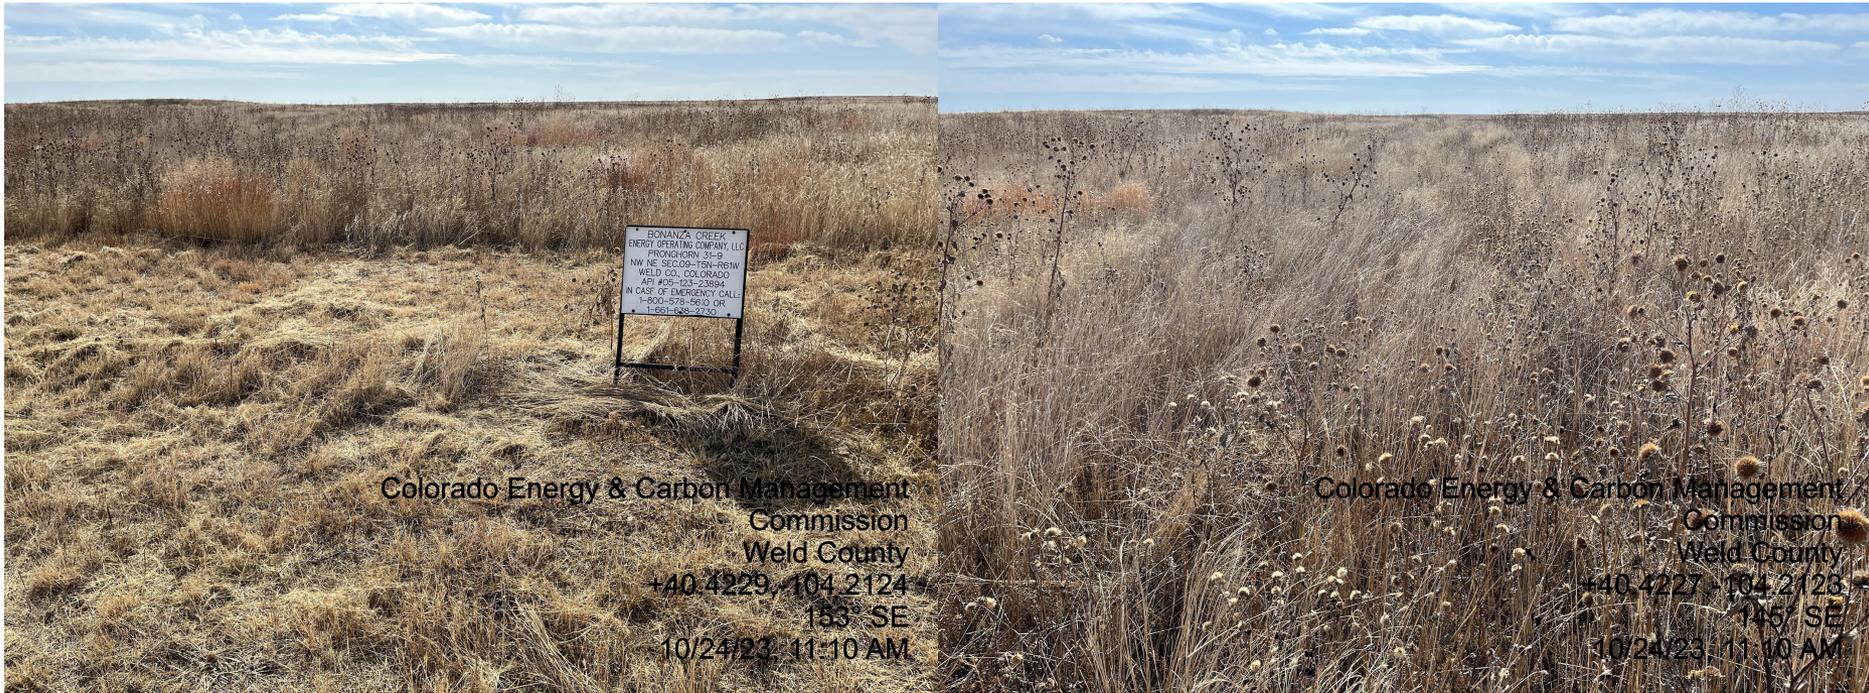
Photo 1. The photo was taken at the entrance to the well location facing Southeast. The photo illustrates the location information sign.

Photo 2. The photo was taken at the entrance to the well location facing Southeast. The photo illustrates the location access road.

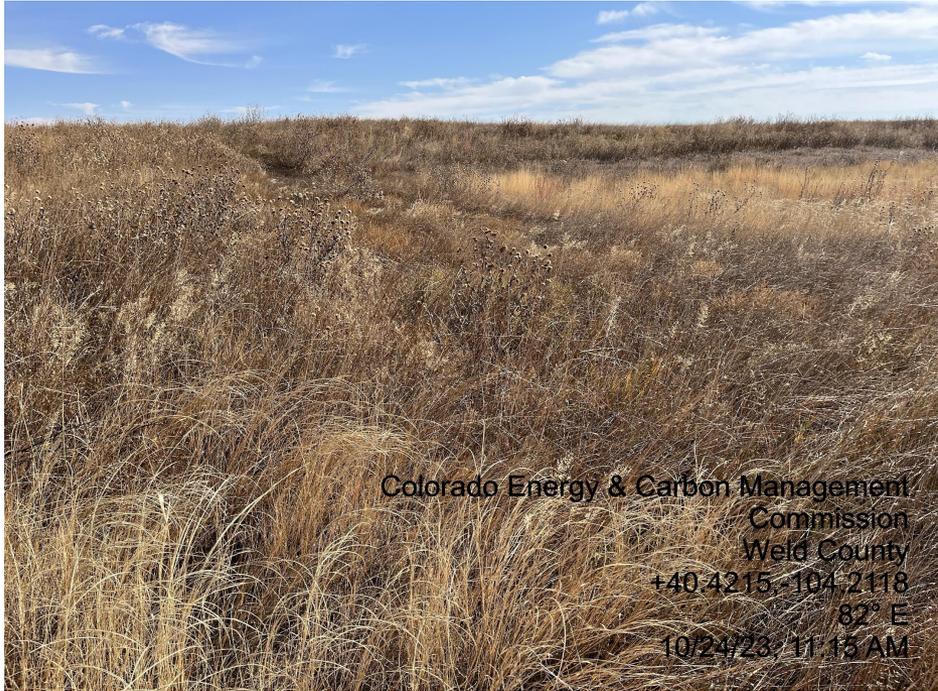
Photo 3. The photo was taken at the well location facing East. The photo illustrates the location is dominated by cereal rye and russian thistle. The photo also illustrates the cut is still apparent on the location.

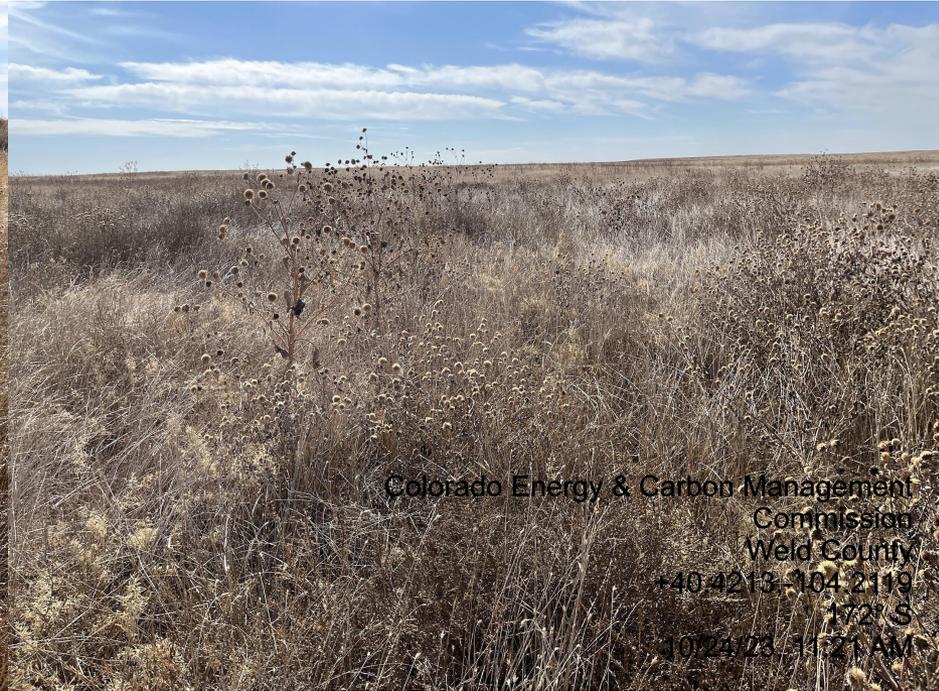
Photo 4. The photo was taken at the well location facing South. The photo illustrates the well location is dominated by russian thistle and cereal rye.

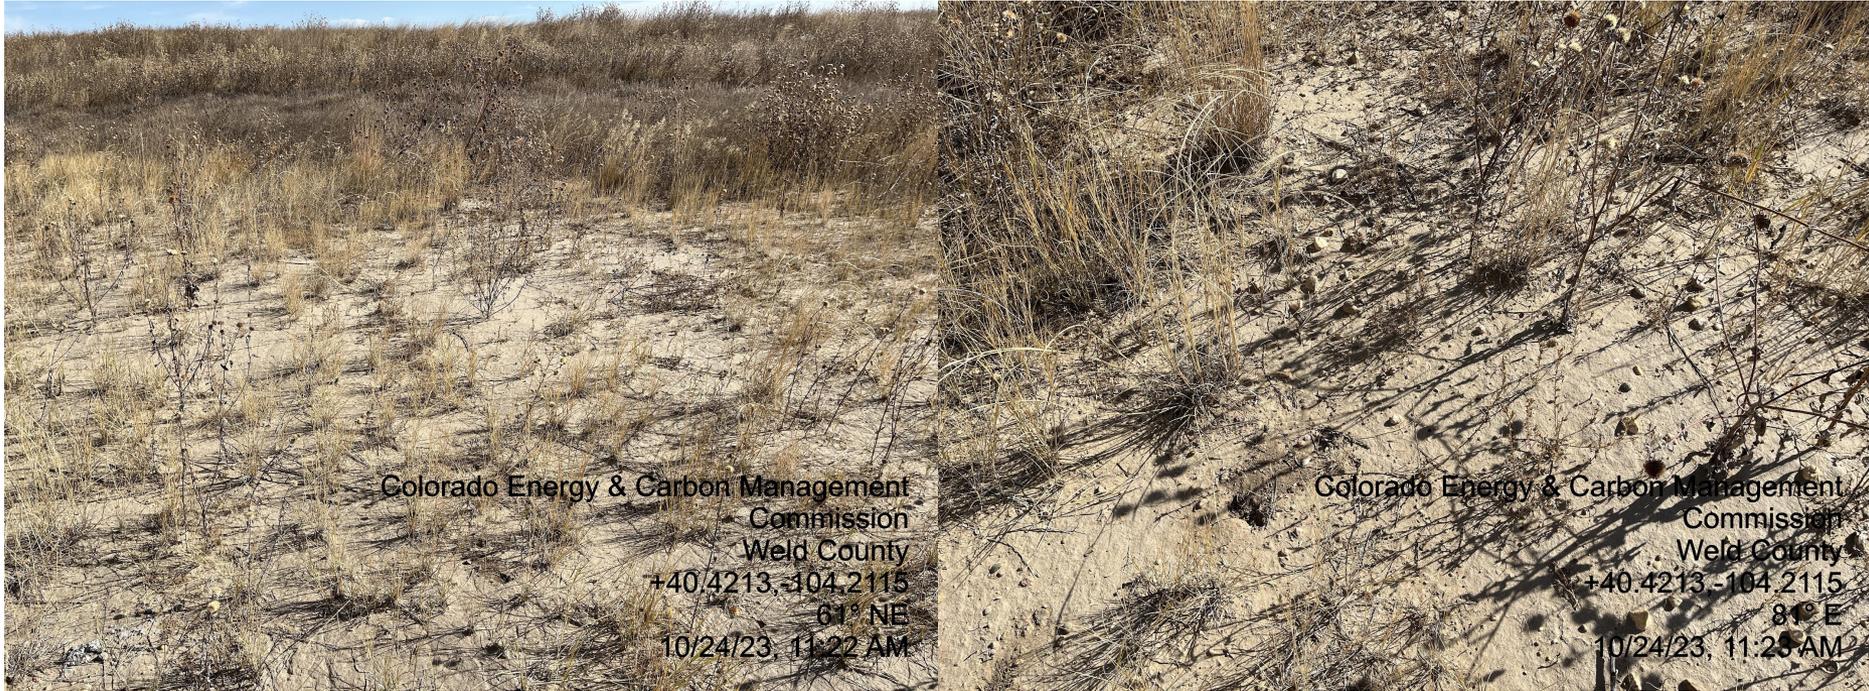
Photo 5. The photo was taken at the well location facing Northeast. The photo illustrates large patches of bare soil on location.

Photo 6. The photo was taken at the well location facing East. The photo illustrates gravel left on location.
