Final Reclamation and Stormwater Inspection

Operator: NOBLE ENERGY INC - 100322

Location ID: 431669

Inspection Photos
Location Name: Lone Pine LB 19-78HN
Location ID: 431669

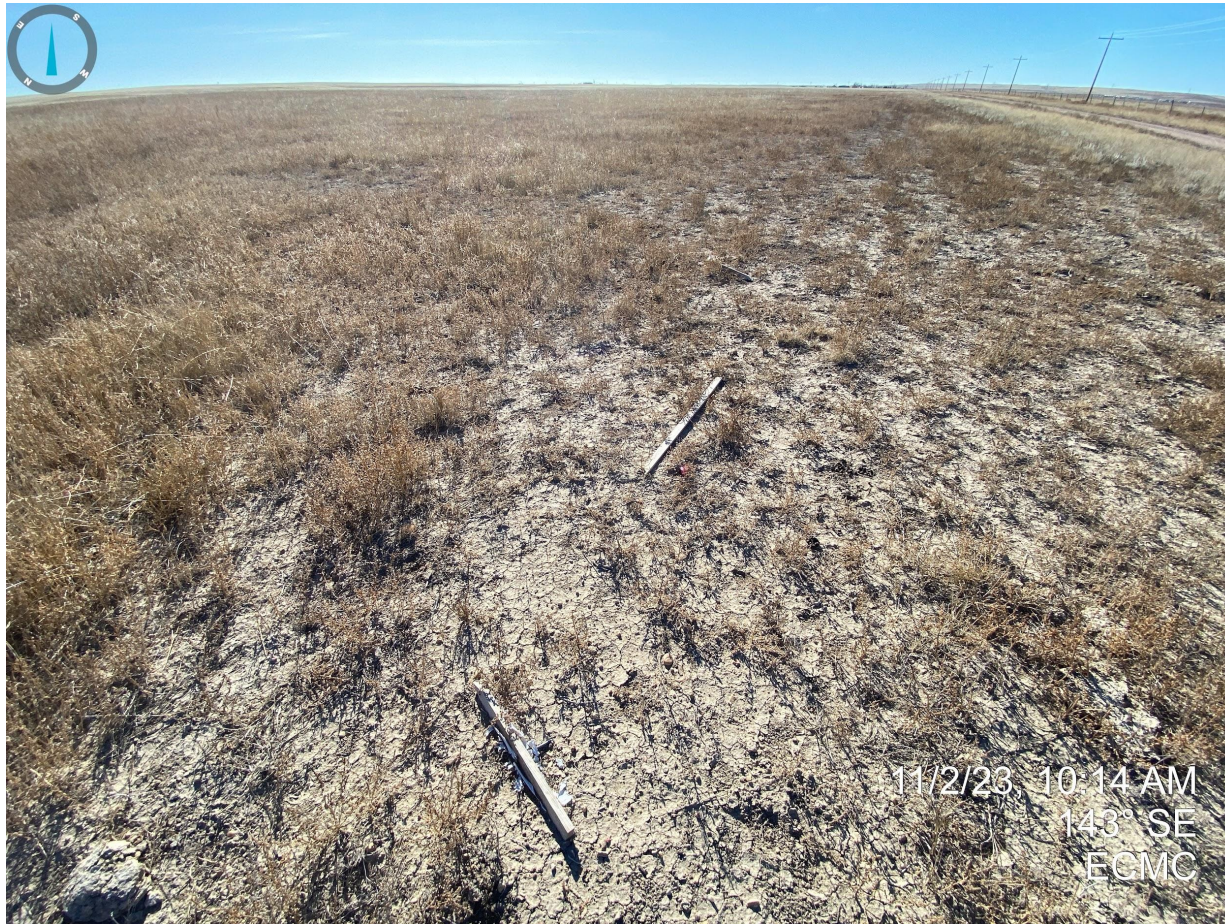
Photo 1. Taken near the northwest corner of the former well location. Photo illustrates debris on location.

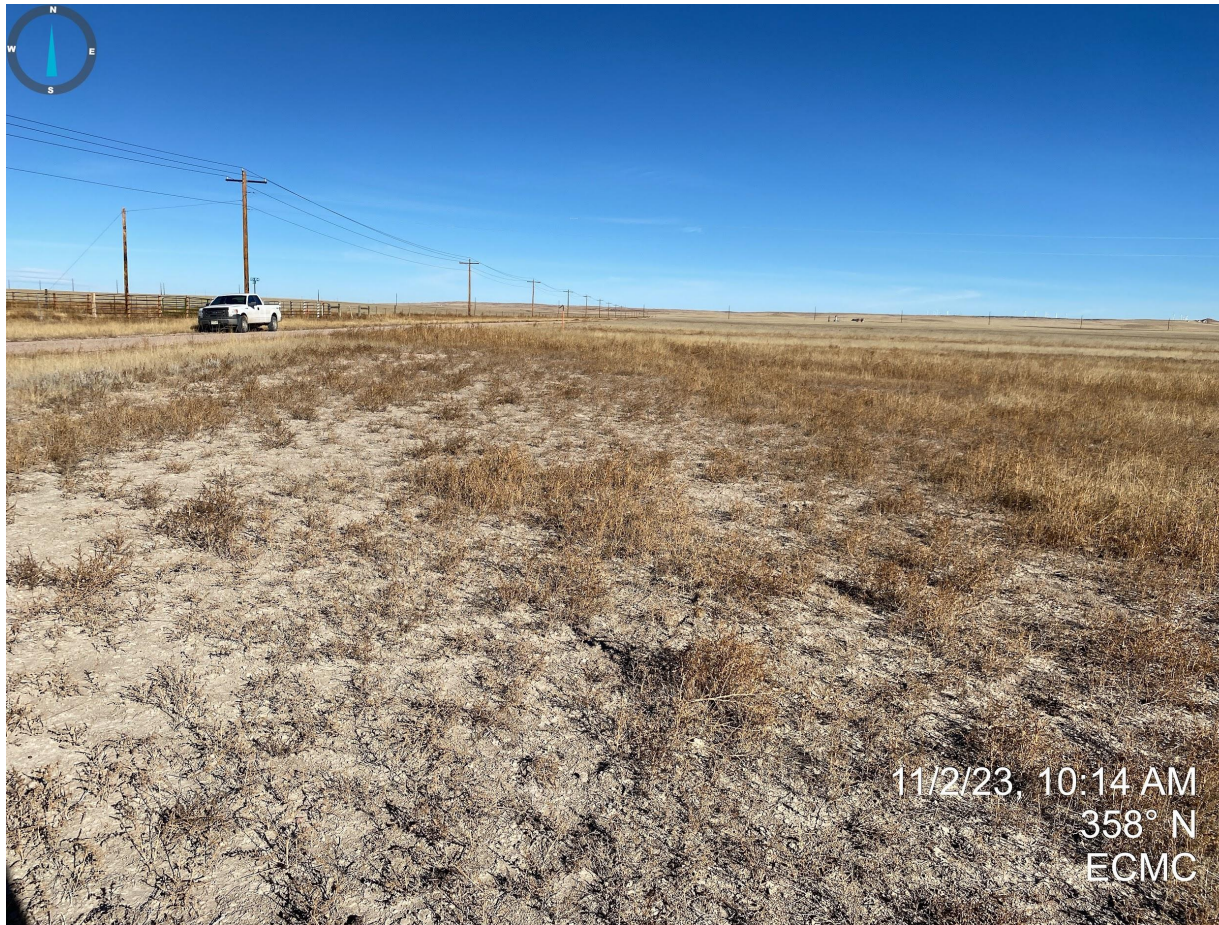
Photo 2. Taken near the northwest corner of the well location. Photo illustrates non-uniform vegetative cover resulting in bare soils and the presence of undesirable weedy vegetation (e.g. kochia and russian thistle).

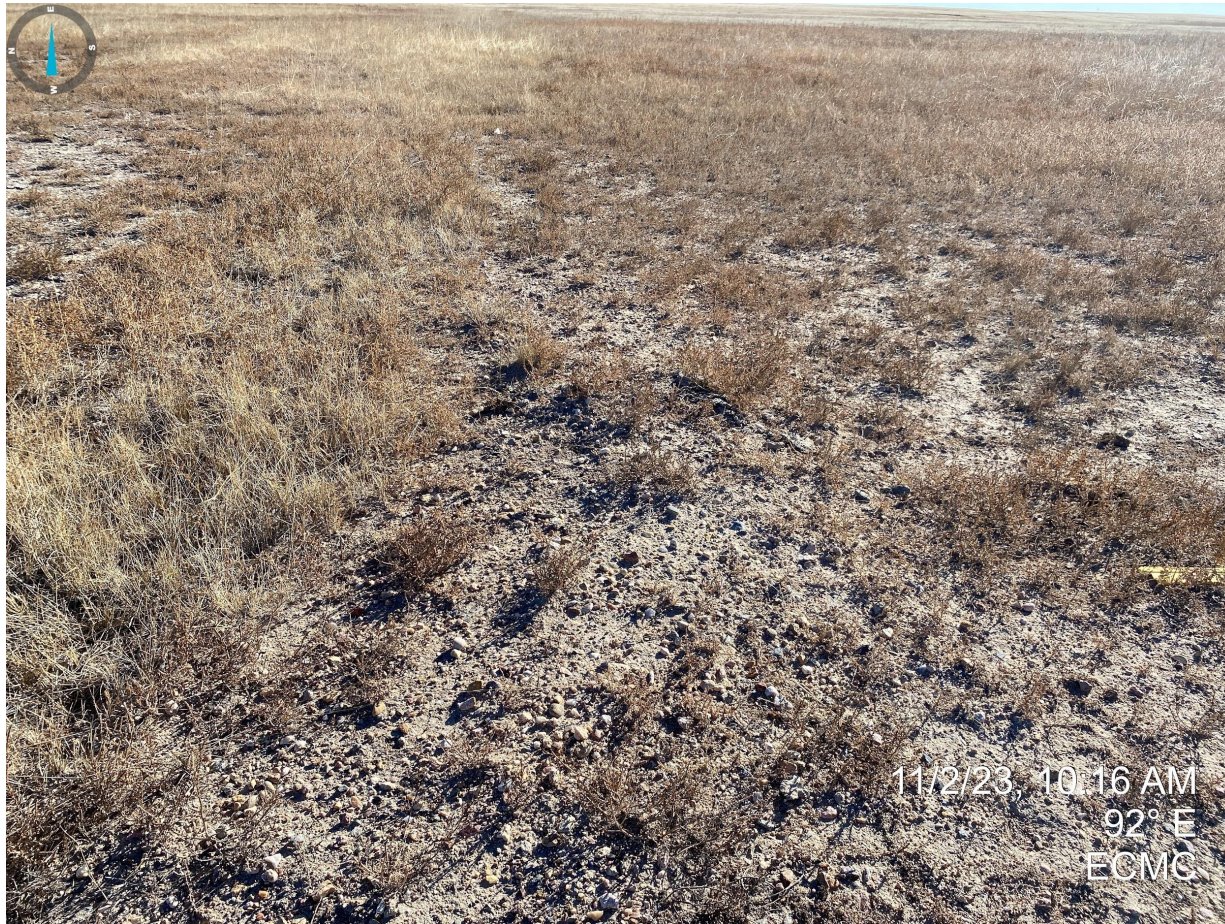
Photo 3. Taken from the southern portion of the well location. Photo illustrates gravel/road base material on location.

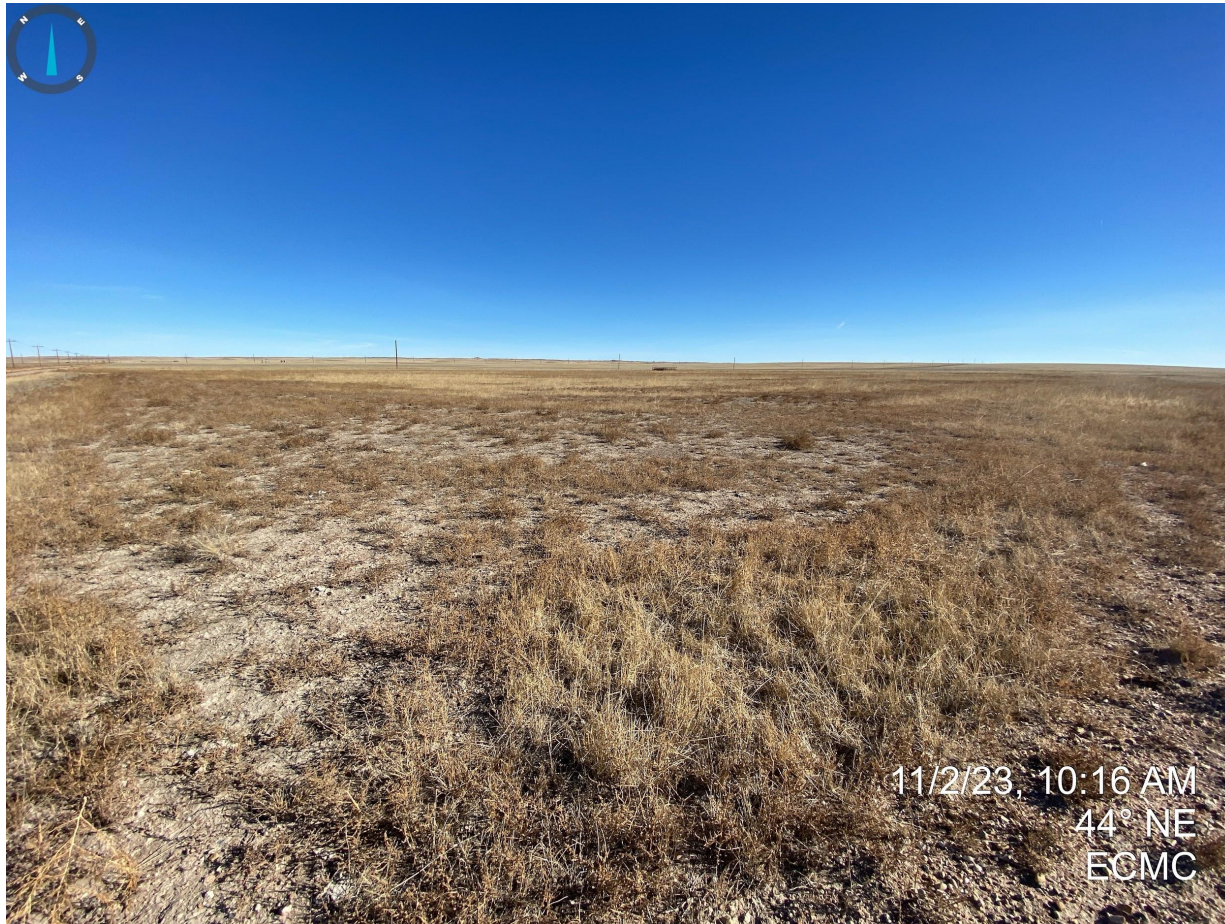
Photo 4. Taken near the southwest corner of the well location. Photo illustrates non-uniform vegetative cover resulting in bare soils and the presence of undesirable weedy vegetation (e.g. kochia and russian thistle).

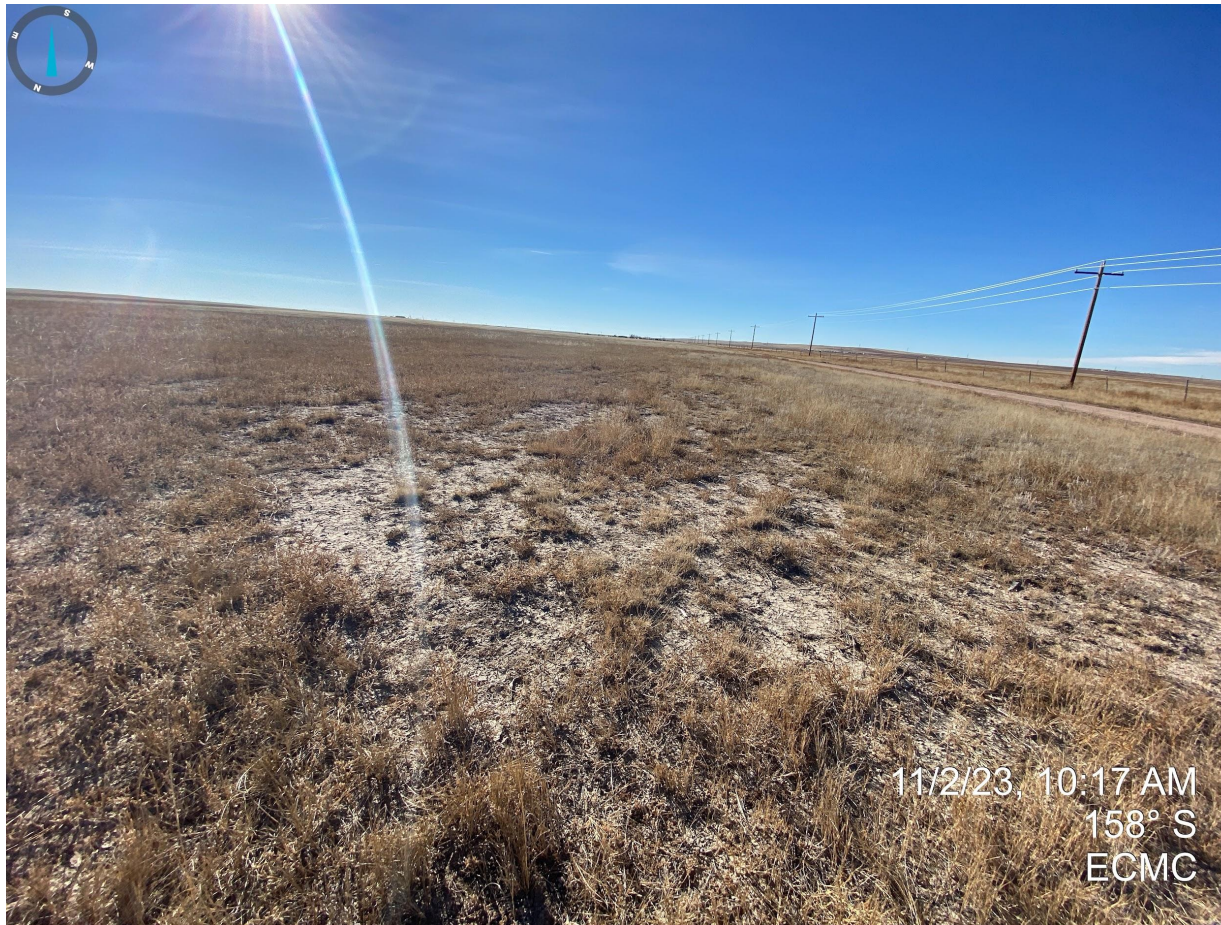
Photo 5. Taken near the northern portion of former tank battery location. Photo illustrates non-uniform vegetative cover resulting in bare soils and the presence of undesirable weedy vegetation (e.g. kochia and russian thistle).

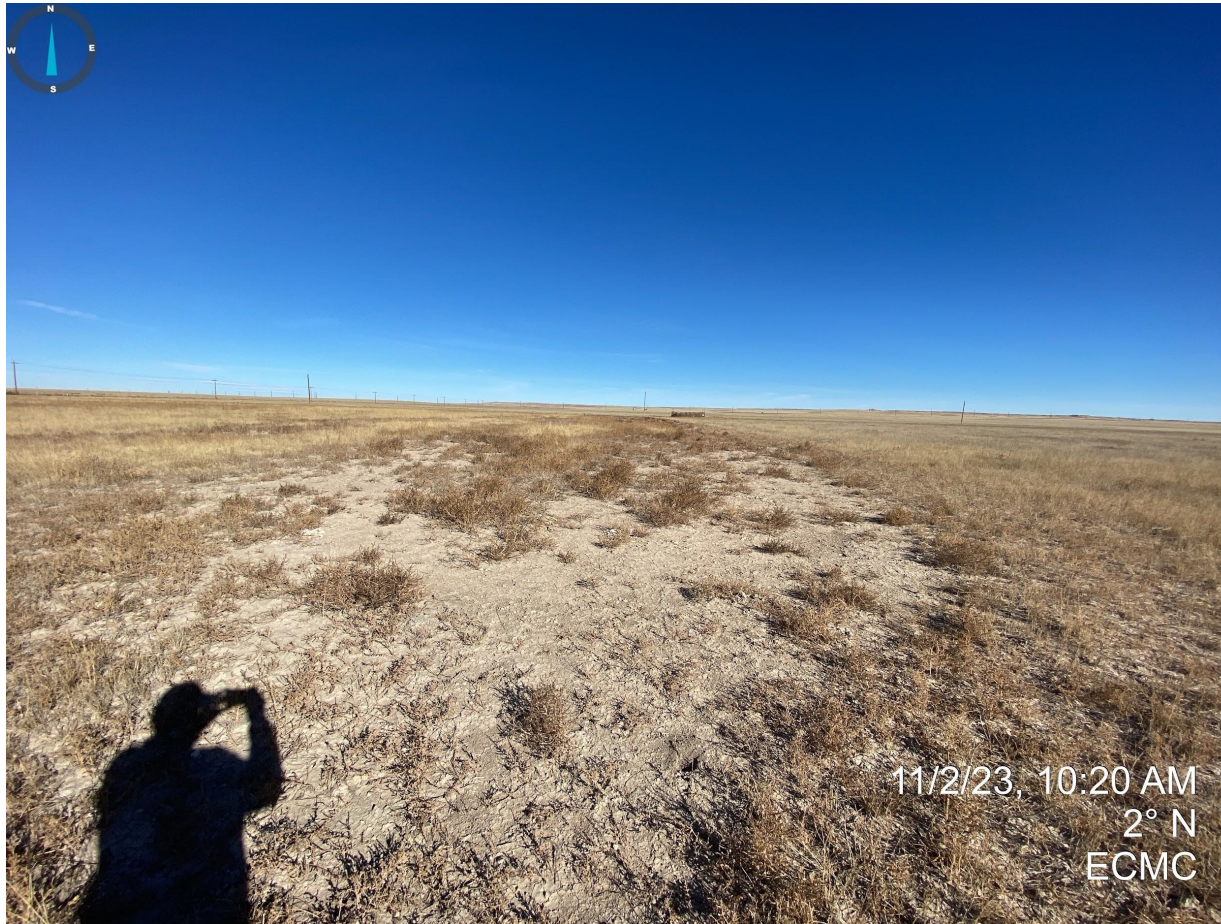
Photo 6. Taken near the southeast corner of the well location (former topsoil stockpile area). Photo illustrates non-uniform vegetative cover resulting in bare soils and the presence of undesirable weedy vegetation (e.g. kochia and russian thistle).

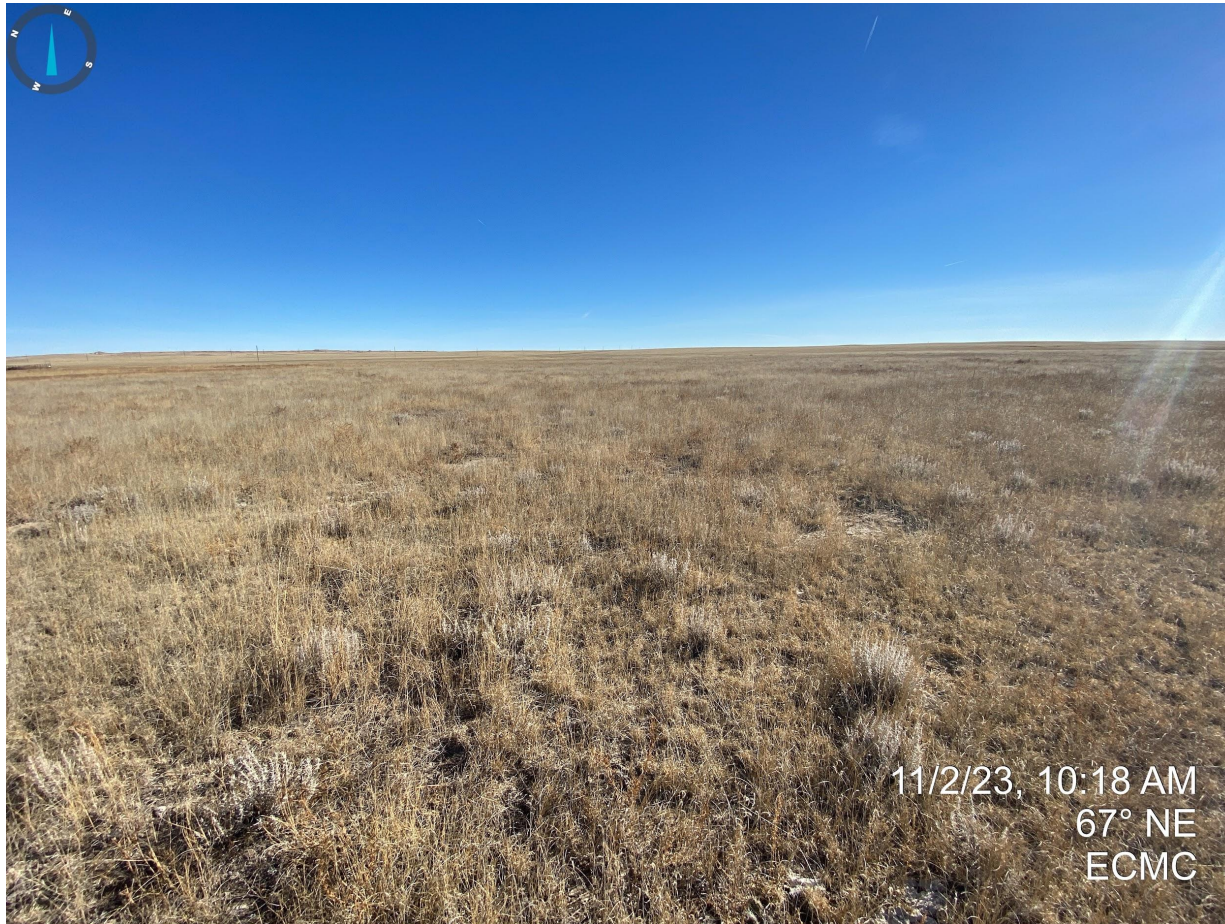
Photo 8. Photo of adjacent reference area taken east of the location. Buffalo grass, blue grama, etc observed.
