Interim Reclamation and Stormwater Inspection

Operator: VERDAD RESOURCES LLC - 10651

Location ID: 422744

Inspection Photos
Location Name: Nelson 17-44-9-60
Location ID: 422744

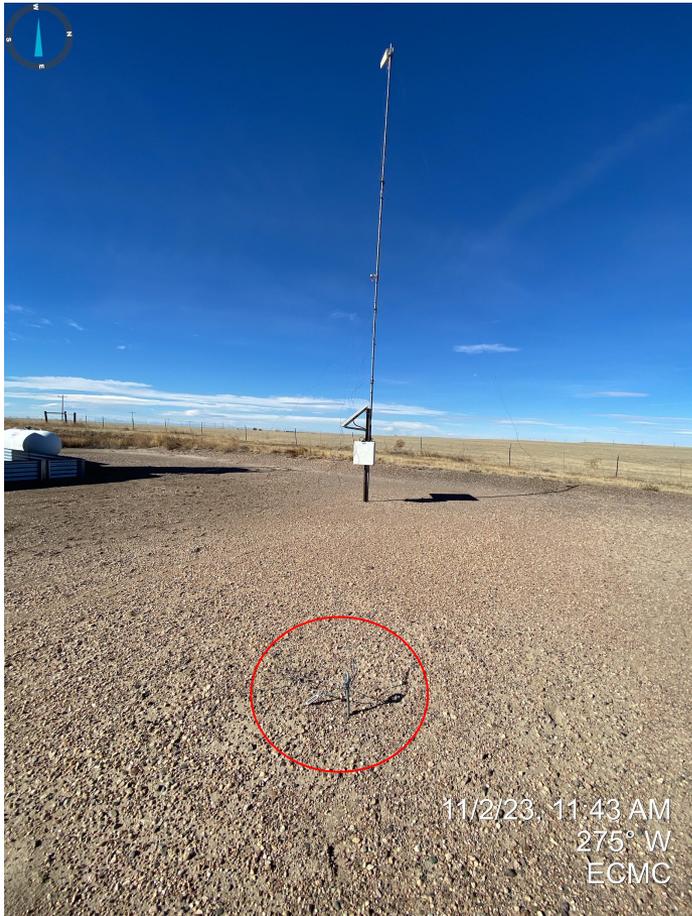
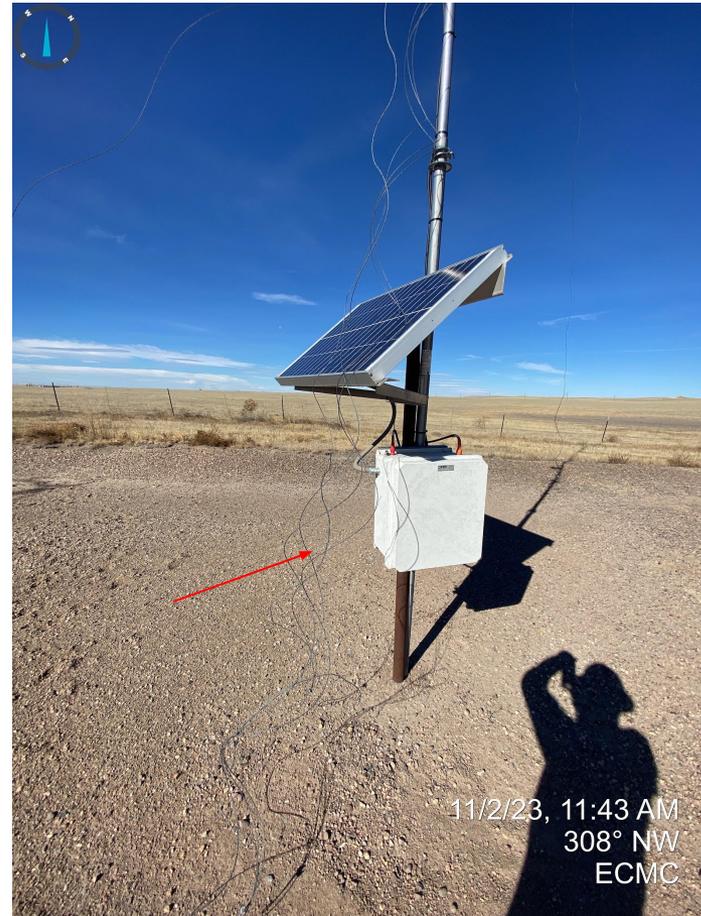
Photo 1. Anchoring equipment (wire) is broken on telemetry equipment.

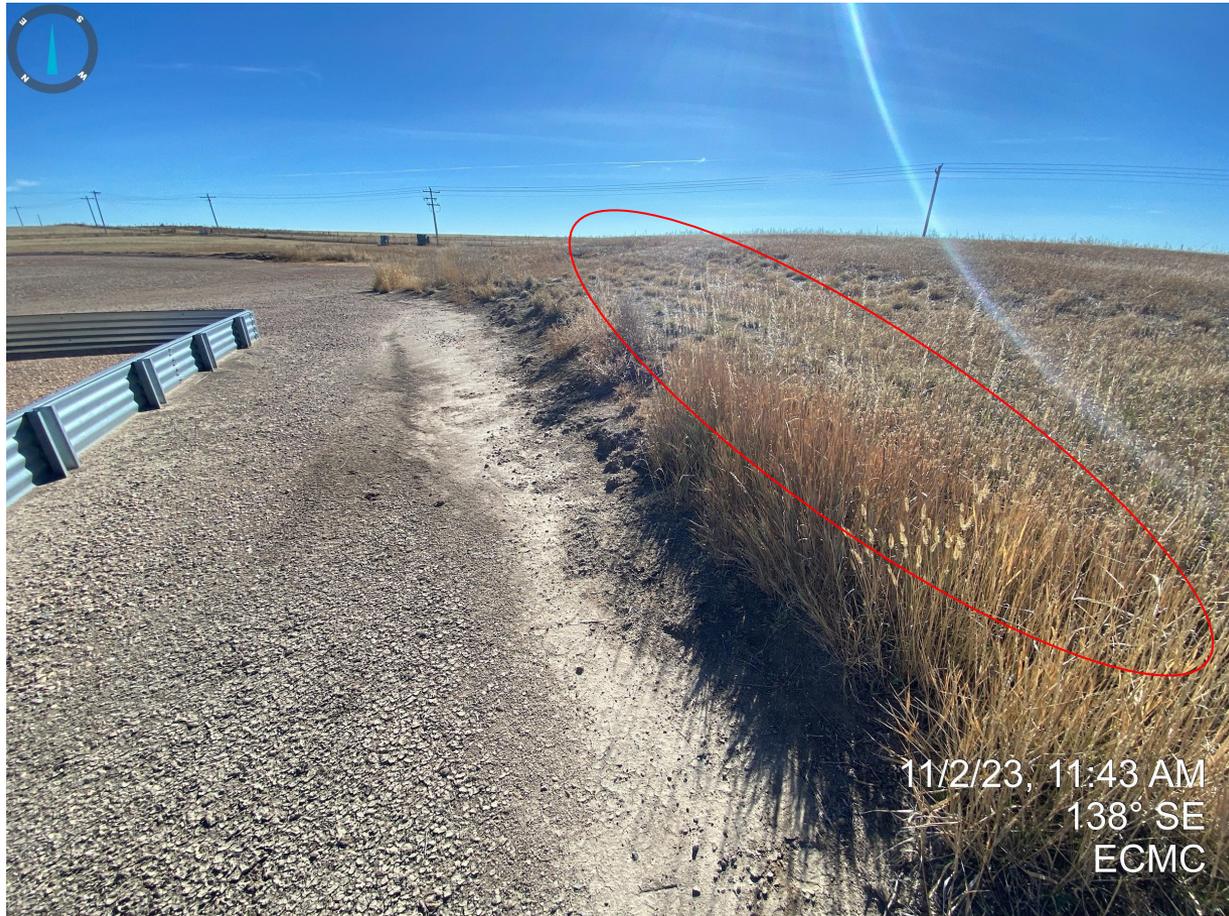
Photo 2. Smooth brome and crested wheatgrass observed to be growing within the interim reclaimed areas. Other portions of the interim areas have been recently mowed.

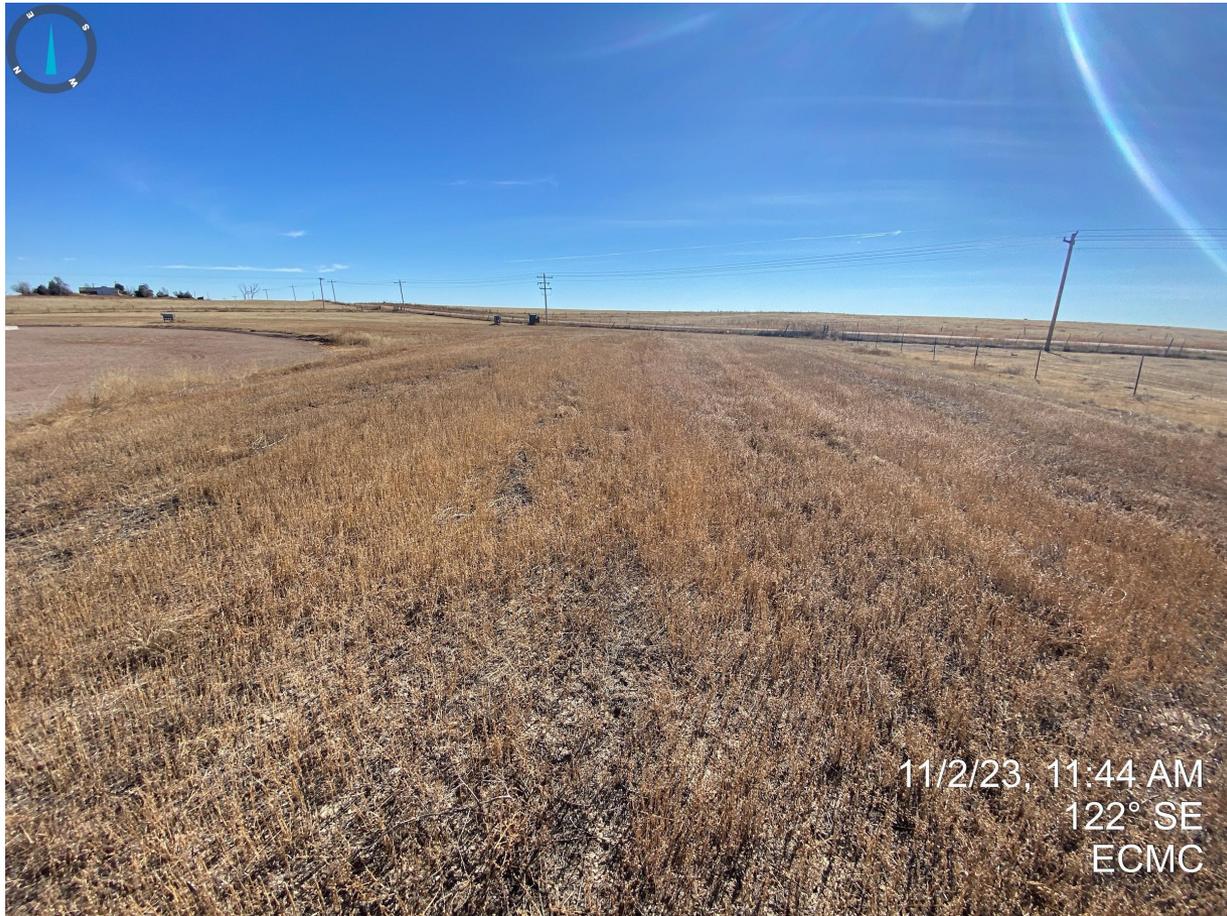
Photo 3. Mowed interim areas are not reflective of adjacent reference areas, with evidence of crested wheatgrass, kochia and smooth brome observed.

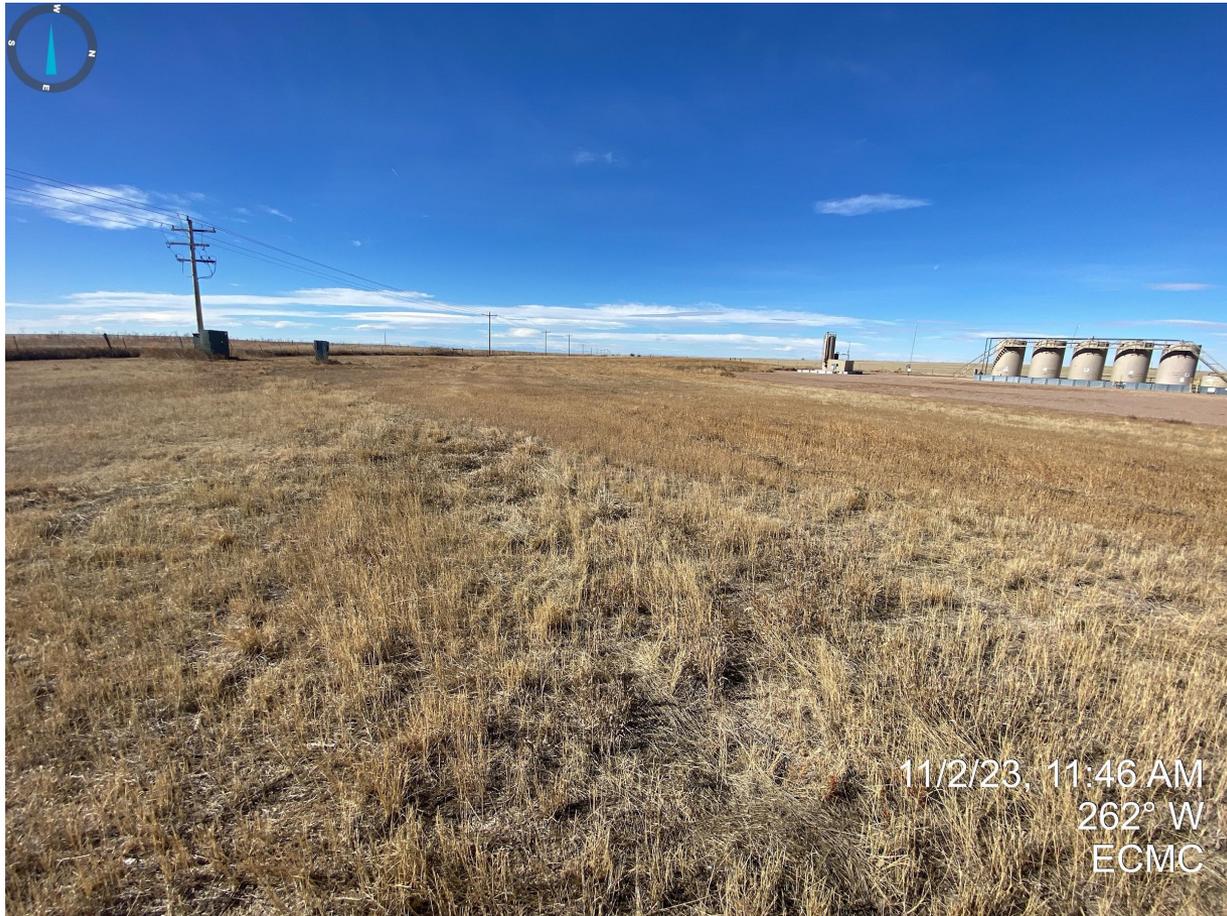
Photo 4. See comments in Photo 3.

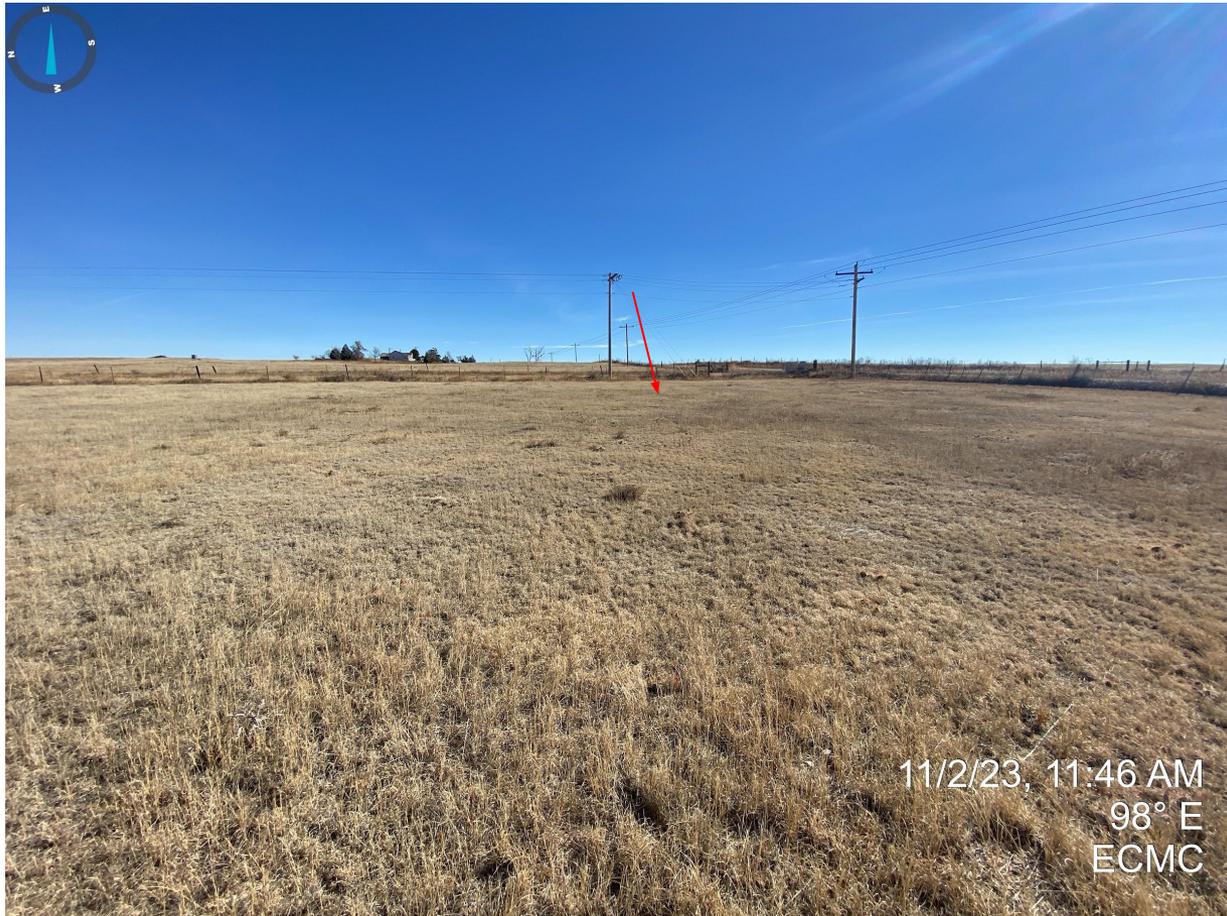
Photo 5. Reference area vegetation (southeast corner of location) was predominantly blue grama.

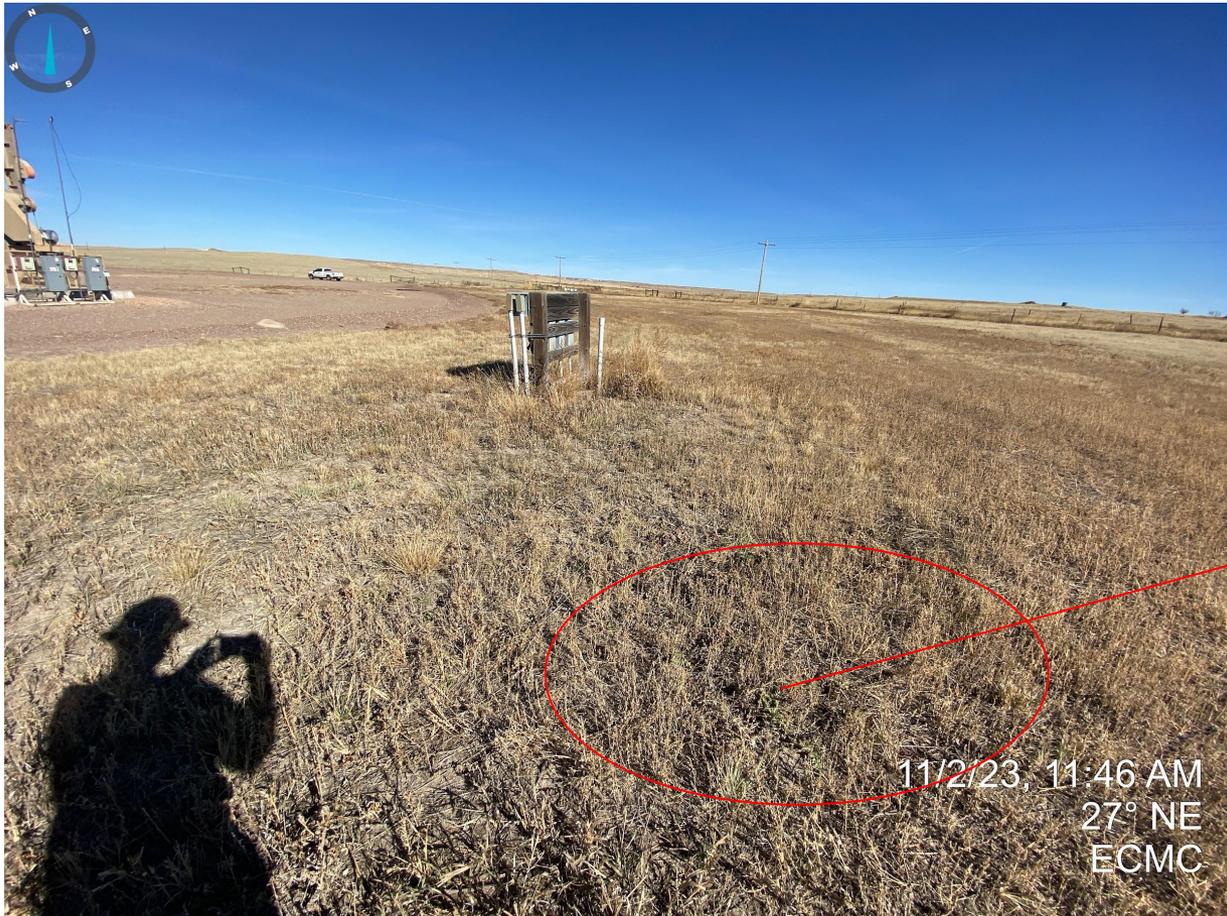
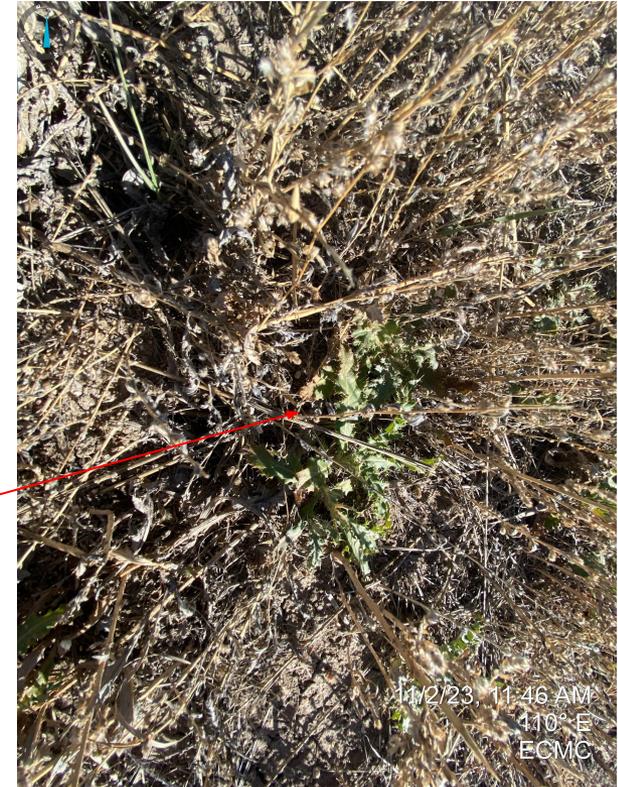
Photo 6. Colorado List B Noxious weed- canada thistle- was observed next to electrical panels for pump jack. While this is only a small population, the Operator shall ensure that this noxious weed infestation is eradicated and controlled in the future.
