Interim Reclamation and Stormwater Inspection

Operator: VERDAD RESOURCES LLC - 10651

Location ID: 431925

Inspection Photos
Location Name: Nelson 2-17-9-60 Pad
Location ID: 431925

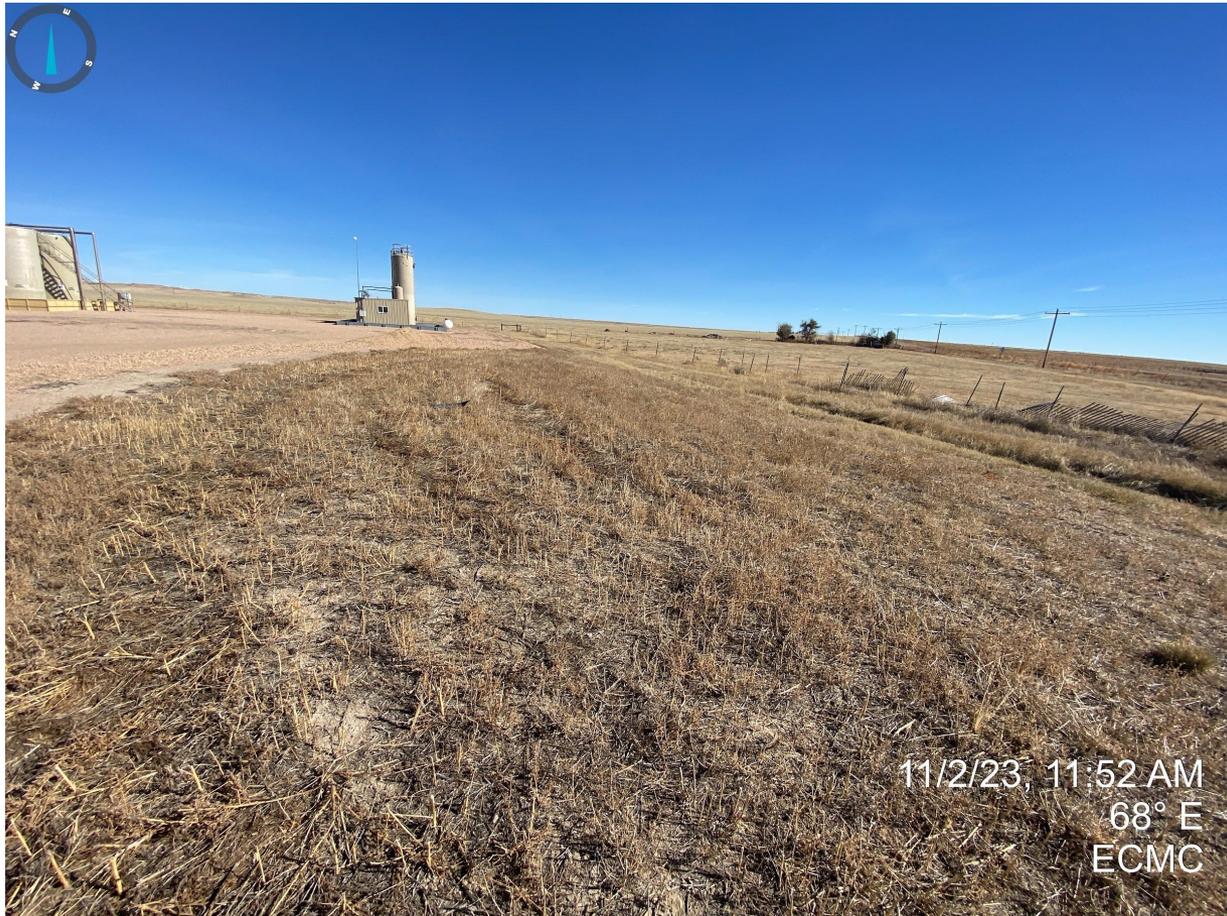
Photo 1. Interim areas are not progressing towards Rule 1003 standards as they are not reflective of adjacent reference areas. Evidence of undesirable vegetation (e.g. kochia and russian thistle) was observed throughout the interim areas; the areas have been recently mowed.

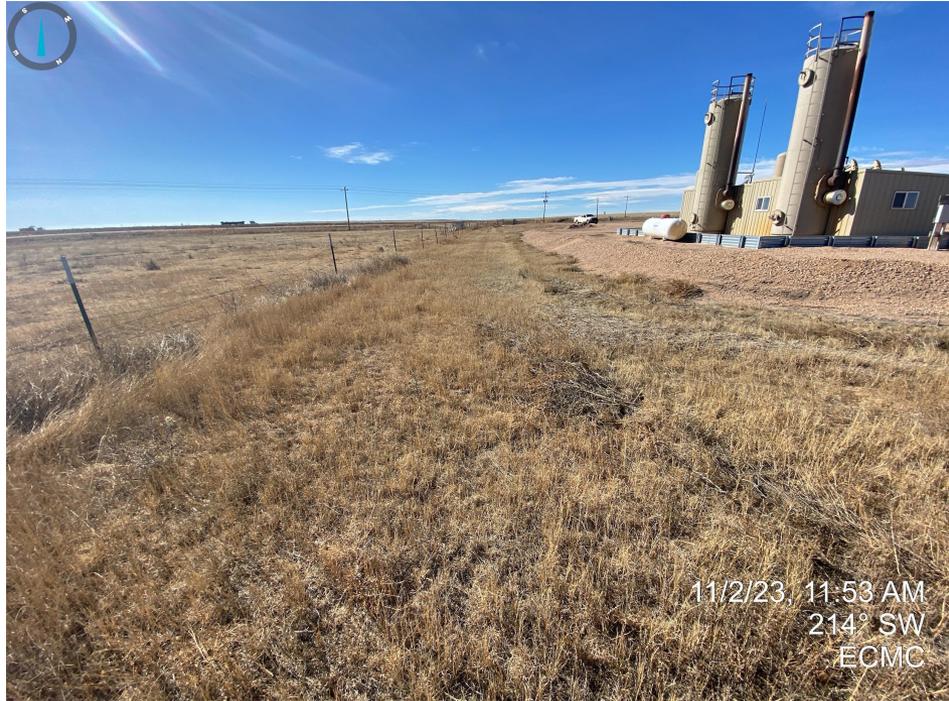
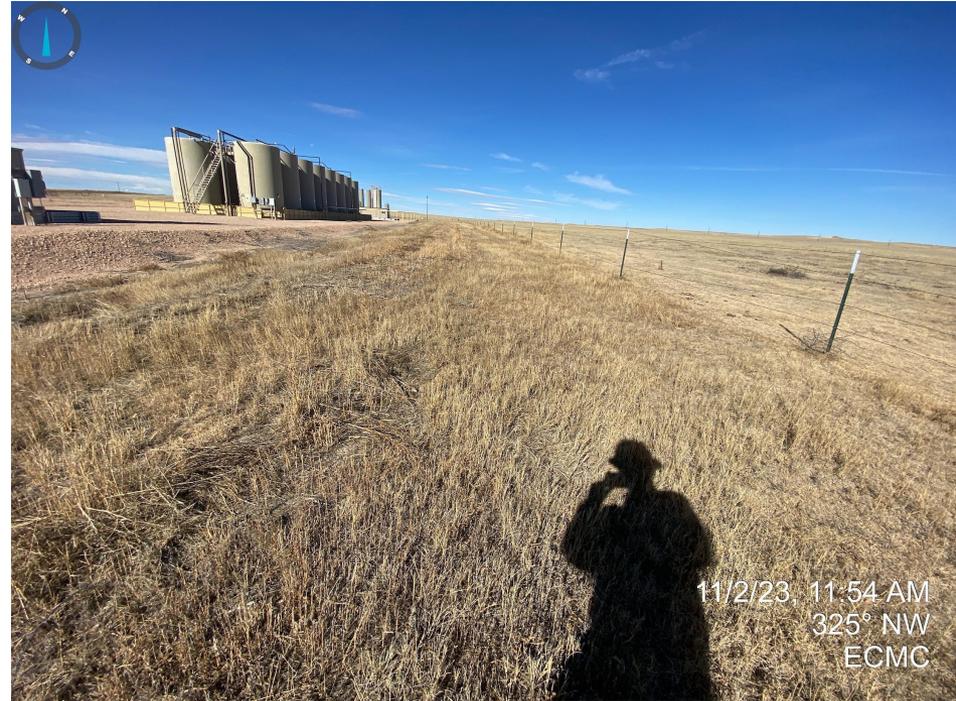
Photos 2 & 3. Taken from the southeast corner of the location. See comments in Photo 1.

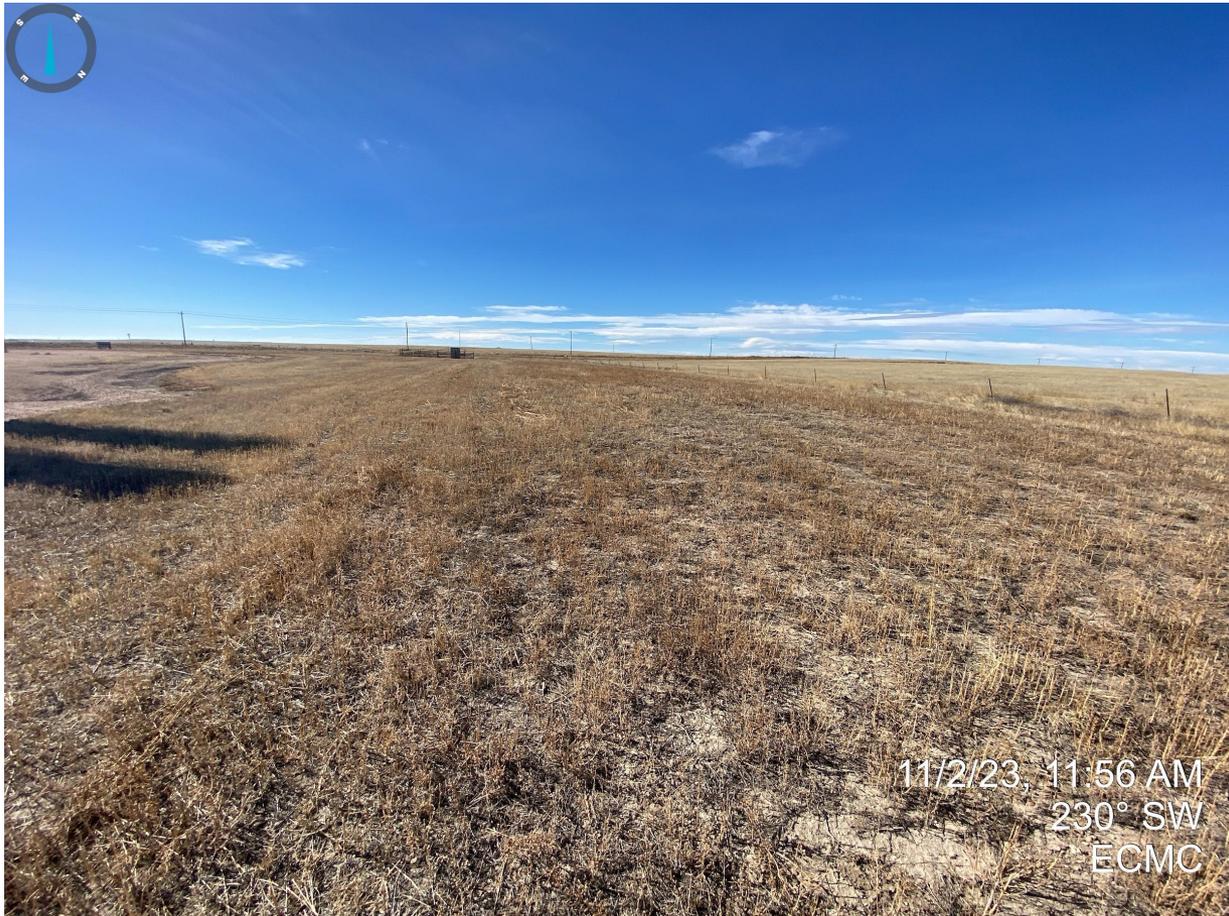
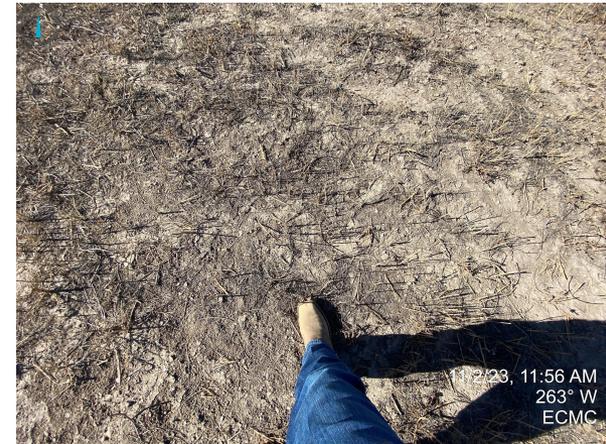
Photos 4 & 5. Taken from the northern/topsoil portion of the location. The topsoil is not properly stabilized with evidence of non-uniform vegetative cover resulting in bare/exposed soil. Additionally, the predominant vegetative cover is undesirable vegetation (e.g. russian thistle and kochia).

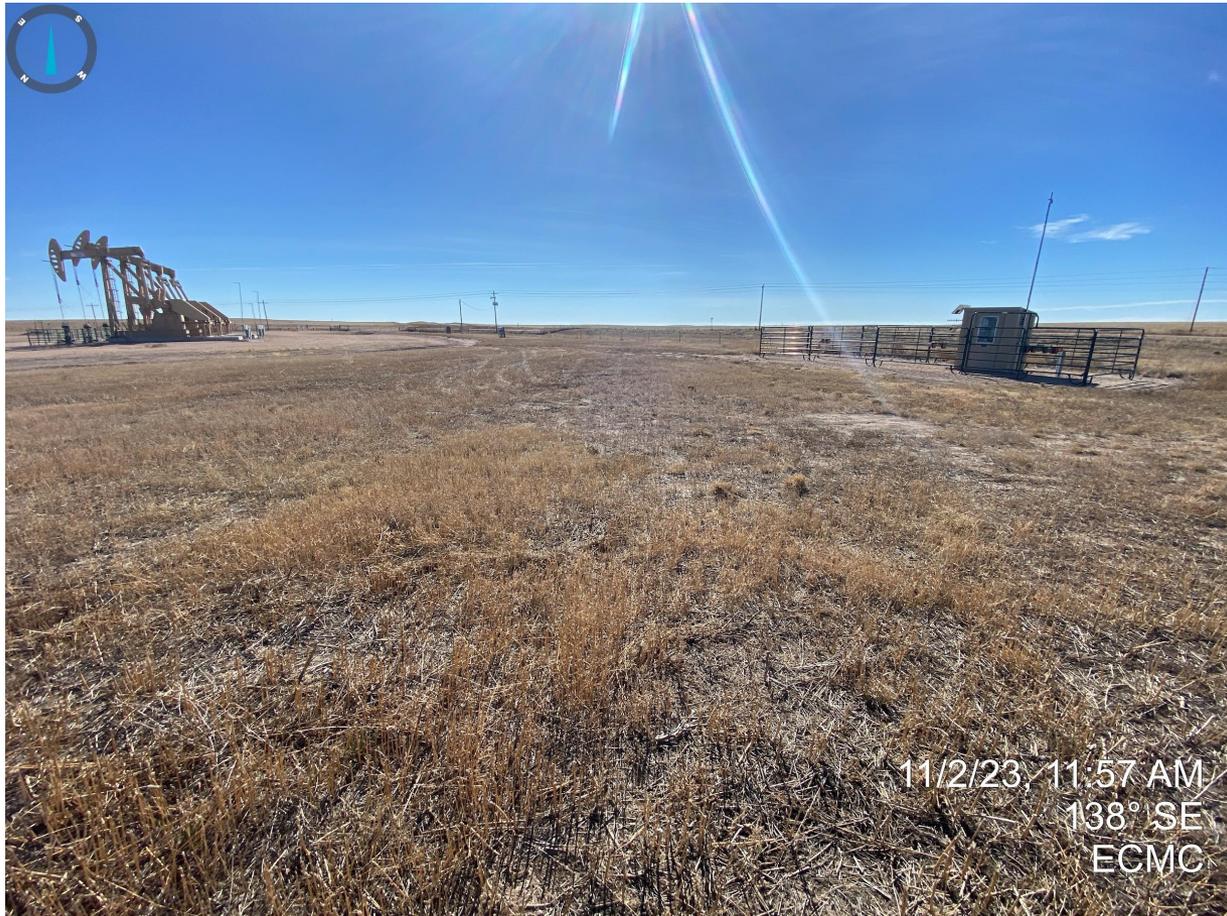
Photo 6. Taken from the northwestern corner of the location. See comments in Photo 1.
