Inspection Photos

Loc: 322241

Operator: **INCREMENTAL OIL & GAS (FLORENCE) LLC**

Inspection Date: 11/08/2023

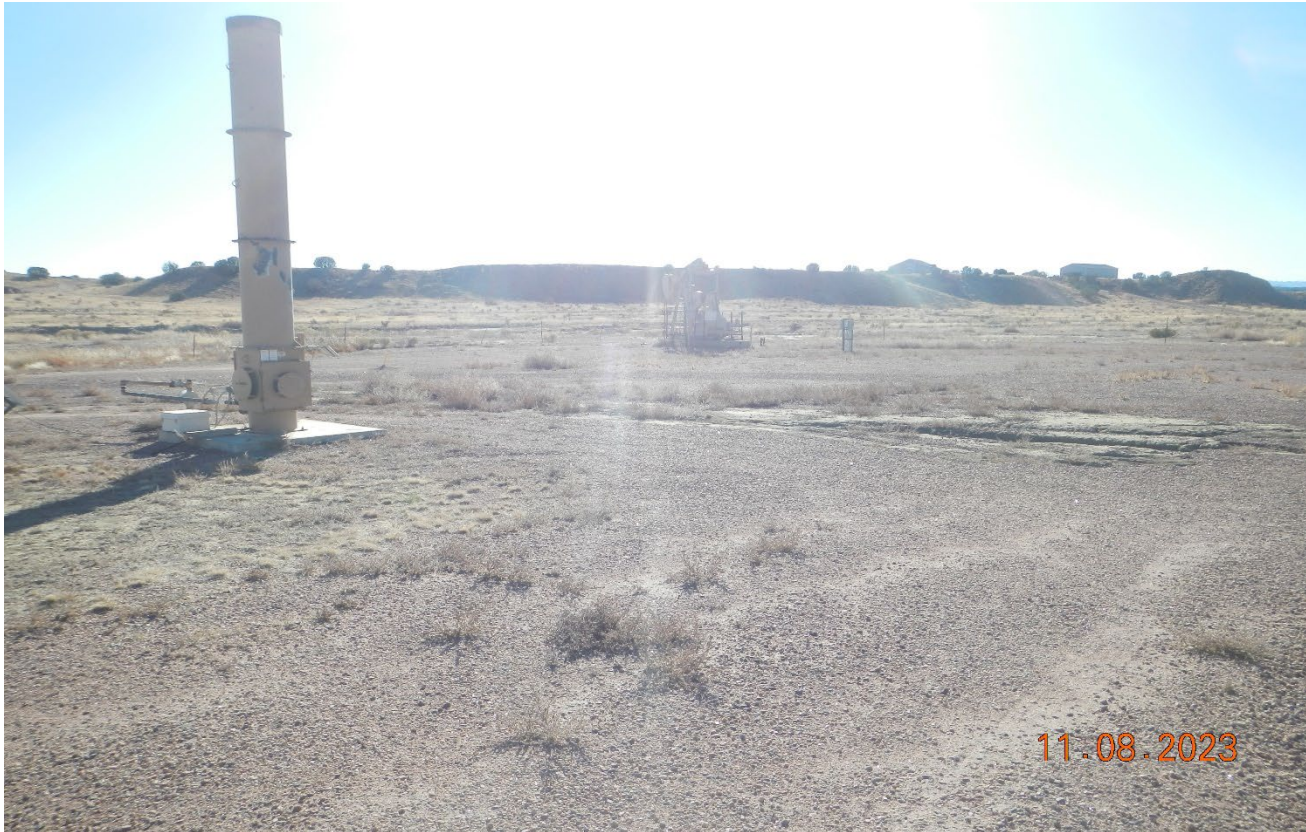
Photo 1. Facing southeast toward the wellsite location.

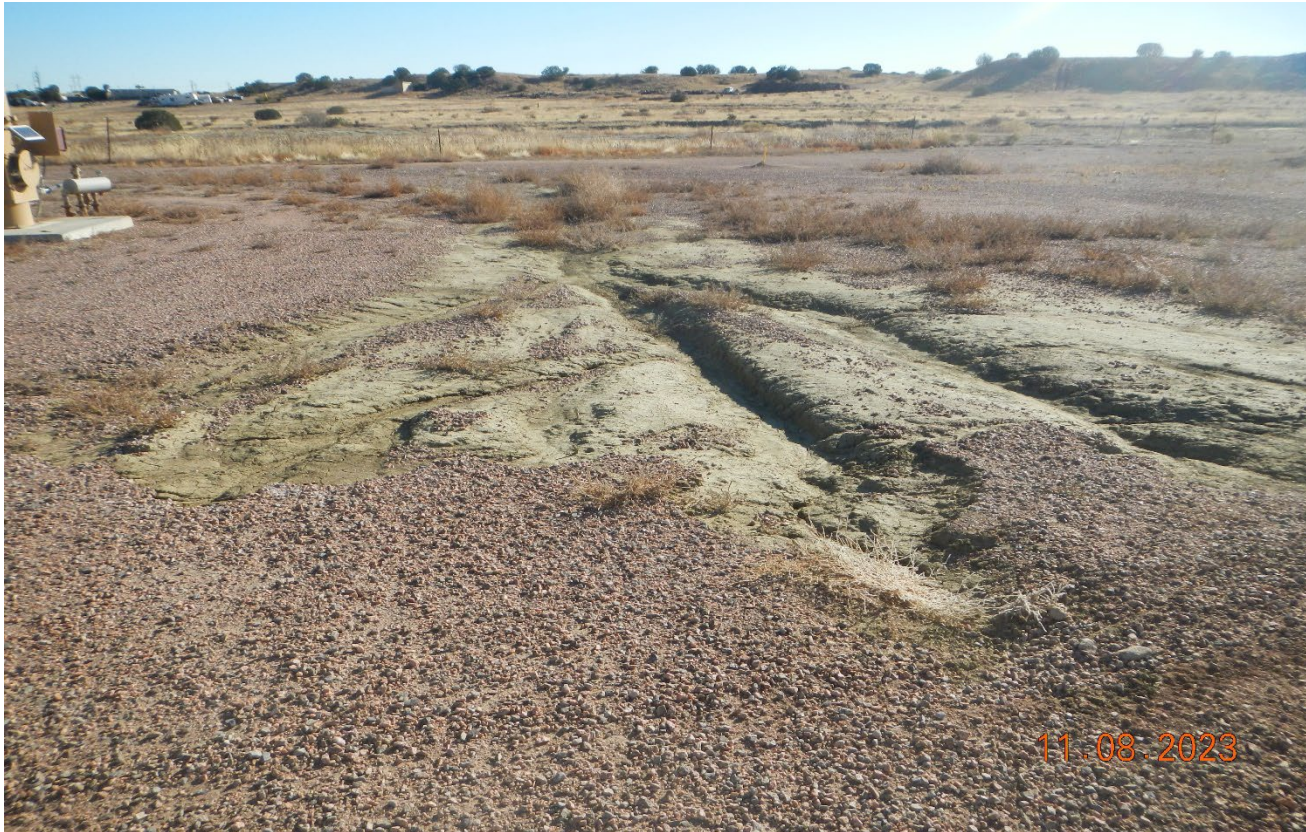
Photo 2. Facing east by the separator. There is erosion along this area of the location that needs to be repaired and stabilized.

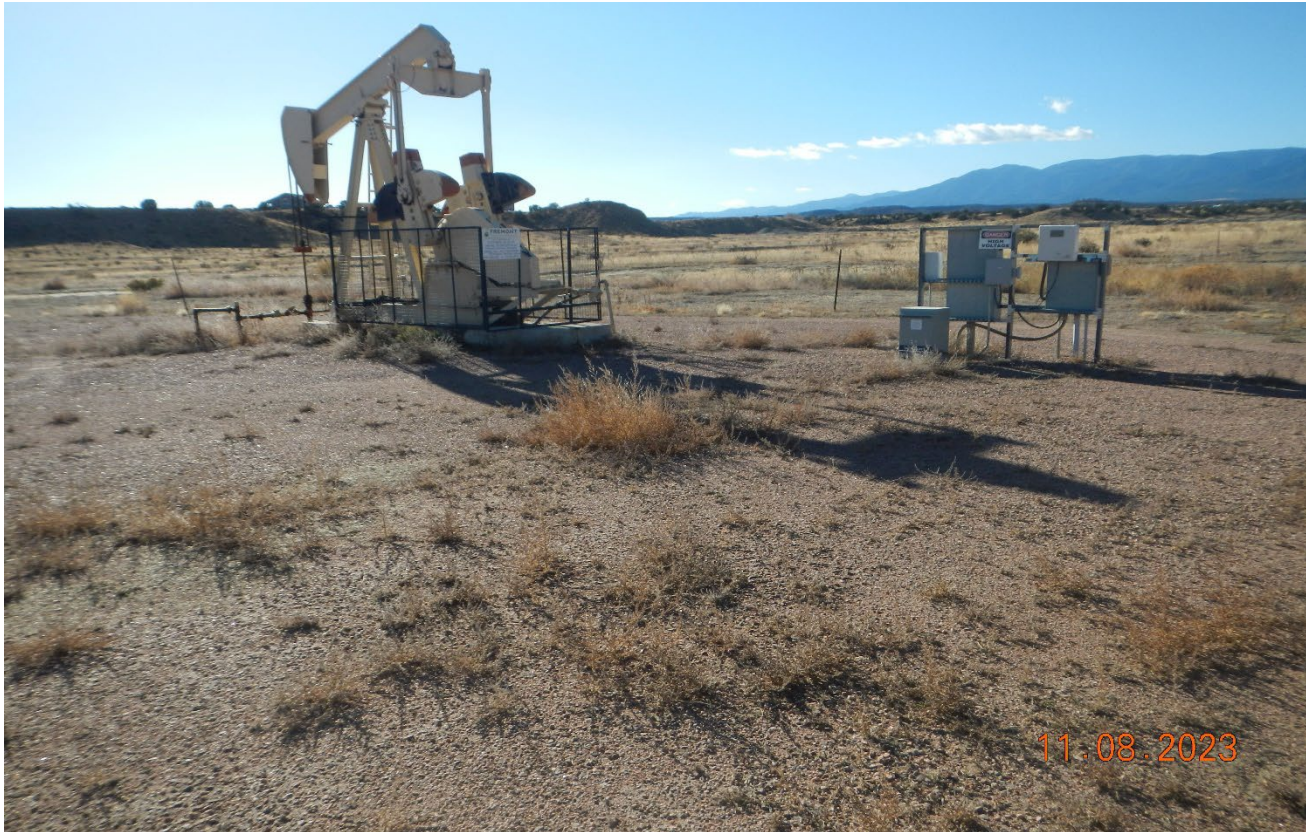
Photo 3. Facing southeast toward the wellhead.

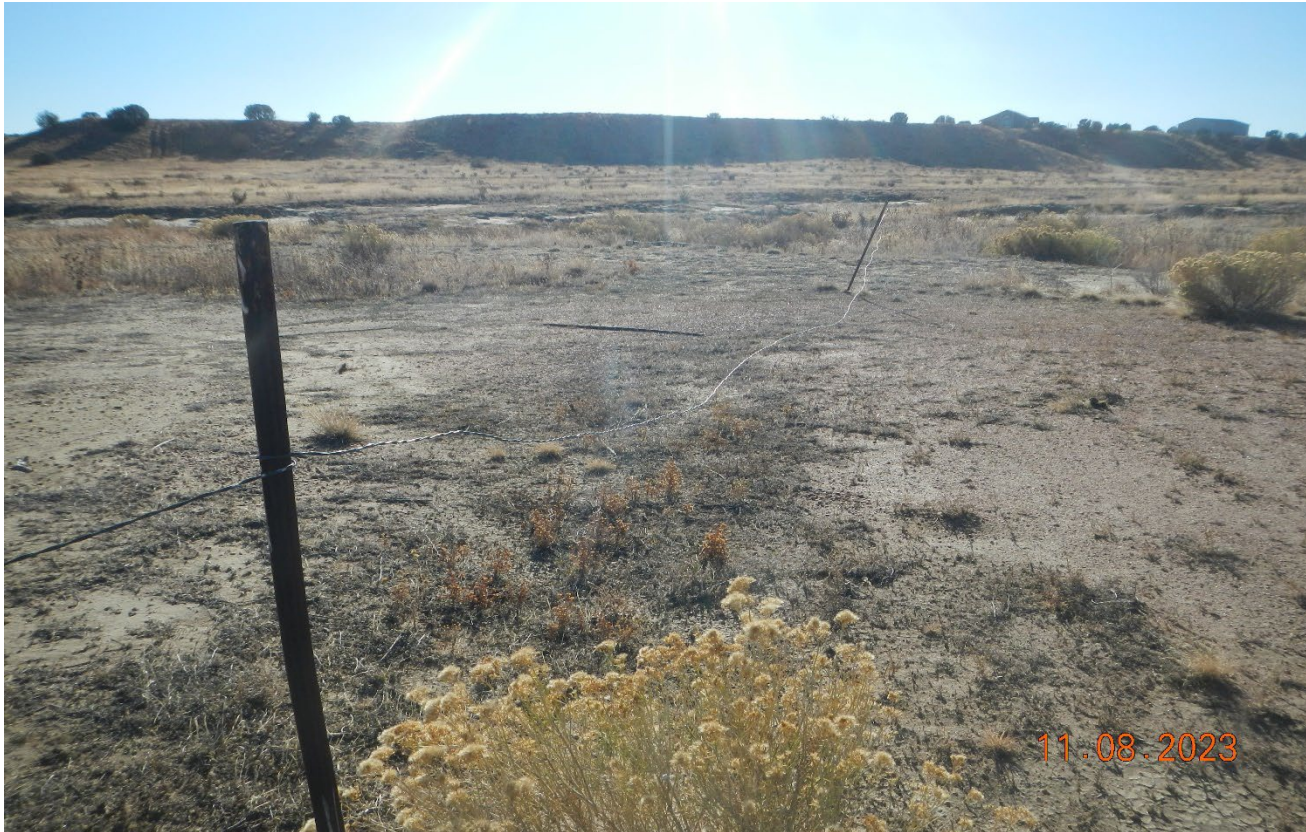
Photo 4. There is a one wire fence at the location which is not maintained and is not highly visible and could pose a collision hazard..
