# SITE-SPECIFIC QUALITY ASSURANCE & QUALITY CONTROL AUDIT

## PERMIT CLOSURE REPORT – RANGELAND

Location ID 319214

Location Name Champlin 1-9 Pad

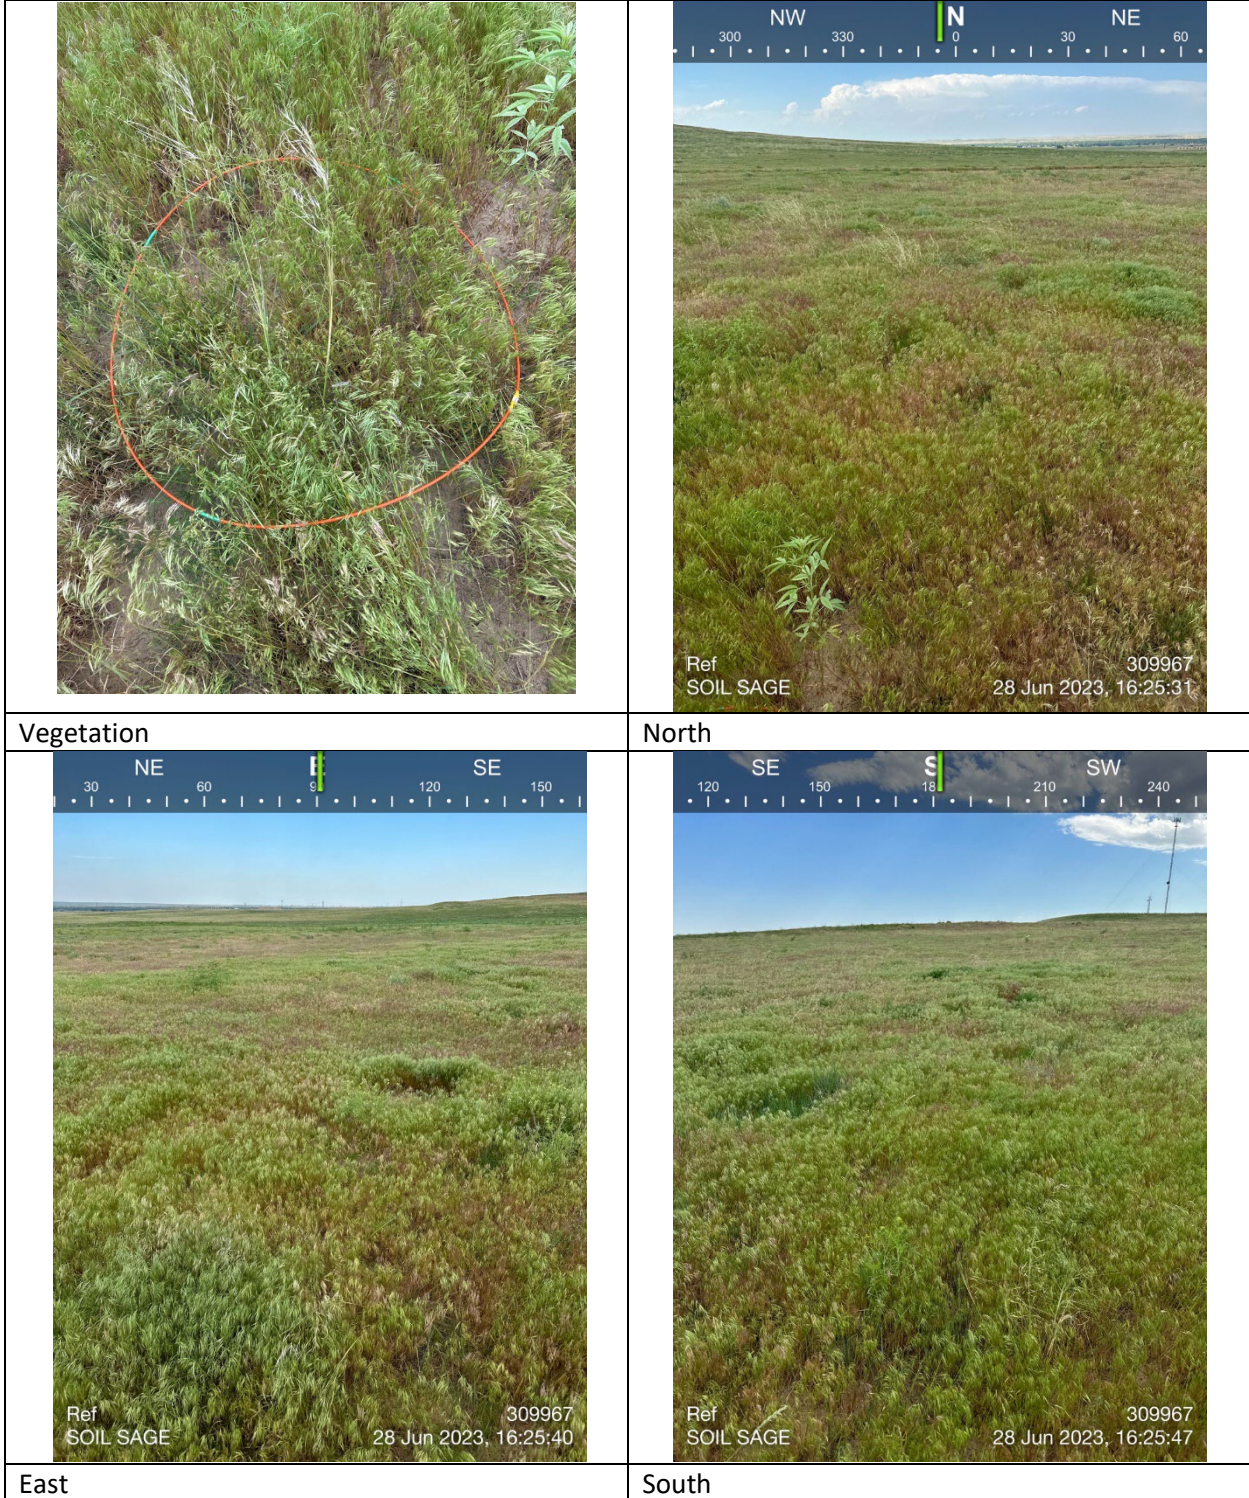
40.324421 / -104.436544

Percent cover is determined using random sampling methods within the vegetation extent and using a sampling hoop of 0.5 sq meters in size.

Common Name	Scientific Name	Percentage
Winter Fat	<i>Krascheninnikovia lanata</i>	20
Mustard (Could be tansy mustard)	<i>Sisymbrium spp.</i>	10
Grasses	<i>Genus poaceae</i>	5

Common Name	Scientific Name	Percentage
Cheatgrass	<i>Bromus tectorum</i>	30
Russian Thistle	<i>Salsola tragus</i>	10

Due to the presence of weeds in the reference extent that exceeds the percentage of observed weeds in the reclaim extent, continuous impact to the reclaim extent is likely. Control of cheatgrass and Russian thistle will be unsuccessful.

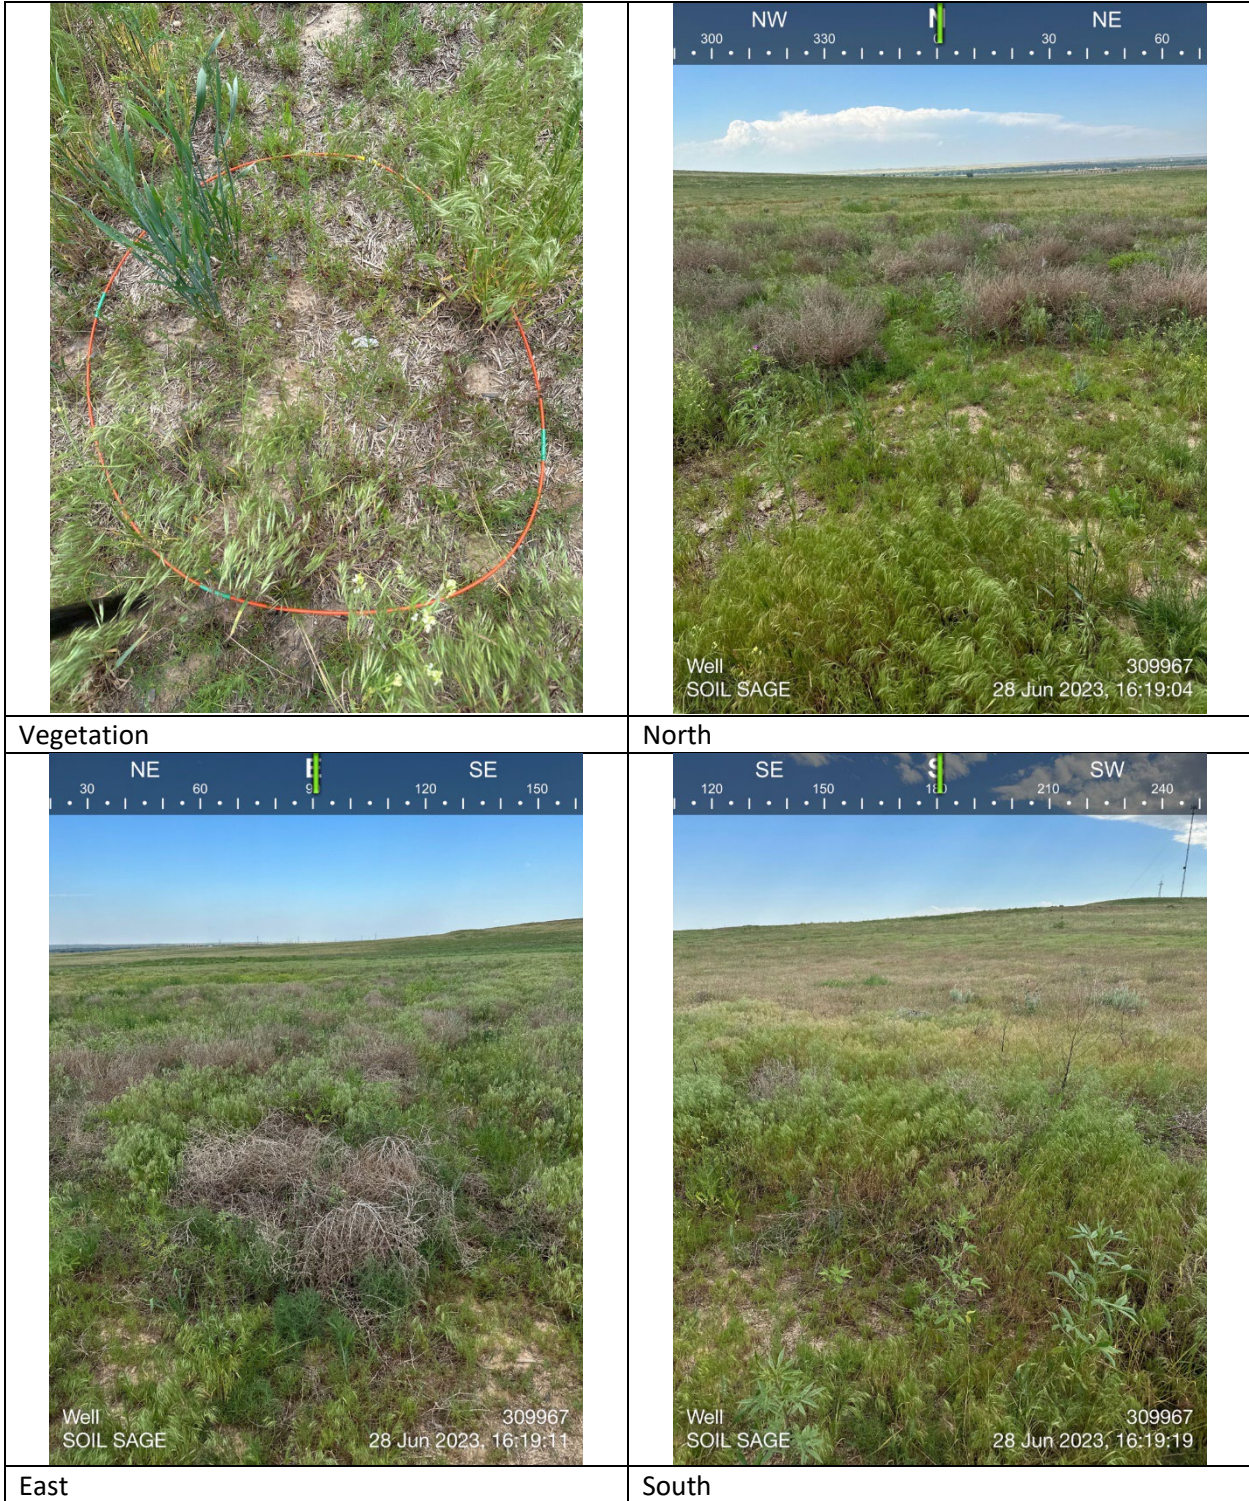
40.32463 / -104.436144

Common Name	Scientific Name	Percentage
Wheat	<i>Triticum spp.</i>	30

Common Name	Scientific Name	Percentage
Russian Thistle	<i>Salsola tragus</i>	-
Cheatgrass	<i>Bromus tectorum</i>	-

These species are in the area – litter indicates last year's Russian Thistle debris

Recommend for this site for closure.

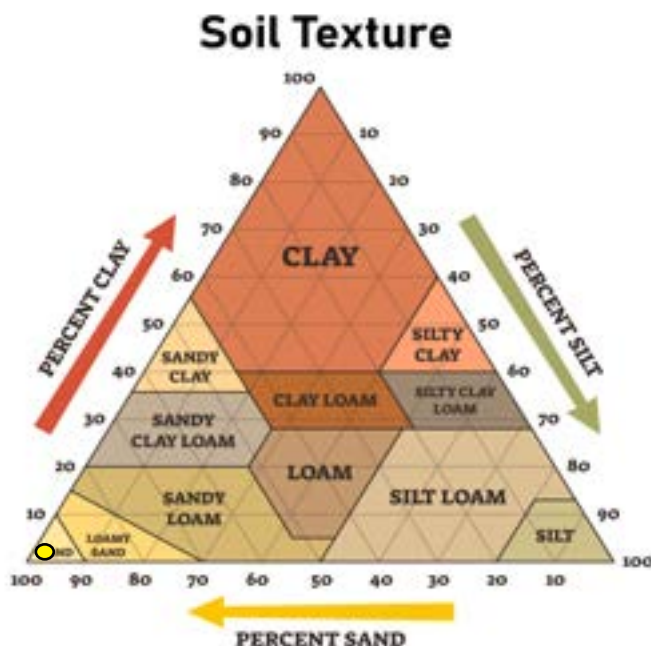
### Soil Texture Triangle reflect the 0-10 in depth

The location of the site is contained within one soil type, Valent sand.

This soil is formed from noncalcareous eolian sands. Landform is hills, dunes, with the Deep Sand Ecological Site. Soils are excessively drained with a very low water holding capacity, and slope 3-9 percent.
