SITE-SPECIFIC QUALITY ASSURANCE & QUALITY CONTROL AUDIT

PERMIT CLOSURE REPORT – RANGELAND

Location ID 423225

Location Name State Whitetail 44-1

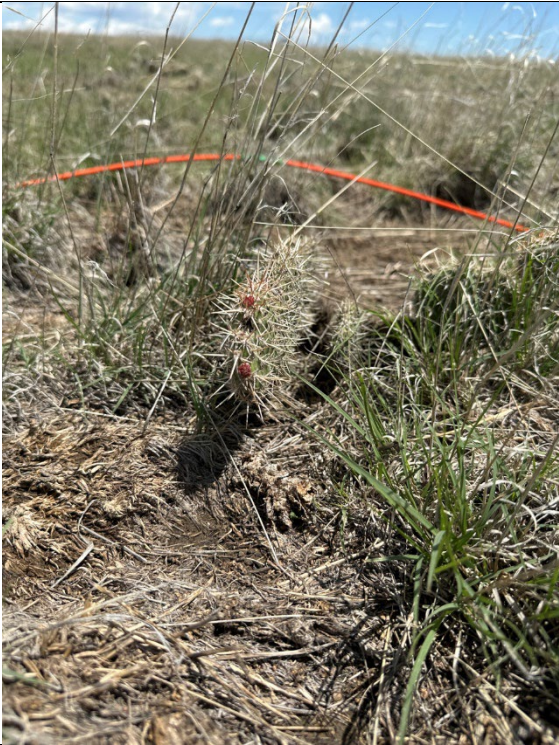
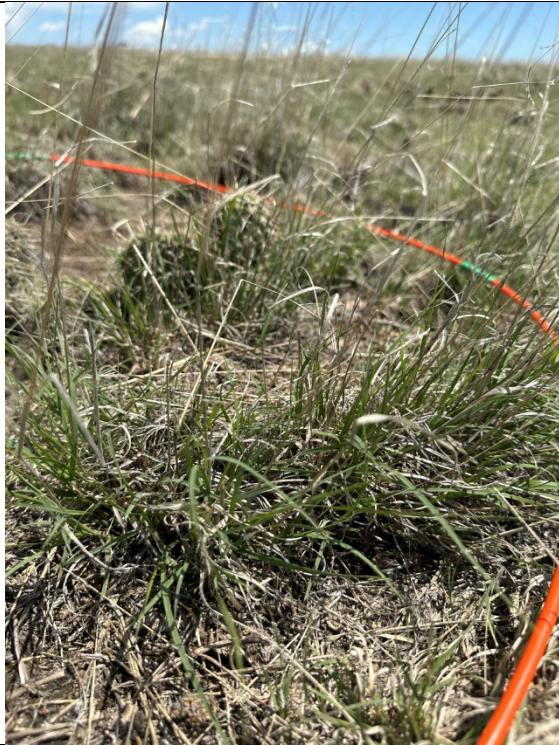
Native or Endemic

Prickly Pear Cactus – <i>Opuntia</i> spp. and Needle and Thread – <i>Hesperostipa comata</i>	Needle and Thread – <i>Hesperostipa comata</i>

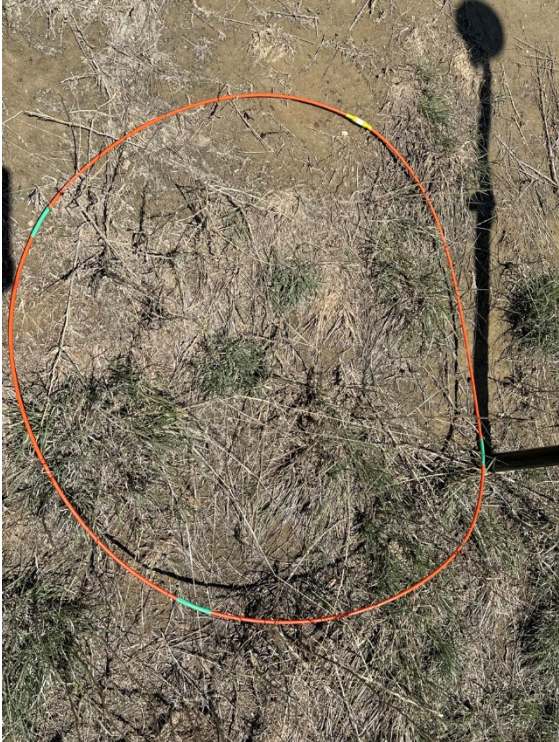
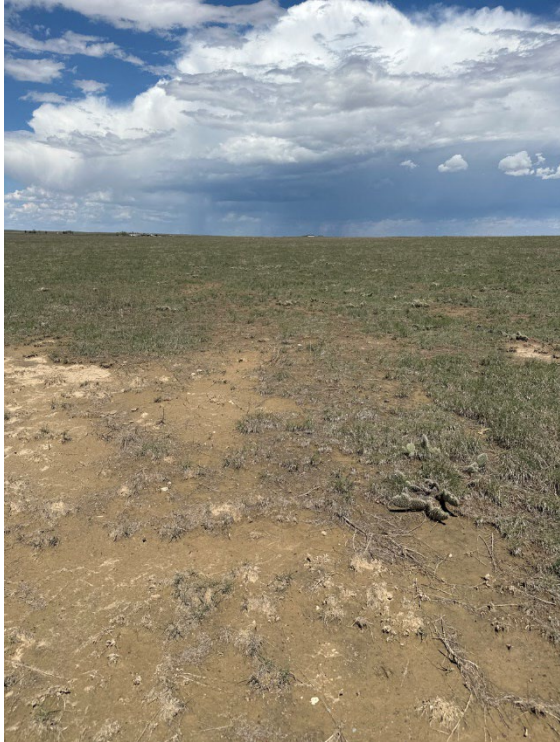
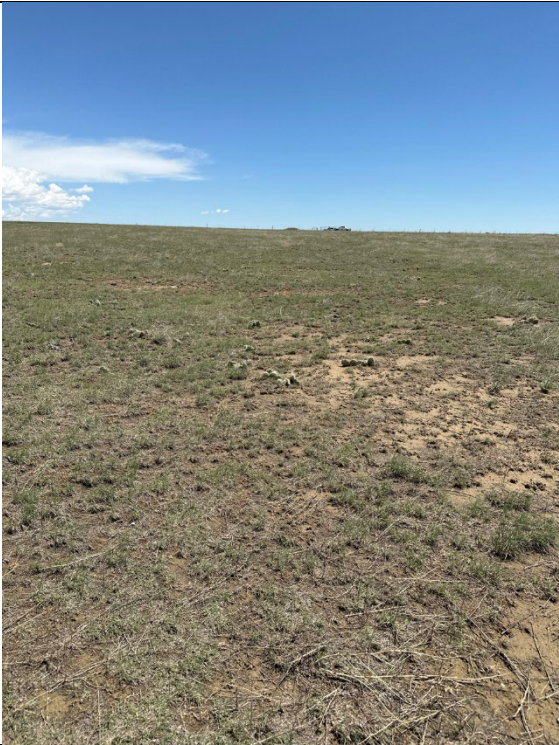
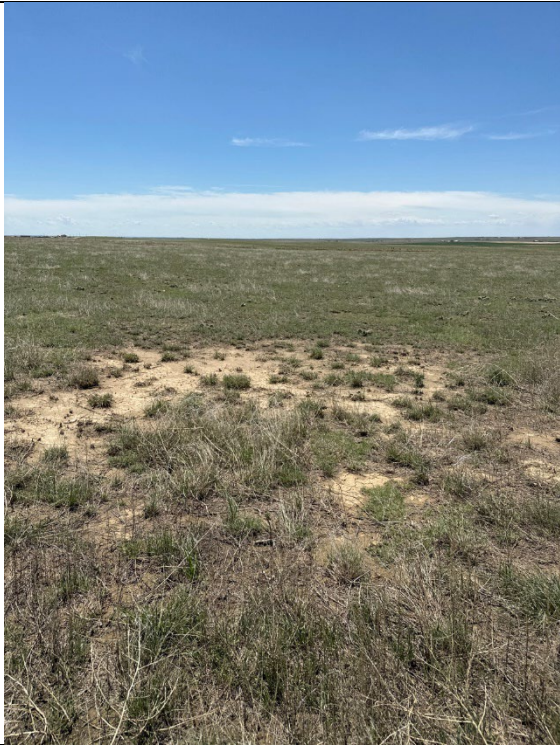
Recovery – Well Pad

Observation Point	Bare Ground	Grass	Forbs	Shrubs	Litter	Weeds	Field Notes
Well Recovery	40	25	0	0	35	0	Pad area has ant hills and cactus. It is similar to surrounding bare areas.
Road Recovery	40	20	20	0	20	0	Forbs are cactus
Reference	10	30	20	0	40	0	Dry, low veg, and cactus

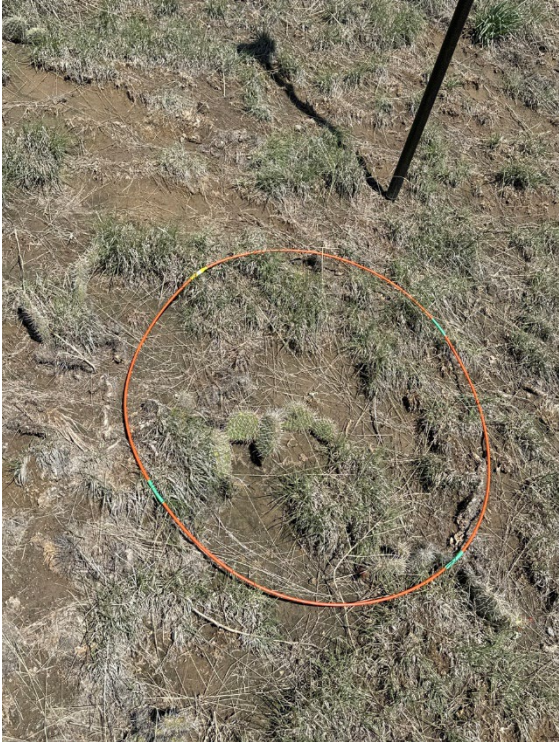
Recovery – Access Road

A close-up photograph of the soil sage vegetation. A circular area is highlighted with a red and green border, showing a dense cluster of green, needle-like plants growing in a sandy, brown soil. A black pole is visible in the upper right corner of the frame.

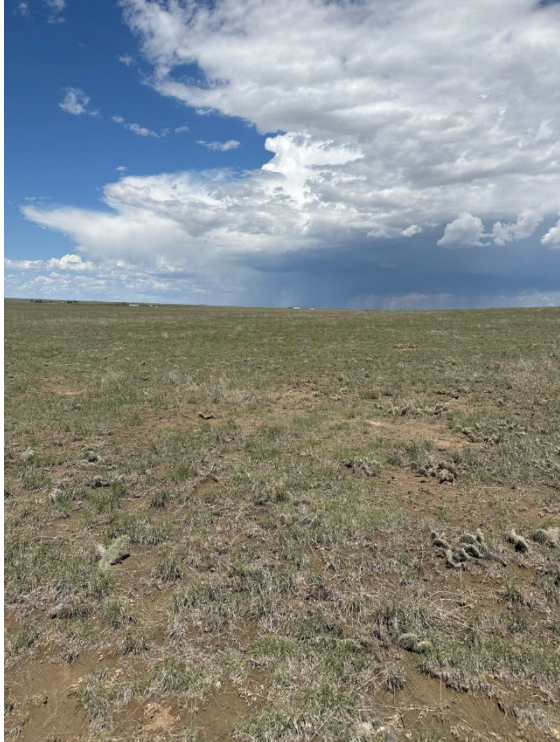
A wide-angle photograph looking north across a flat, open field. The ground is covered with sparse, low-lying green vegetation and patches of brown soil. The horizon is flat, and the sky is blue with scattered white clouds.
Vegetation	North

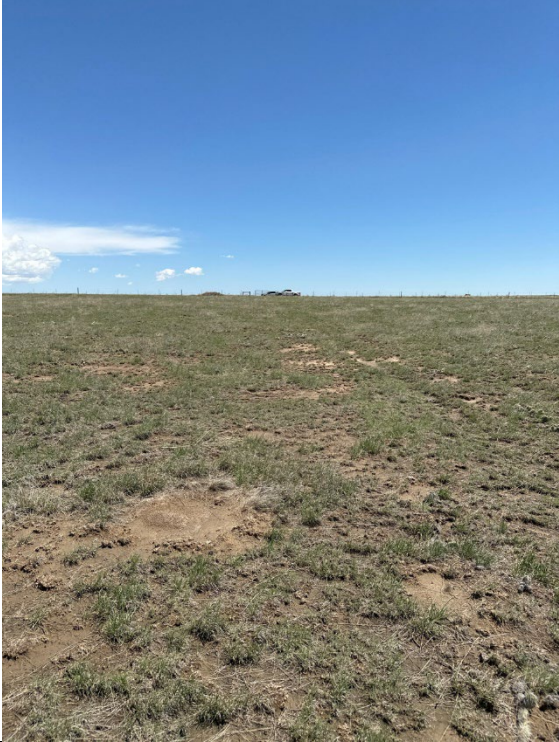
A wide-angle photograph looking east across the field. The terrain is flat with sparse green vegetation and brown soil. In the distance, a few small structures and a fence line are visible on the horizon under a clear blue sky.

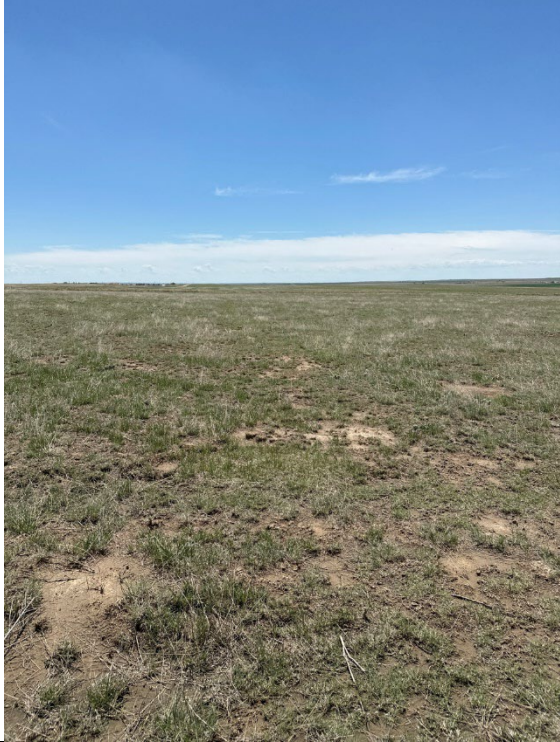
A wide-angle photograph looking south across the field. The landscape is flat with sparse green vegetation and brown soil. The horizon is flat, and the sky is blue with a few wispy clouds.

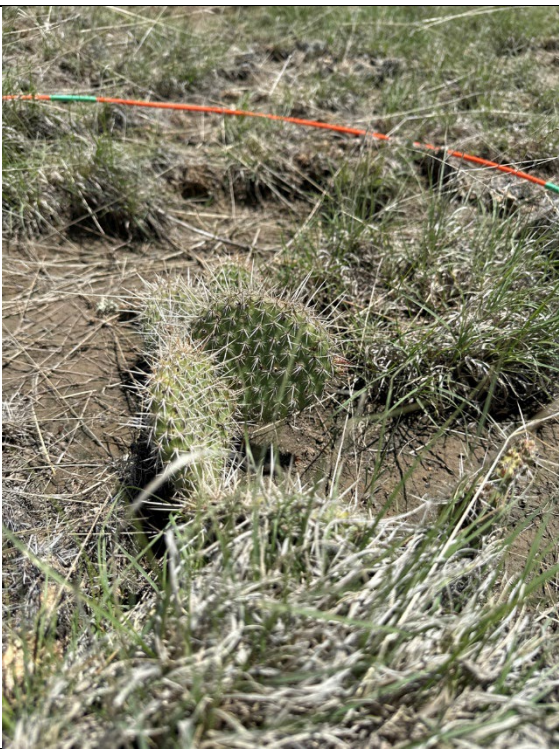
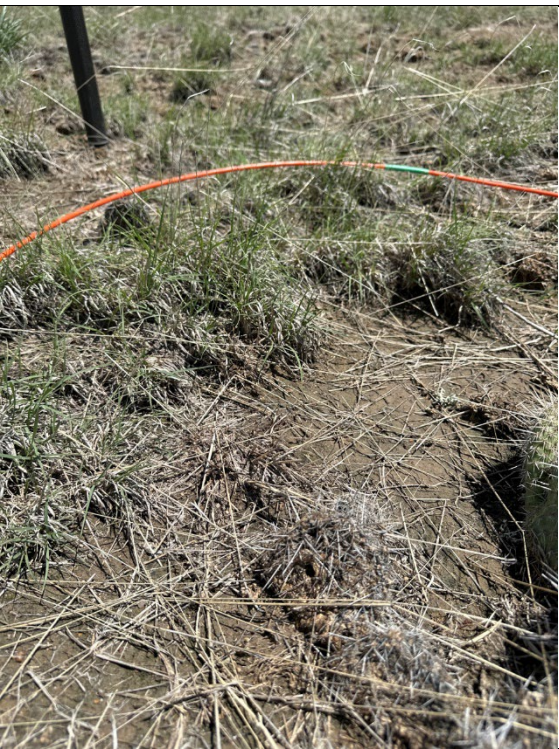
Native or Endemic

Prickly Pear Cactus – <i>Opuntia</i> spp.	Needle and Thread – <i>Hesperostipa comata</i>

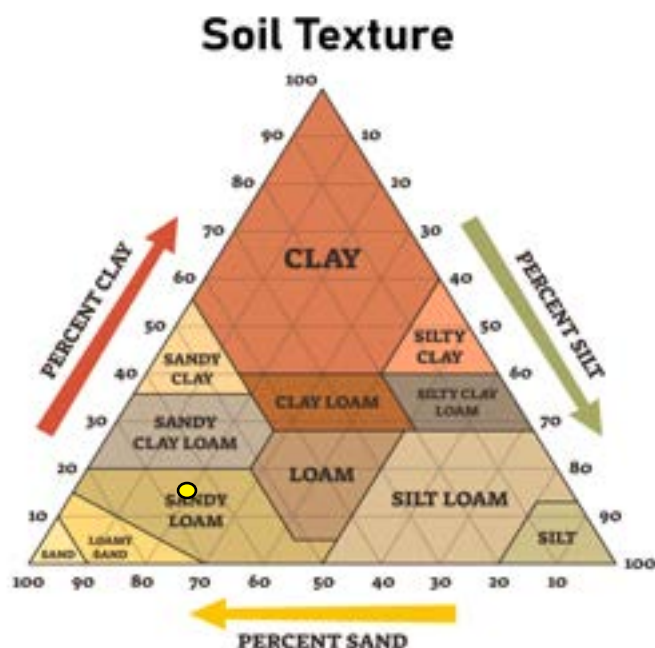
Soil Texture Triangle reflect the 0-10 in depth

This soil is formed from mixed deposit outwash. Landform is plains, with the Sandy Plains Ecological Site. Soils are well drained with a moderate water holding capacity, and slope 1-3 percent.

Depth (in)	Physical			Chemical			
	Texture	Bulk Density	Partical Size Percent sand, silt, clay	pH	EC	SAR	OM%
0-10	Fine Sandy Loam	1.43	65-20-15	7.2	0.0	0.0	0.75
10-20	Sandy Clay Loam	1.33	56-17-27	7.2	0.0	0.0	0.75
20-30	Sandy Clay Loam	1.41	62-22-16	8.3	1.0	0.0	0.25
30-40	Fine Sandy Loam	1.50	64-26-10	8.5	1.0	0.0	0.25
40-50	Fine Sandy Loam	1.50	64-26-10	8.5	1.0	0.0	0.25
50 +	Fine Sandy Loam	1.50	64-26-10	8.5	1.0	0.0	0.25

- K Factor, Whole soil - .24. Values of K range from 0.02 to 0.69. Other factors being equal, the higher the value, the more susceptible the soil is to sheet and rill erosion by water.
- Wind Erodibility Group – 3. The soils assigned to group 1 are the most susceptible to wind erosion, and those assigned to group 8 are the least susceptible.

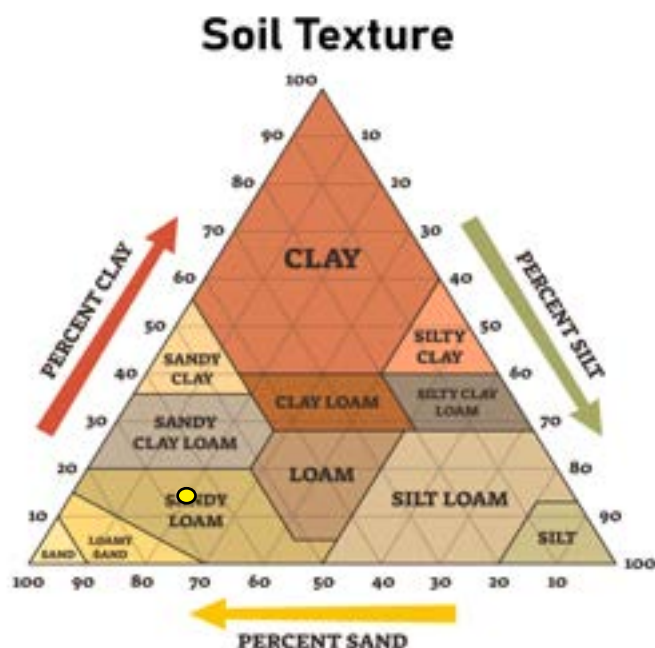
Soil Texture Triangle reflect the 0-10 in depth

This soil is formed from residuum weathered from sandstone. Landform is plains, with the Sandy Plains Ecological Site. Soils are well drained with a low water holding capacity, and slope 3-9 percent.

Depth (in)	Physical			Chemical			
	Texture	Bulk Density	Partical Size Percent sand, silt, clay	pH	EC	SAR	OM%
0-10	Fine Sandy Loam	1.43	66-20-14	7.2	0.0	0.0	1.05
10-20	Fine Sandy Loam	1.43	66-21-13	7.4	0.2	0.0	0.75
20-30	Fine Sandy Loam	1.43	63-26-11	8.2	1.0	0.0	0.75
30-40	Fine Sandy Loam	1.43	63-26-11	8.2	1.0	0.0	0.75
40-50	Weathered Bedrock						
50 +

- K Factor, Whole soil - .20. Values of K range from 0.02 to 0.69. Other factors being equal, the higher the value, the more susceptible the soil is to sheet and rill erosion by water.
- Wind Erodibility Group – 3. The soils assigned to group 1 are the most susceptible to wind erosion, and those assigned to group 8 are the least susceptible.
