# Final Reclamation Inspection

Operator: PDC ENERGY INC - 69175

Location ID: 331001

Inspection Photos  
Location Name: MATT-64N67W 24NWSW  
Location ID: 331001

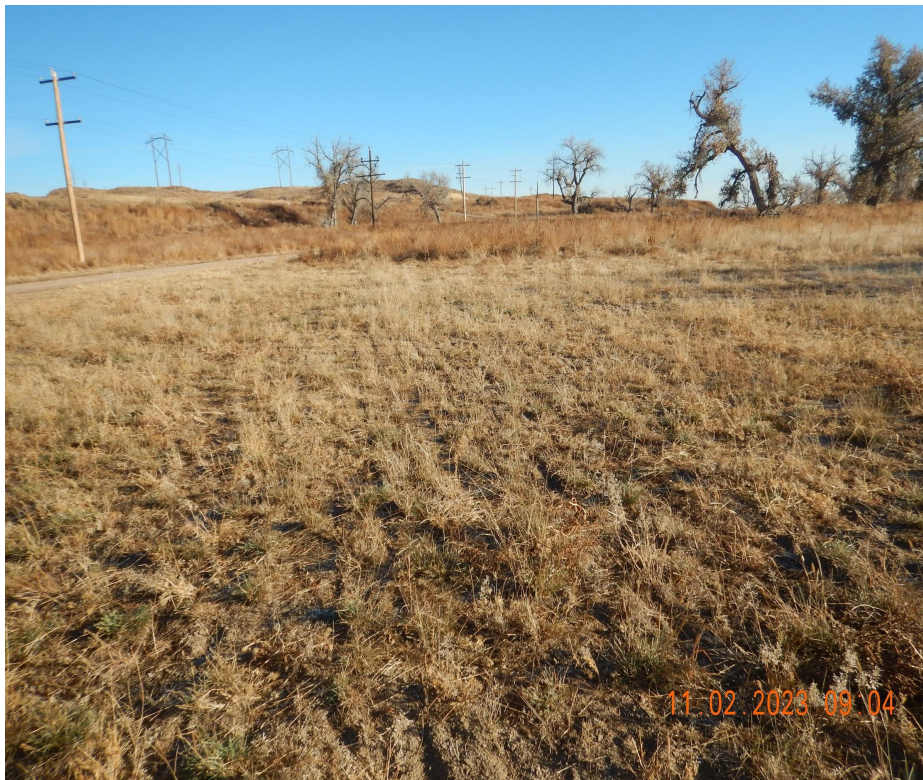
**Photo 1.** Photo taken from the off location tank battery, facing North. Photo illustrates the establishment of perennial vegetation, which has a higher percentage of perennial vegetation cover than the nearby reference areas.

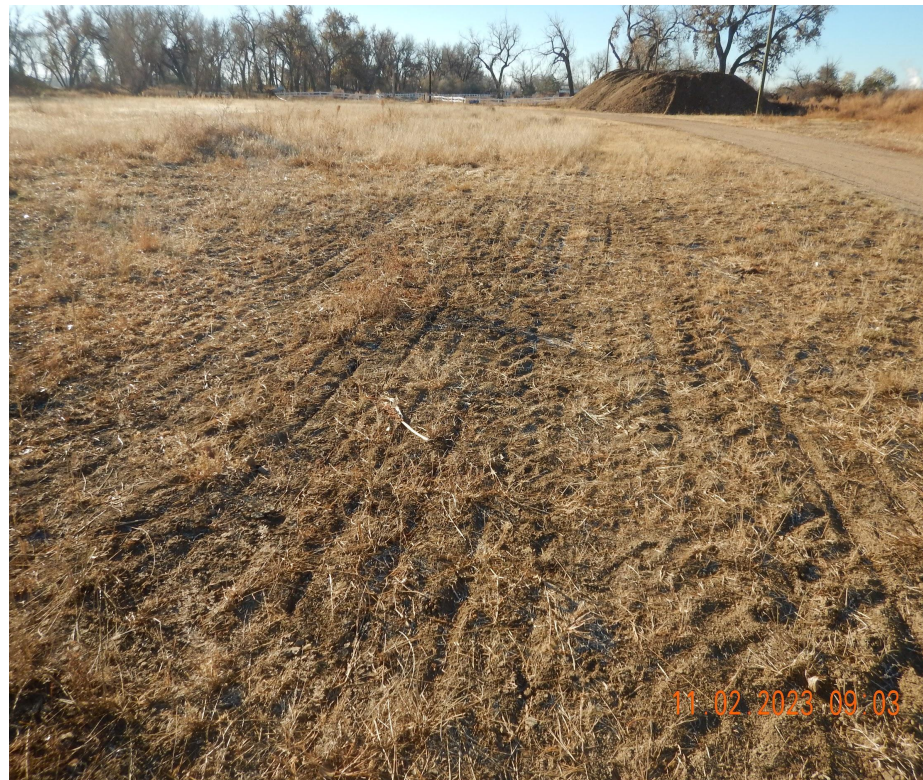
**Photo 2.** Photo taken from the off location tank battery, facing South. See comments under Photo 1.

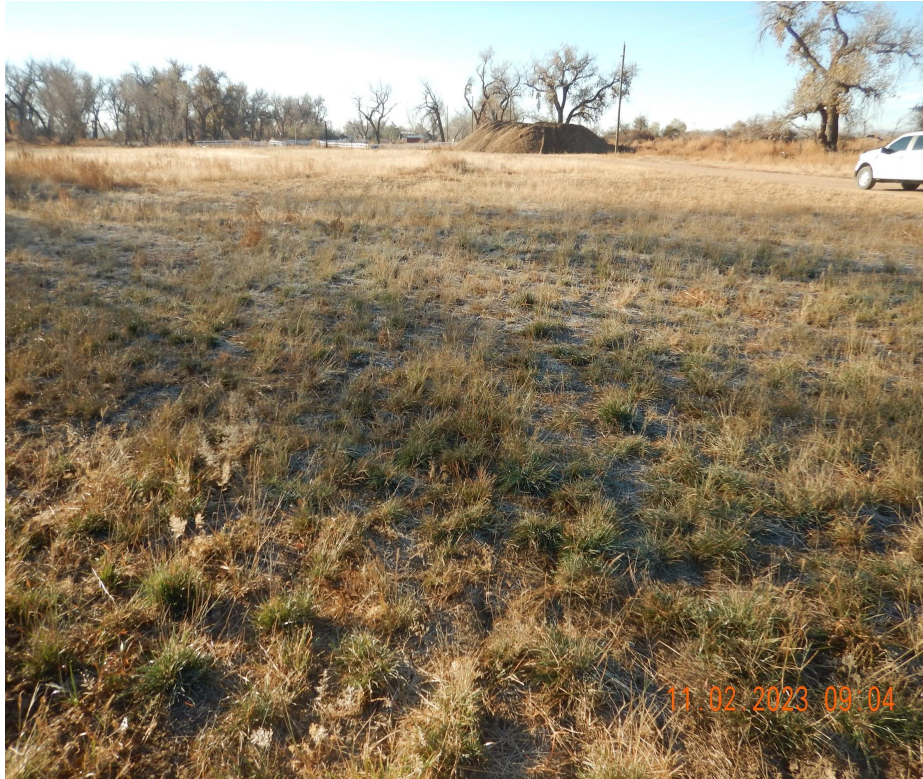
**Photo 3.** Photo taken from the off location tank battery, facing South. See comments under Photo 1.

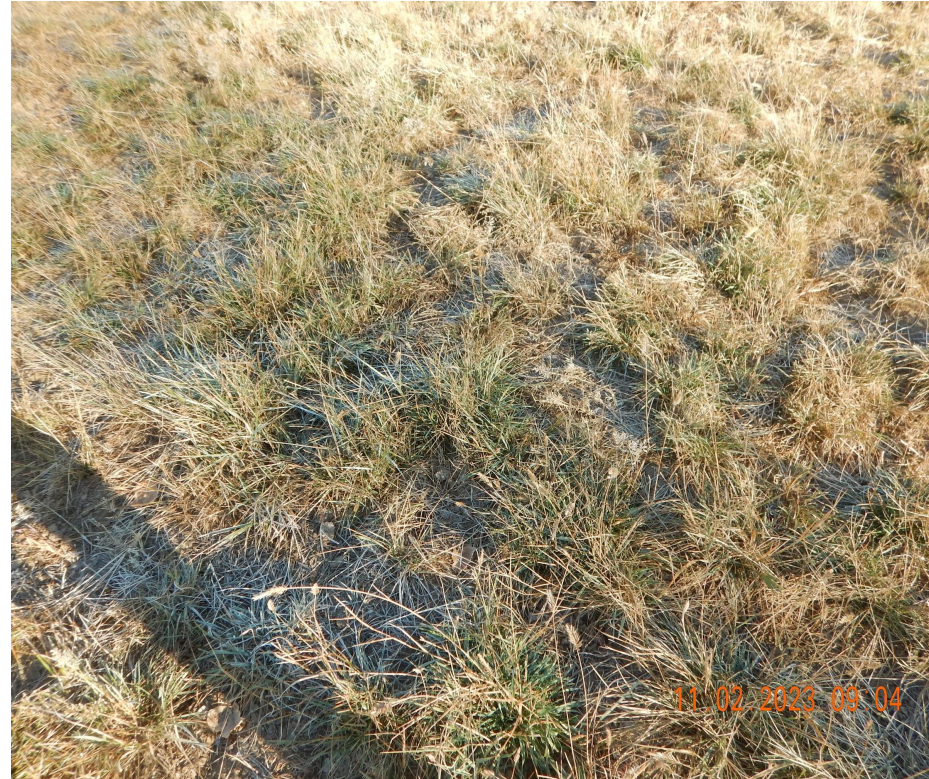
**Photo 4.** Close up photo taken from the off location tank battery. Photo illustrates the establishment of perennial vegetation.

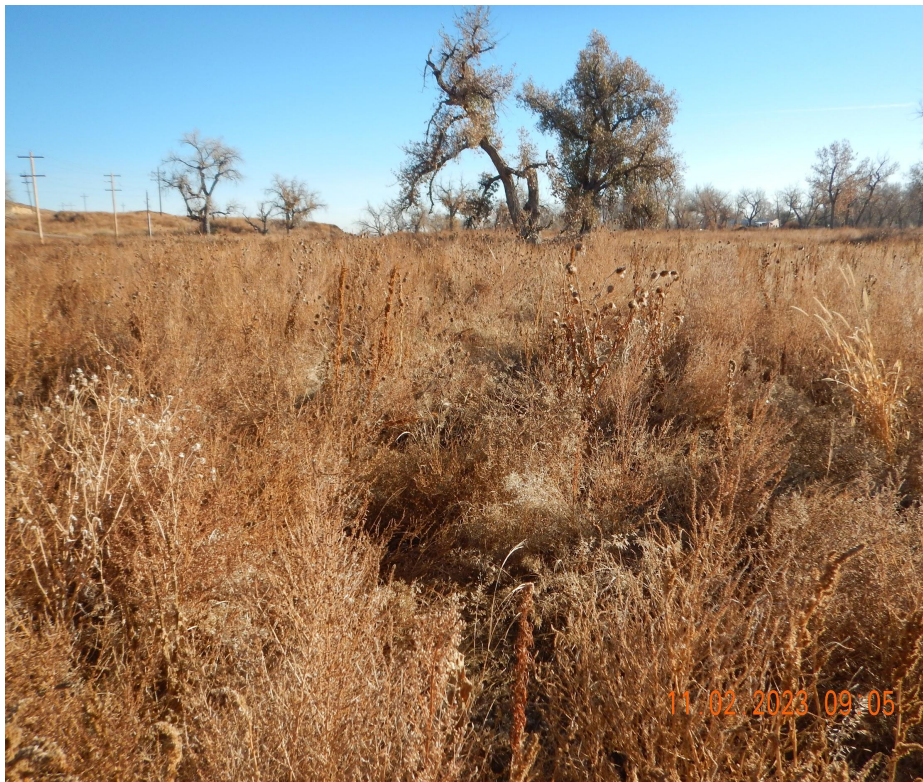
**Photo 5.** Reference photo taken just north of the off location tank battery, facing North. Photo illustrates a dominance of annual vegetation that appears to have established after a recent stormwater run-on evident.

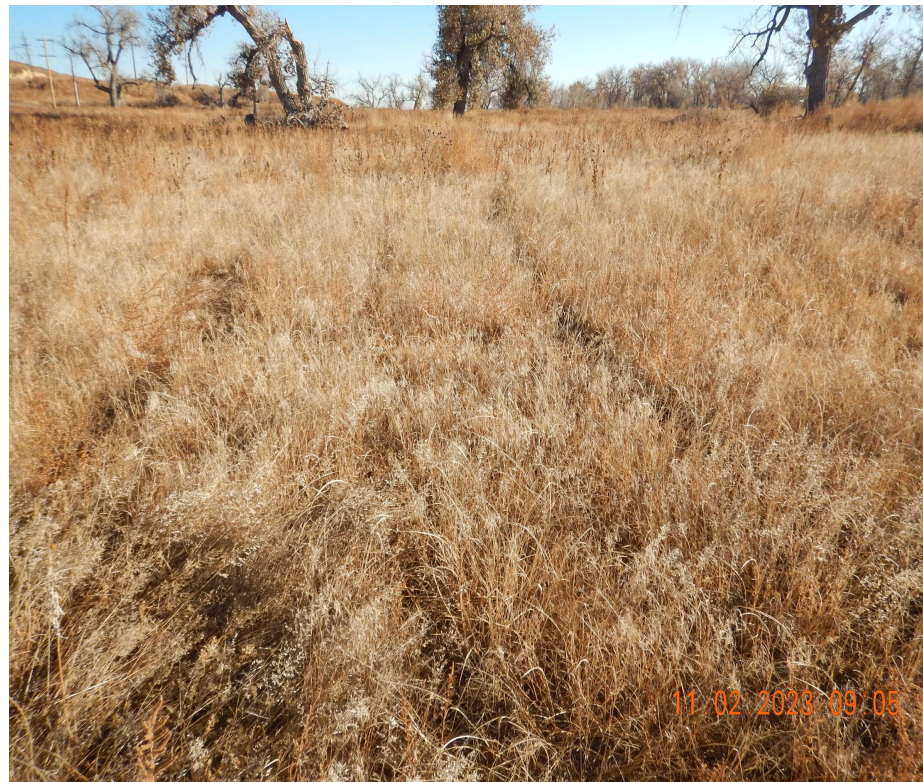
**Photo 6.** Another reference photo taken east of the off location tank battery, facing North. Photo illustrates a high density of cheatgrass mixed with sand dropseed.

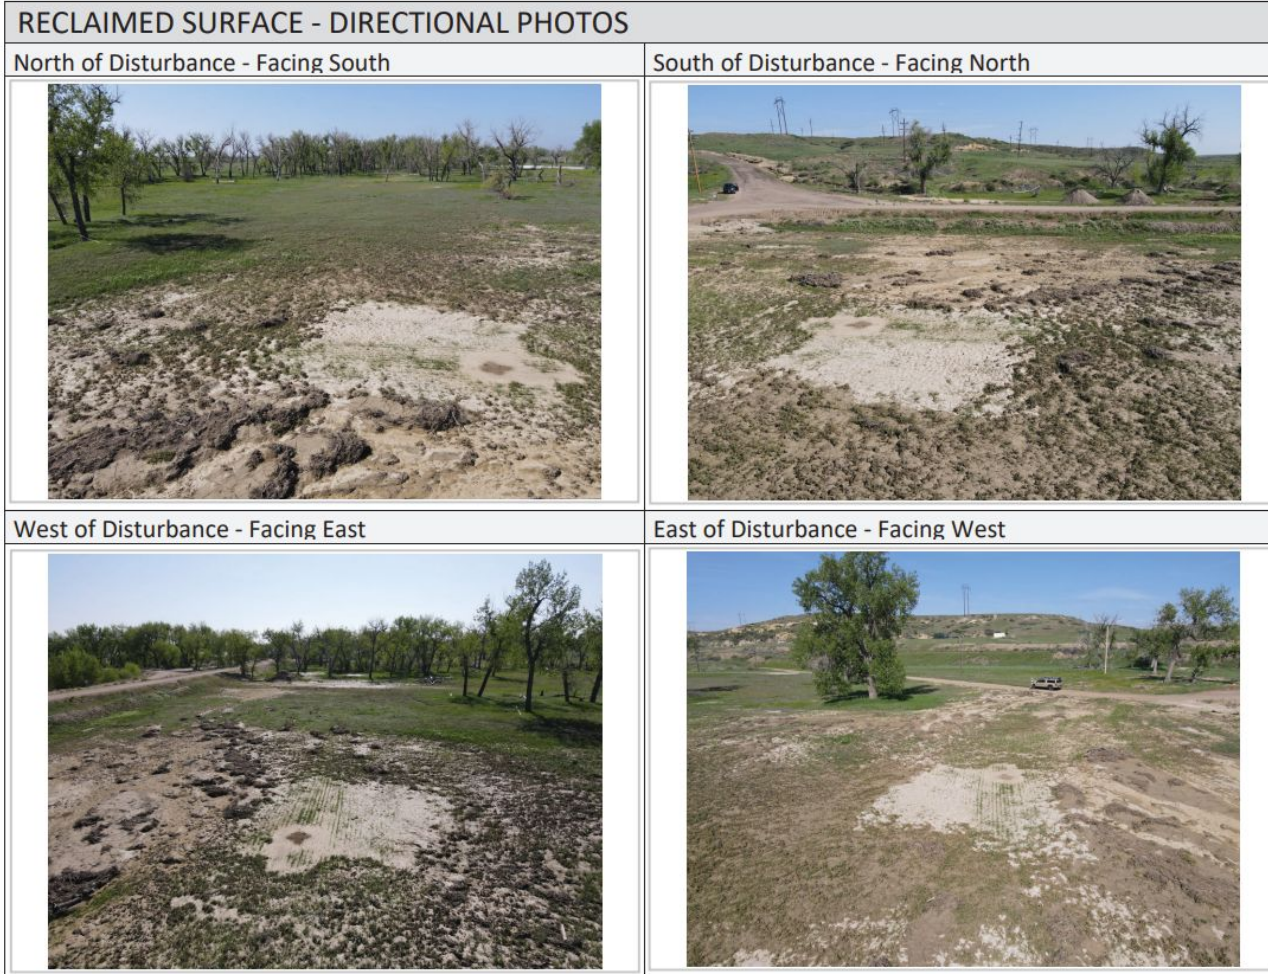
**Photo 7.** 2023 Operator supplied documentation of the wellhead. Subsidence was repaired in 2022 and is in process of establishing, as shown in the photos. The 2023 report noted continued subsidence even after the 2022 repairs and suggests additional repairs during sediment removal from a stormwater run-on event.
