Final Reclamation Inspection

Operator: Arkoma Operations LLC - 10766

Location ID: 333602

Inspection Photos
Location Name: Olson Smith Unit 1
Location ID: 333602

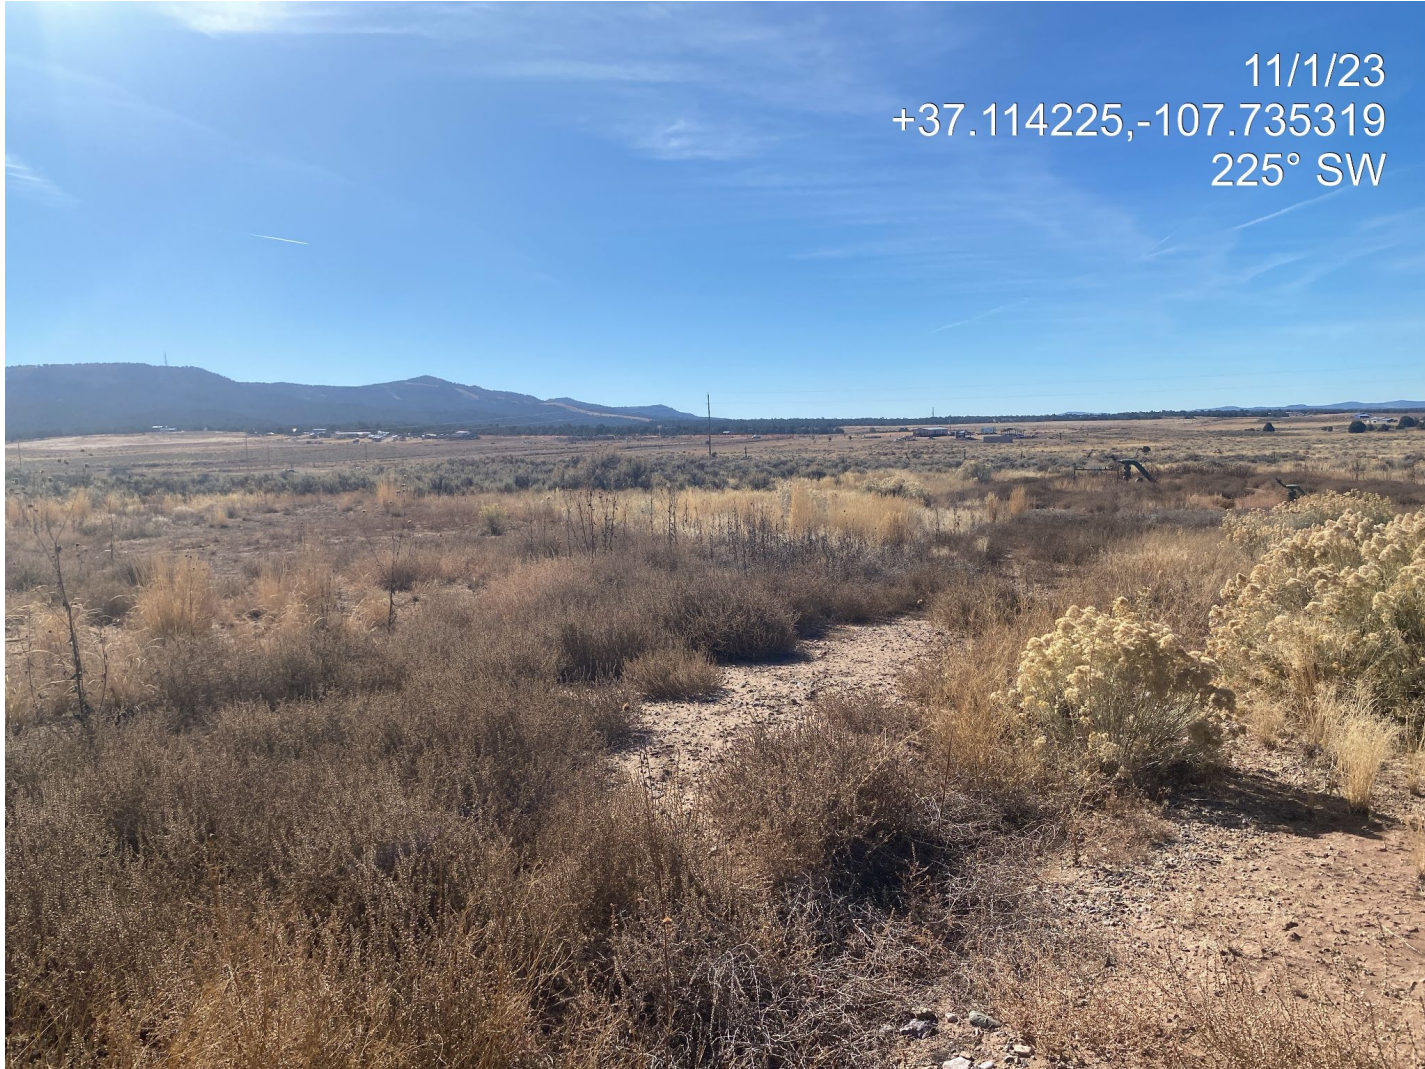
Photo 1. View of the project area taken from the entrance facing center.
Note: project area is dominated by undesirable plant species including cheatgrass and russian thistle.

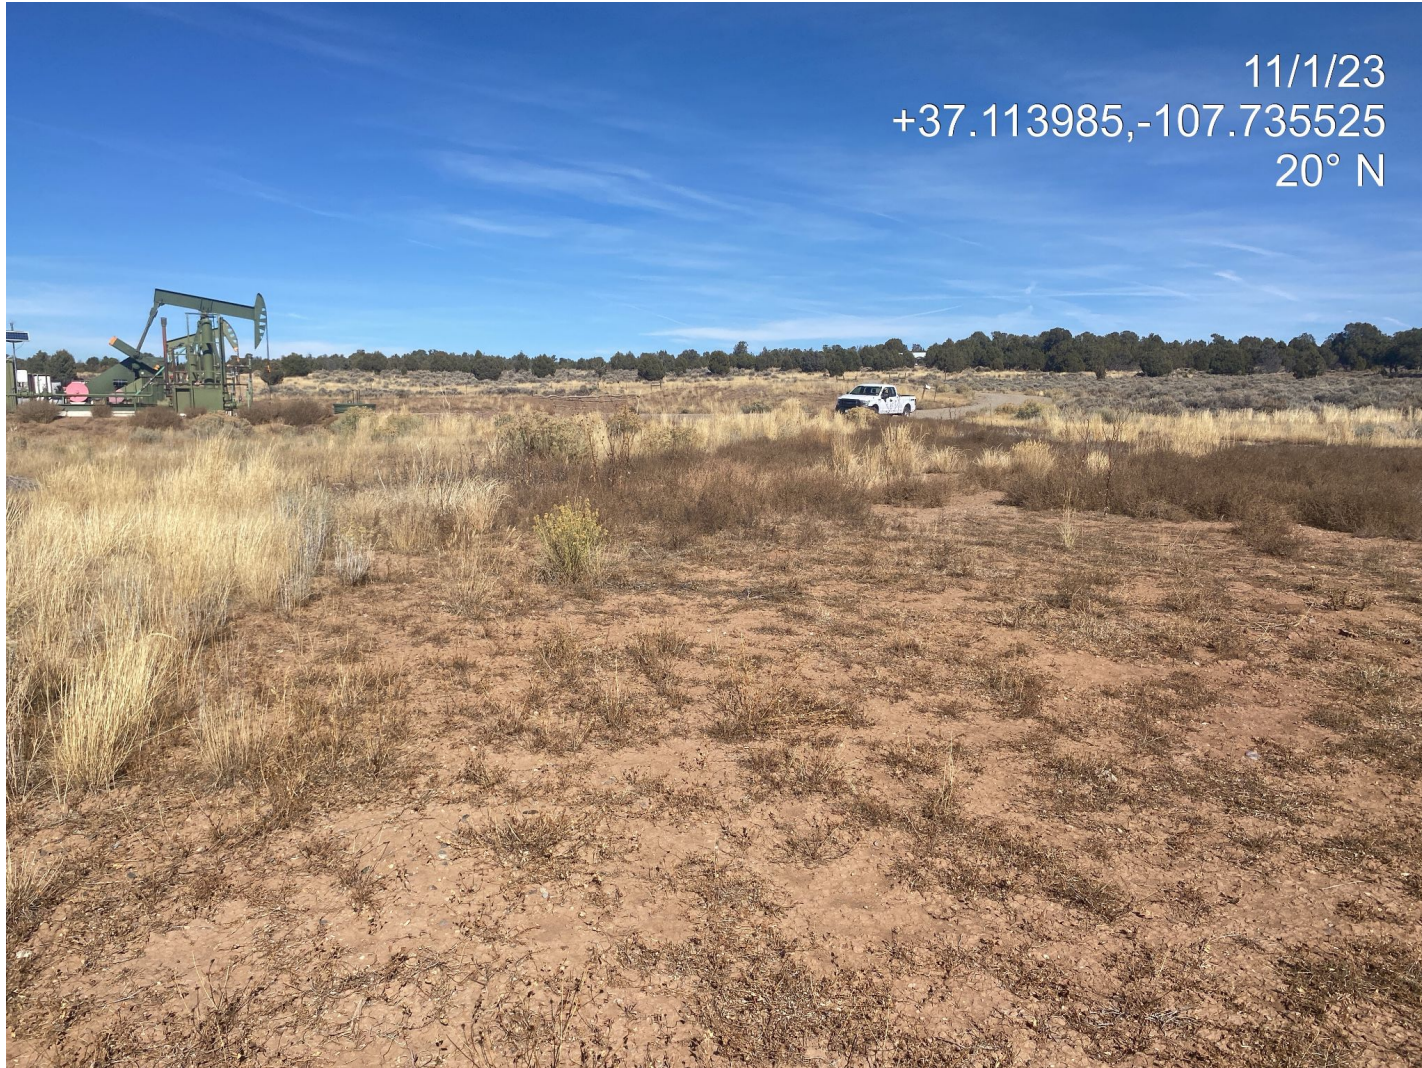
11/1/23
+37.113985,-107.735525
20° N

Photo 2. View of the project area taken from the southern edge facing north. Note: large bare patch of soil observed in the center of the project area.

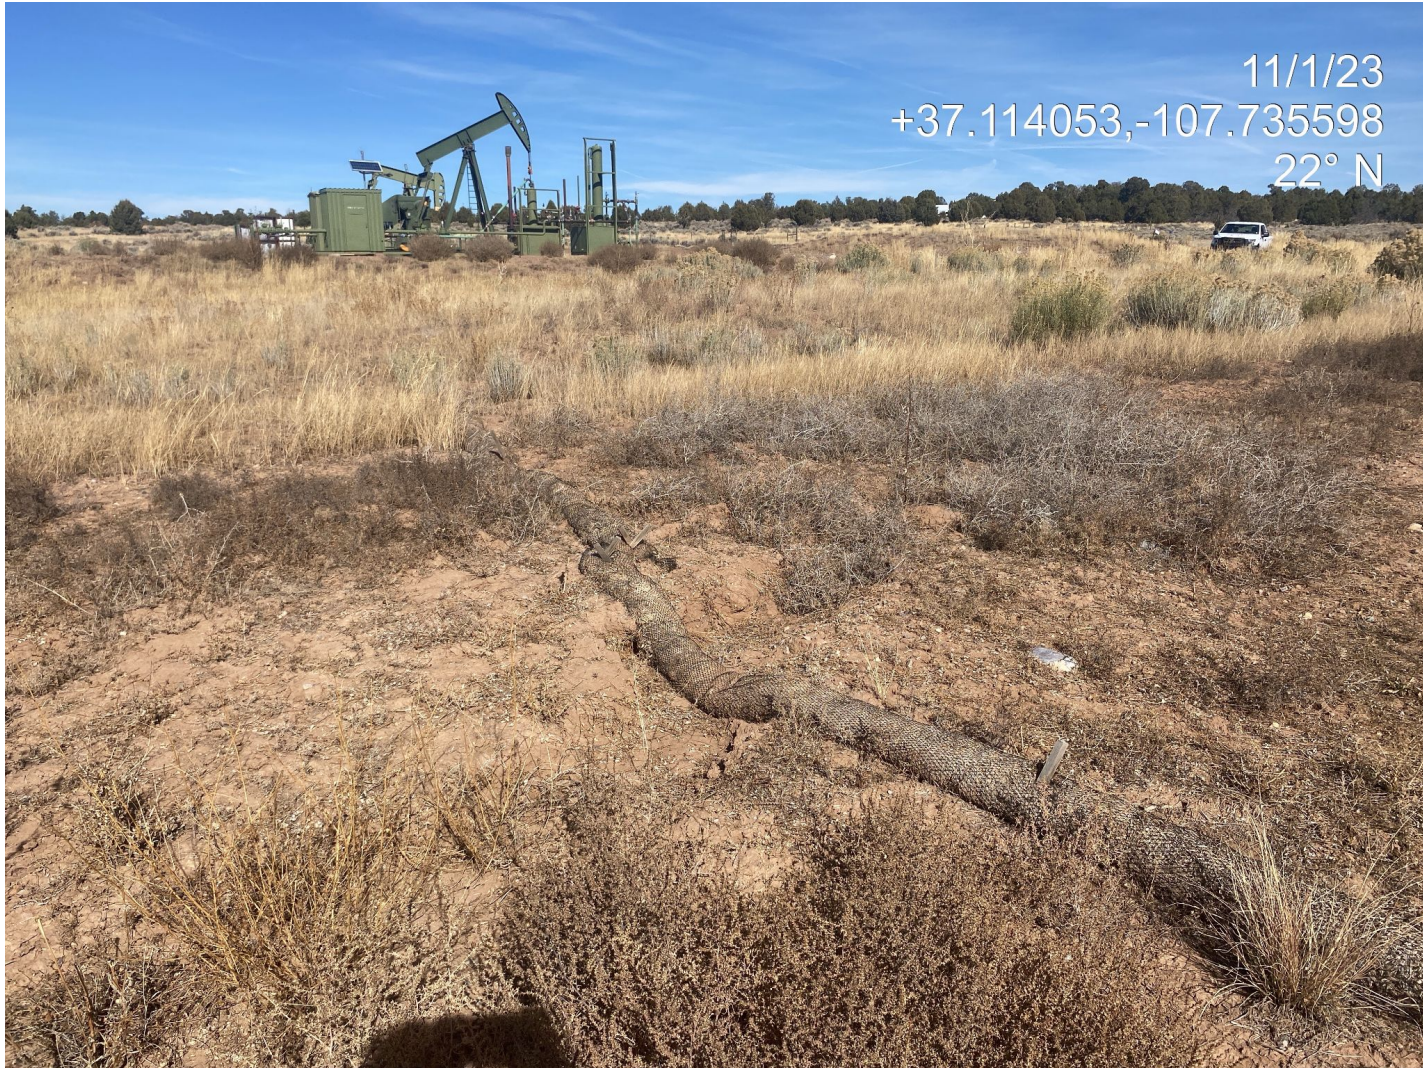
Photo 3. View of erosion/stormwater BMPs at the center of the project area that are not functioning properly.

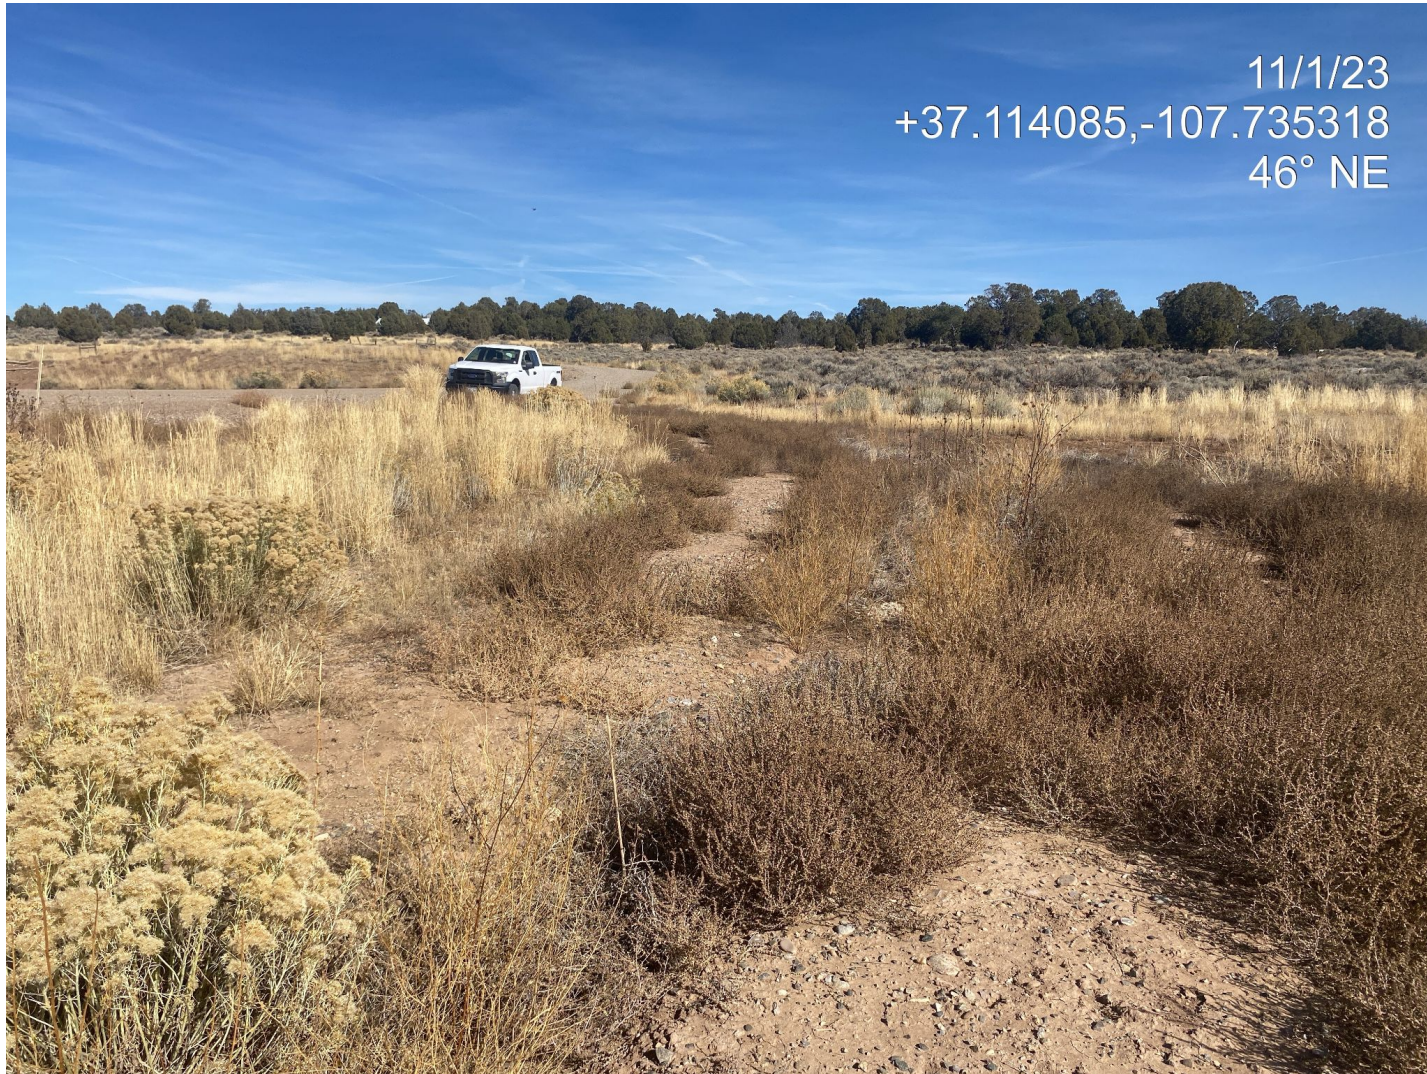
Photo 4. View of the access road/access point that remains unreclaimed with gravel in the northeast portion of the project area.

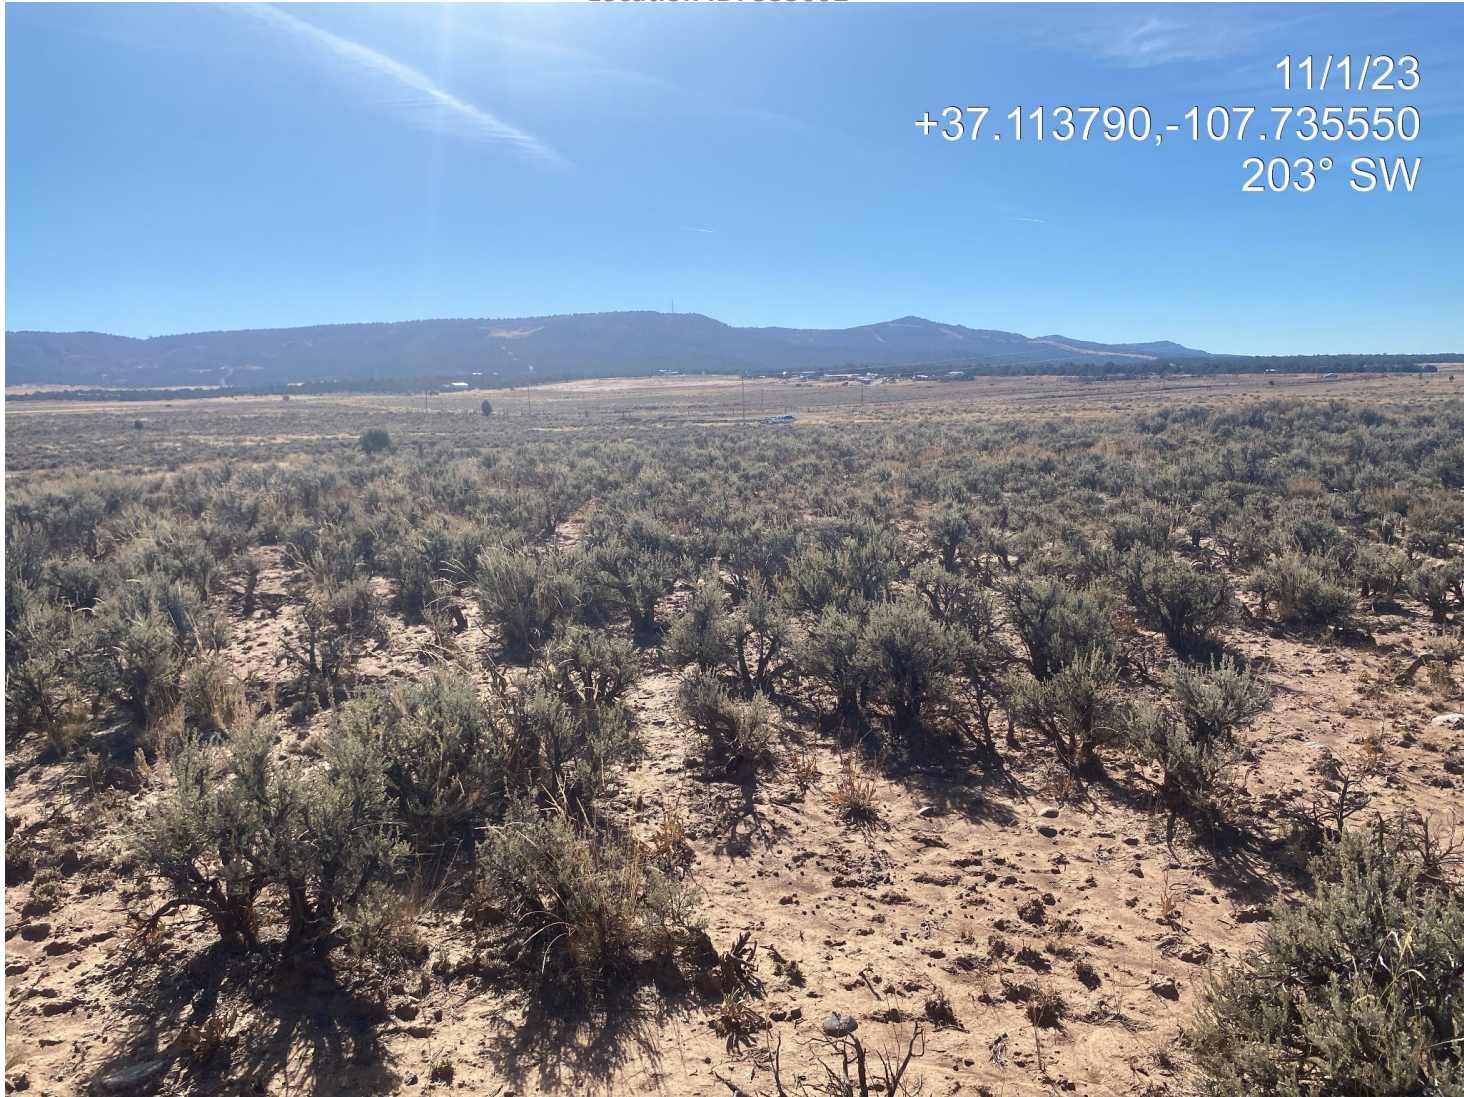
Photo 5. Reference area comprised of sagebrush and poa secunda.
