Final Reclamation Inspection

Operator: Logos Operating LLC - 10679

Location ID: 385734

Inspection Photos
Location Name: Bondad 33-9 35
Location ID: 385734

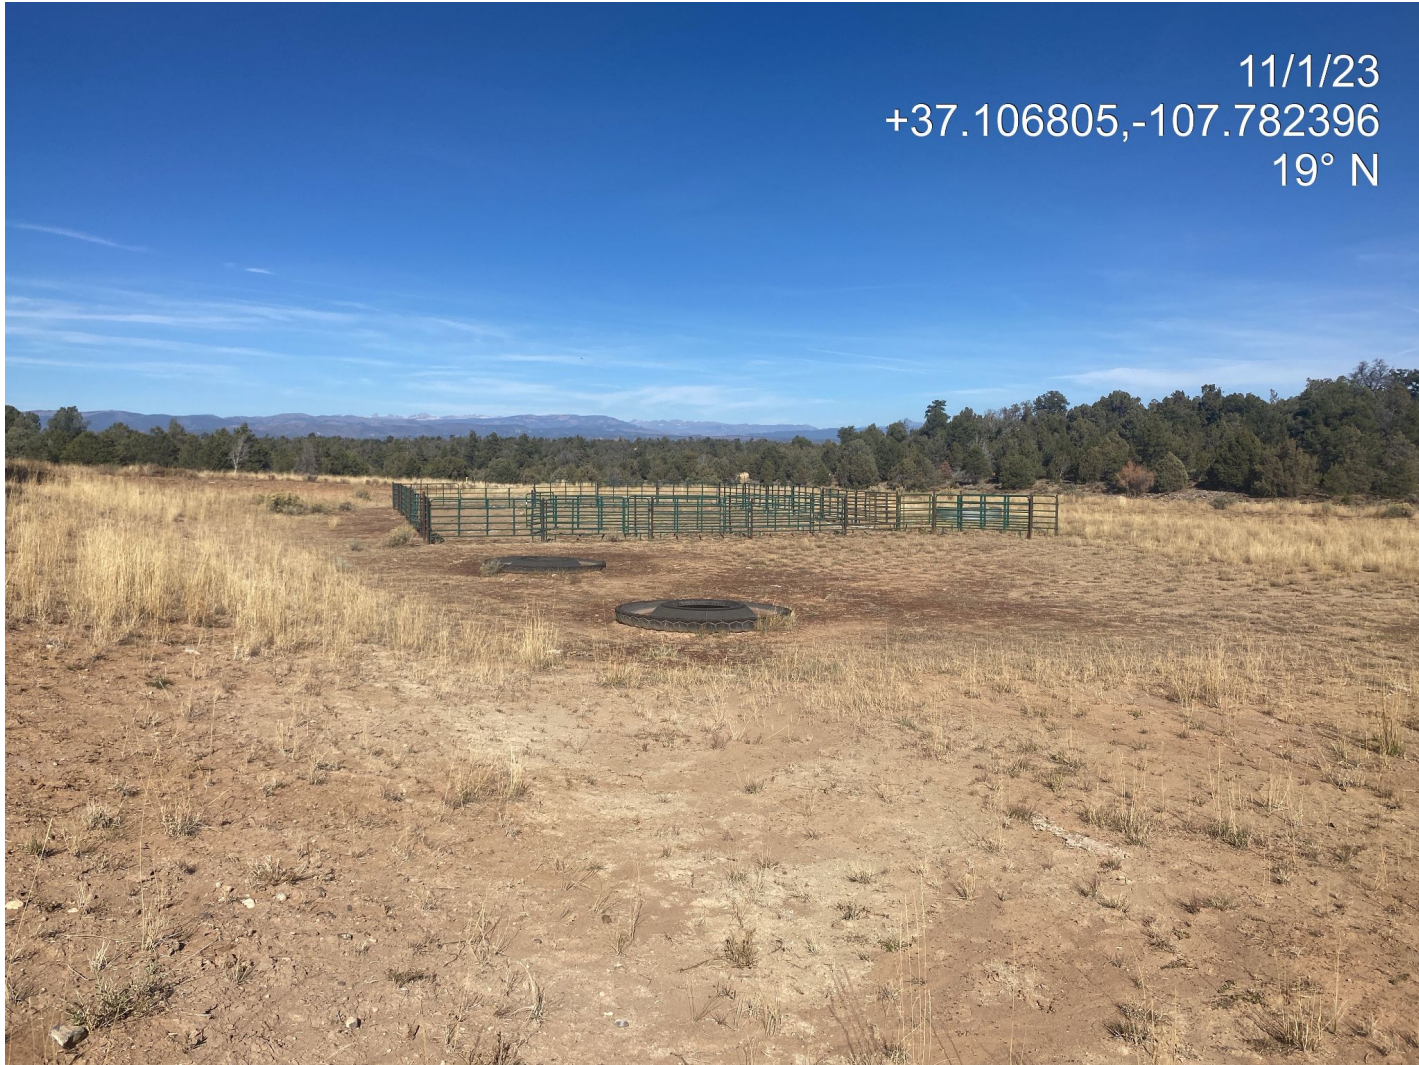
Photo 1. View of the project area taken from the southern edge facing north. Horse corral on project area appears to be hindering final reclamation.

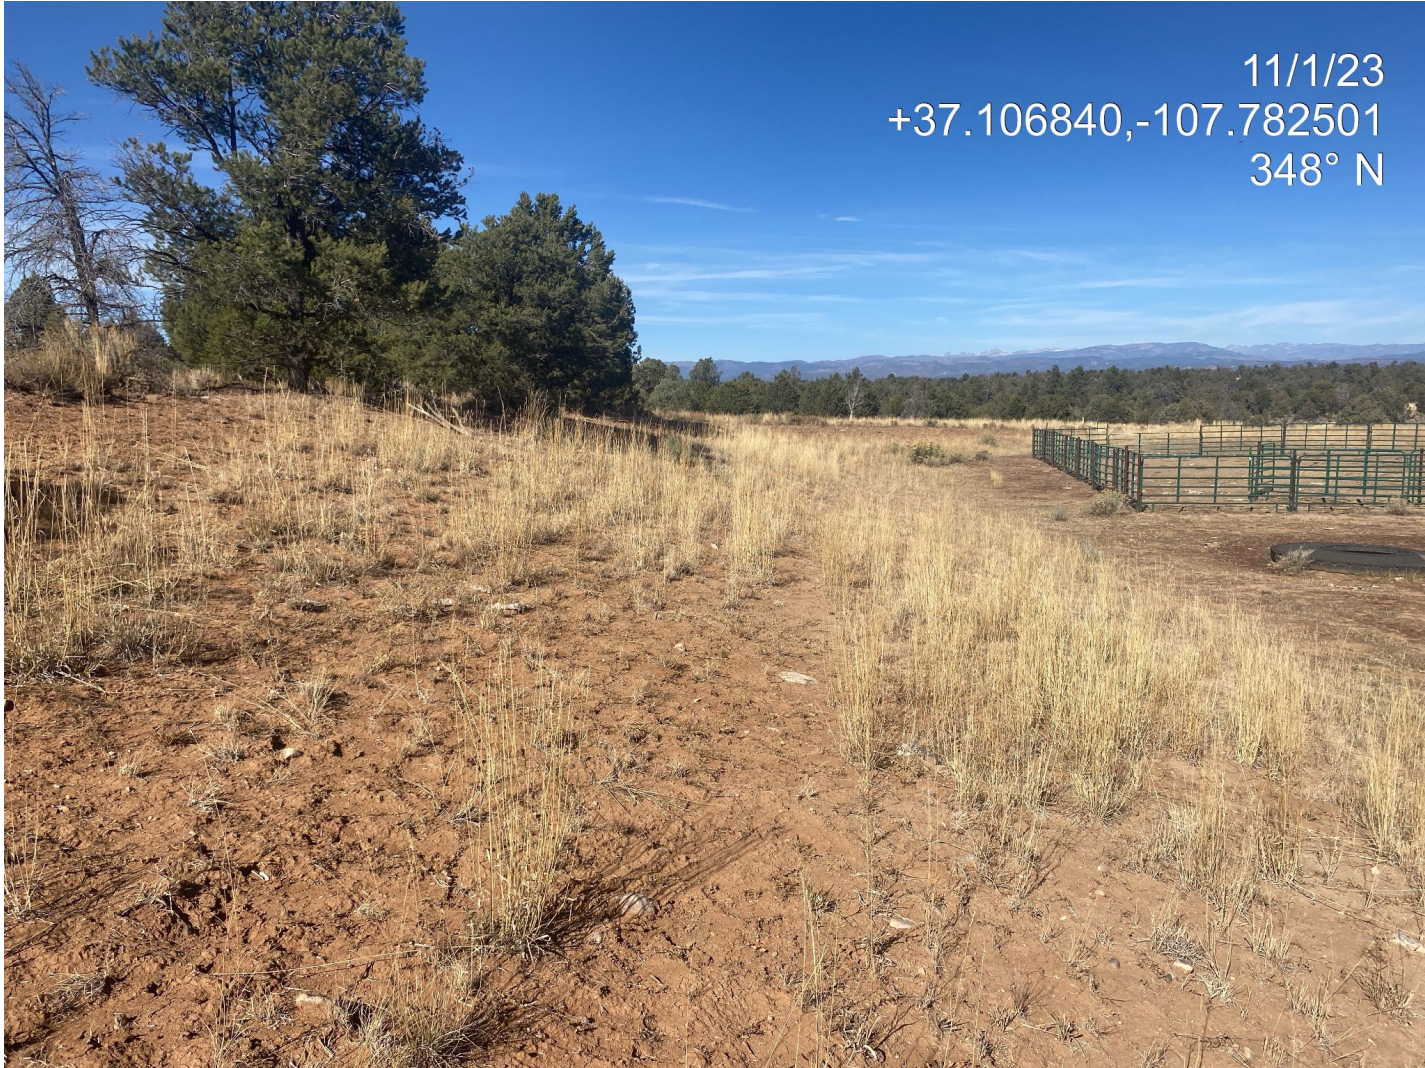
Photo 2. View of western cutslope taken from the southern edge facing north. Cut slope and flat well pad disturbance suggest the project area has not been recontoured.

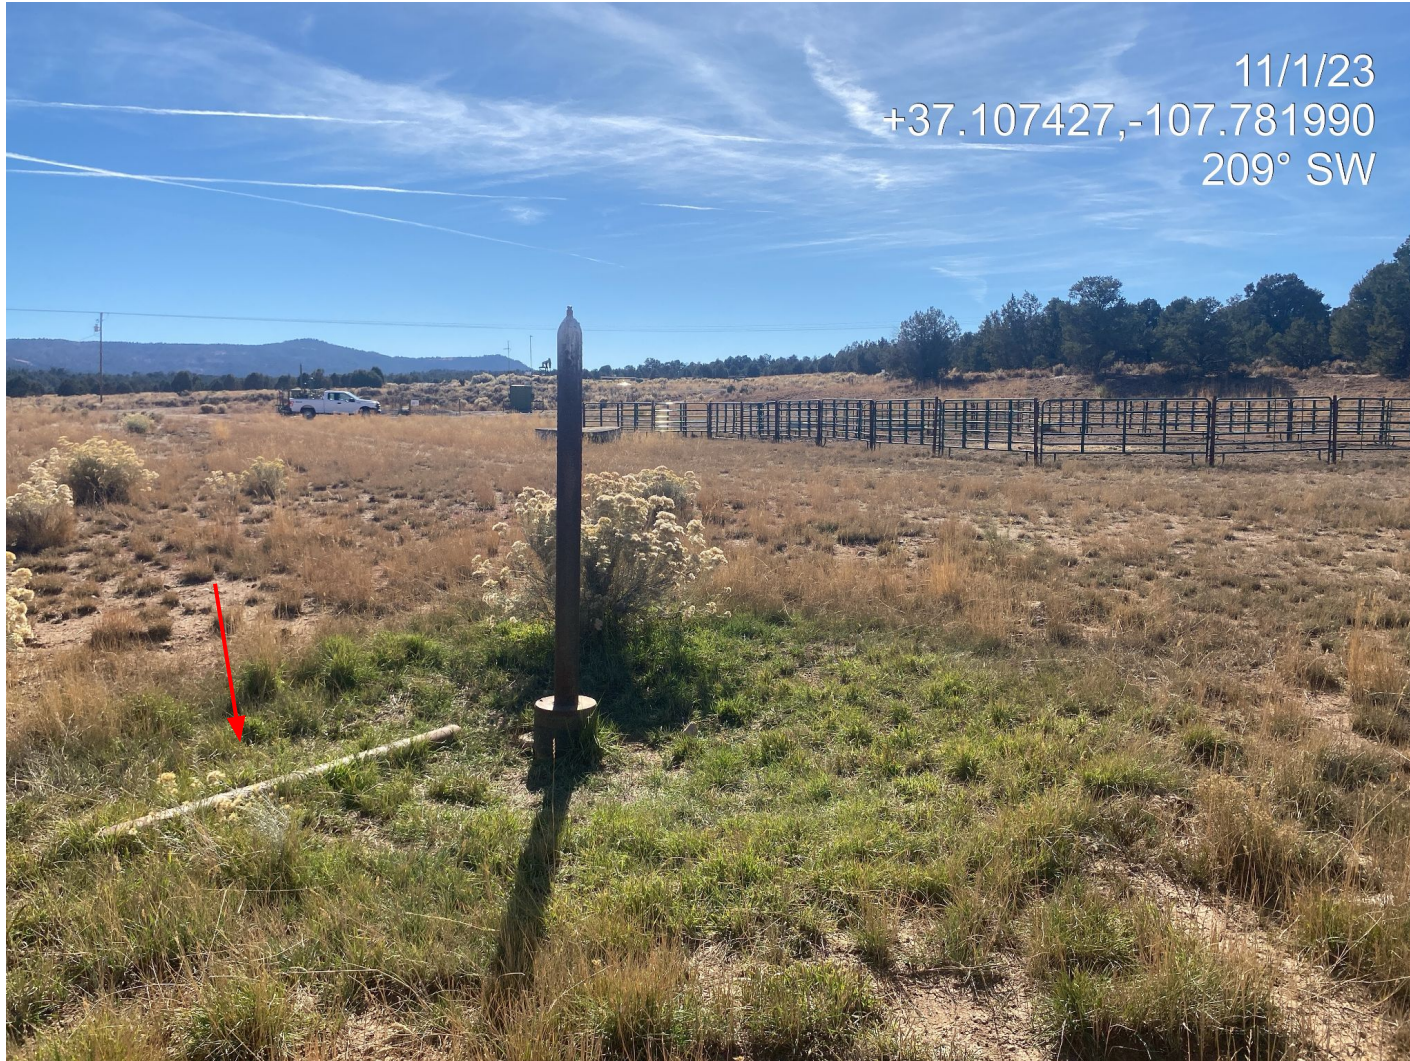
Photo 3. View of the project area taken from the northeast corner facing center. Note: additional unused well head marker remains on location.

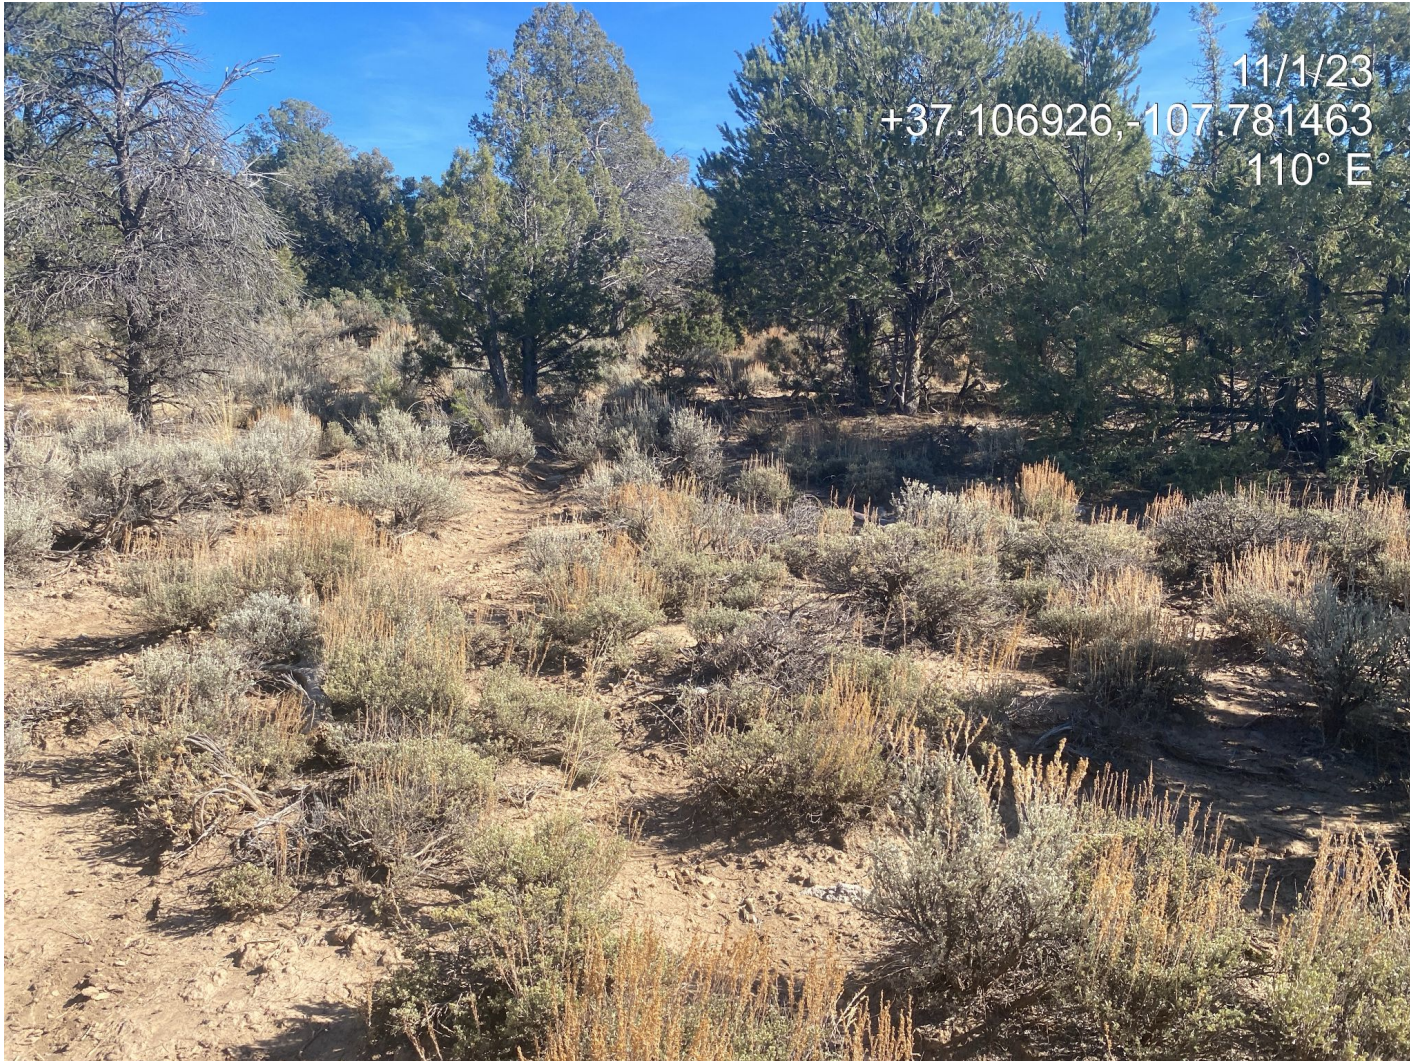
Photo 4. Reference area comprised of pine, juniper, sagebrush and indian rice grass.
