Inspection Photos

Loc: 322277

Operator: **CINNAMON CREEK OIL & GAS INC**

Inspection Date: 11/08/2023

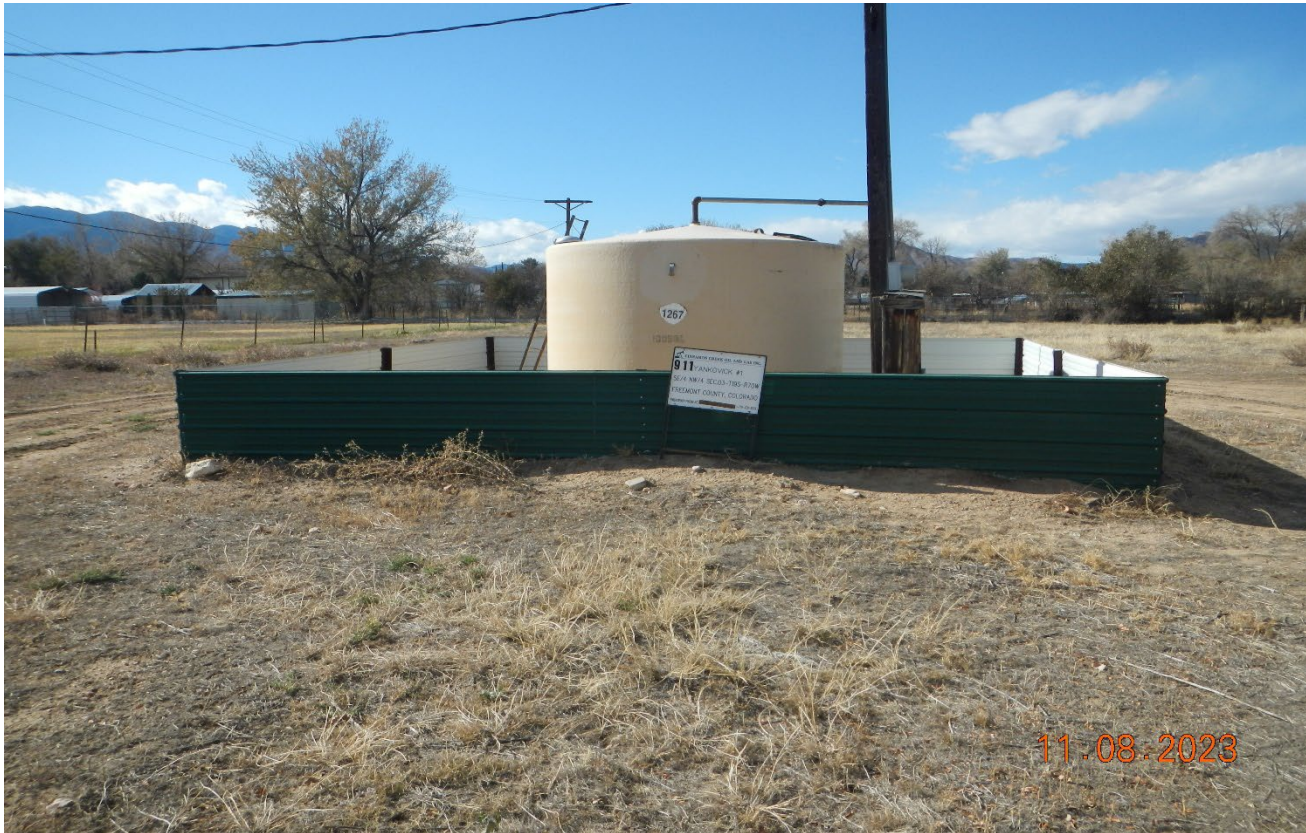
Photo 1. Facing west toward the tank battery. It looks like the capacity has been posted on from of tank 100BBL.

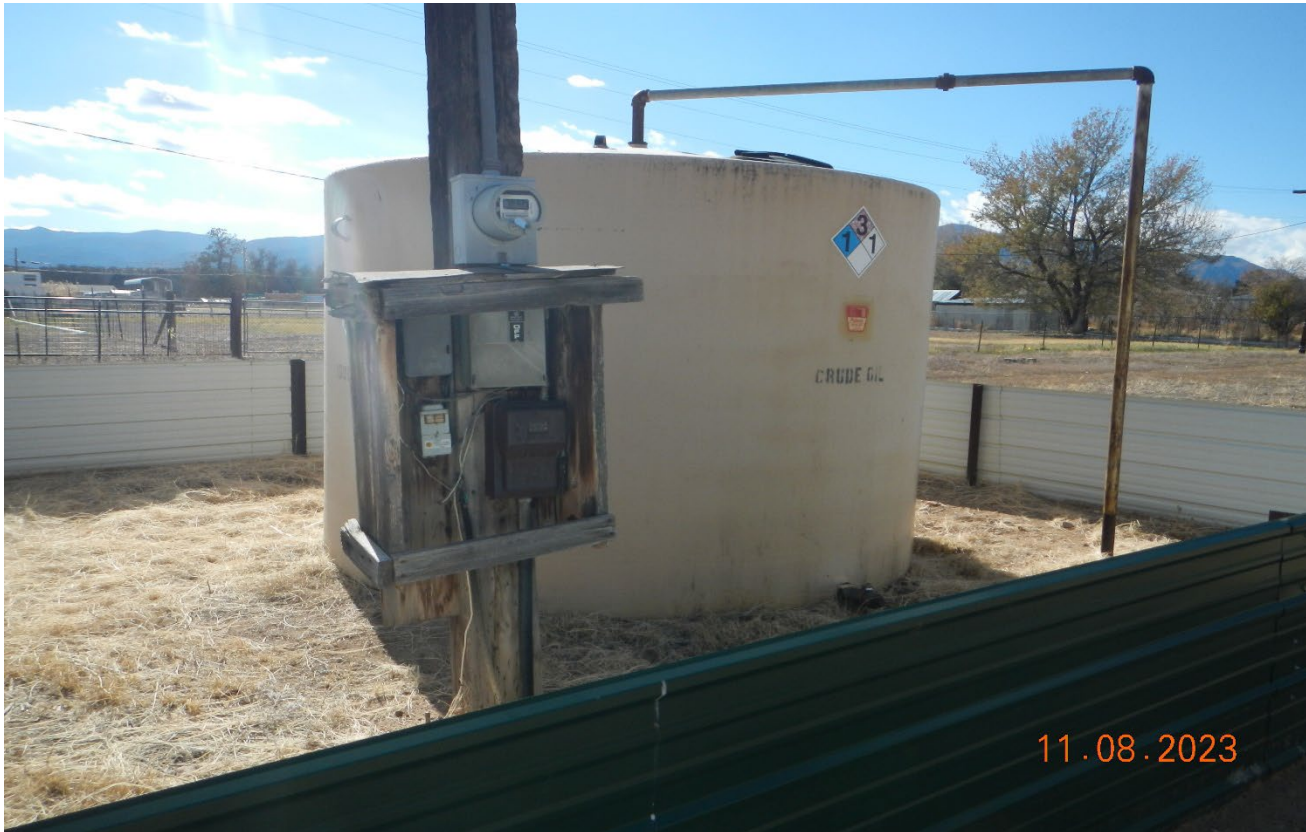
Photo 2. The wires are still exposed on electric breaker box which is a safety issue. Grass was mowed inside the containment but should also be raked up and removed.

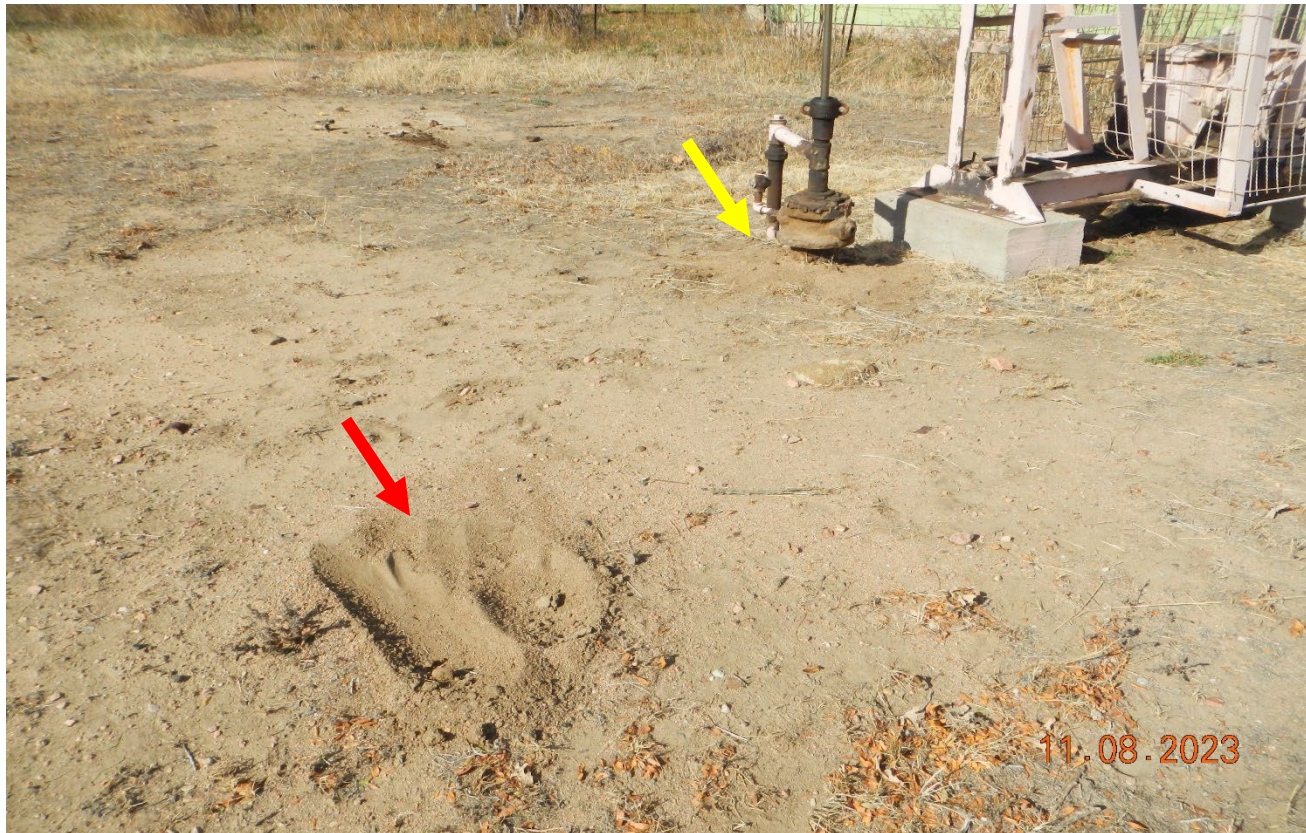
Photo 3. Facing toward the well. It appears soils was scooped up at red arrow to cover oil stained soil at the wellhead. The oil stained soils need to be cleaned up and properly disposed.

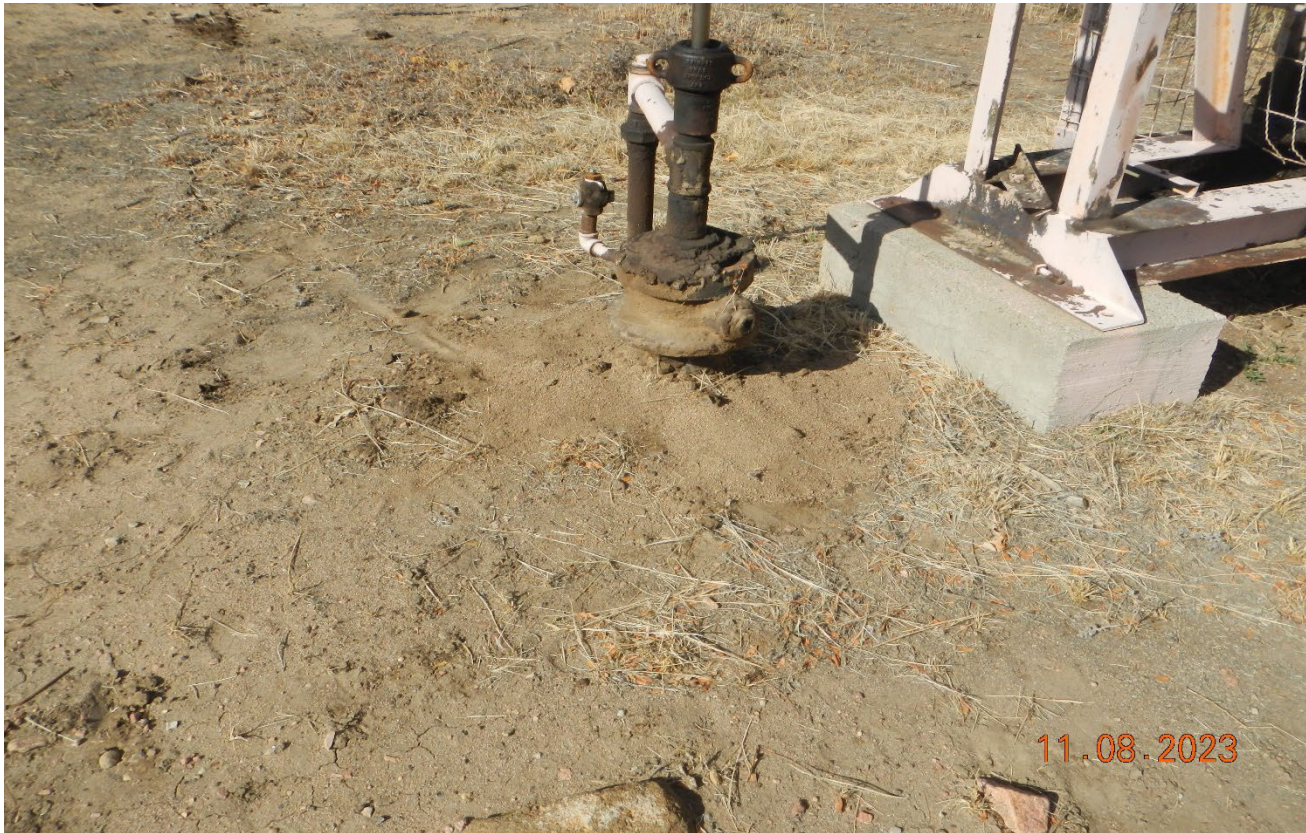
Photo 4. Facing toward the wellhead. Dirt has been placed over the stained soils at wellhead.

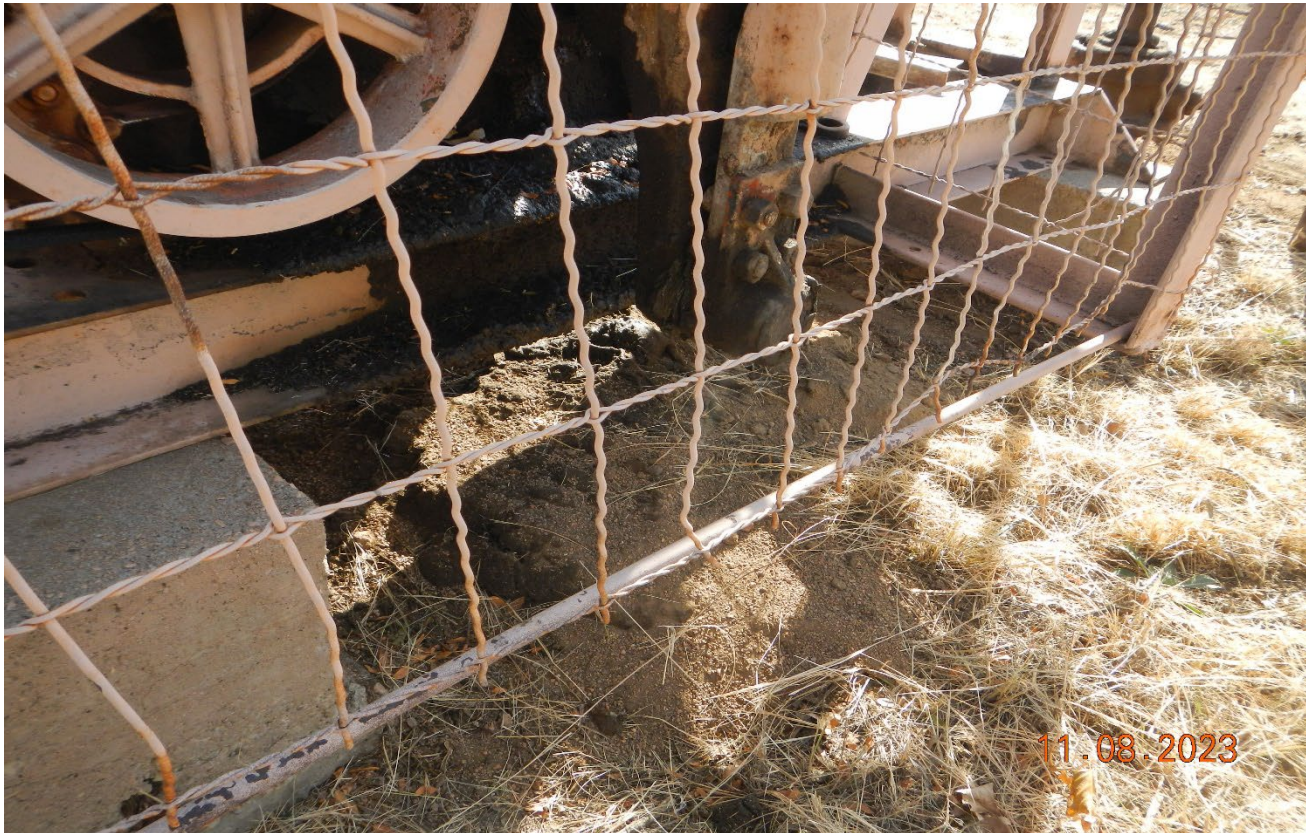
Photo 5. It appears soils were also shoveled over the oil at the pumpjack that was previous written up. The oil stained soils need to be cleaned up and properly disposed.

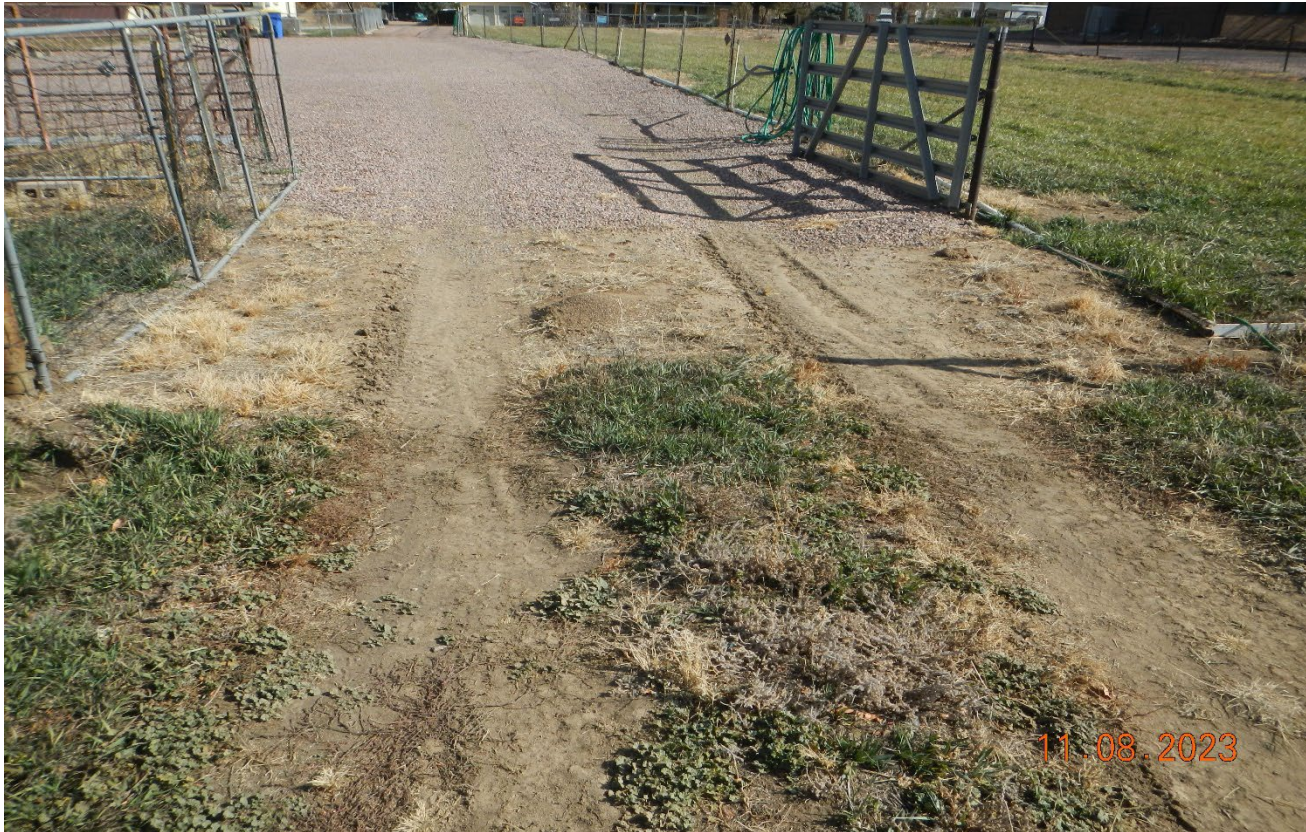
Photo 6. Facing east toward the access. Operator must ensure vehicle aren't tracking mud onto landowners graveled area.
