**Operator: CIVITAS NORTH LLC**  
**Location Name: Canvasback Pad**  
**Loc ID: 461821**  
**Inspection: 708200674**

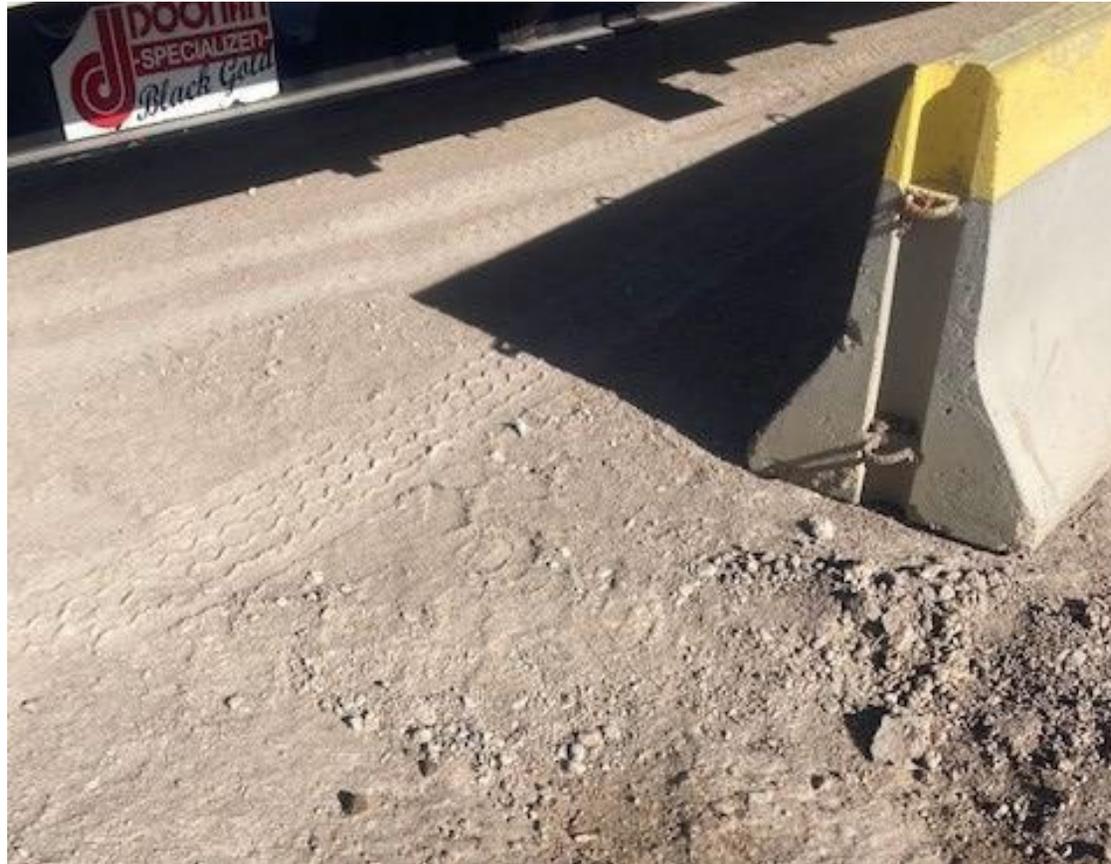
**Exhibit A**

**CA:** Stained soil observed on the southern portion of the production/drilling area. Refer to attached inspection photos. Properly dispose of oily waste in accordance with 905.e. The location will remain out of compliance until corrective action has been resolved.

**CA Resolution:** Operator has addressed stained soil at the southern portion of the location to comply with Rule 905.e.
