Interim Reclamation and Stormwater Inspection

Operator: PDC Energy Inc. - 69175

Location ID: 329884

Inspection Photos
Location Name: WEISS 1-34
Location ID: 329884

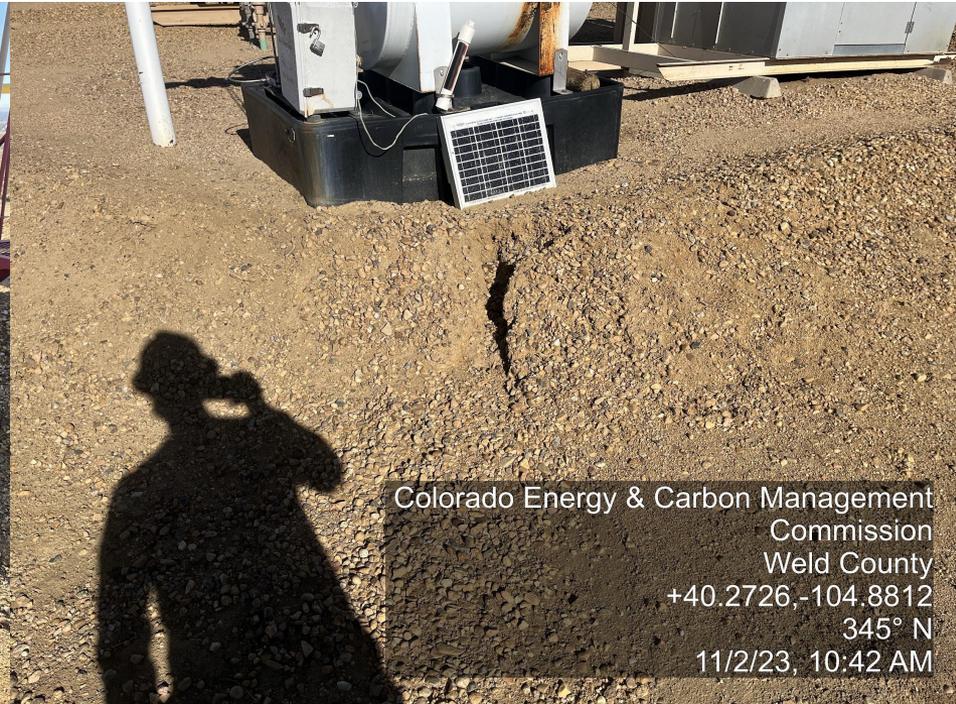
Photo 2. The photo was taken on the South side of the tank battery location facing North. The photo illustrates erosion creating rills in the road mix pad.

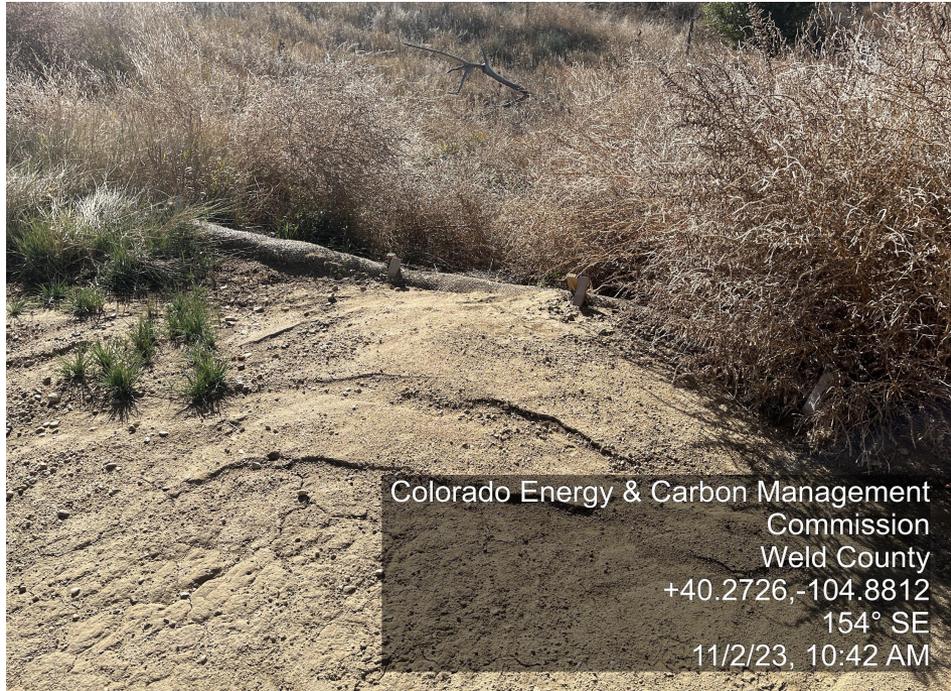
Photo 3. The photo was taken on the South side of the tank battery location facing Southeast. The photo illustrates sediment from Photo 2 being carried downslope and over straw wattle at the edge of the location. The photo also illustrates kochia growing all along the edge of the location.

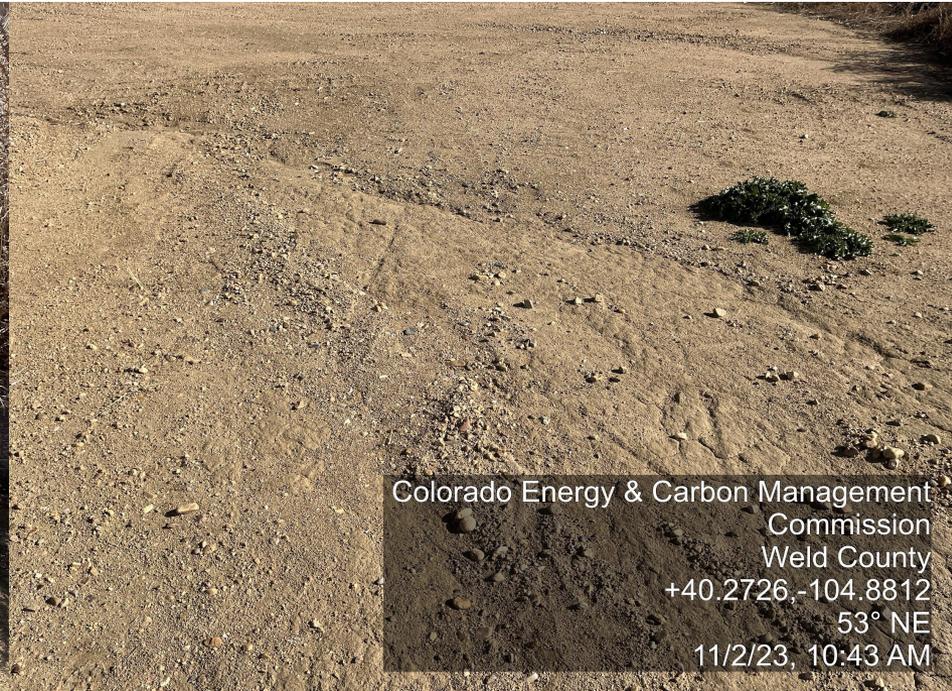
Photo 4. The photo was taken on the tank battery location facing Northeast. The photo illustrates rilling across the pad as well as Scotch thistle growing at the location tank battery.

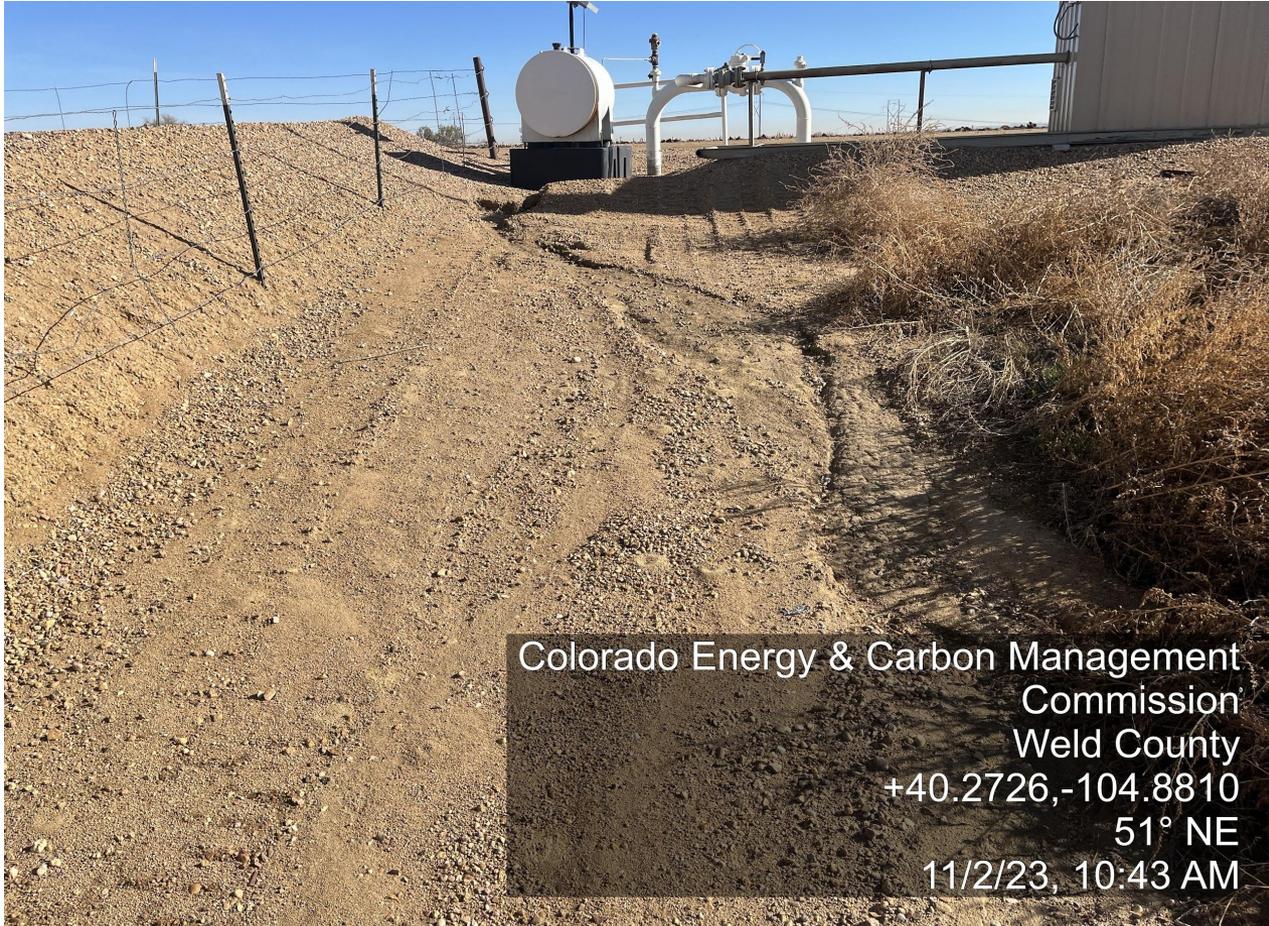
Photo 5. The photo was taken at the South side of the tank battery location facing Northeast. The photo illustrates large amounts of rilling and undesirable vegetation.
