Operator: HIGHPOINT OPERATING CORPORATION

Location Name: Anschutz-Williams 5-61-27 SWSW

Loc ID: 452726

Inspection: 696305384

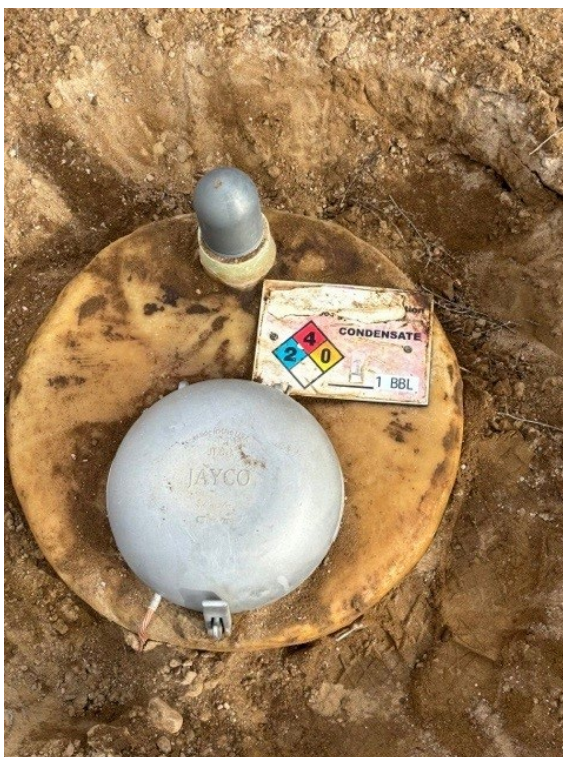
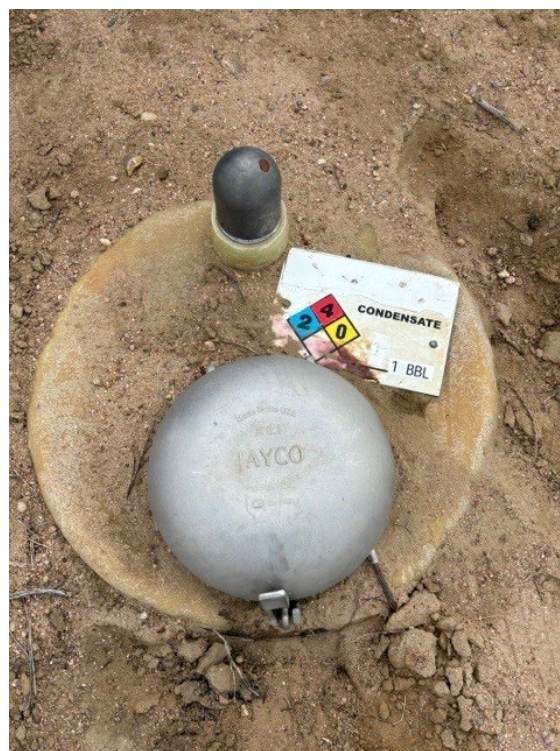
CA: Condensate Vault West of Separators is buried by Sand, Labels no longer visible. Condensate Vault at NW Corner of Tank Berm missing Capacity Label. Install sign to comply with Rule 605.h.

CA Resolution: Identified Condensate Vaults have been appropriately addressed by the Operator to ensure that the proper signage is up to date and visible to comply with Rule 605.h.

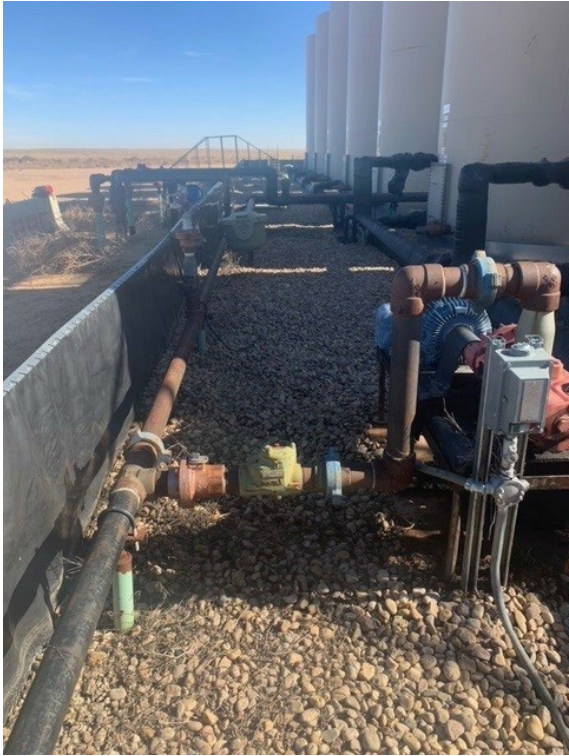
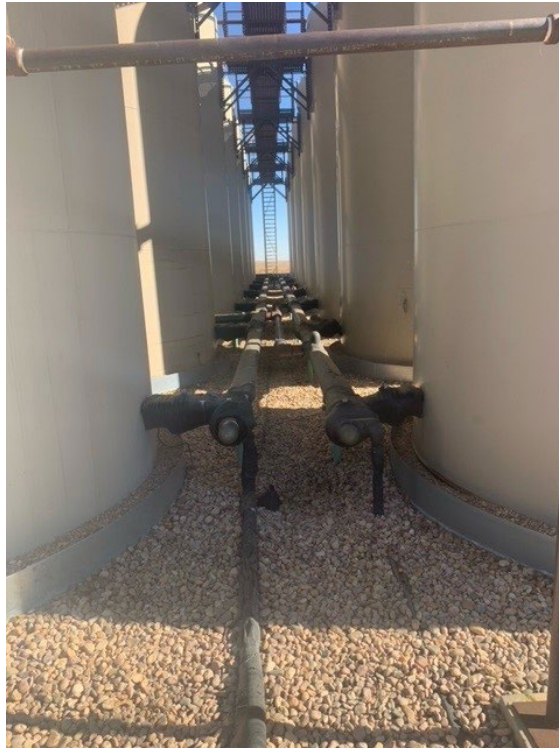
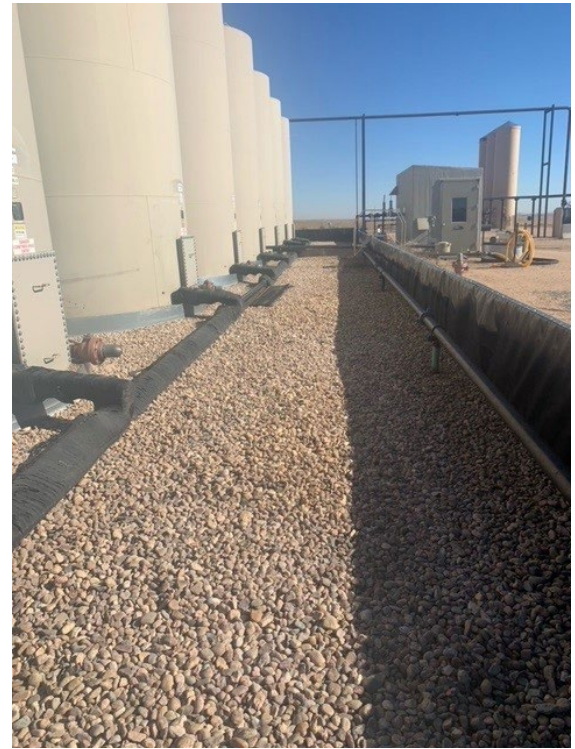
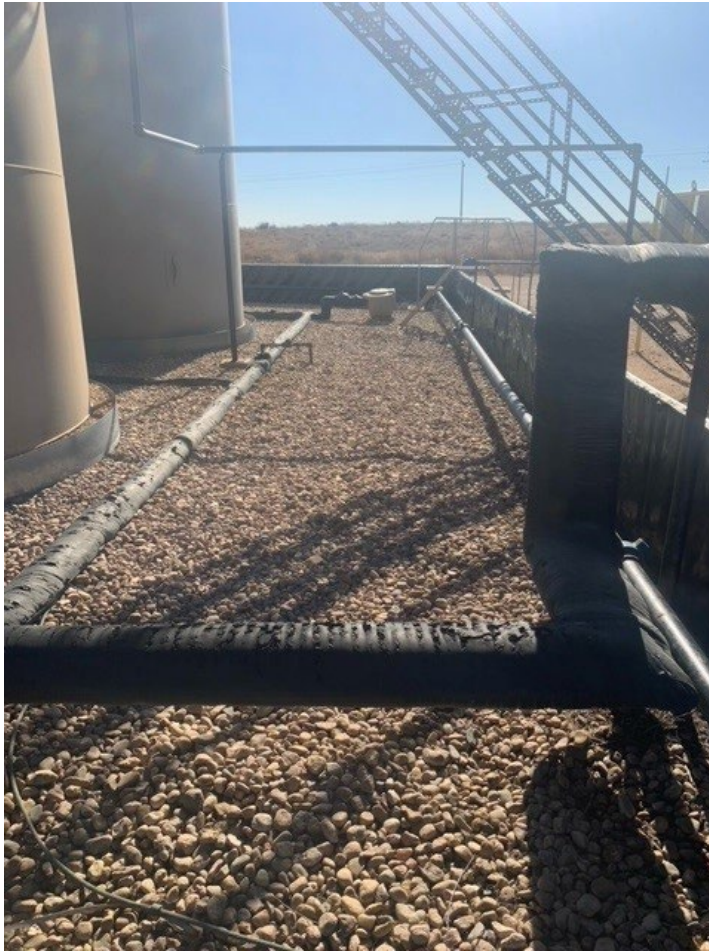
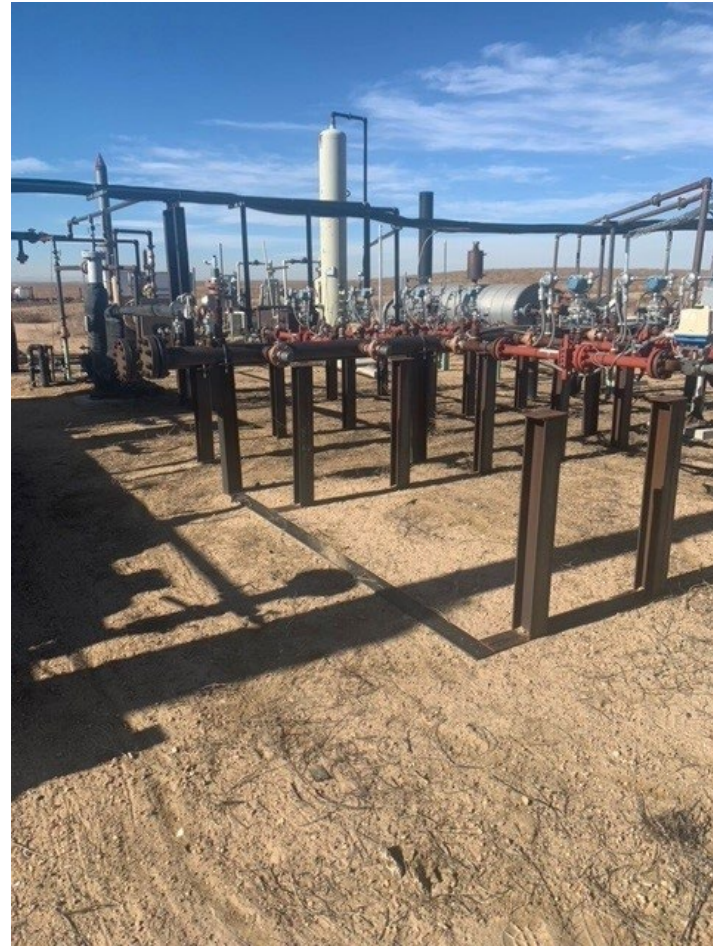
CA: Locate Flags on location no longer valid. Comply with Rule 606.

CA: Tumbleweed Debris at Gas Meter Rack, North end of Location and in and around Tank Berm; Comply with Rule 606.

CA Resolution: Operator has removed identified locate flags on location to comply with Rule 606.

CA Resolution: The Operator has addressed and cleared identified tumbleweed debris to comply with Rule 606.

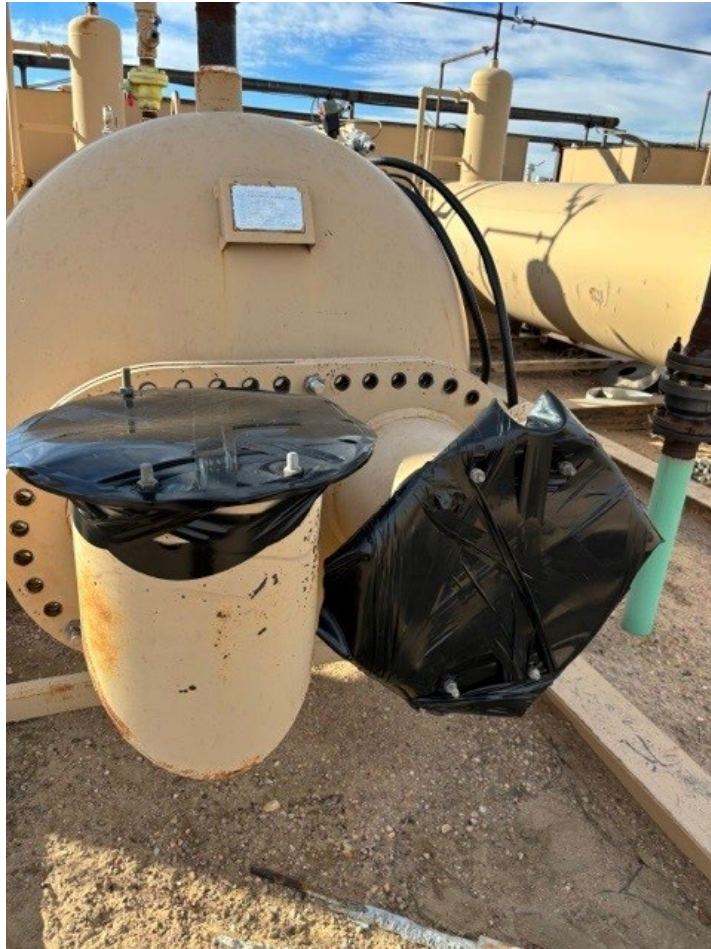
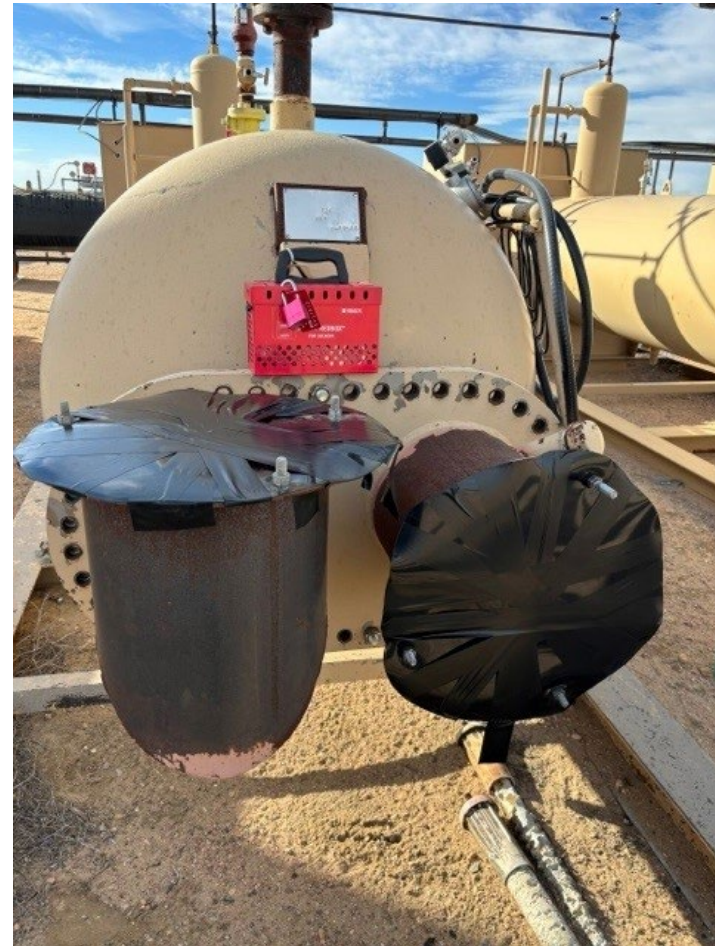
CA: South 2 Separators are open to Atmosphere. Appear to be down for Maintenance Install Temporary or repair wildlife protection equipment. Prevent any unauthorized discharge (specify condition if it is E&P waste, improper disposal, trash, etc.) Per Rule 902.b.

CA Resolution: Operator has installed material to close open separators to prevent unauthorized discharge to comply with Rule 902.b.
