Final Reclamation and Stormwater Inspection

Operator: PDC Energy Inc - 69175

Location ID: 410027

Inspection Photos
Location Name: Guttersen 41-11
Location ID: 410027

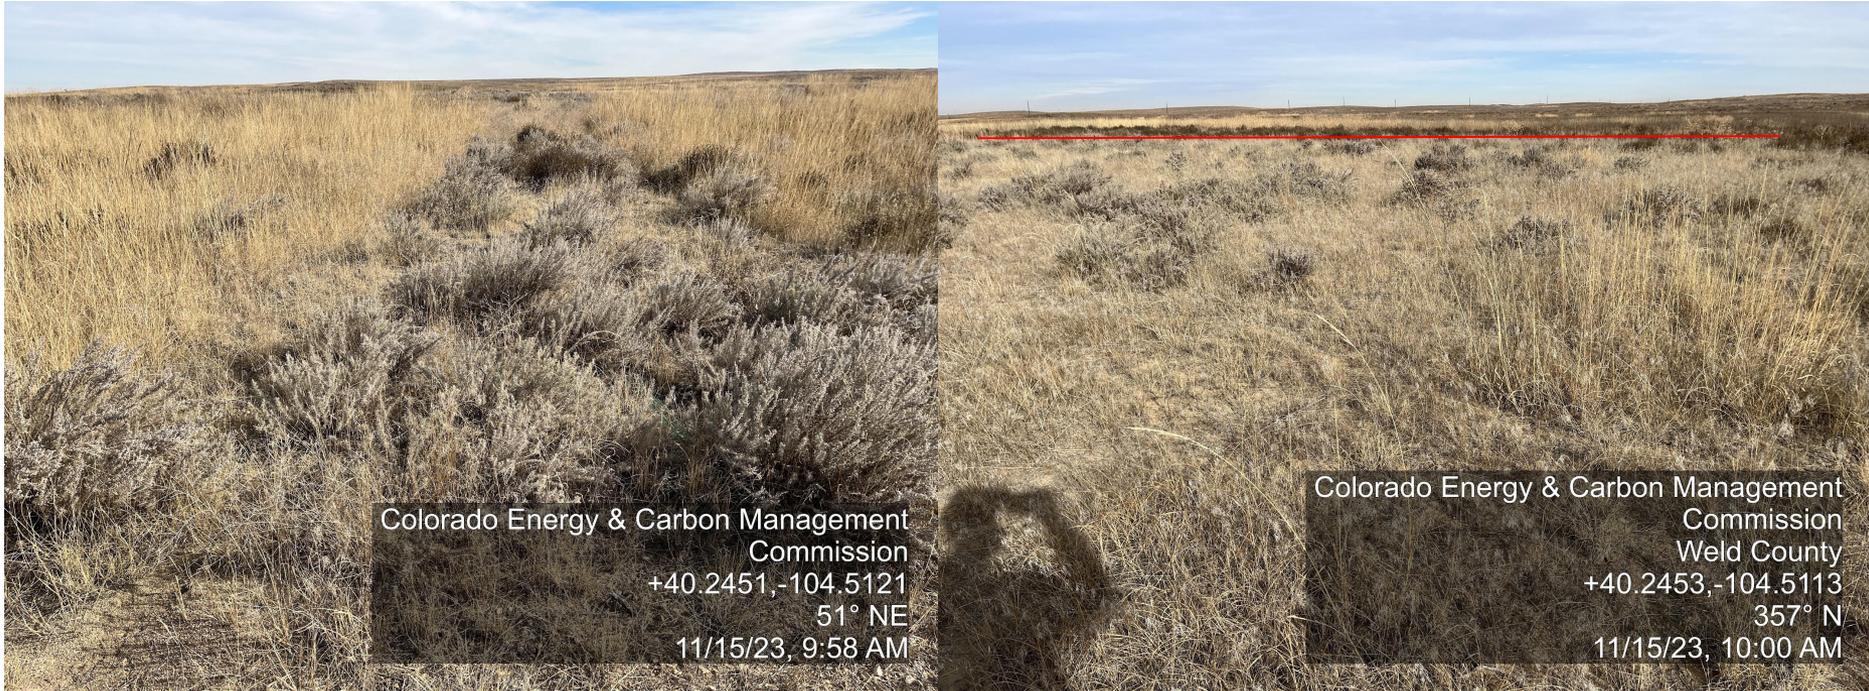
Photo 1. The photo was taken at the entrance to the access road facing Northeast. The photo illustrates the access road to the location dominated by sand sagebrush and blue grama.

Photo 2. The photo was taken from the center of the location facing North. The photo illustrates dominant cheatgrass with bunches of sand sagebrush and reed canary grass as well as russian thistle dominating the Northwestern boundary seen by the red line.

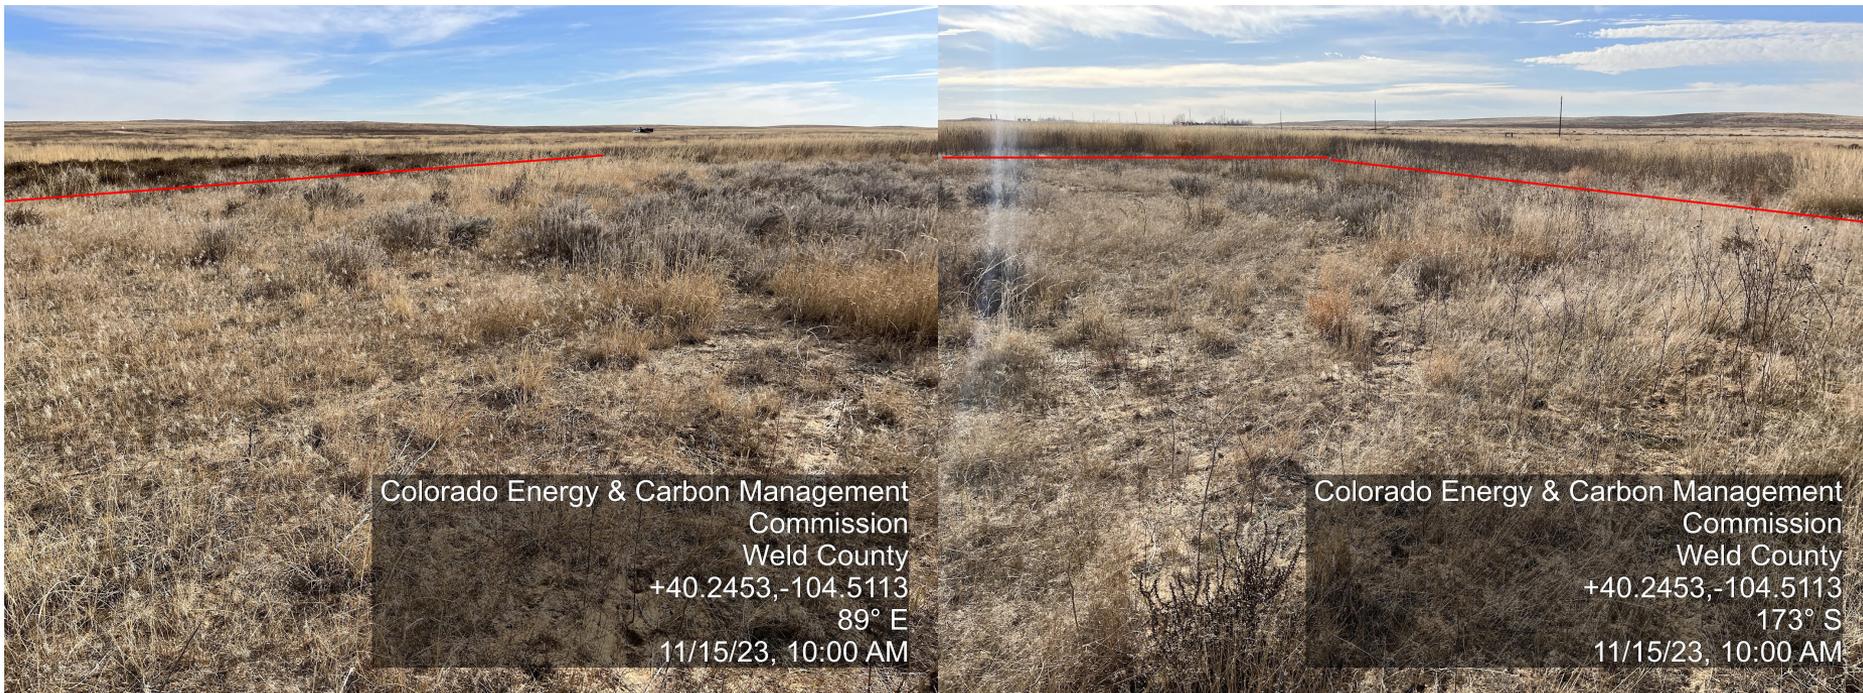
Photo 3. The photo was taken from the center of the well location facing East. Refer to the comment for photo 2.

Photo 4. The photo was taken from the center of the well location facing South. The photo illustrates the pad area is dominated by cheatgrass while the reference area beyond the red line is dominated by reed canary grass, sunflower and blue grama.

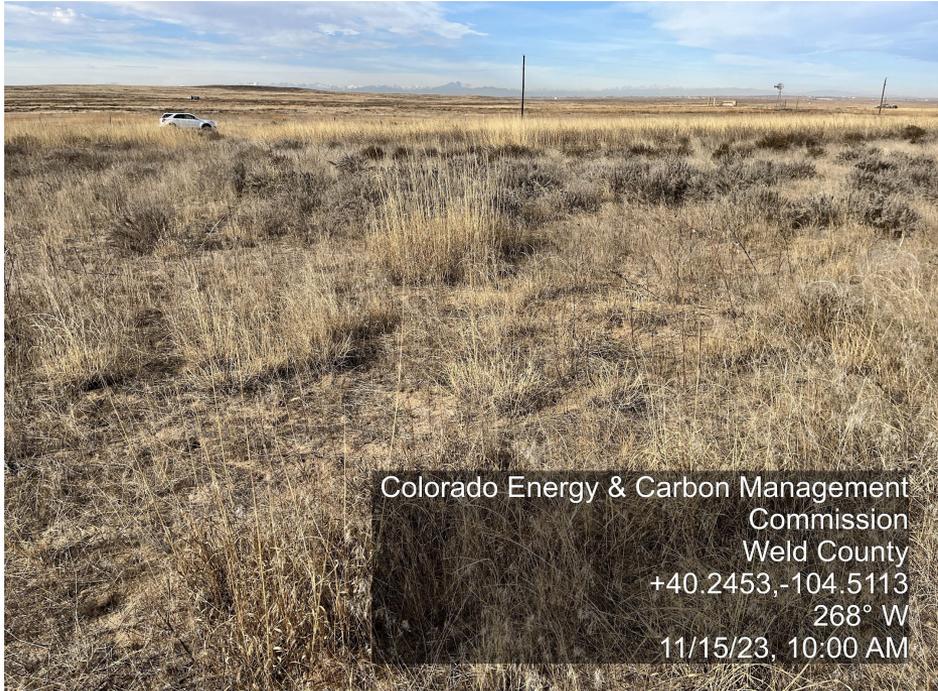
Photo 5. The photo was taken from the center of the well location facing West.

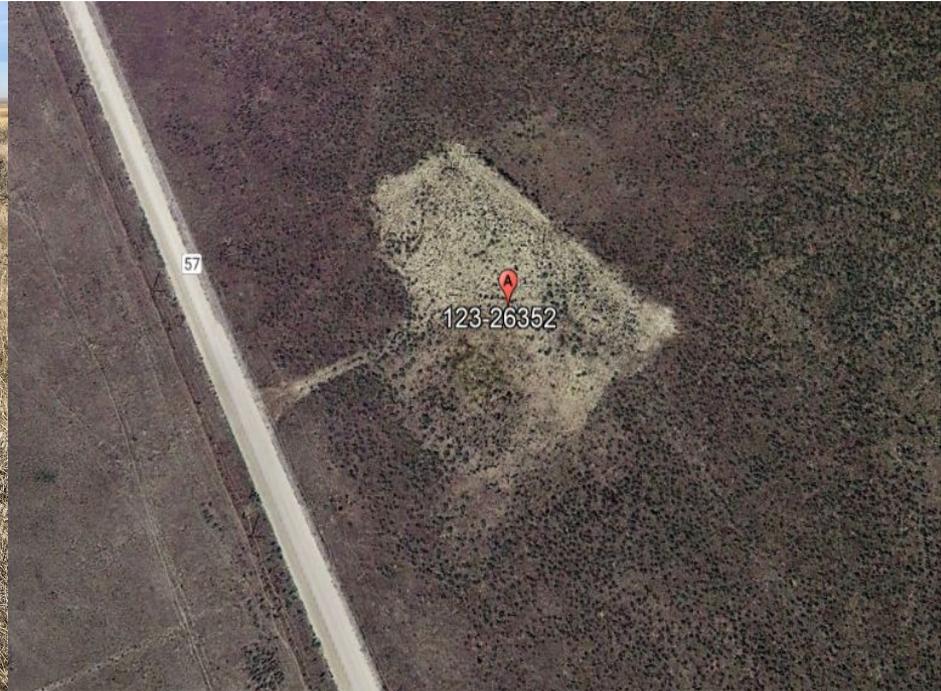
Photo 6. The aerial imagery from Google Earth in 2013 illustrates that the location was constructed for the proposed well location.
