Final Reclamation and Stormwater Inspection

Operator: Noble Energy Inc. - 100322

Location ID: 329077

Inspection Photos
Location Name: HSR-O'neil 16-29
Location ID: 329077

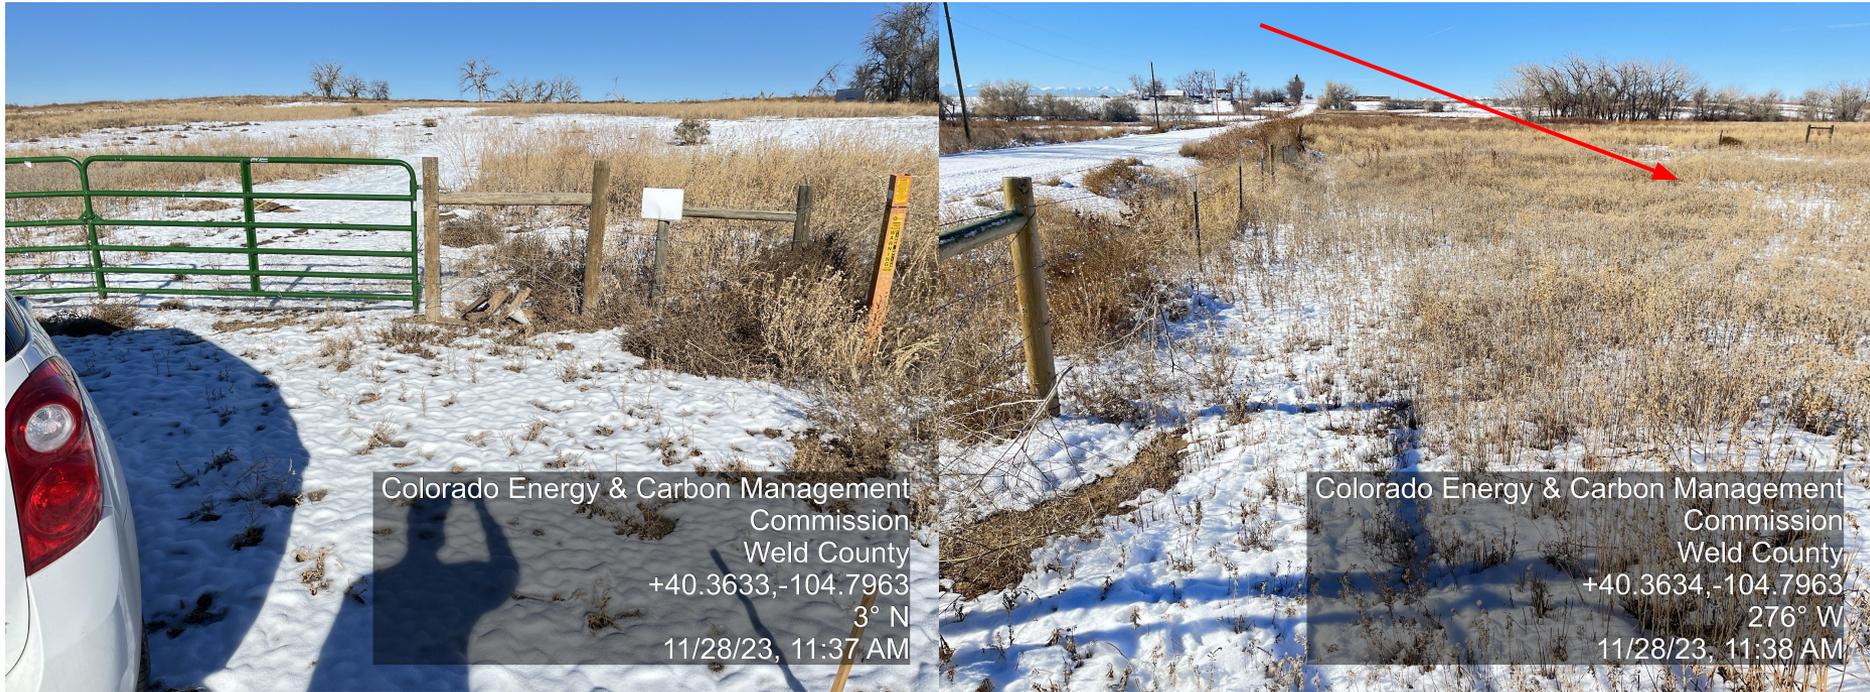
Photo 1. The photo was taken at the entrance to the location facing North. The photo illustrates the annual weed dominance on the location.

Photo 2. The photo was taken inside the entrance to the location facing West. The photo illustrates the former location of the tank battery is dominated by tumbleweeds and bare soil.

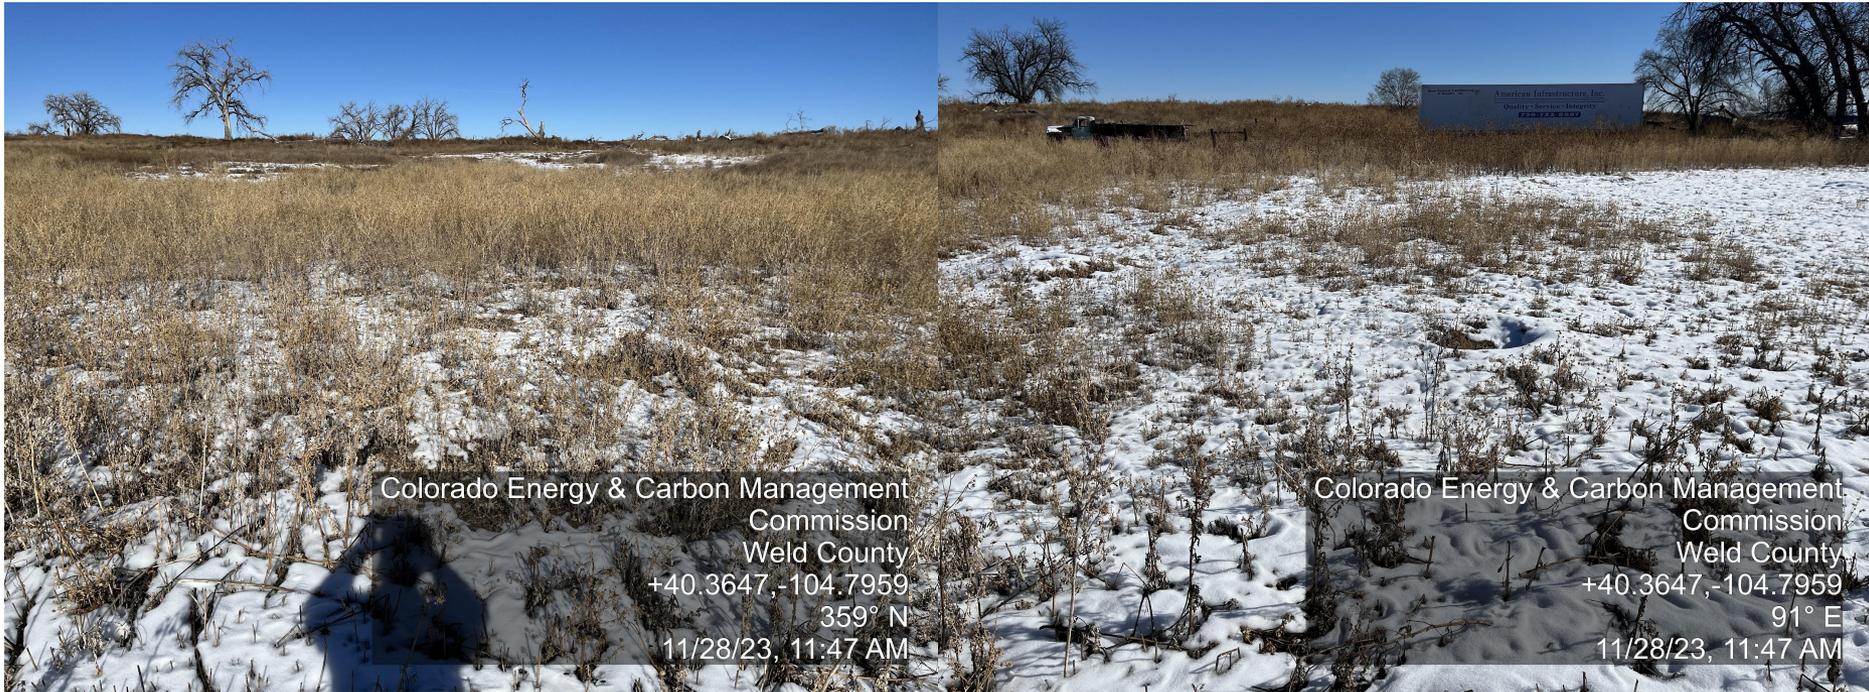
Photo 3. The photo was taken at the well location facing North. The photo illustrates the location is dominated by tumbleweeds and bare soil.

Photo 4. The photo was taken at the well location facing East. Refer to the comment for photo 3.

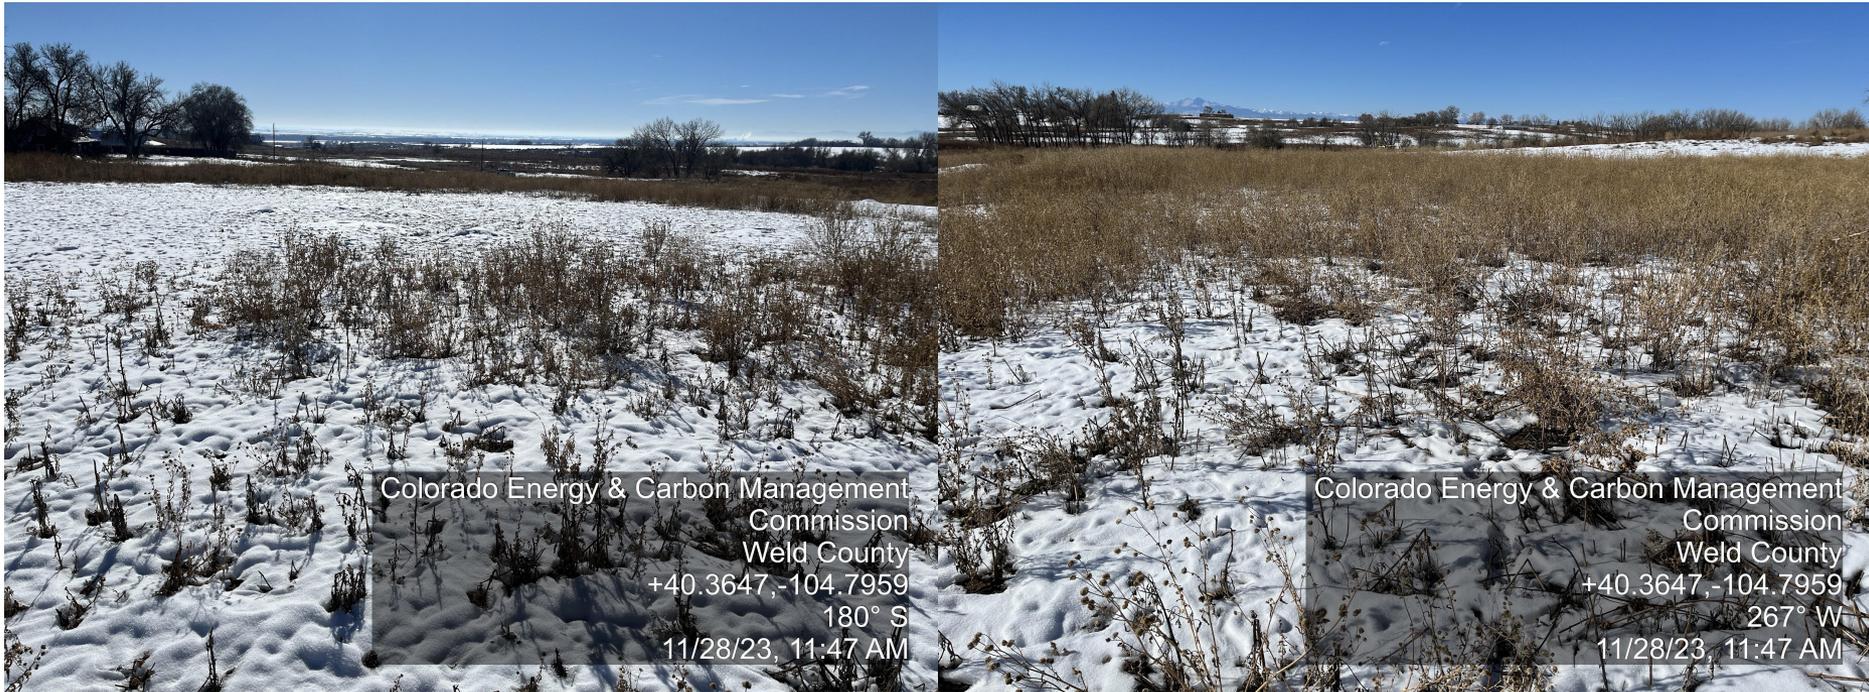
Photo 5. The photo was taken at the well location facing South. Refer to the comment for photo 3.

Photo 6. The photo was taken at the well location facing West. Refer to the comment for photo 3.

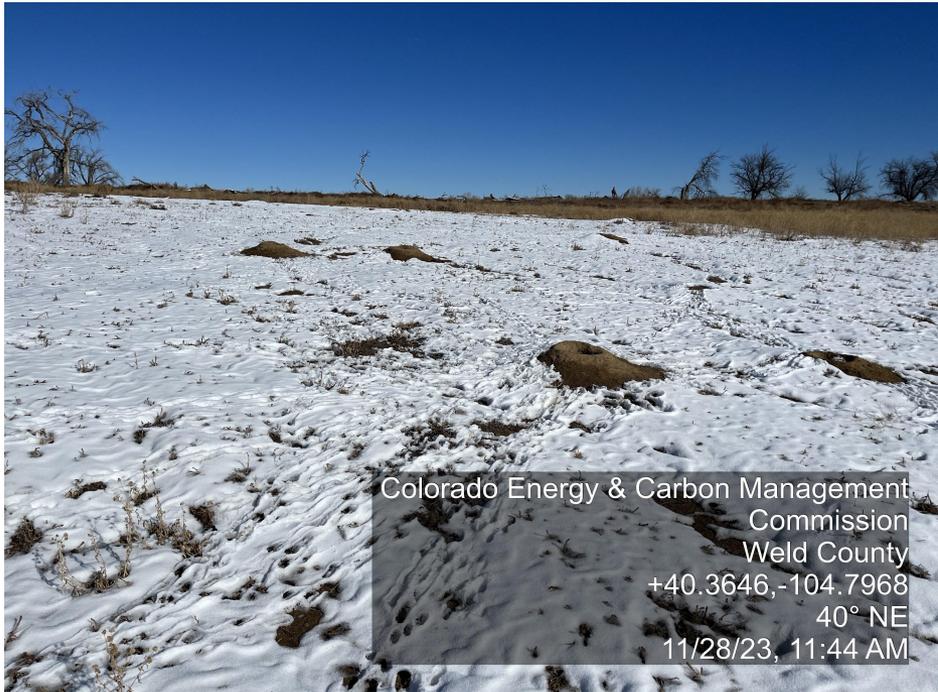
Photo 7. The photo was taken at the well location facing Northeast. The photo illustrates a large prairie dog colony on the location.

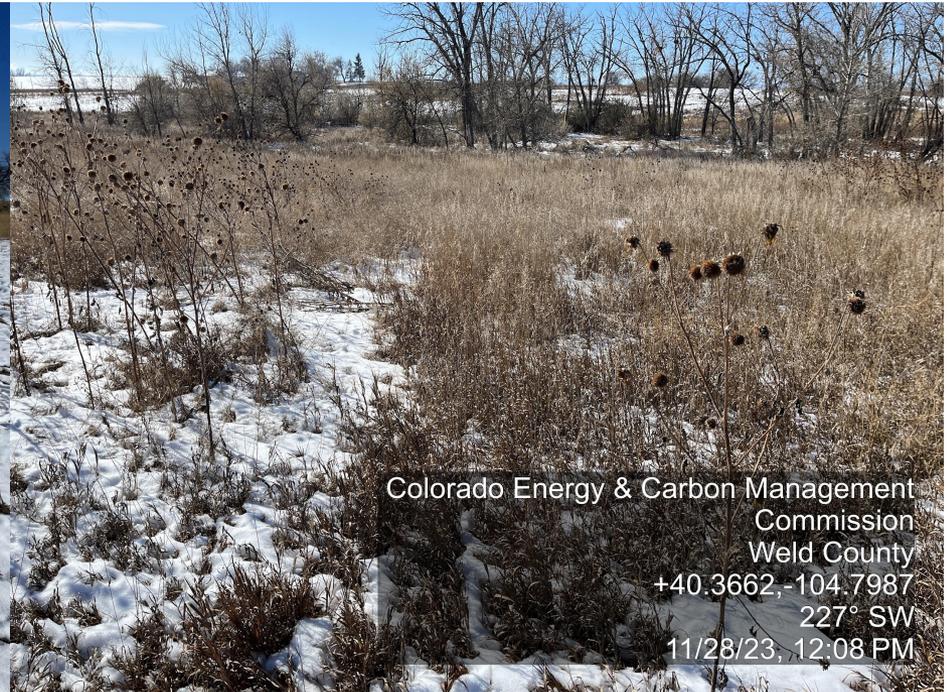
Photo 8. The reference photo was taken near the well location facing Southwest. The photo illustrates the area is dominated by smooth brome and sunflower.
