Interim Reclamation and Stormwater Inspection

Date: 11/28/23

Location ID: 435425

Inspection Document #: 713900152

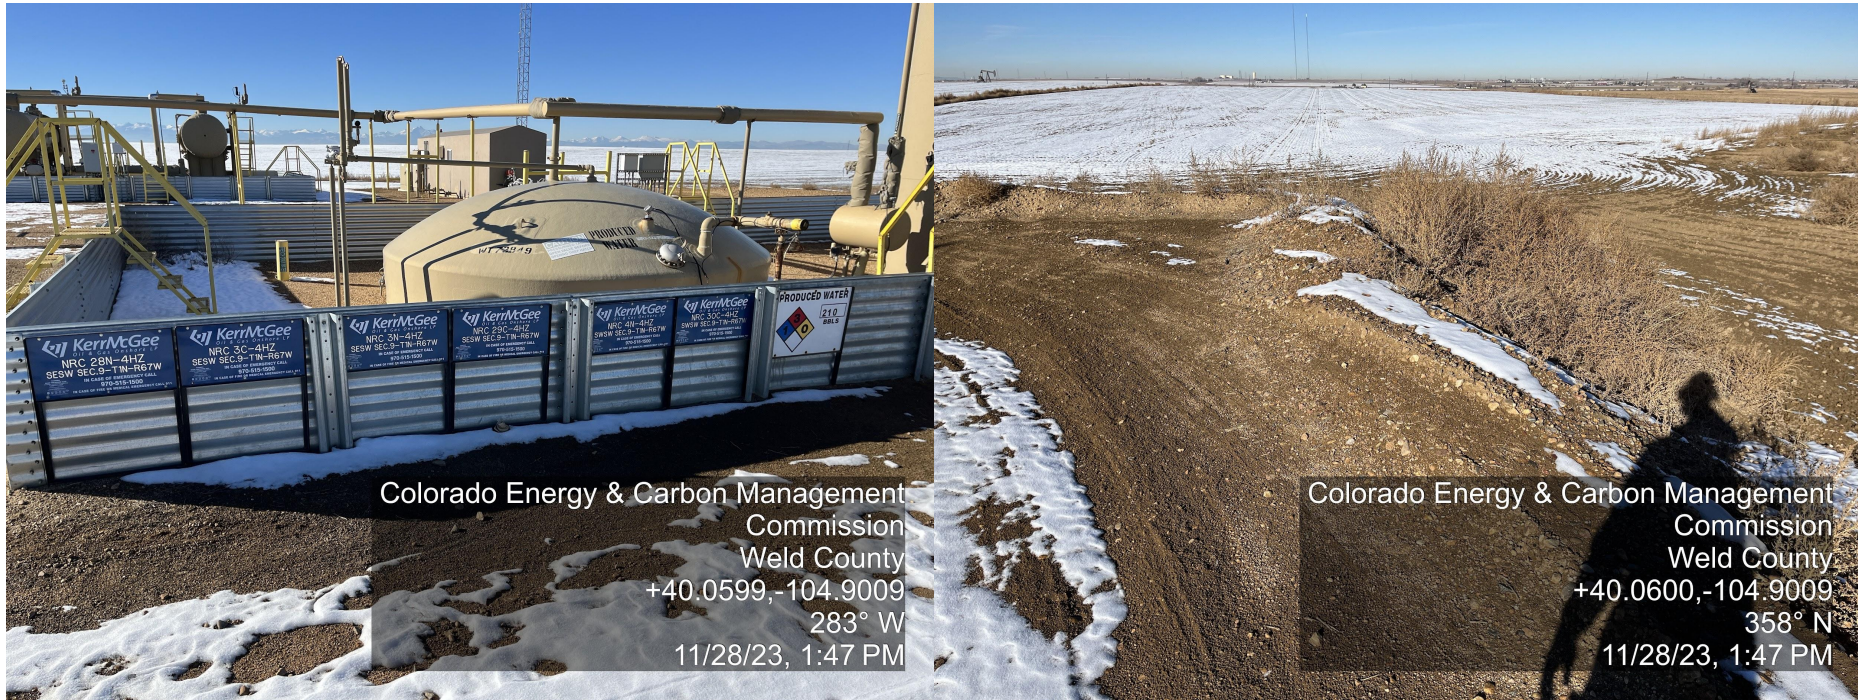
Photo 1. The photo was taken at the tank battery location facing West. The photo illustrates the operator well signs.

Photo 2. The photo was taken at the tank battery location facing North. The photo illustrates the tumbleweeds (kochia) growing around the boundary of the pad and well location.

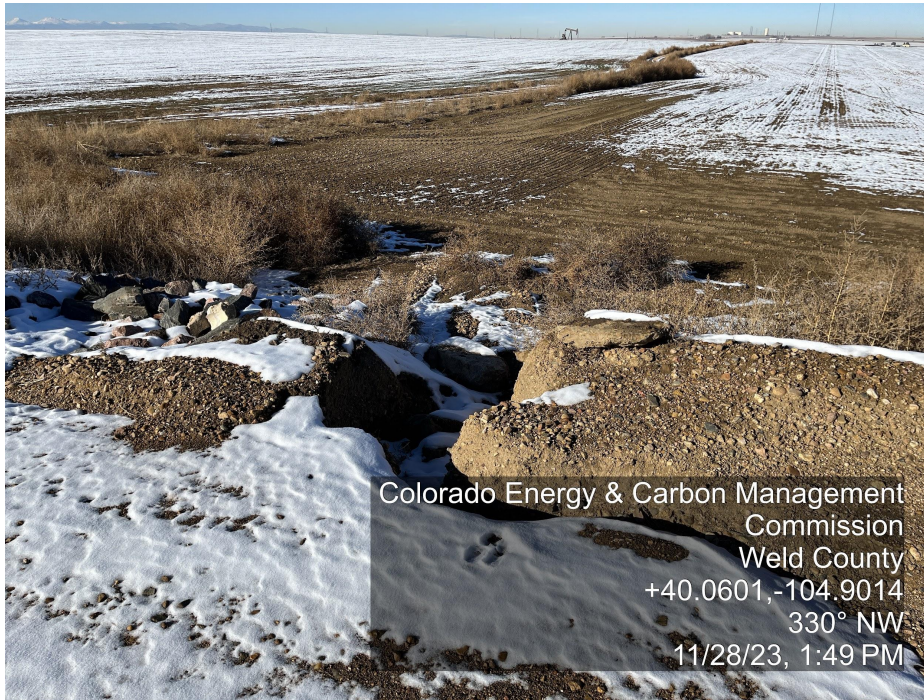
Photo 3. The photo was taken at the tank battery location facing Northwest. The photo illustrates rill erosion carrying sediment offsite.

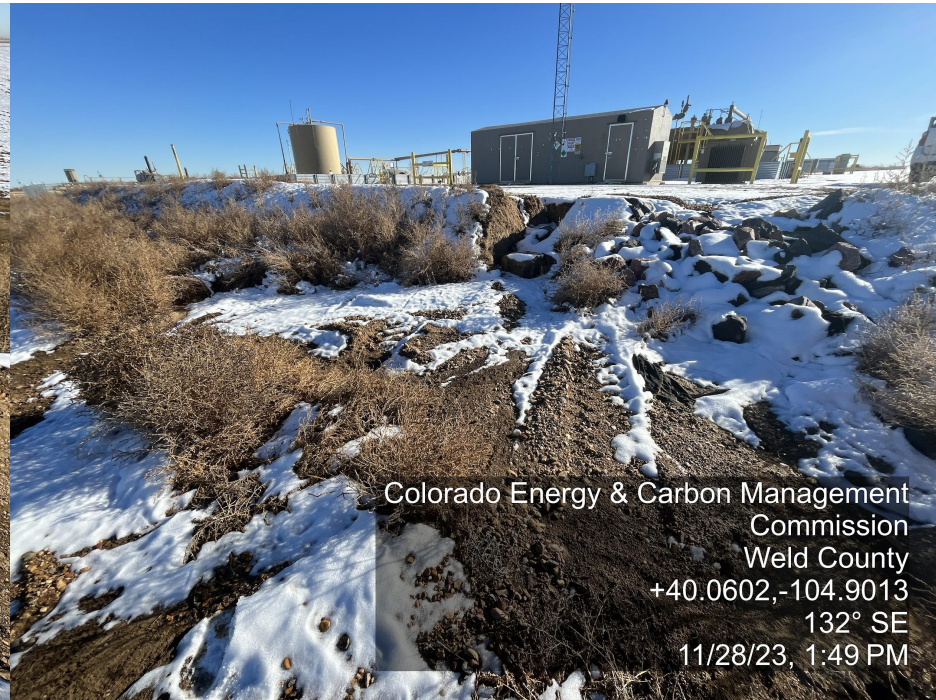
Photo 4. The photo was taken North of the tank battery location facing Southeast. The photo illustrates the erosion issue in photo 3 from the other side.

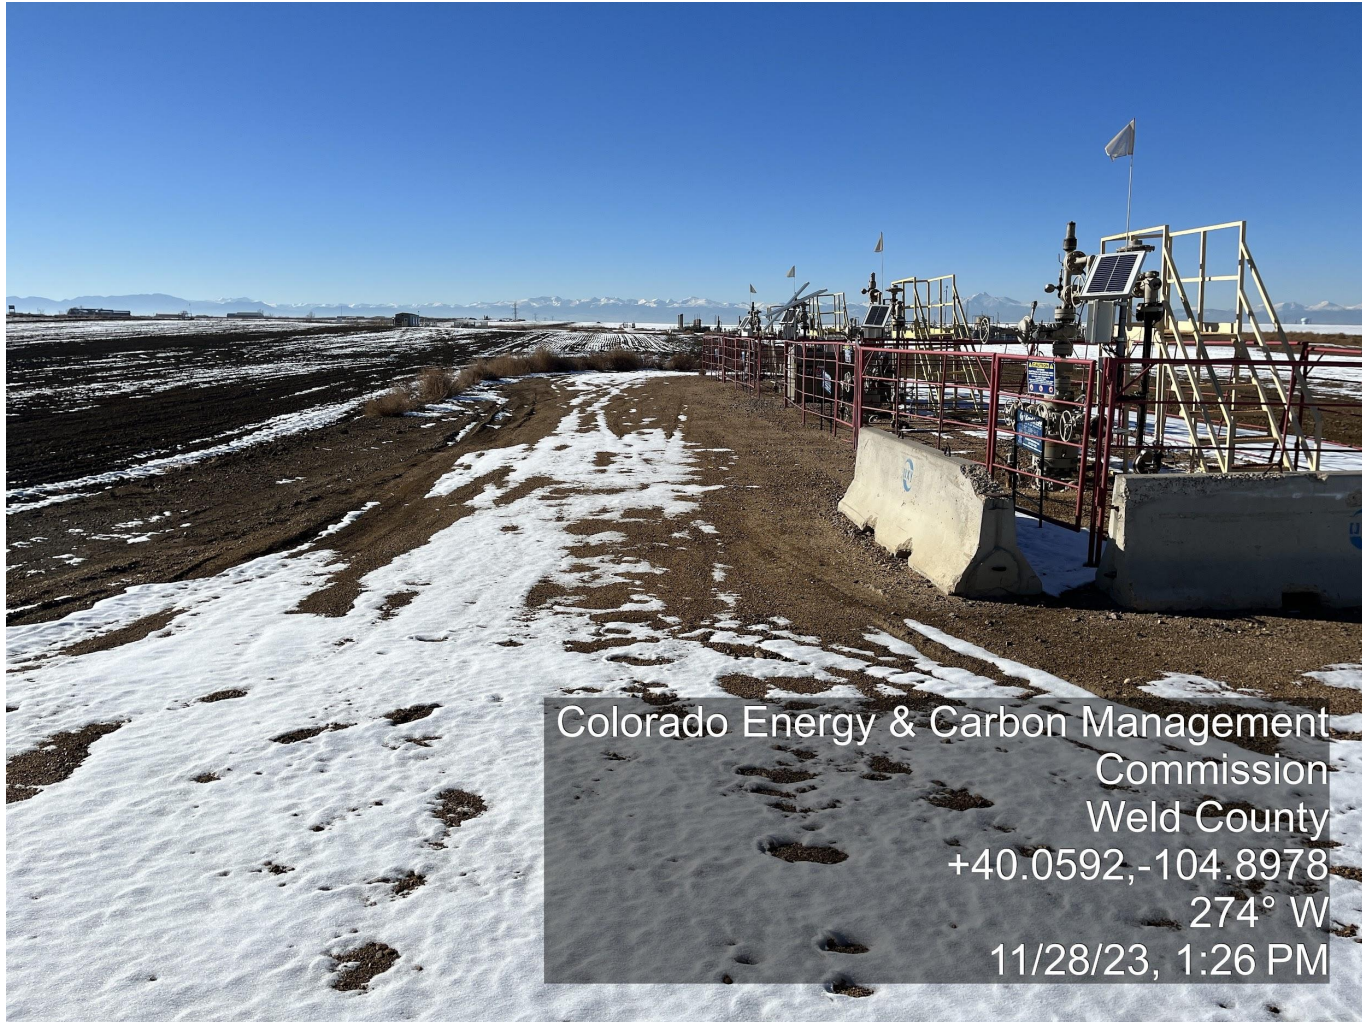
Photo 5. The photo was taken at the well location facing West. The photo illustrates the tumbleweeds growing along the edge of the pad.
