Inspection Photos

Operator: NONSUCH NATURAL GAS INC
#10163

Location ID: 324169

Inspection Doc: 696205434

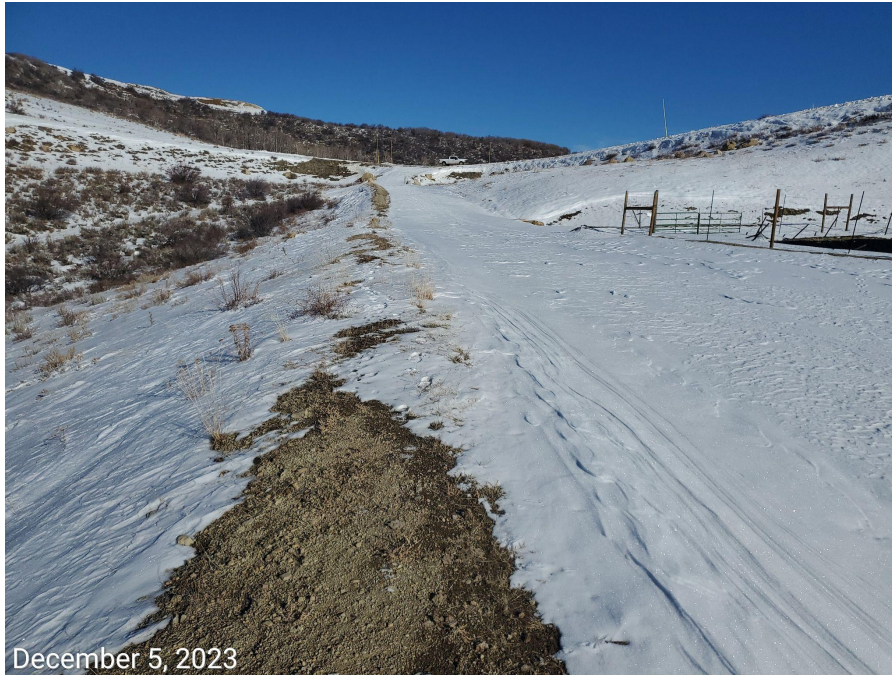
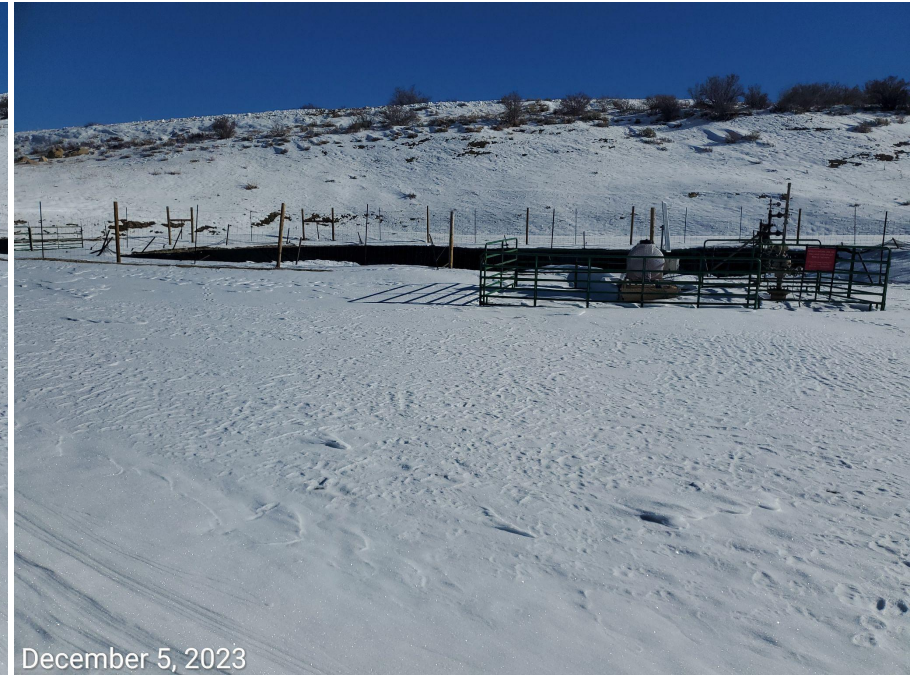
Photo 1: Photos 1-2 taken from southern working pad surface. Photos provide an overview of the Location from north, east to southeast.

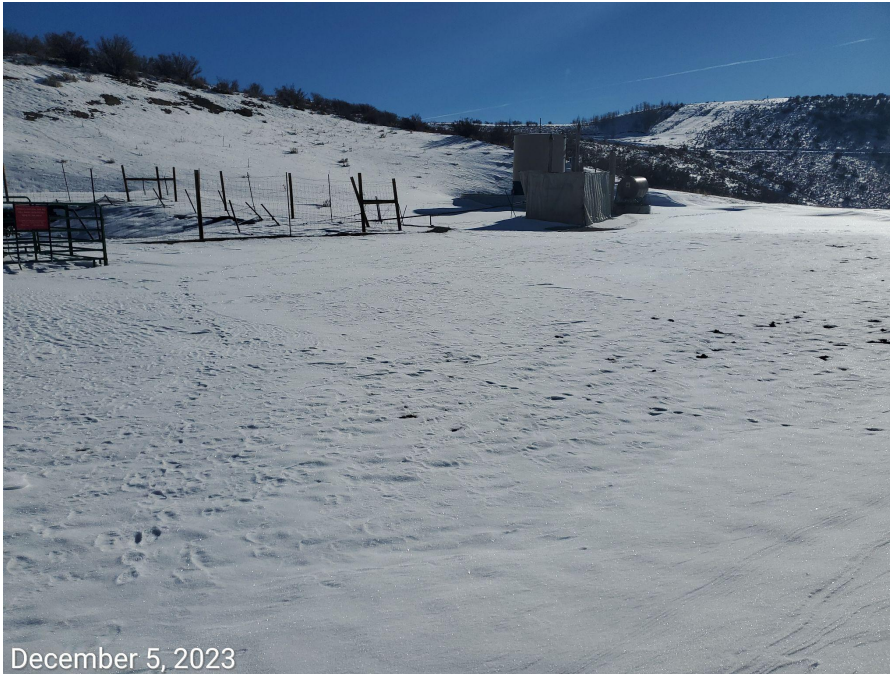
Photo 2: See comments under photo 2.

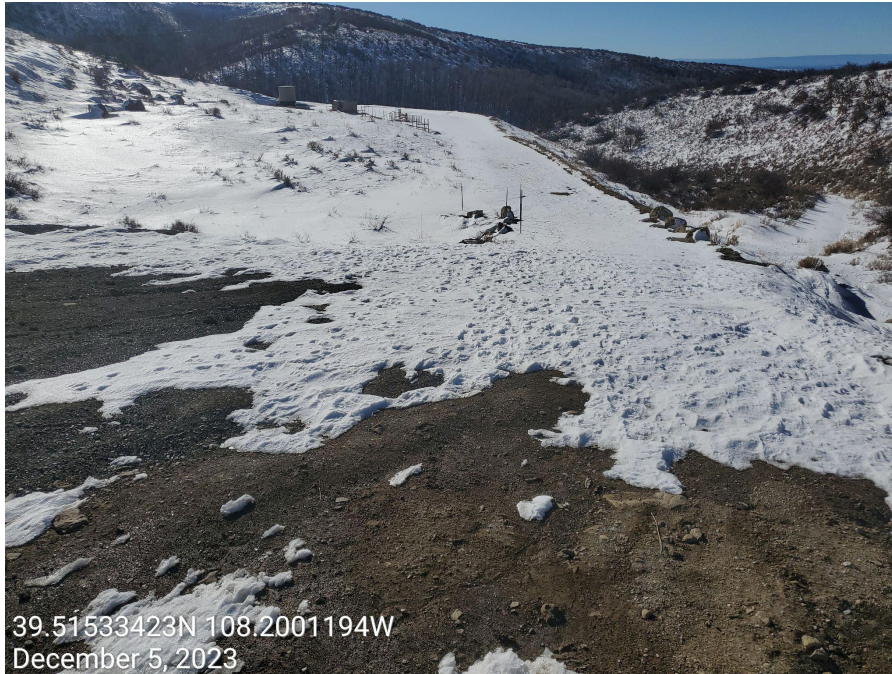
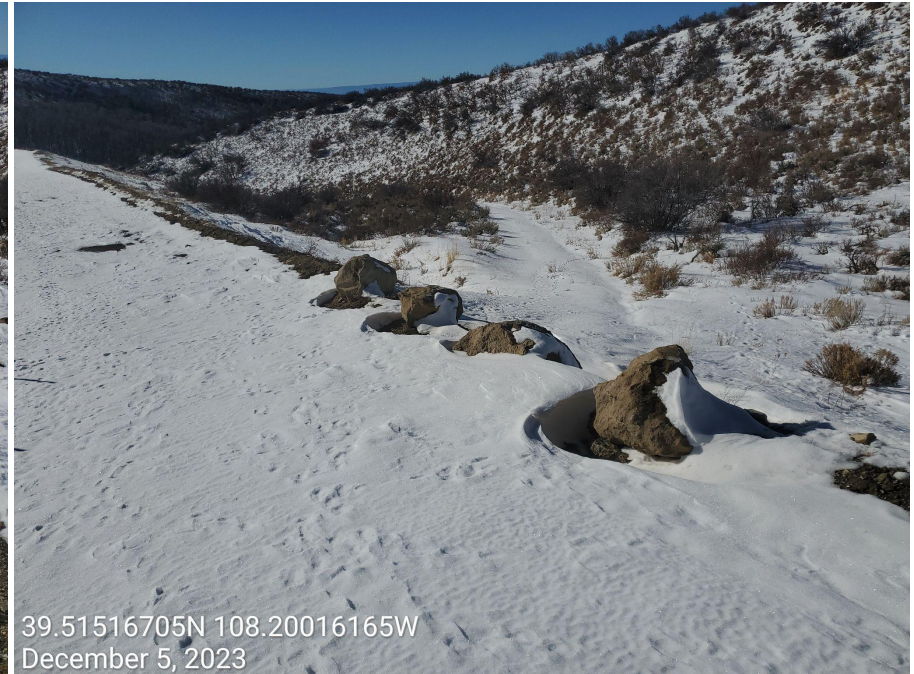
Photo 3: Photos taken from along the access road. Limited inspection due to snow cover, however, unable to find evidence that stormwater and erosion control measures to stabilize, minimize erosion, manage runoff have been implemented. Boulders have been placed along sections of the road. Operator's email communication to staff indicated that that the access road will be reconstructed to redirect runoff, and that a water bar (berm) will be installed across the entrance to limit runoff from Trail Ridge Road; unable to find evidence that this work has been performed.

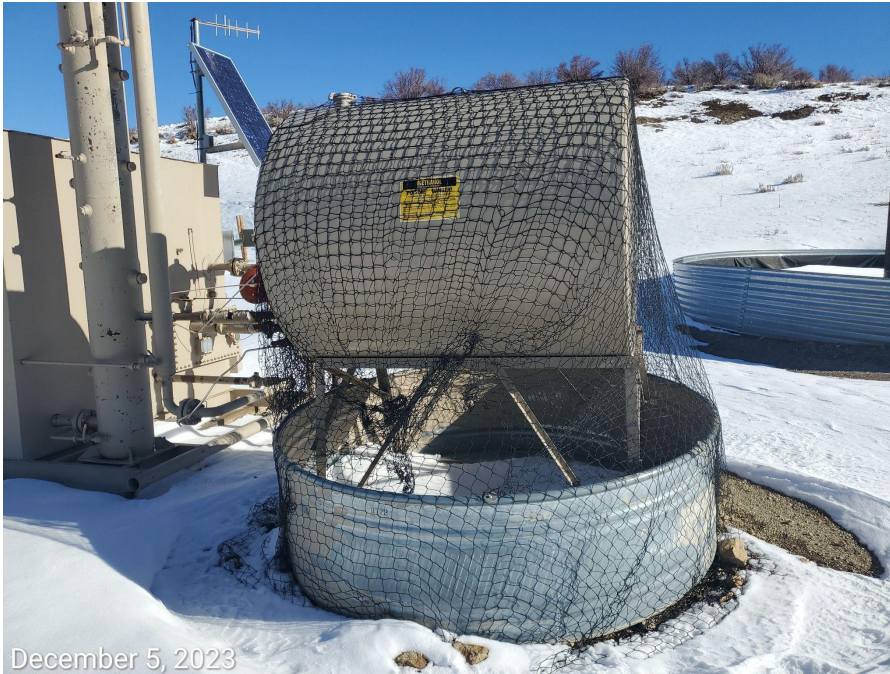
Photo 4: Wildlife protection devices (netting) has been maintained.

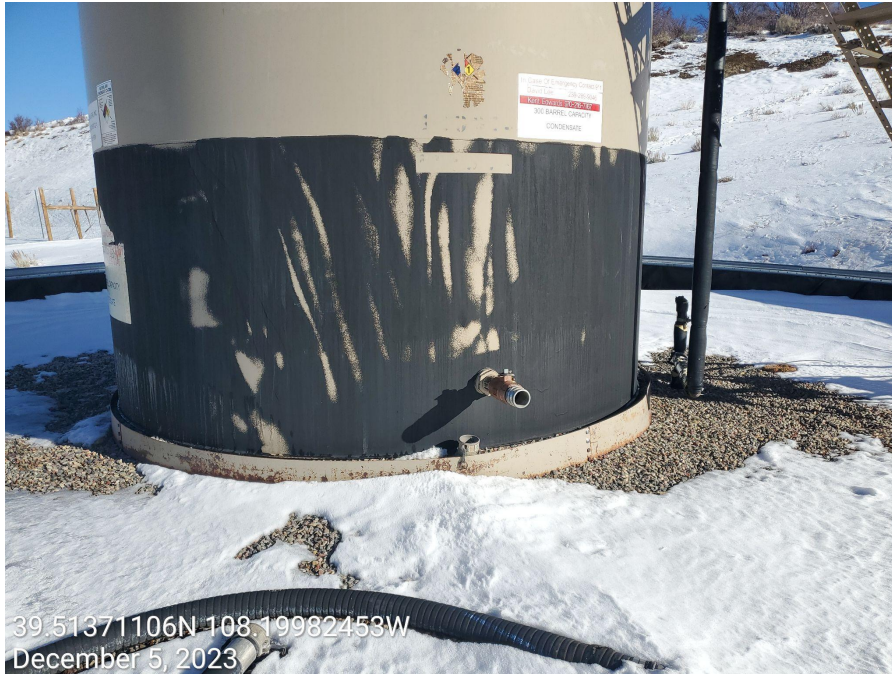
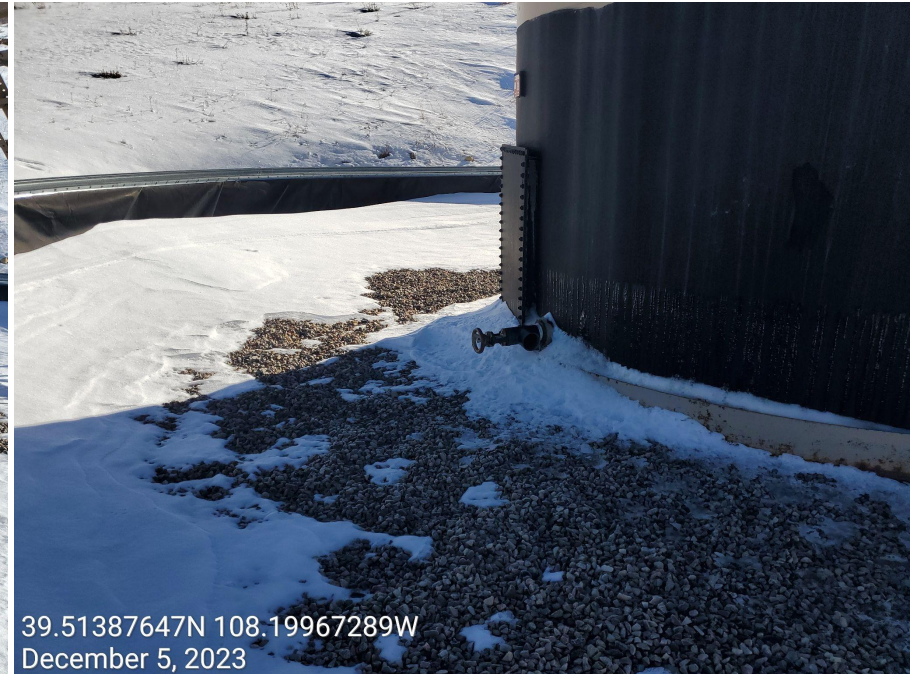
Photo 5: Caps/plugs missing from tanks.

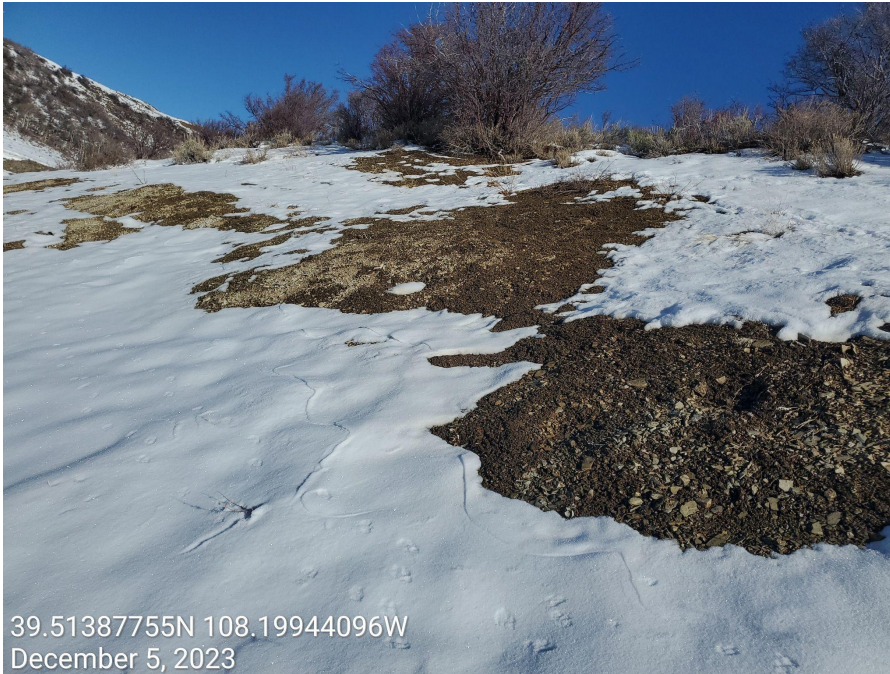
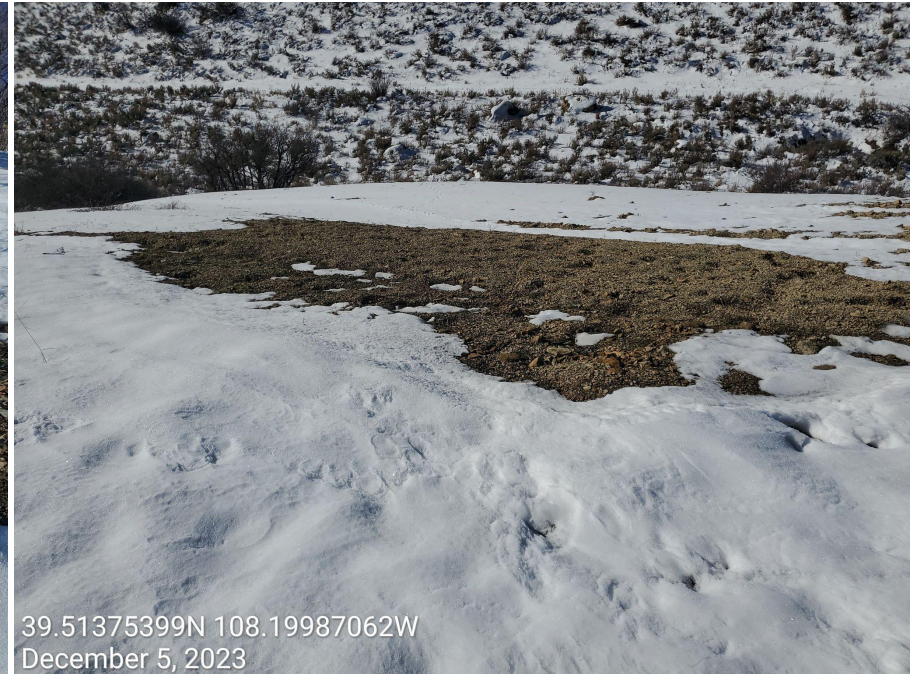
Photo 6: Limited reclamation inspection due to snow cover, however, unable to find evidence that additional reclamation/revegetation work was performed and control measures to stabilize the seeded soils installed per the corrective actions; areas of the Location that were observable remains predominantly bare.

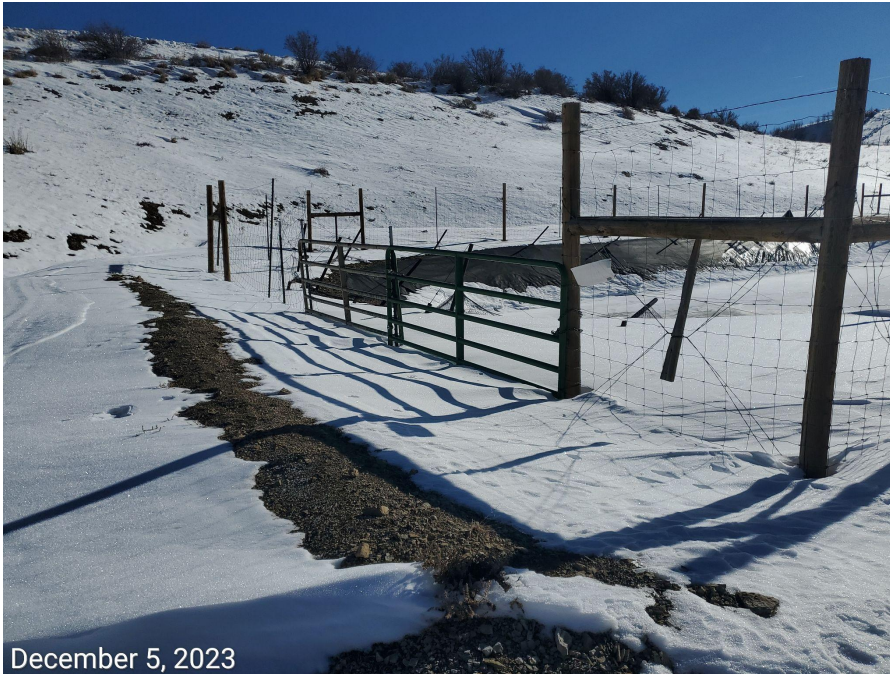
Photo 7: Photo taken from the pit. Gate/Fence has been repaired. Netting remains stored on the east end of the pit.

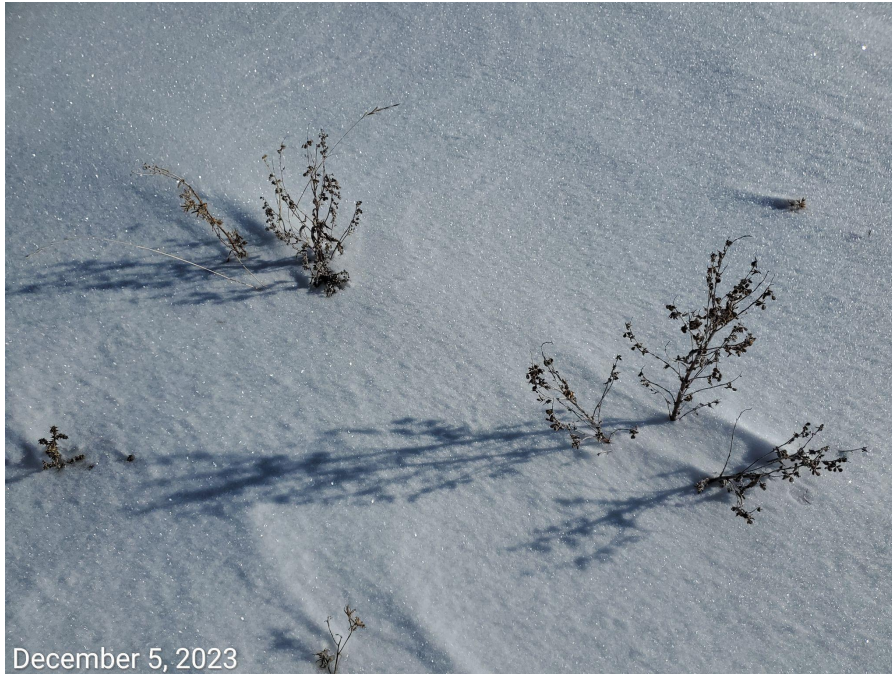
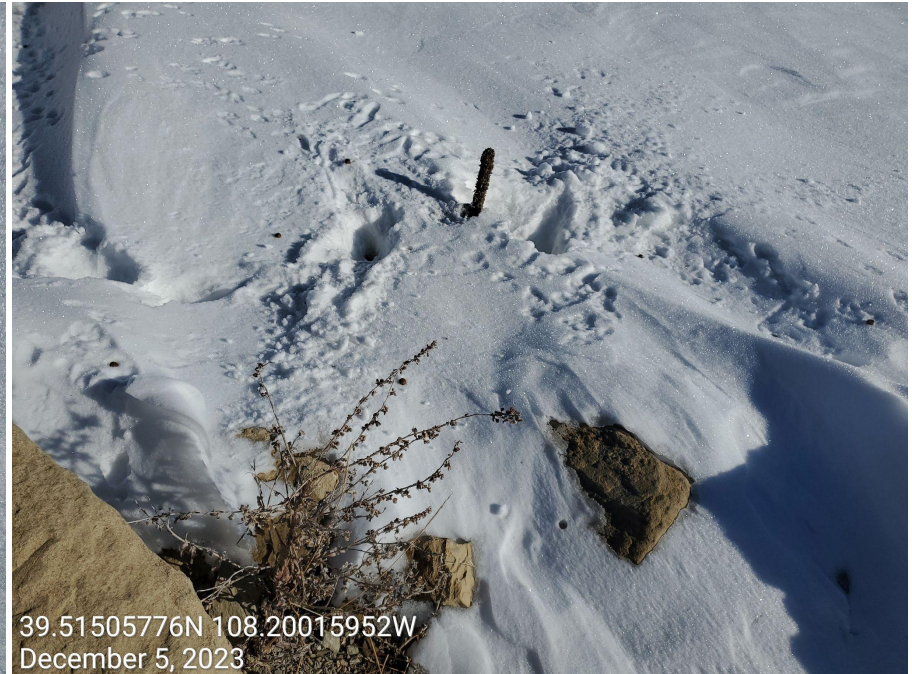
Photo 8: Photos examples showing Undesirable and noxious weeds observed in the previous inspection(s) throughout the Location and interim areas (houndstongue, mullein) were evident above the snow, have matured and produced seed. Ongoing weed management has not been performed, or remains inadequate to keep Location free of undesirable and noxious plant species.
