The final work steps addressing the ECMC inspection #693904348 for the AMOCO Legacy P&A Koon 1 API No. 05-067-06050 were complete 12/08/2023.

Attached are the completion photos for the Koon 1 PxA ECMC Inspection #693904348.

Koon 1 PxA API No. 05-067-06050
ECMC Inspection 693904348

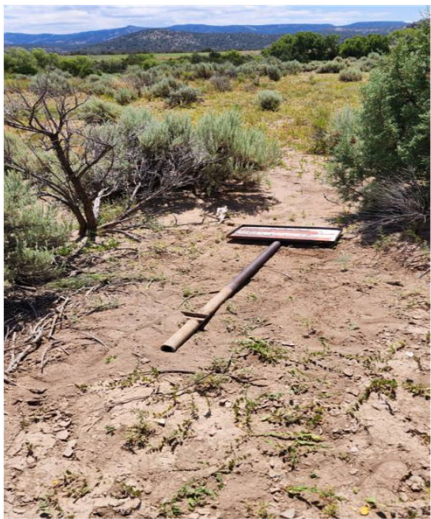
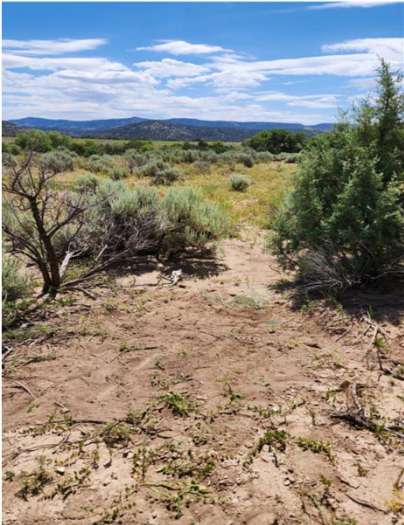
Before Sign removed. After

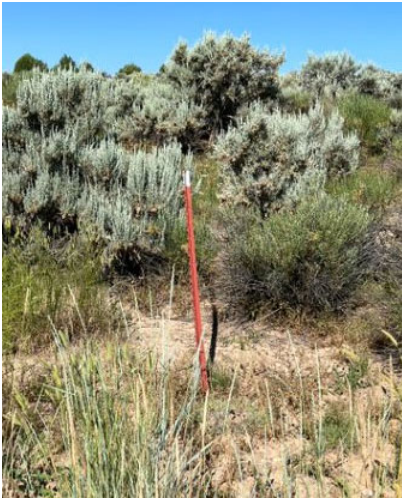
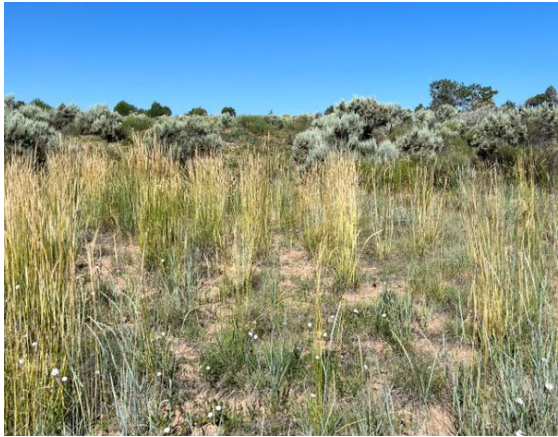
Before T-post removed After

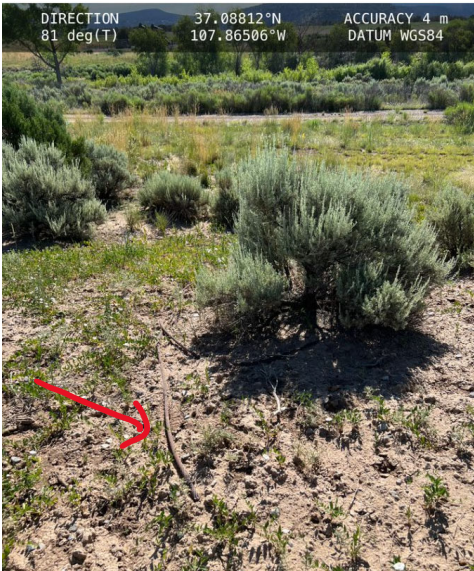
Before

Cable removed

After

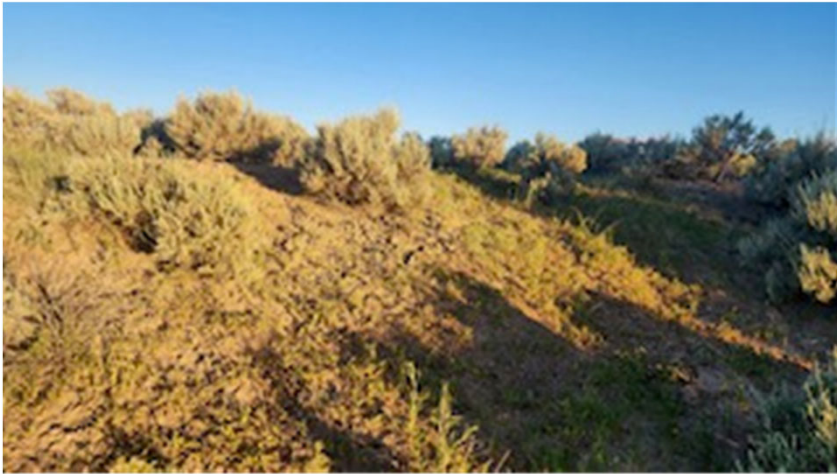
Picture of existing above ground valve, belongs to Harvest (took over Williams' assets) as shown on carsonite. Valve is part of active pipeline and not part of PxA. Harvest notified that valve could use a blind flange. This equipment is not SIMCOE's.

- Trash picked up – cable, sign, carsonite, white pvc tube, t-post
- Valve and riser shown in inspection photo #4 belongs to Harvest and is part of an active pipeline

system. Harvest took over from Williams; Williams is on the pipeline carsonite. Valve/riser is not SIMCOE's and not part of the plug and abandonment.

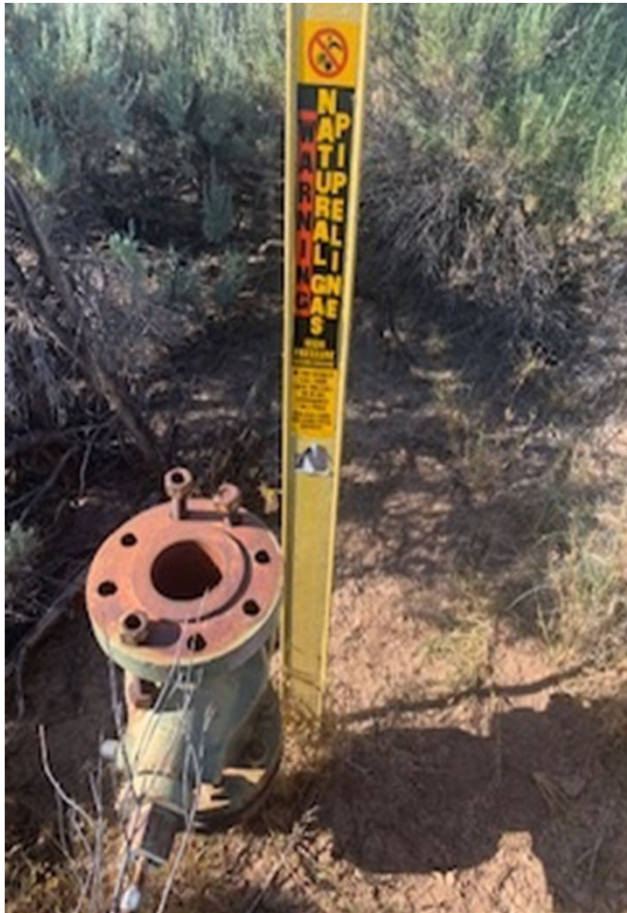
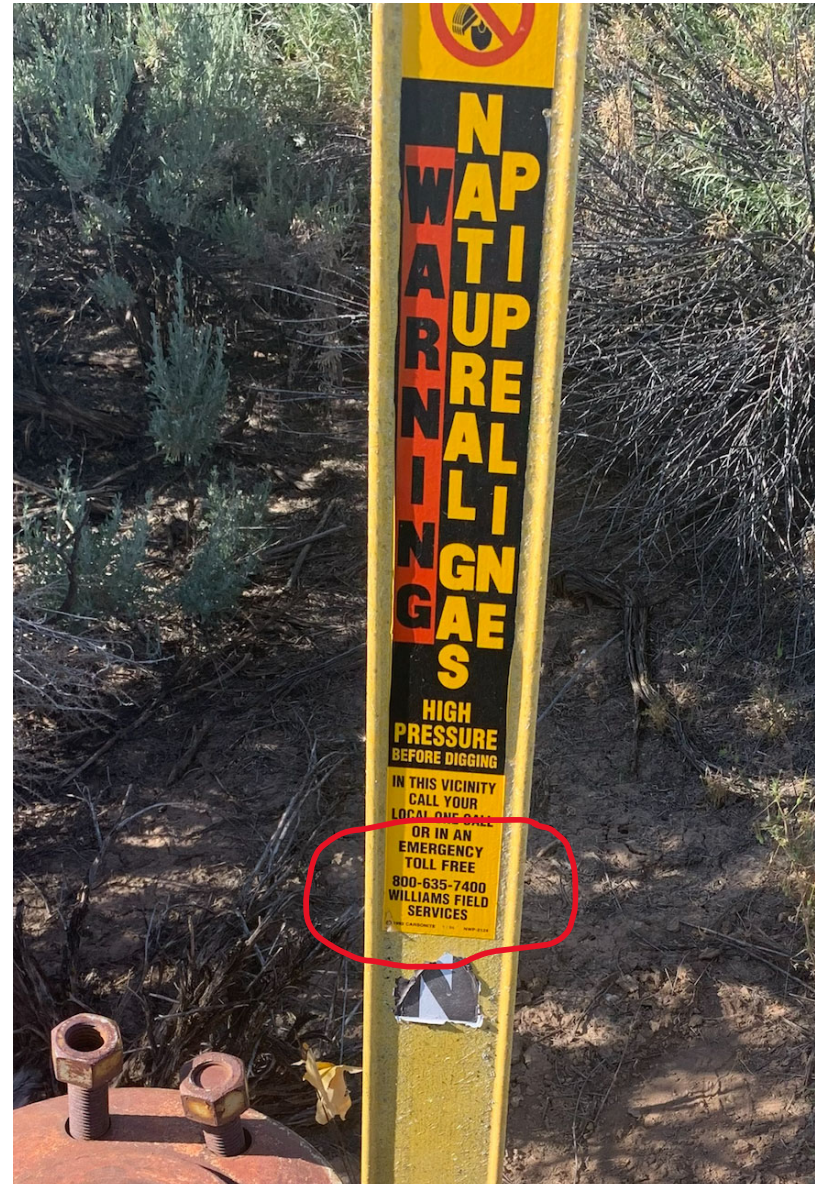
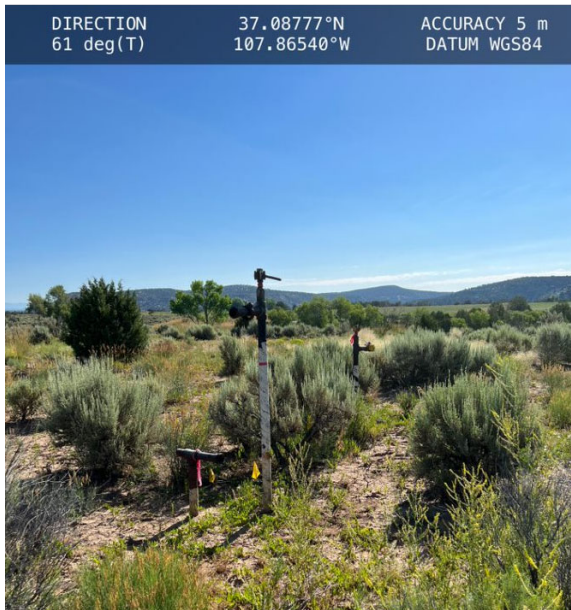
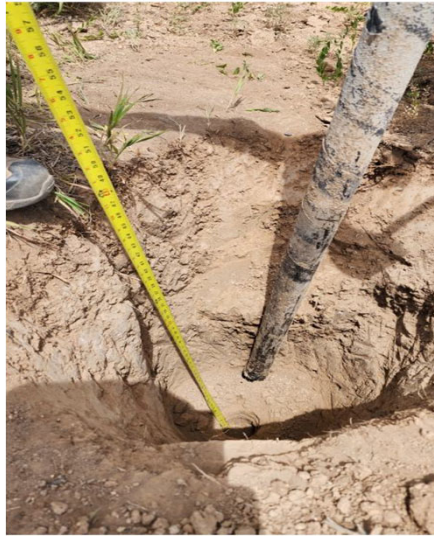
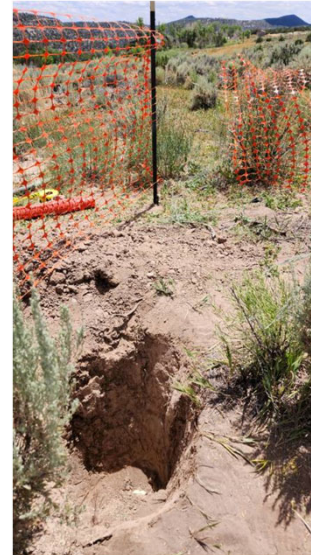
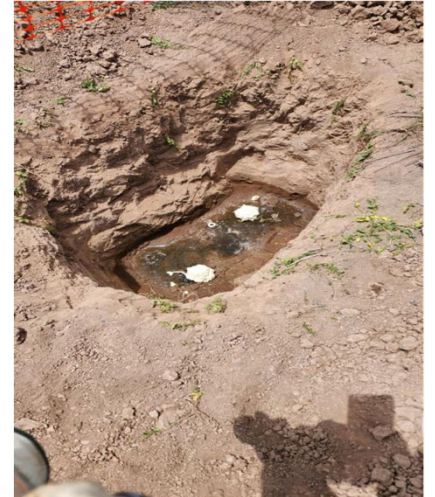
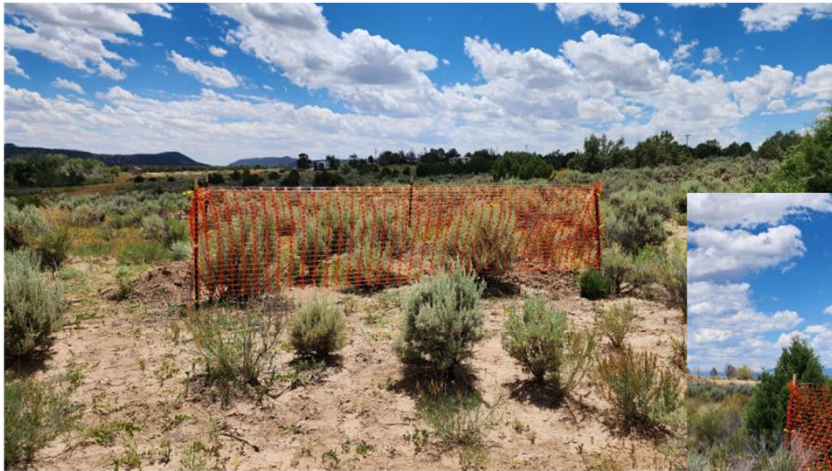
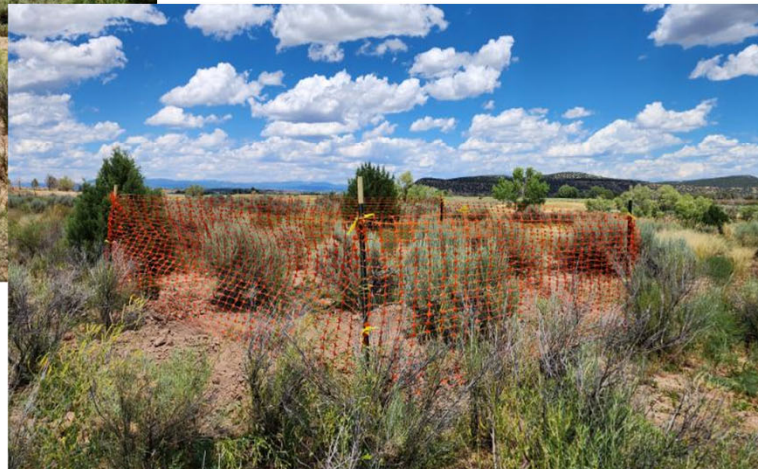
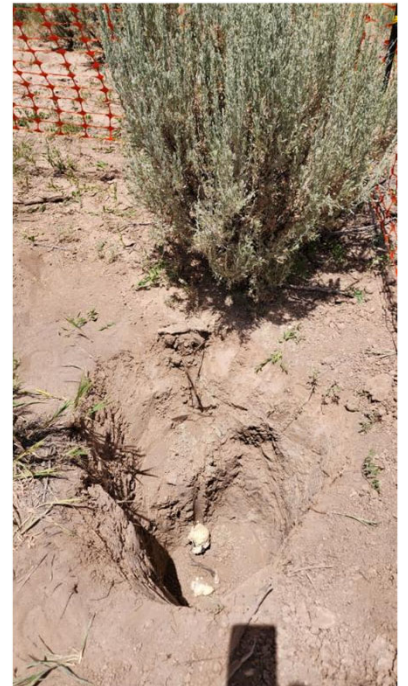
On location above ground flowline stubs removed. Cut and capped below grade. Completed July 2023

Before

After

- Cut and capped remaining on location flowline risers. Removed above ground items.

As part of the riser abandonment, samples were taken at the on location flowline abandonment locations. One location did not meet all the ECMC Table 915-1 requirements. SIMCOE plans to treat this location and resample. SIMCOE is working with the ECMC via Form 27's on this remediation. Removal of netting, backfilling of flowline holes, and seeding will be performed once the remediation and sample results are approved. This is still in progress.

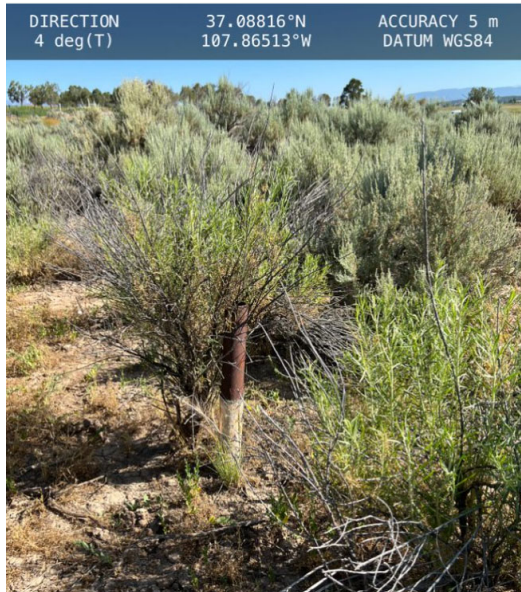
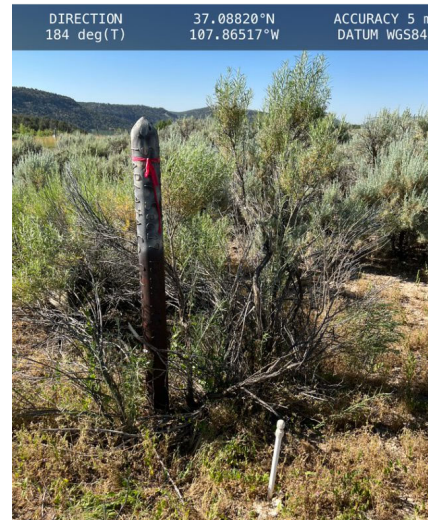
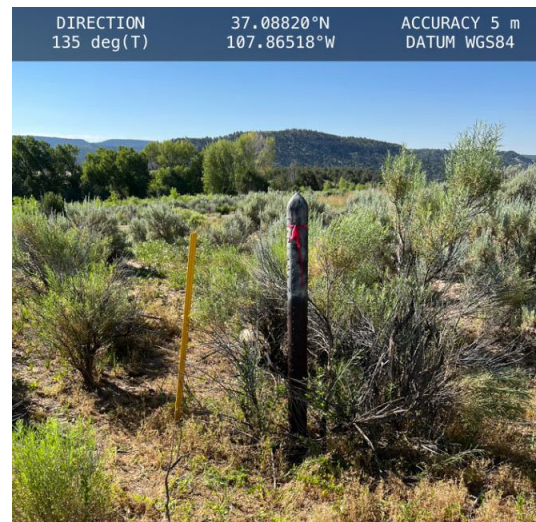
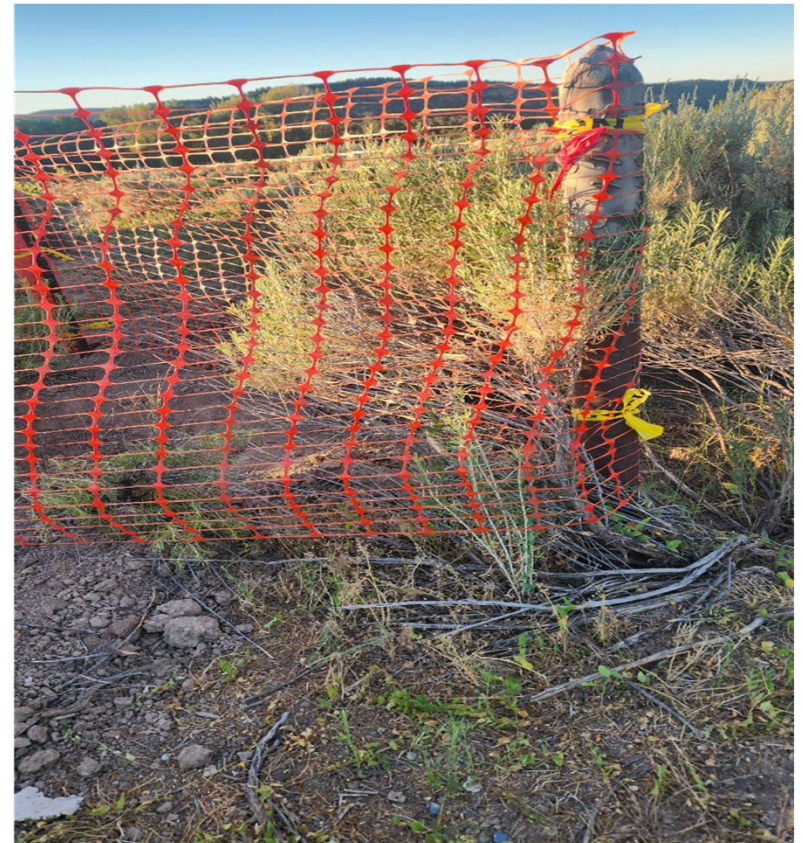
On location above ground flowline stub and trash near marker removed. Cut and capped below grade. White PVC is not flowline riser, just trash. Carsonite removed. Completed July 2023.

Before

After

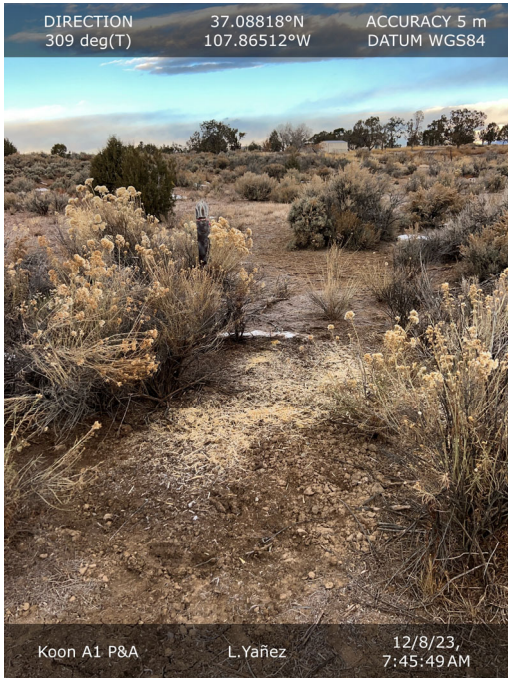
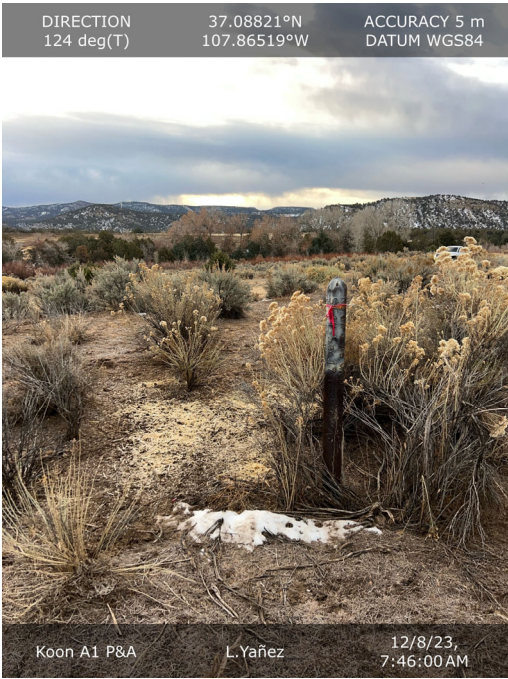
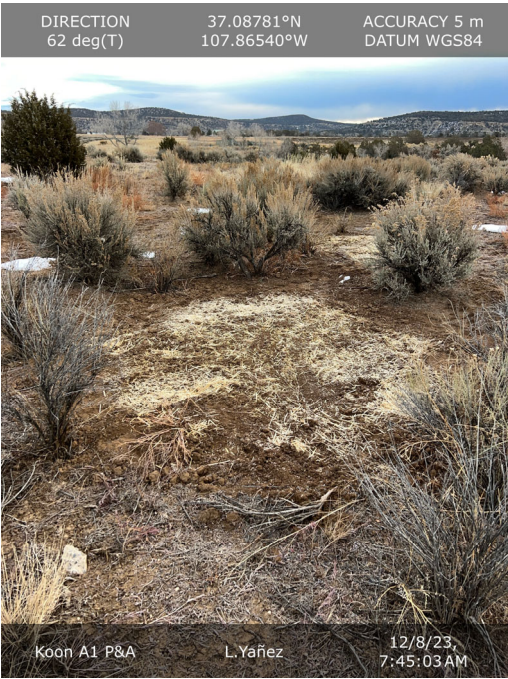
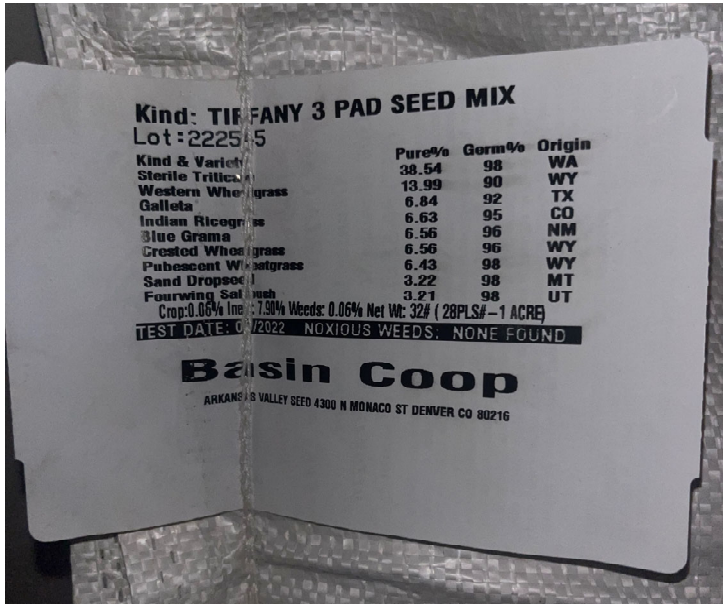
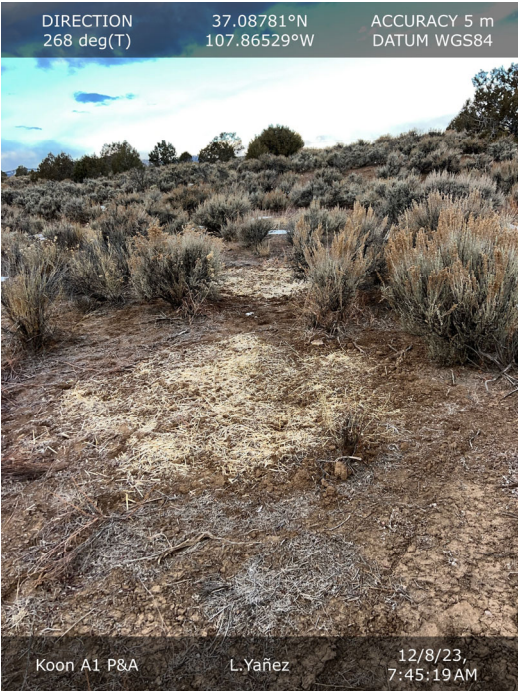
Post sample results below thresholds, holes backfilled, and seeded. Completed 12/8/2023.

Much of this work was complete in July 2023 but we needed to work through the on location flowline abandonment sampling and remediation steps. Once the samples passed the required ECMC threshold values, we backfilled and seeded the disturbances.
