Inspection Photos

Operator: CAERUS PICEANCE LLC #10456

Location ID: 335000

Inspection Doc: 696205494

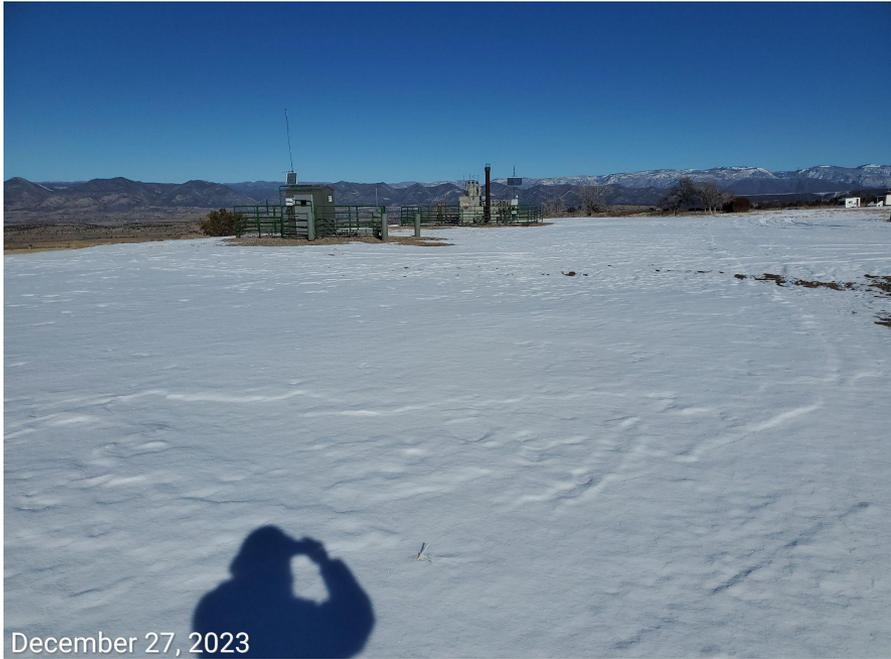
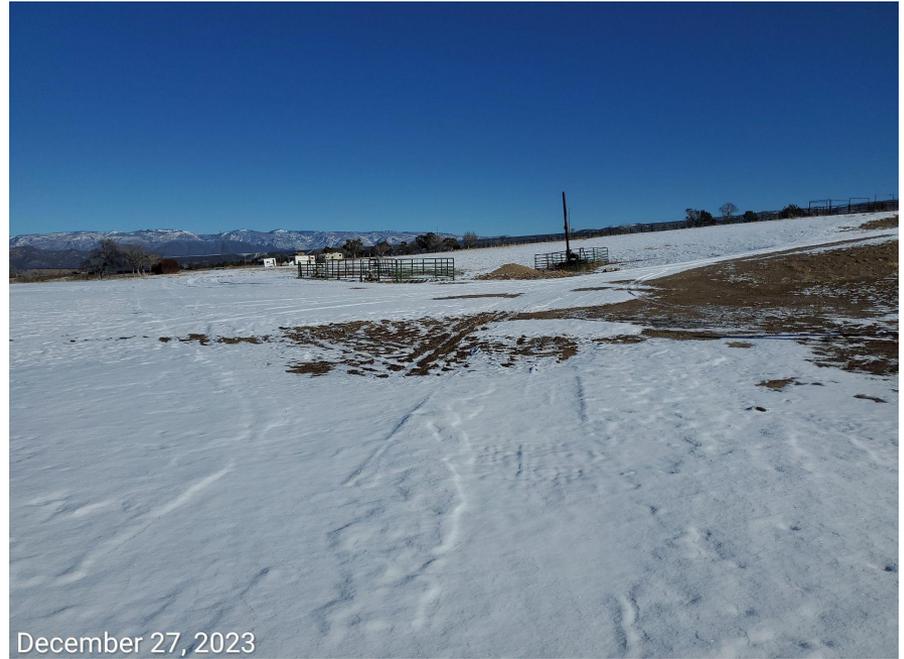
Photo 1: Photos taken from the west end of the Location. Photos provide an overview of the Location from northeast to southeast.

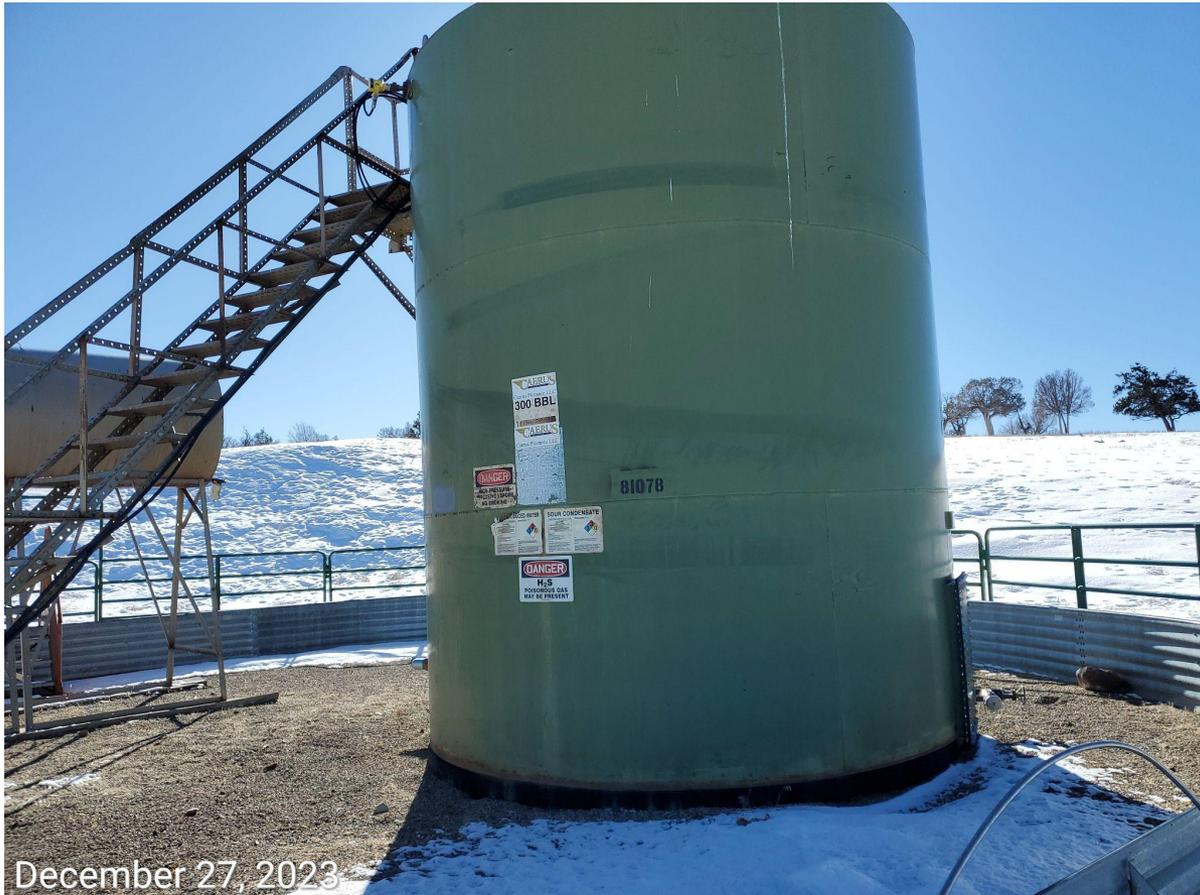
Photo 2: Tank battery facility on the south end of the Location.

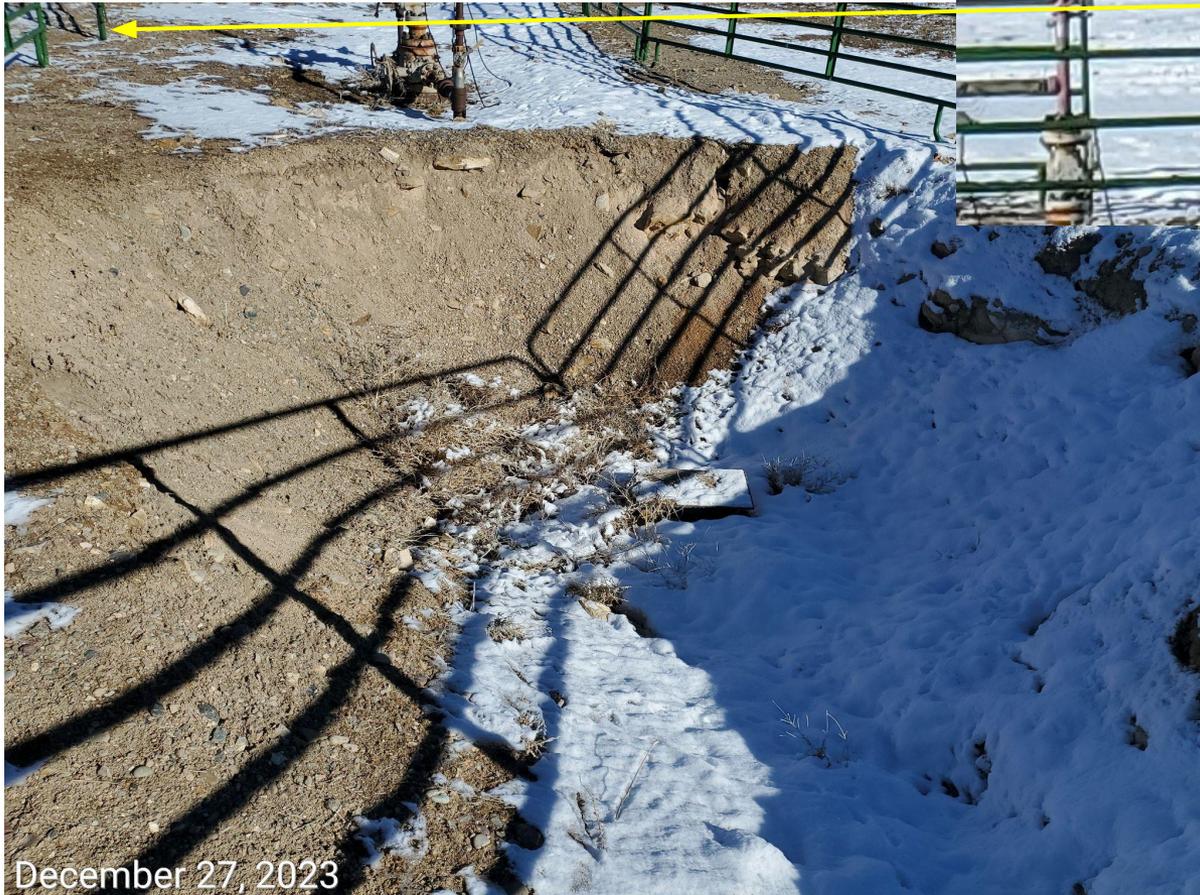
Photo 3: Photo shows the excavation associated with the PAd well 045-09327 has not been backfilled. Photo top right shows gap in fencing around wells; BMPs to prevent livestock access to the wells and excavation is inadequate.
