Final Reclamation Inspection

Operator: EDGE ENERGY II LLC - 10671

Location ID: 422460

Inspection Photos
Location Name: RAWHIDE FLATS 10-68-16 #1H
Location ID: 422460

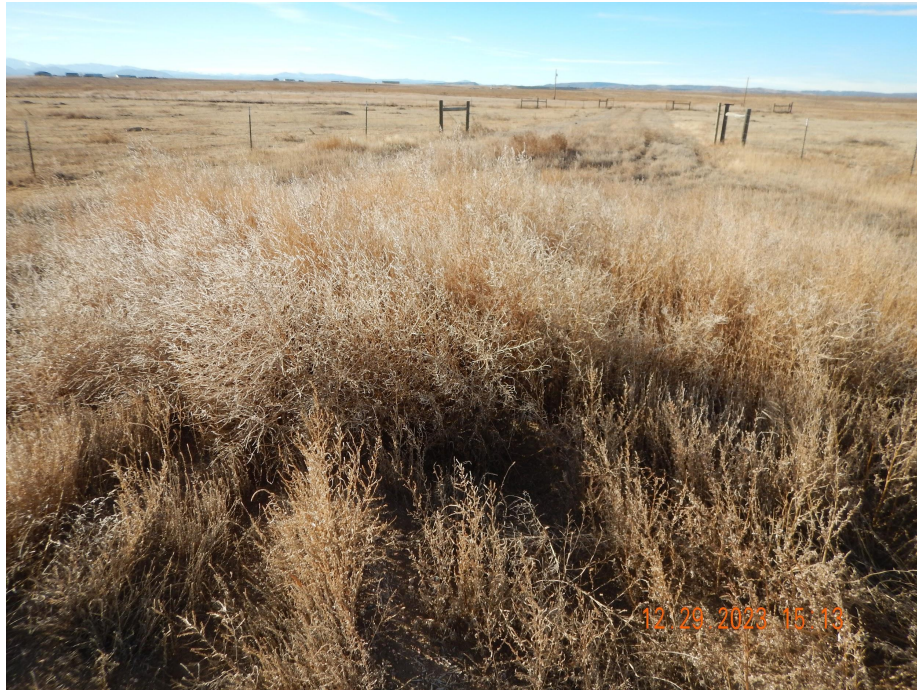
Photo 1. Photo taken from the entrance of location off CR7, facing West. Photo illustrates unmanaged weeds. Also gravel and the cattle guard remain- refer to Photo 2.

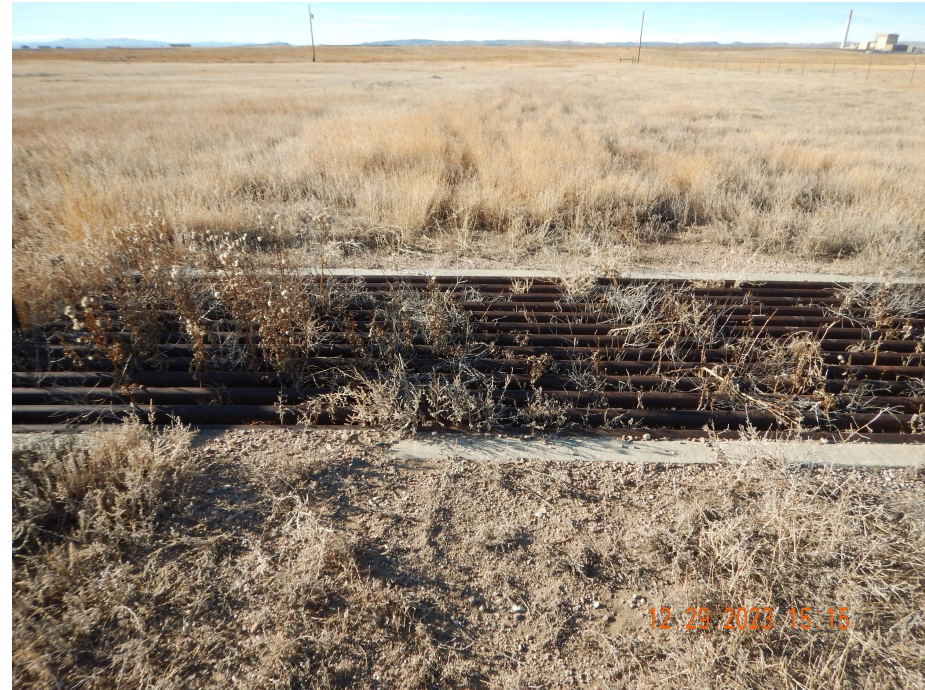
Photo 2. Photo taken from the entrance of location, facing West. See comments under Photo 1.

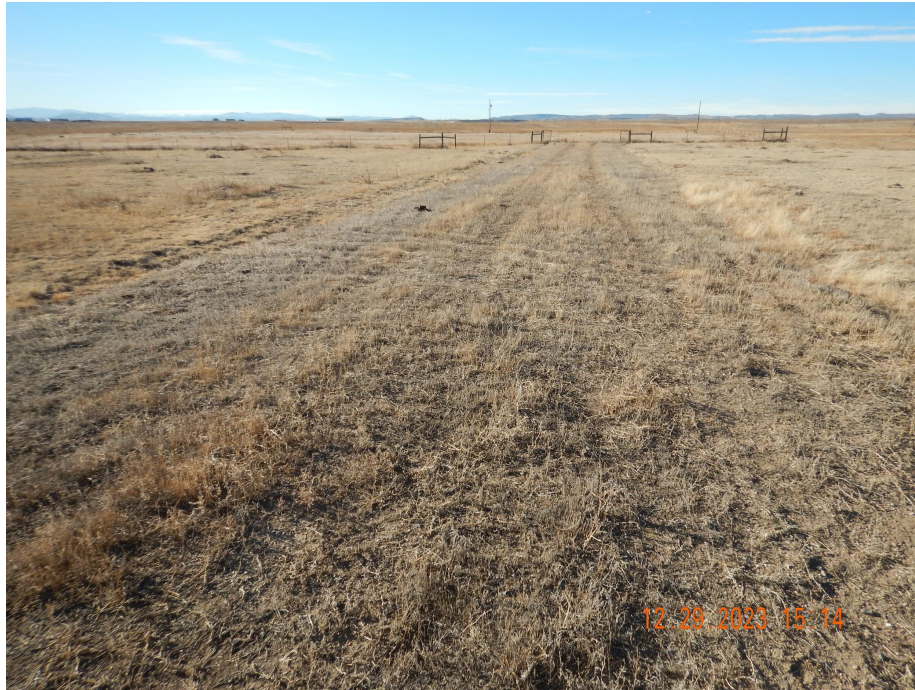
Photo 3. Photo taken from the eastern access road, facing West. Photo illustrates the Operator failed to properly recontour the access road and does not appear to have removed all the gravel. Also, there was no desirable vegetation establishment.

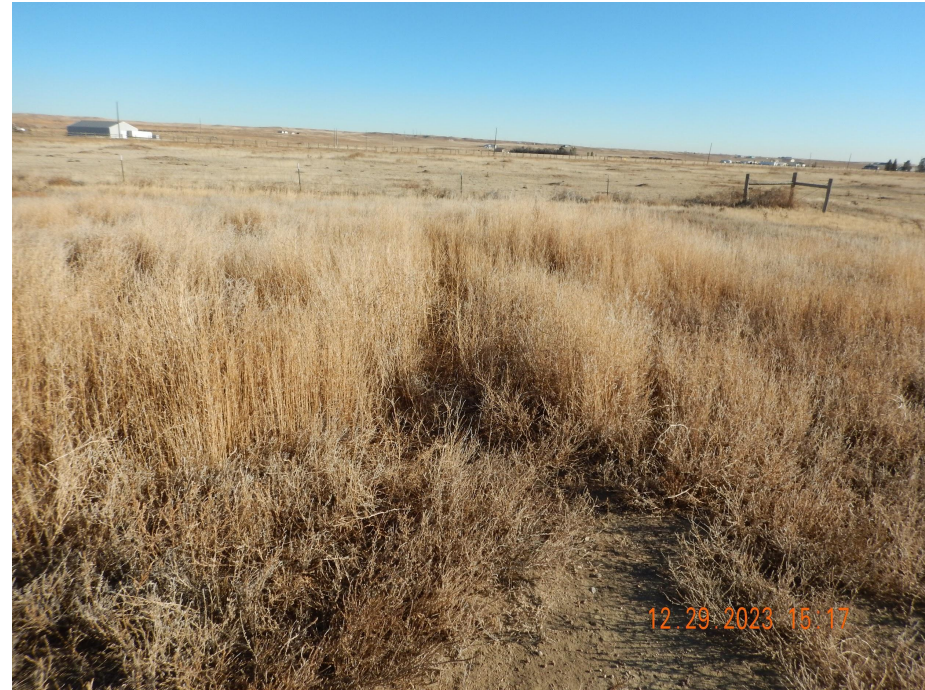
Photo 4. Photo taken from the southeastern location, facing East. Photo illustrates unmanaged weeds which were observed throughout the entire location.

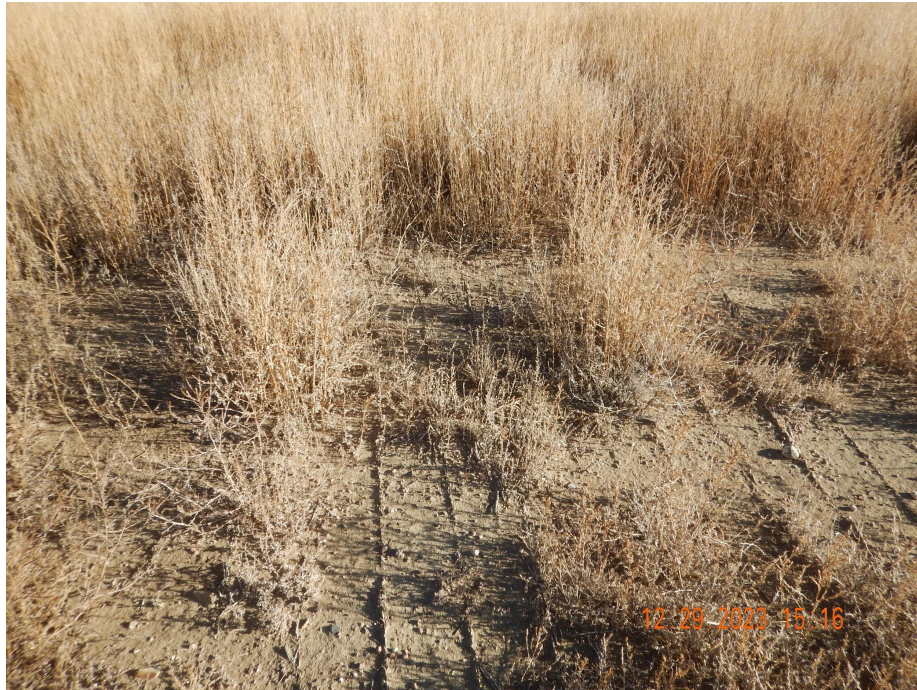
Photo 5. Photo taken from an area at the location. Photo illustrates the evidence of drill rows indicating final reclamation was performed. However, there was not any desirable vegetation observed.
Note- there was some straw mulch observed in areas.

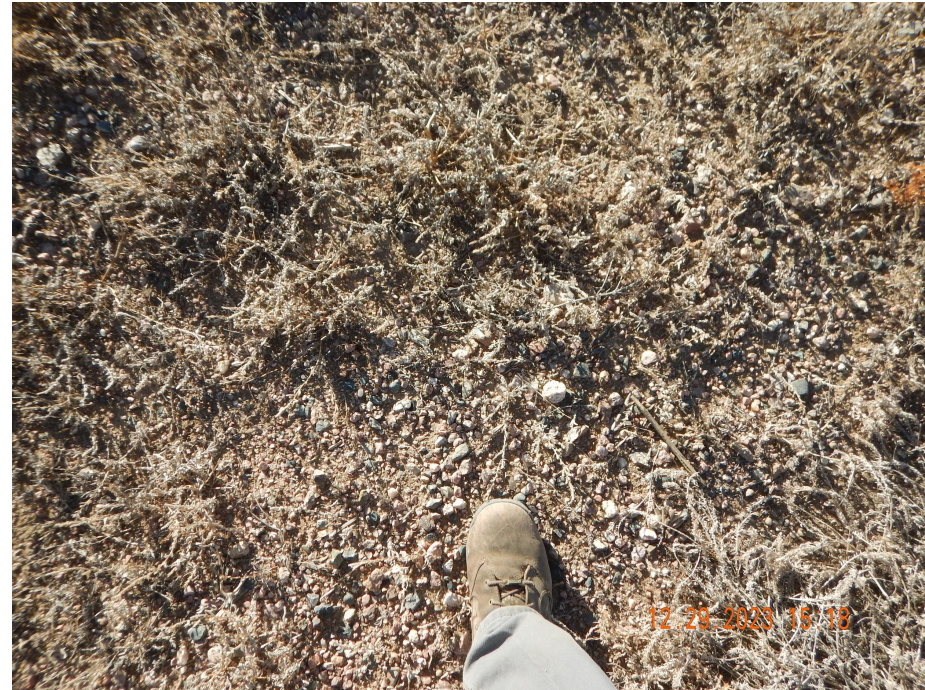
Photo 6. Photo taken from an area at the location. Photo illustrates the Operator did a poor job at removing gravel.

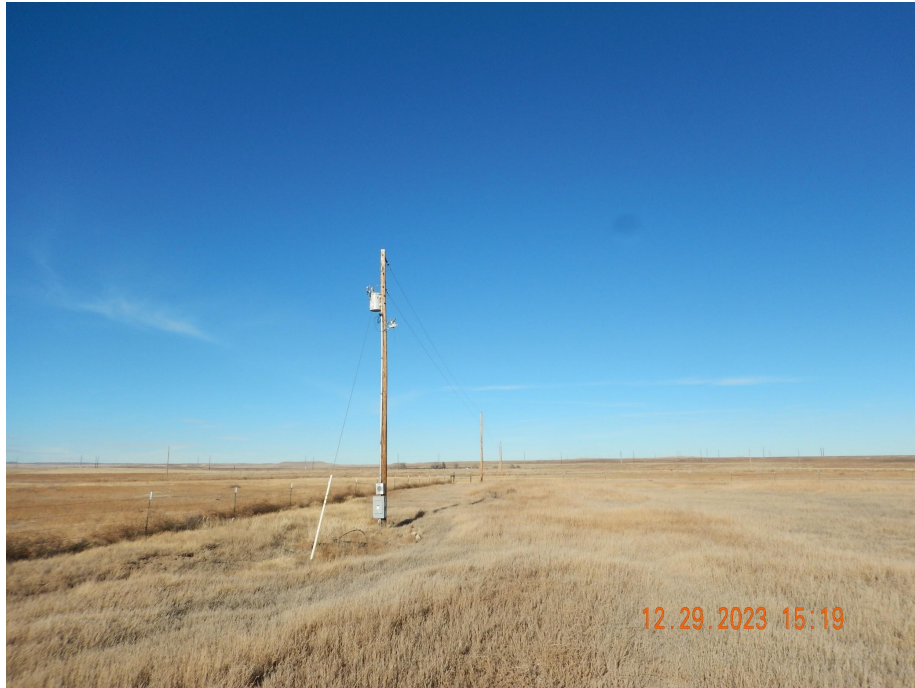
Photo 7. Photo taken from western location, facing North. Photo illustrates power lines remain at the location, which were installed for oil and gas operations.

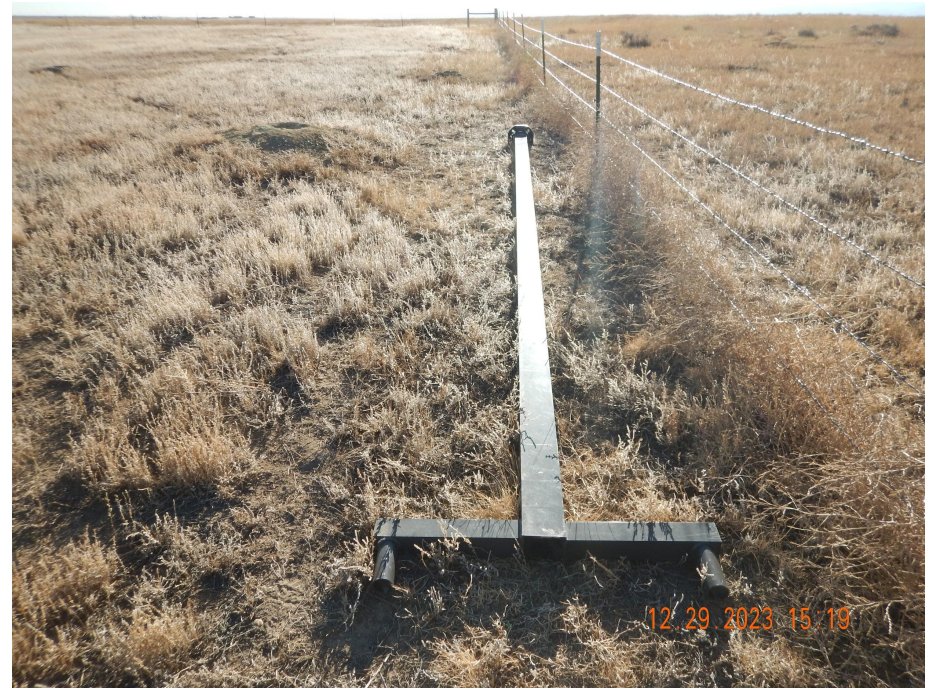
Photo 8. Photo taken from western location. Photo illustrates debris left behind.

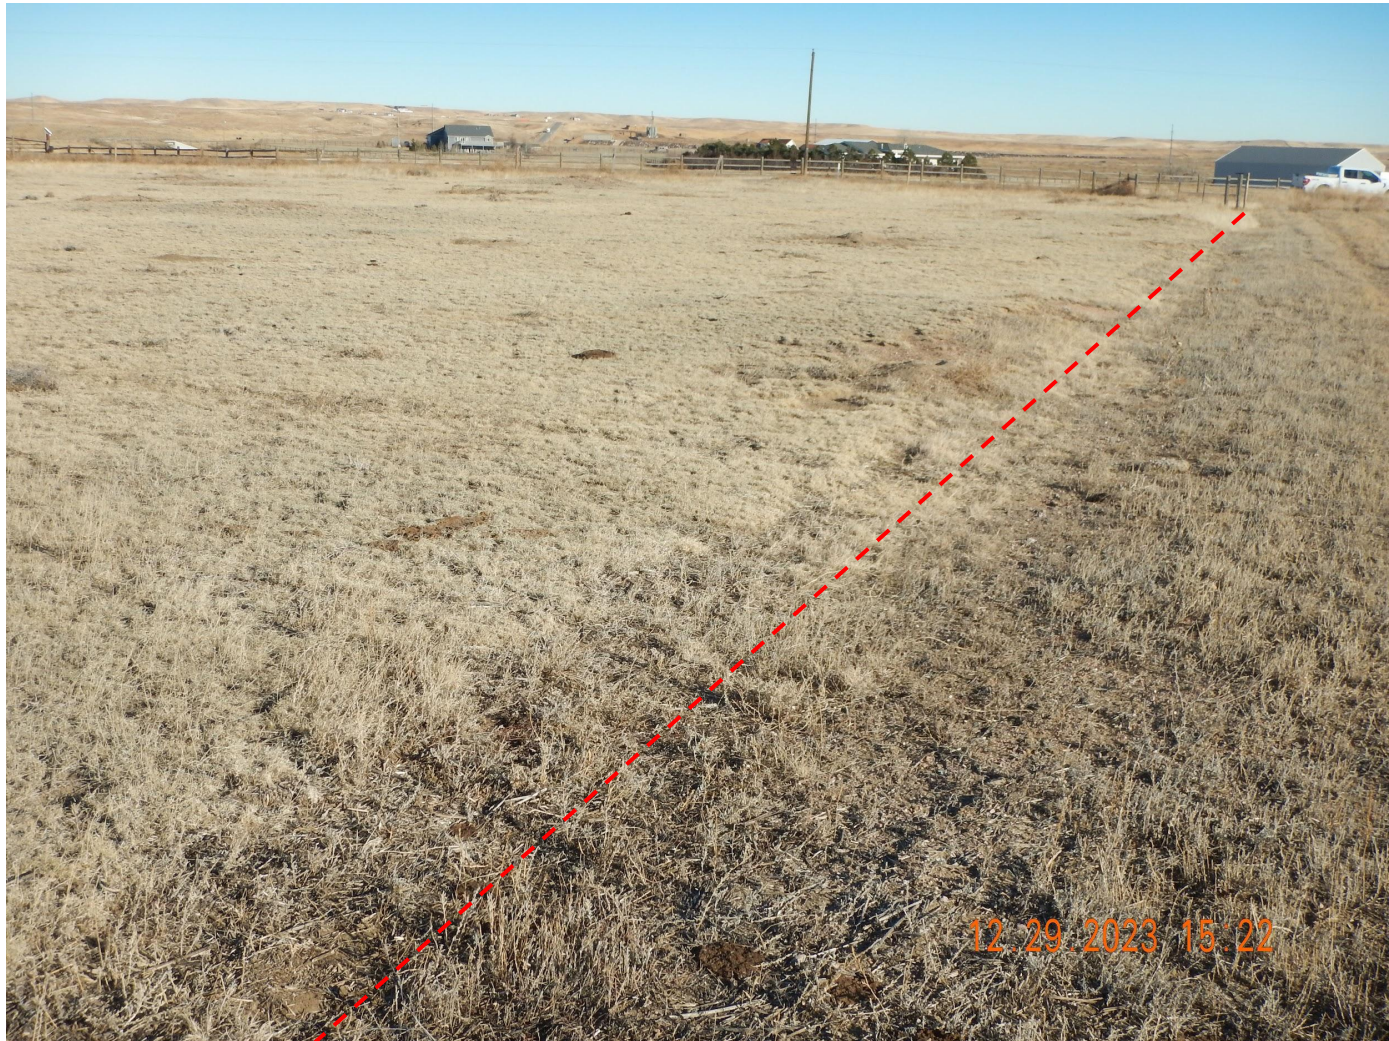
Photo 9. Reference are photo taken along the access road, facing East. Reference area to the left of the red-dashed line; unreclaimed access road to the right of the red-dashed line.
