**Operator: BONANZA CREEK ENERGY OPERATING COMPANY LLC**

**Location Name: Antelope F-15 Pad**

**Loc ID: 429977**

**Inspection: 696305514**

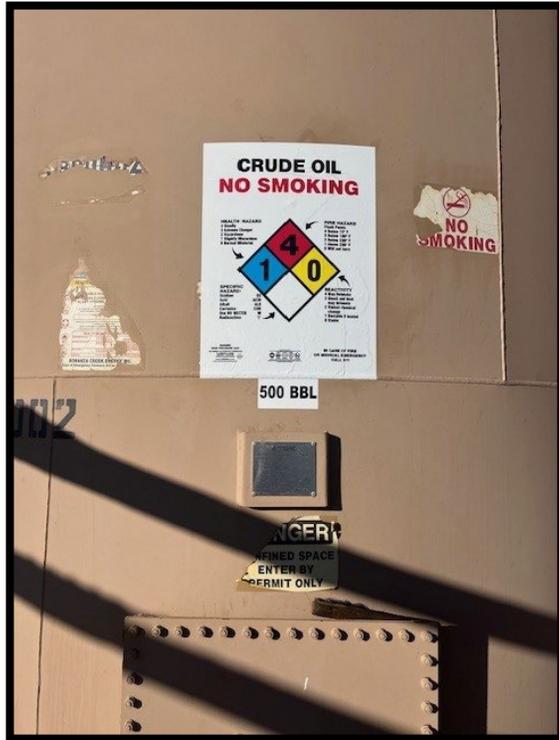
Exhibit A

**CA:** EAST TANK BATTERY LABELS - #1336 - NFPA and Content. #220404 - Content, Capacity and NFPA. #220403 - NFPA. #220402 - Capacity and Content. #220401 - NFPA. East side of East Tanks - far North Tank - Capacity. Far South Tank - Content, Capacity and NFPA. See photos. Install sign to comply with Rule 605.h.

**CA Resolution:** Operator has installed updated NFPA and Capacity signage on the identified tanks. Contents signage is in the process of being installed to ensure the site complies with Rule 605.h.

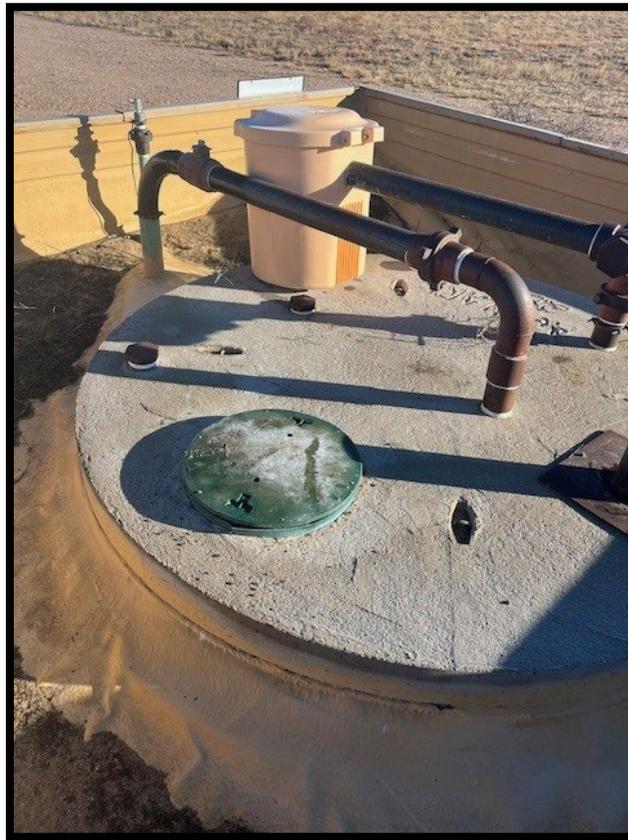
**Exhibit A**

**CA:** Tumbleweed Debris build-up at Maintenance Tank. Lid is open to Atmosphere. Comply Rule 606. Install or repair wildlife protection equipment. Prevent any unauthorized discharge (specify condition if it is E&P waste, improper disposal, trash, etc.) Per Rule 902.b.

**CA Resolution:** Operator has appropriately cleared tumbleweed debris to comply with Rule 606, and addressed open lid to prevent any unauthorized discharge to comply with Rule 902.b
