Inspection Photos

Operator: CAERUS PICEANCE LLC #10456

Location ID: 334617

Inspection Doc: 696205515

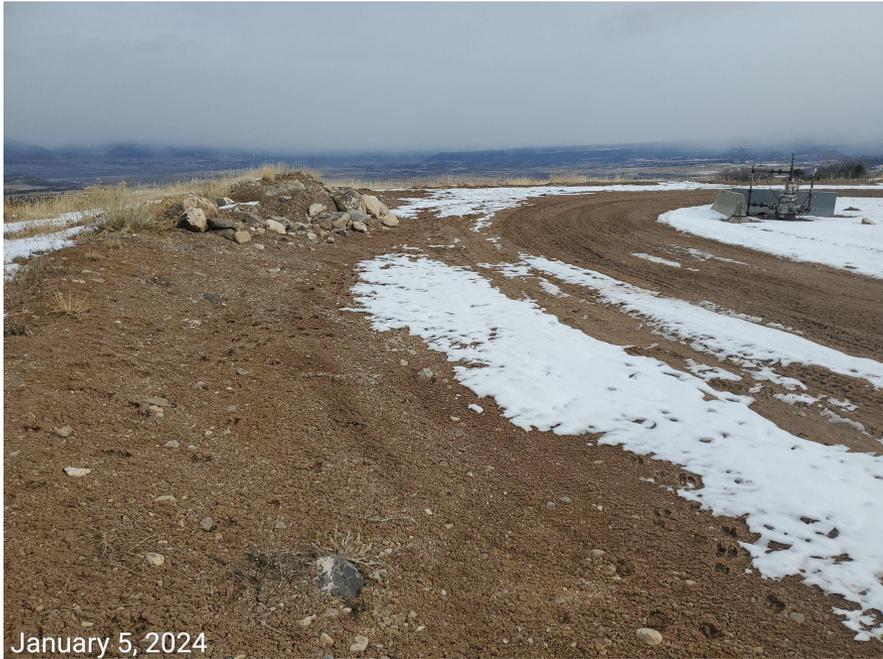
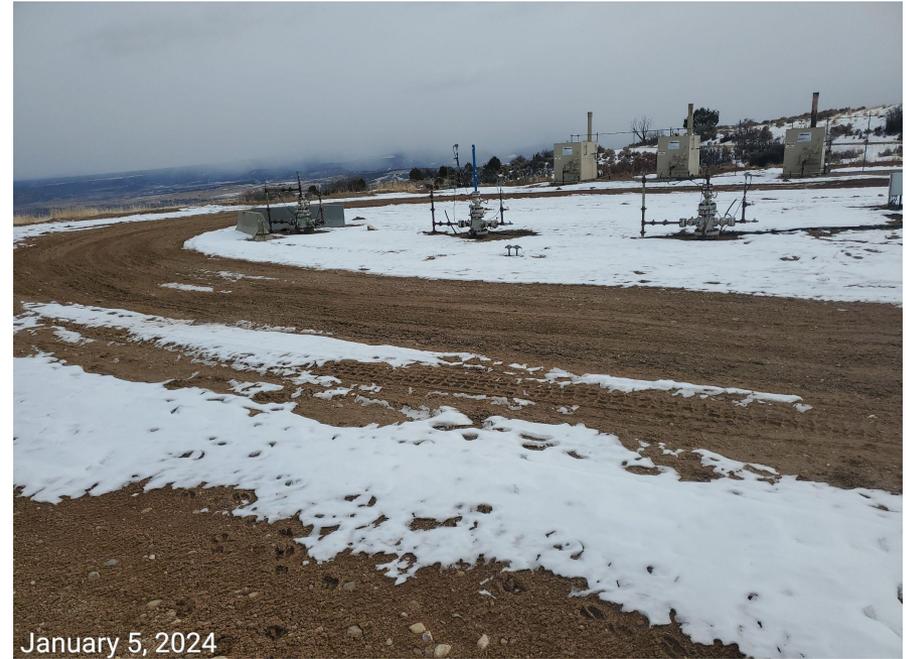
Photo 1: Photos 1-2 taken from the western working pad surface of the Location. Photos provide an overview of the Location from north, northeast, southeast to south.

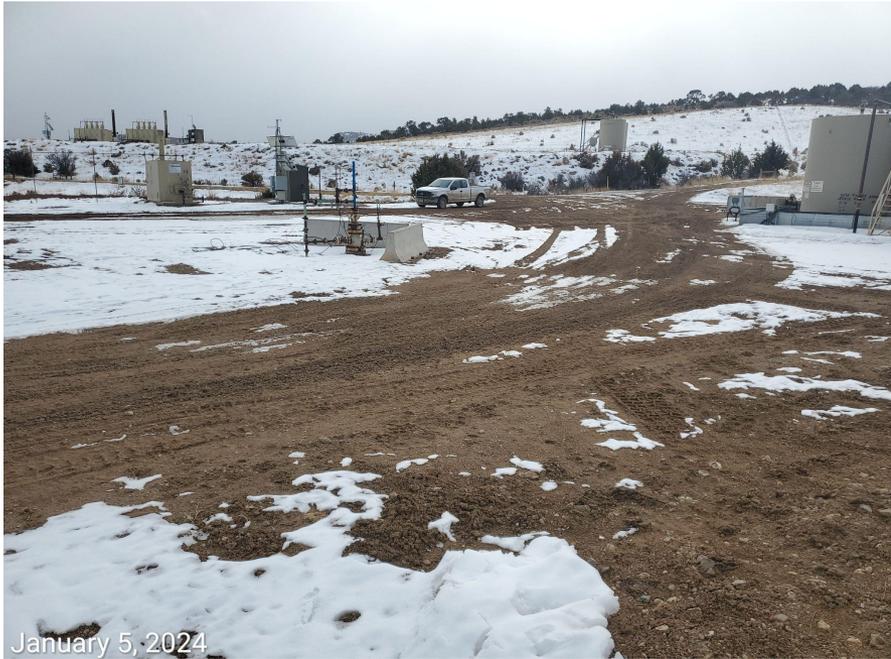
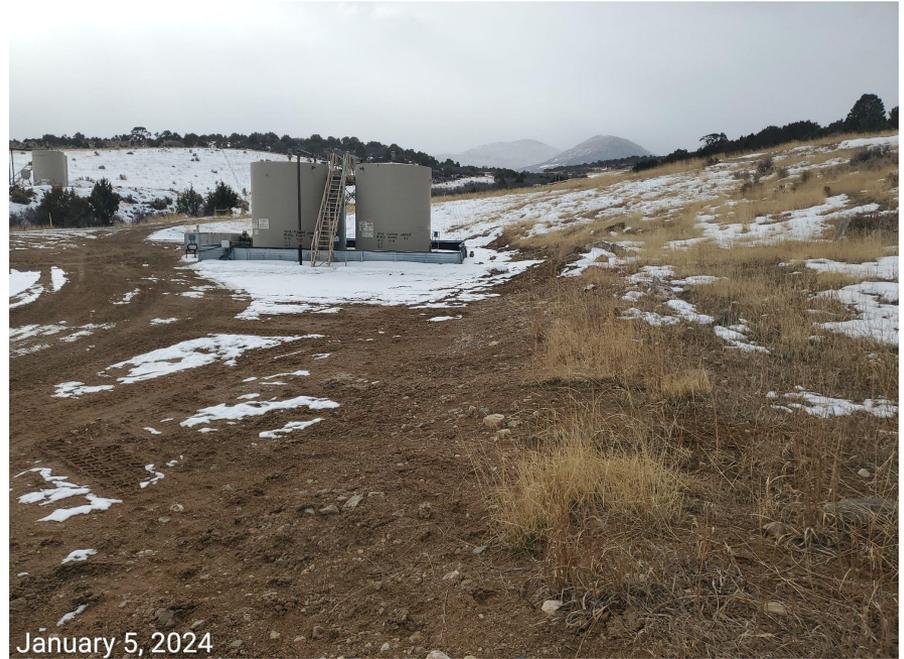
Photo 2: See comments under photo 1.

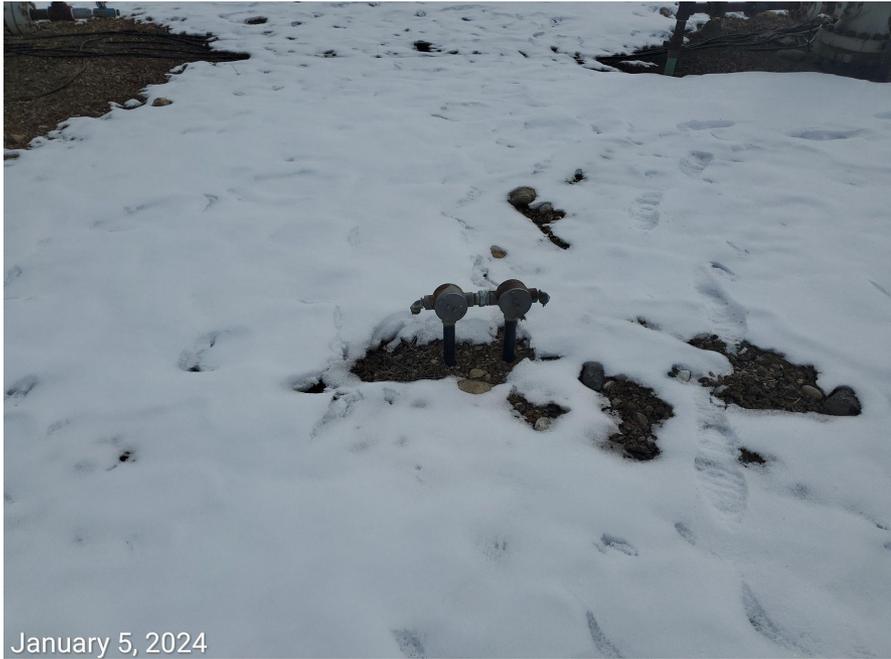
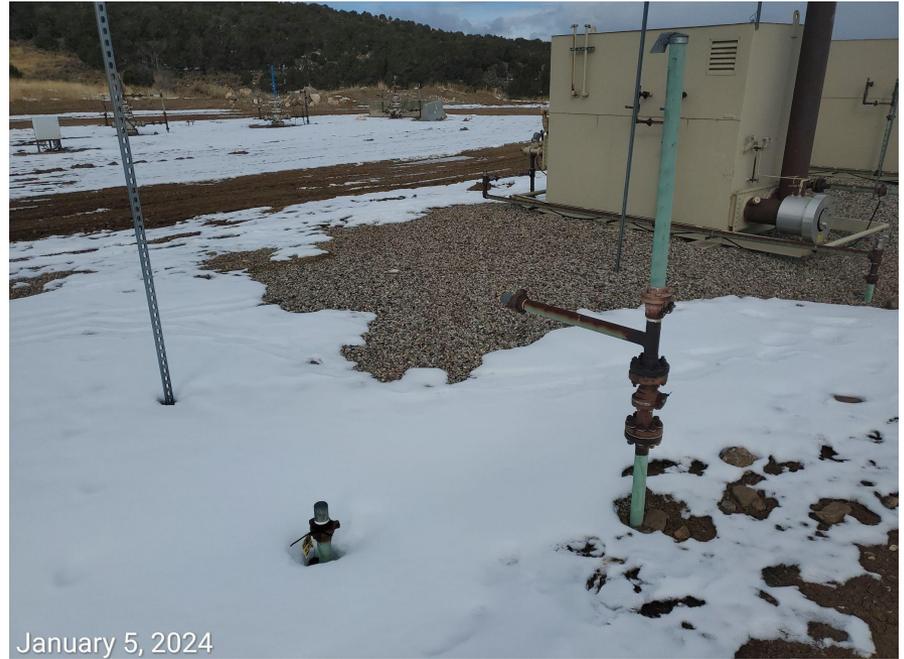
Photo 3: Unused equipment

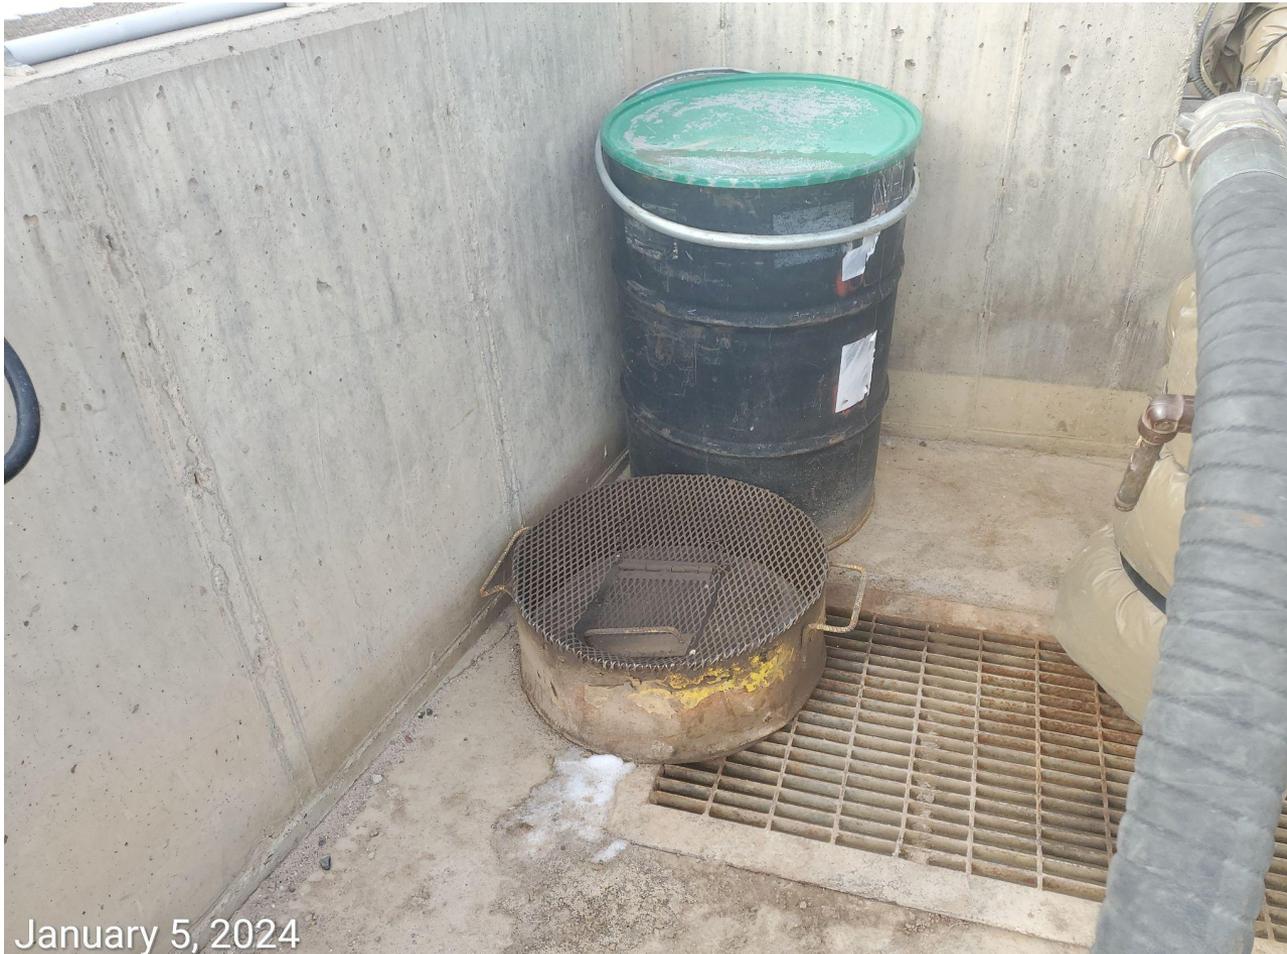
Photo 4: Unused container/drum/equipment.

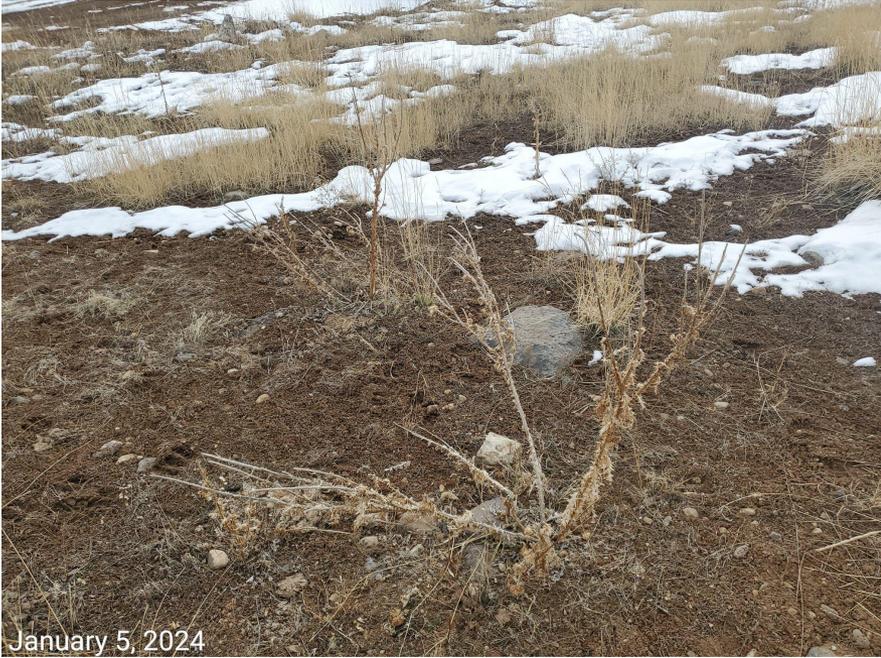
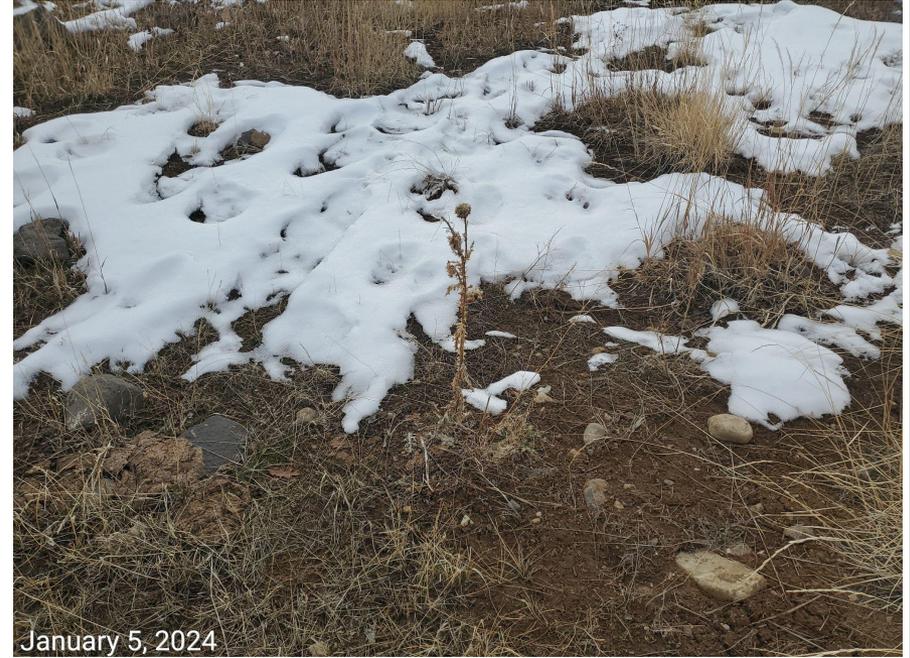
Photo 5: Photos examples showing noxious weeds (musk thistle) observed established within the interim areas of the Location.

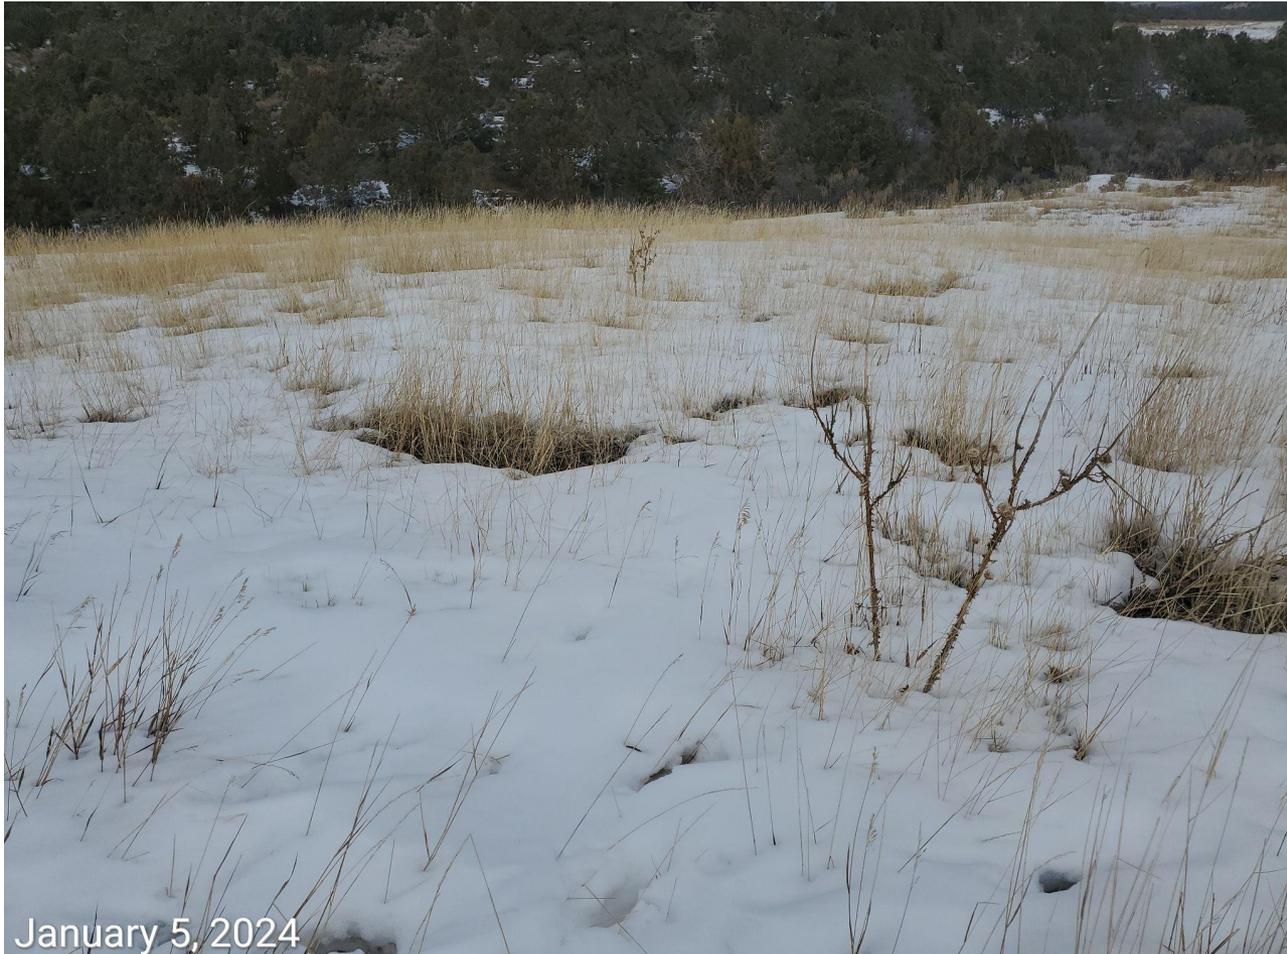
Photo 6: See comments under photo 5.

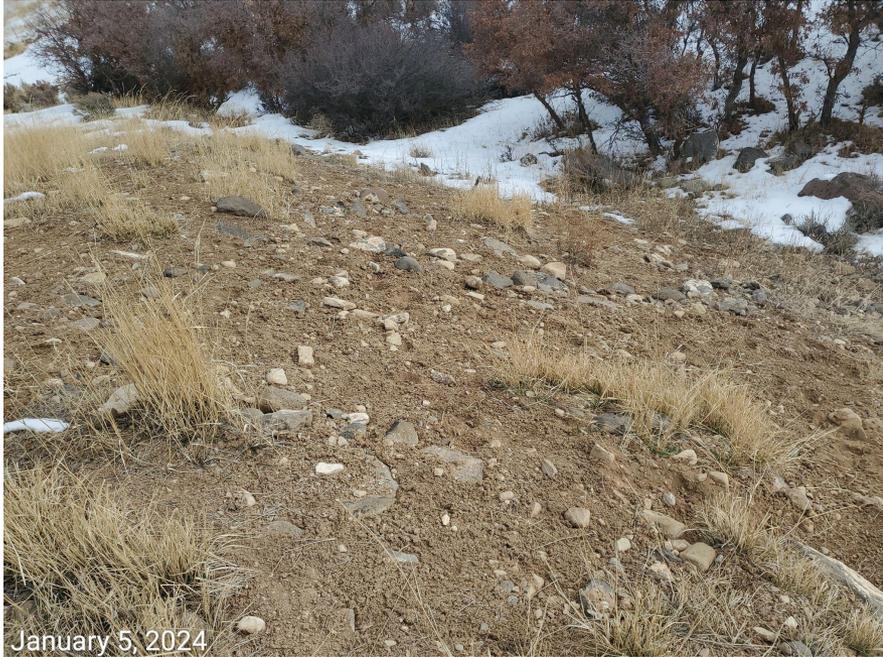
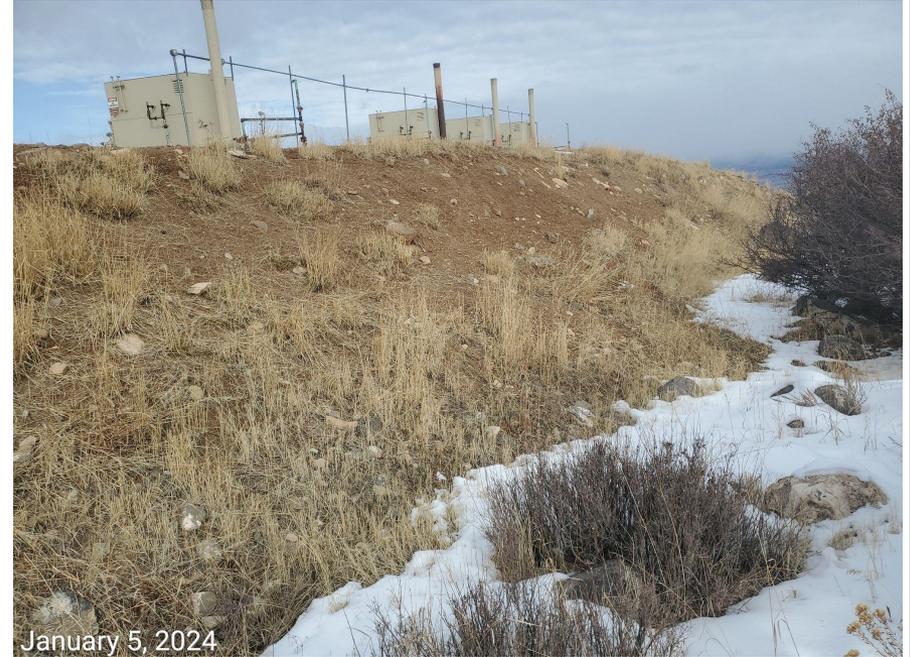
Photo 7: Photo taken from the slopes on the east end of the Location. Photos examples showing areas not progressing towards 1003 uniform, desirable perennial vegetative requirements.

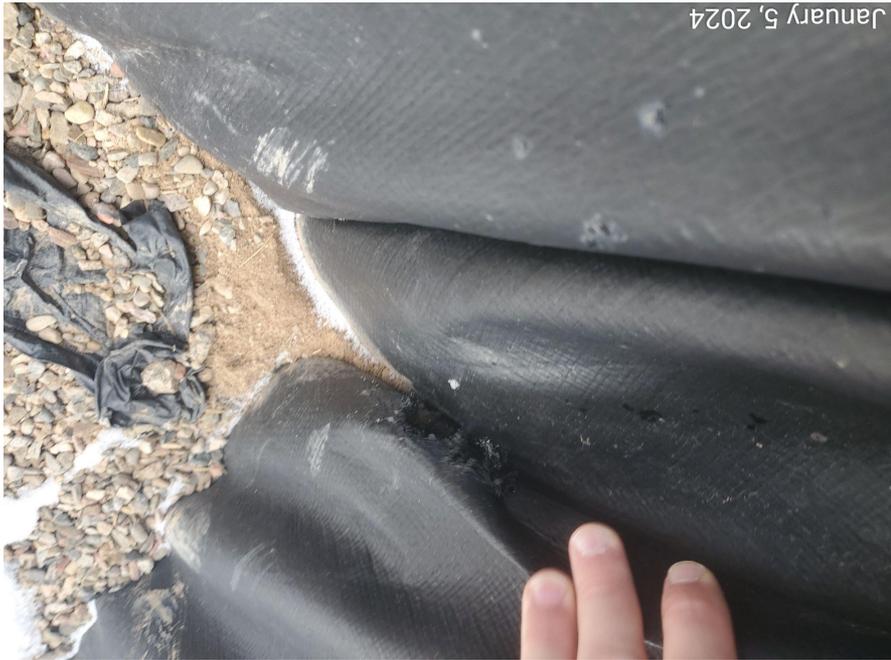
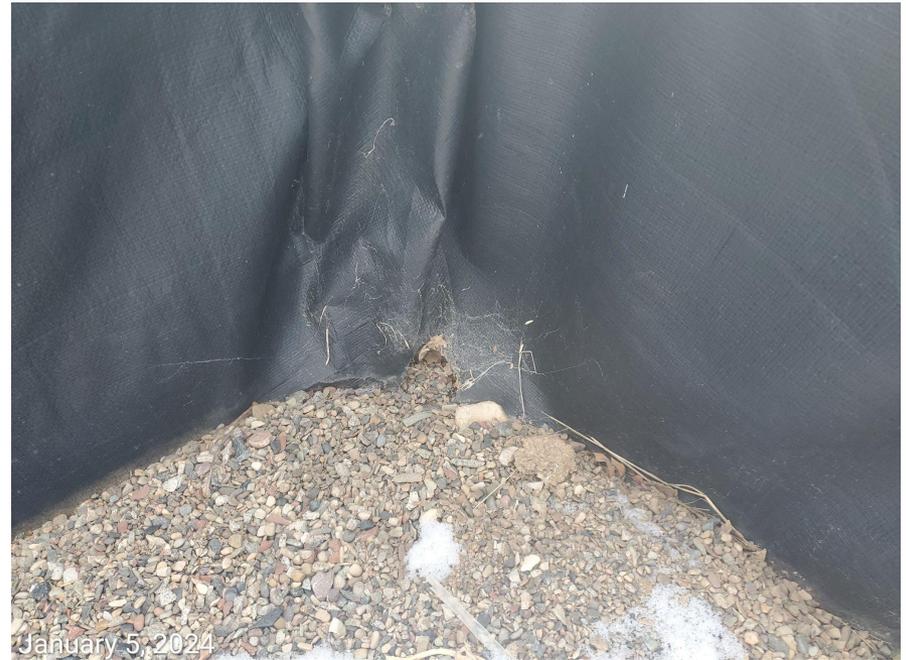
Photo 8: Containment liner no longer impervious to contain a spill or release. Photos examples showing holes within liner.

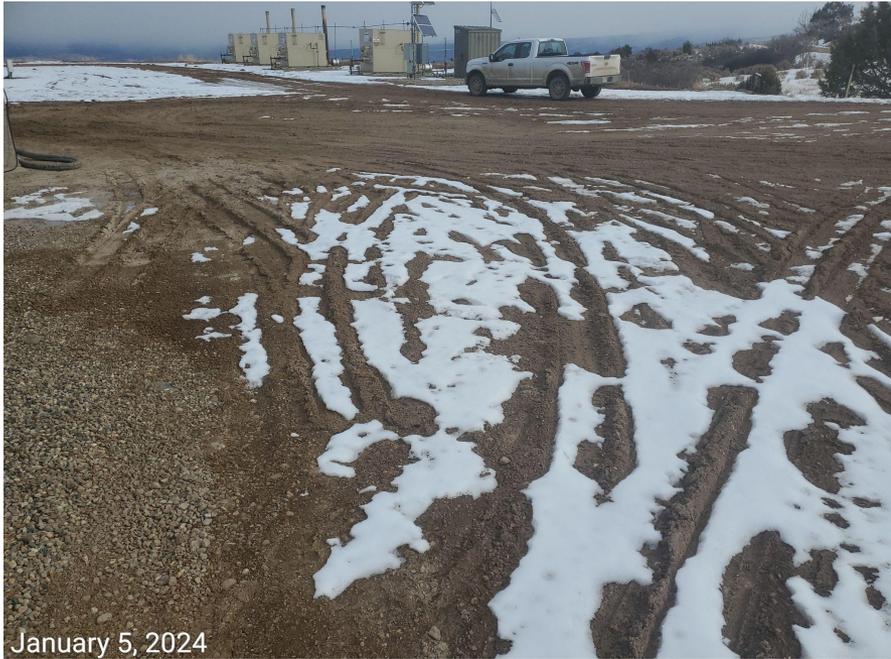
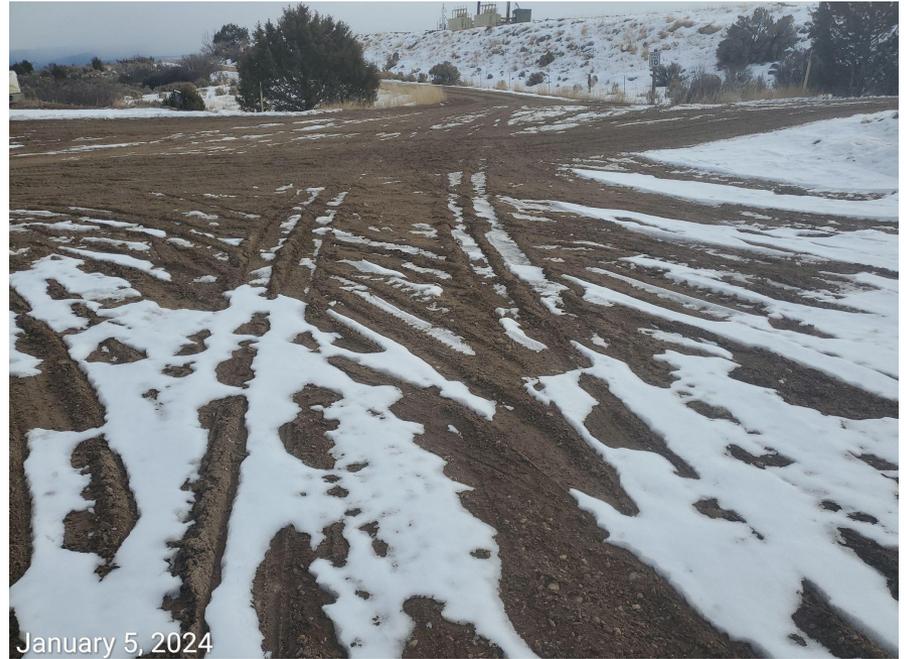
Photo 9: Working pad surface lacks stabilization. Tracking controls no longer in proper functioning condition. Track-out measures (such as a tracking pad) not observed.
