Final Reclamation and Stormwater Inspection

Date: 01/03/2024

Location ID: 313649

Inspection Photos
Location Name: Sand River Unit 9
Location ID: 313649

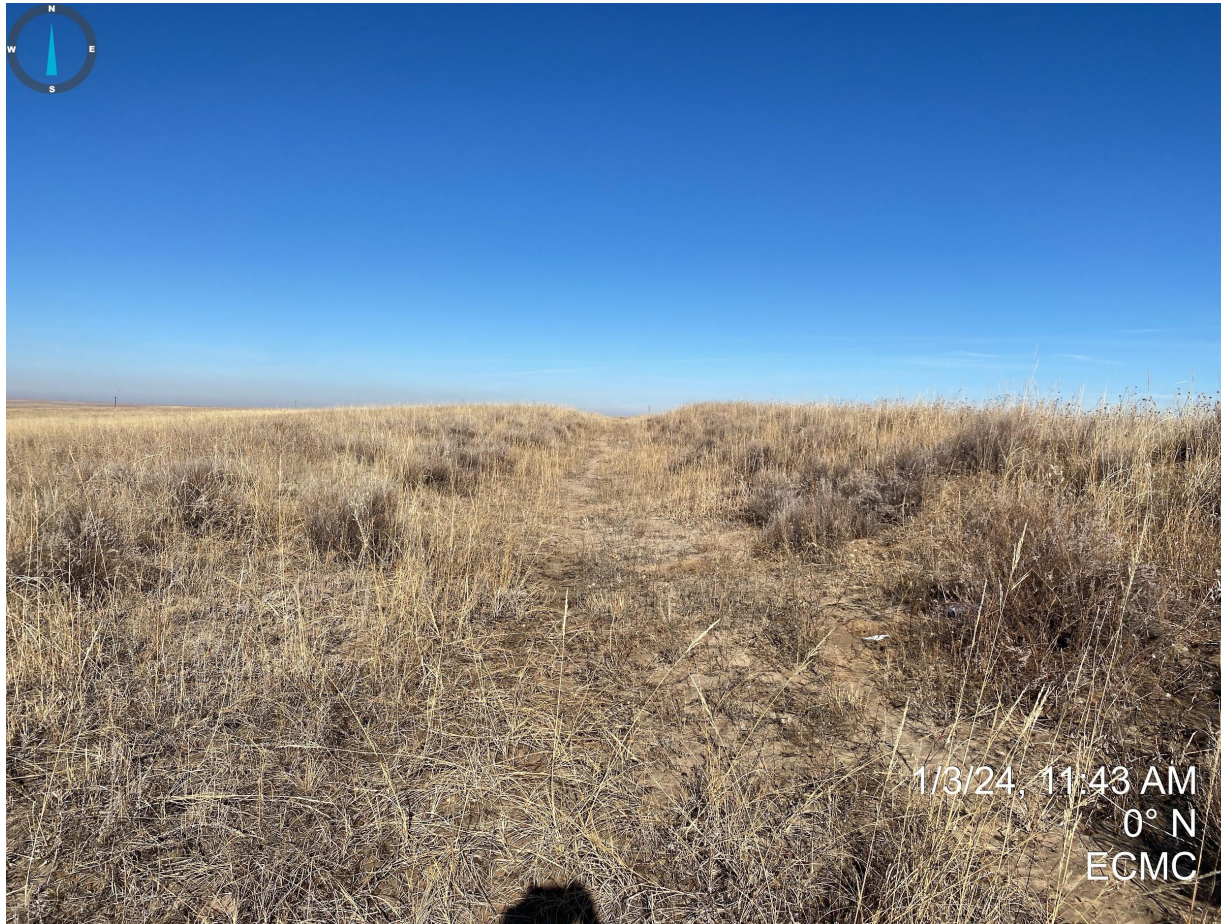
Photo 1. Taken from the access road, south of the location. Photo illustrates that the access road has not been regraded or contoured to reflect adjacent reference areas, or pre-disturbance conditions. Additional reclamation activities are required.

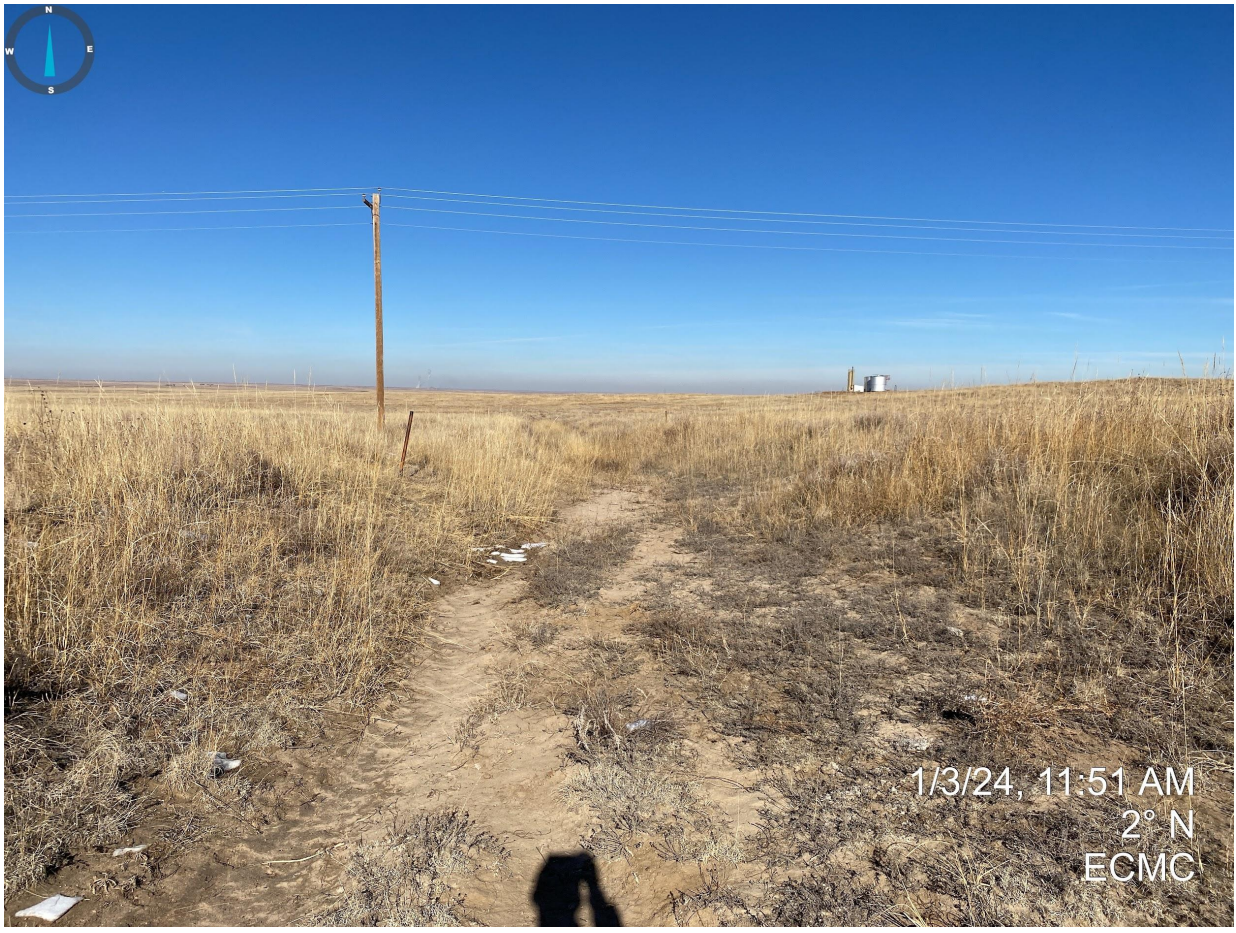
Photo 2. Taken from the access road north of the location. See comments in Photo 1.

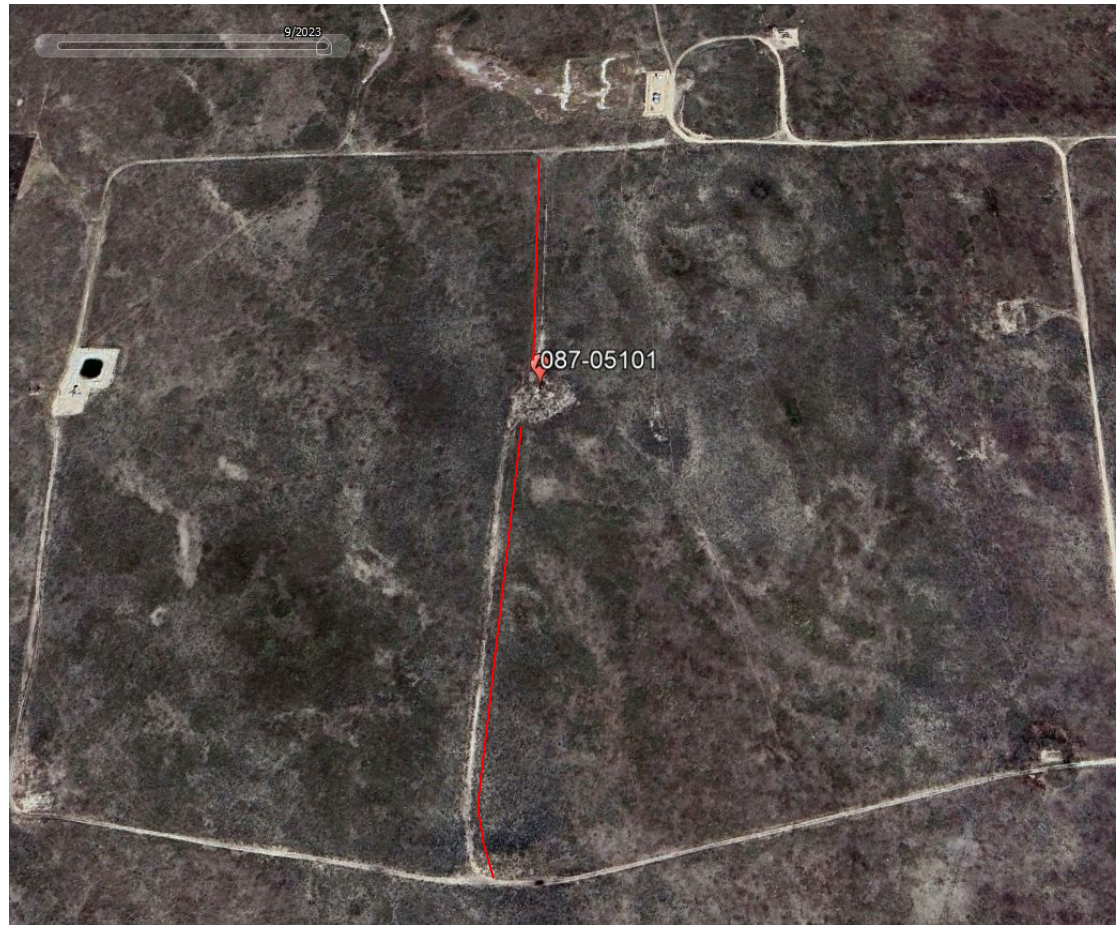
Photo 3. Google Earth aerial imagery taken circa 09/2023. Photo illustrates the access roads, highlighted in red, that require additional reclamation activities (e.g. contouring, regrading, revegetation, etc).

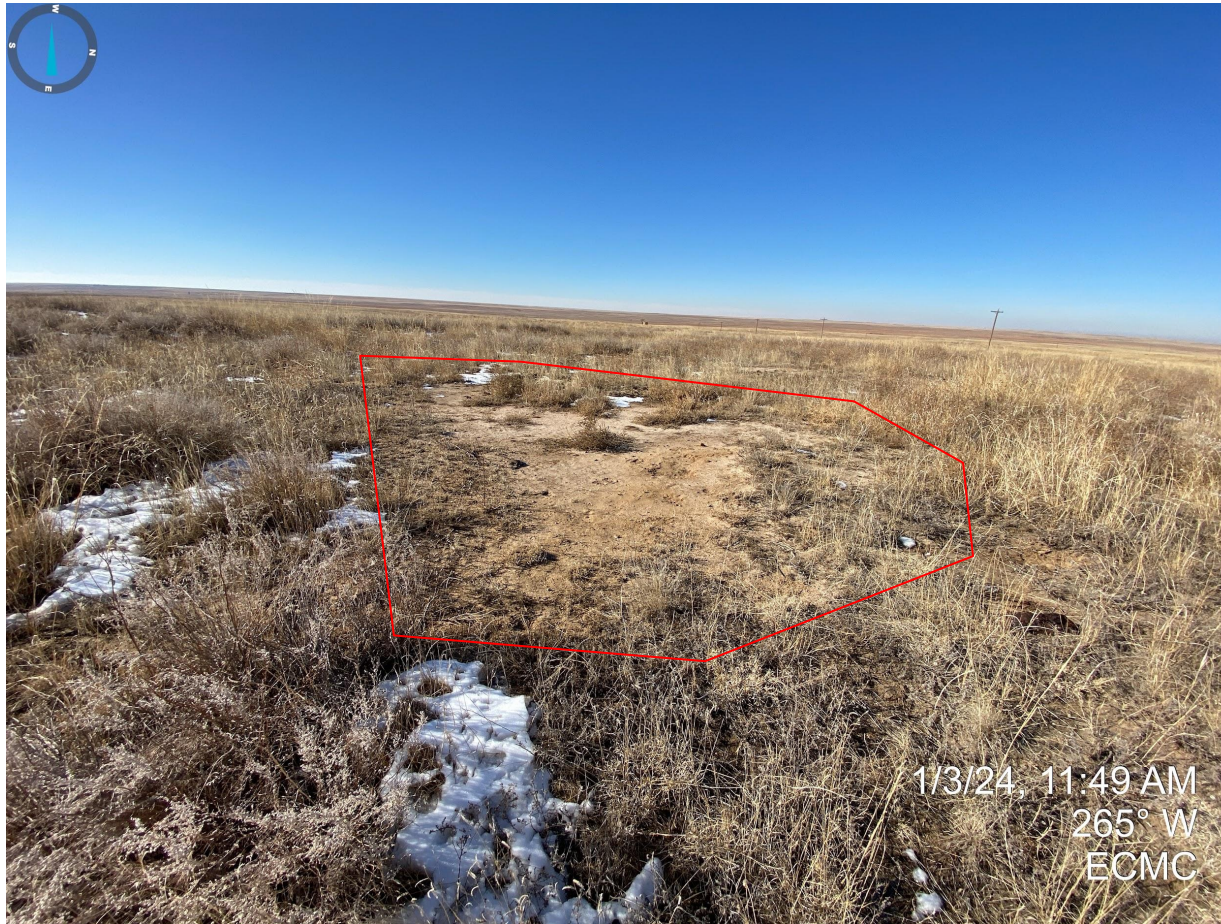
Photo 4. Taken from the eastern portion of the location, facing west. Non-uniform vegetation cover resulting in bare/exposed soils highlighted in red.

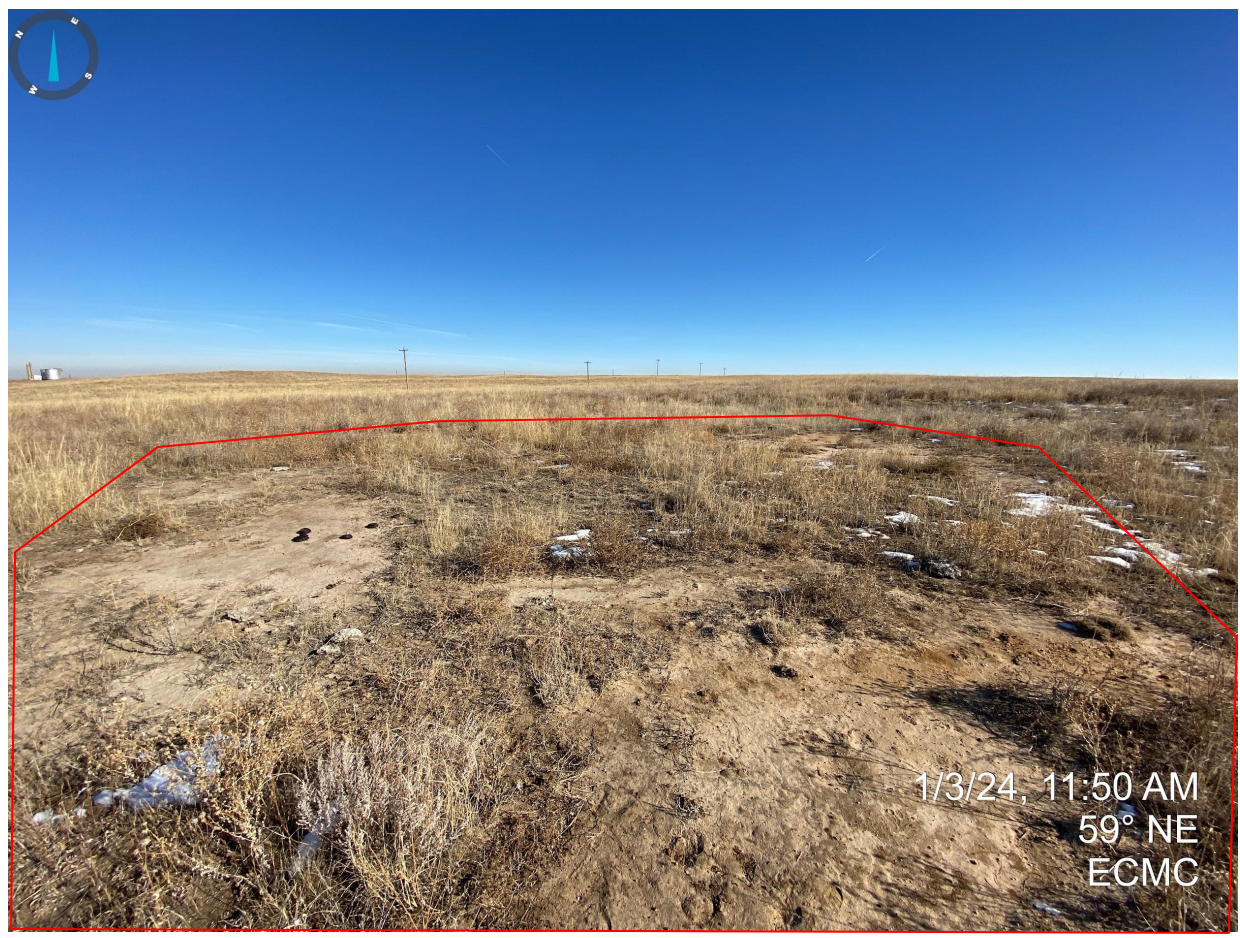
Photo 5. Taken from the western portion of the location, facing northeast. See comments in Photo 4.

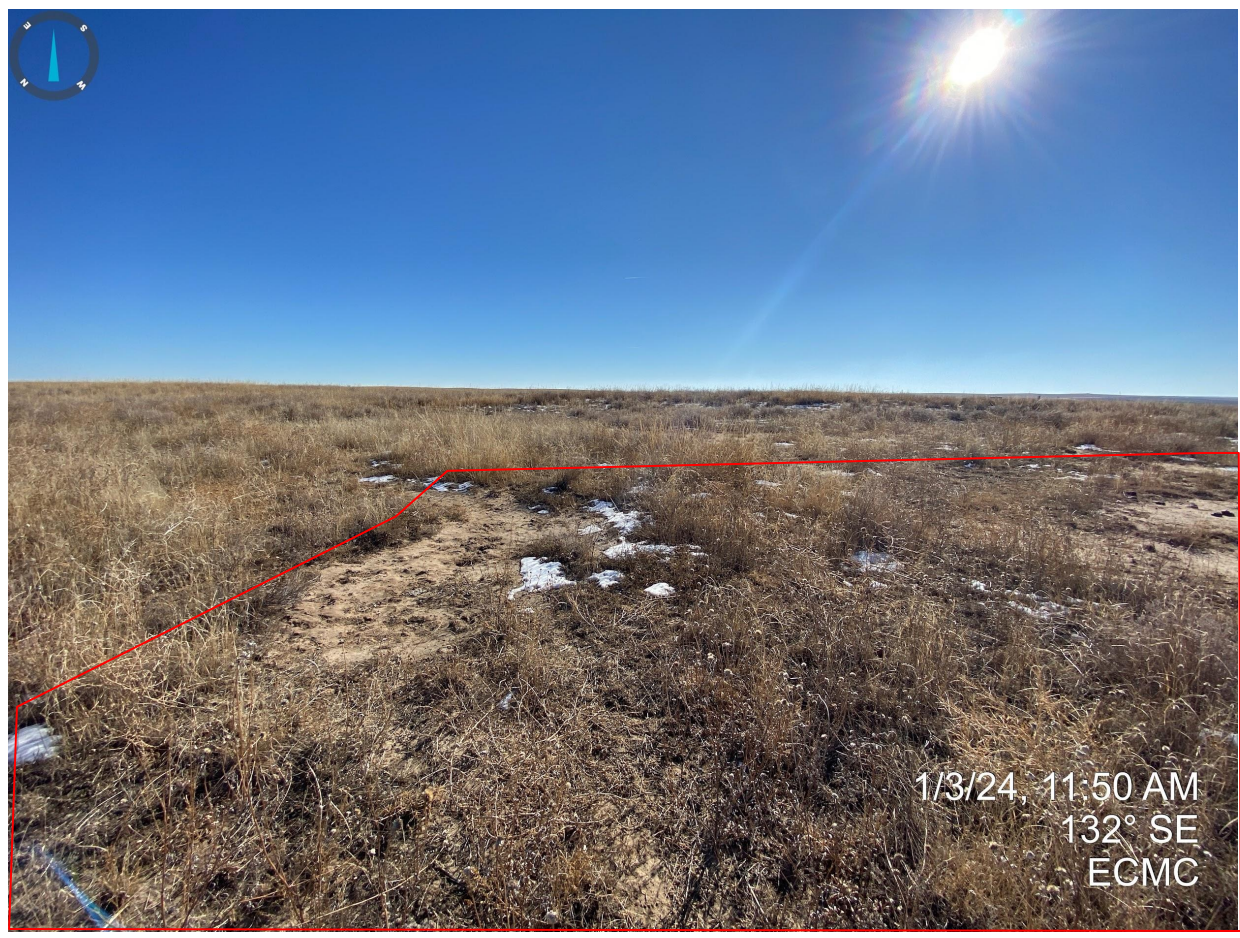
Photo 6. Taken from the northern portion of the location, facing southeast. See comments in Photo 4.
