Final Reclamation and Stormwater Inspection

Operator: WESTERN OPERATING COMPANY - 95620

Location ID: 313653

Inspection Photos
Location Name: Sand River 7
Location ID: 313653

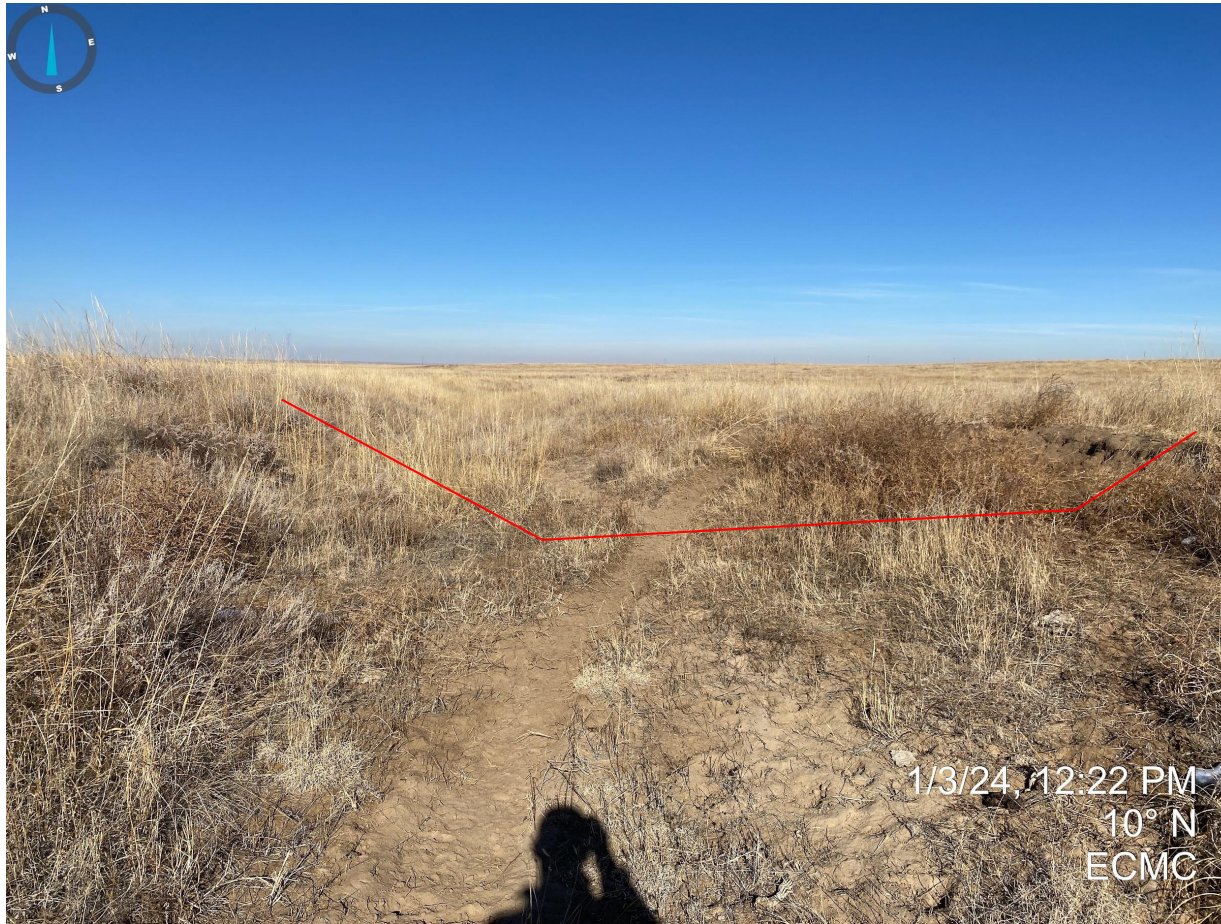
Photo 1. Taken from the start of the southern access road. The access road has not been reclaimed as it has not been regraded and/or contoured to reflect adjacent reference area, or pre disturbance conditions. Red line illustrates contouring issues.

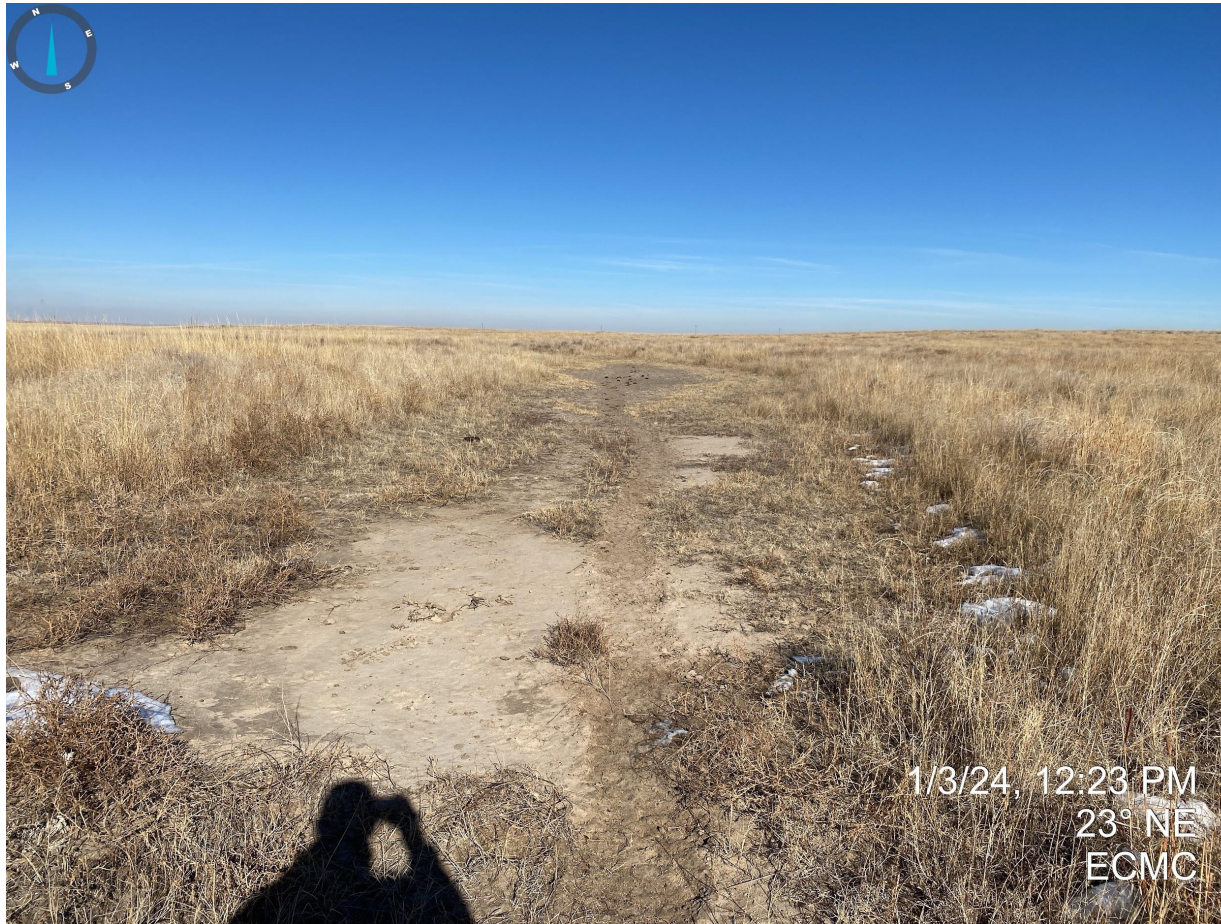
Photo 2. The access road, east of the former well location has not been reclaimed as evidence by bare/exposed soils and contouring/grading issues.

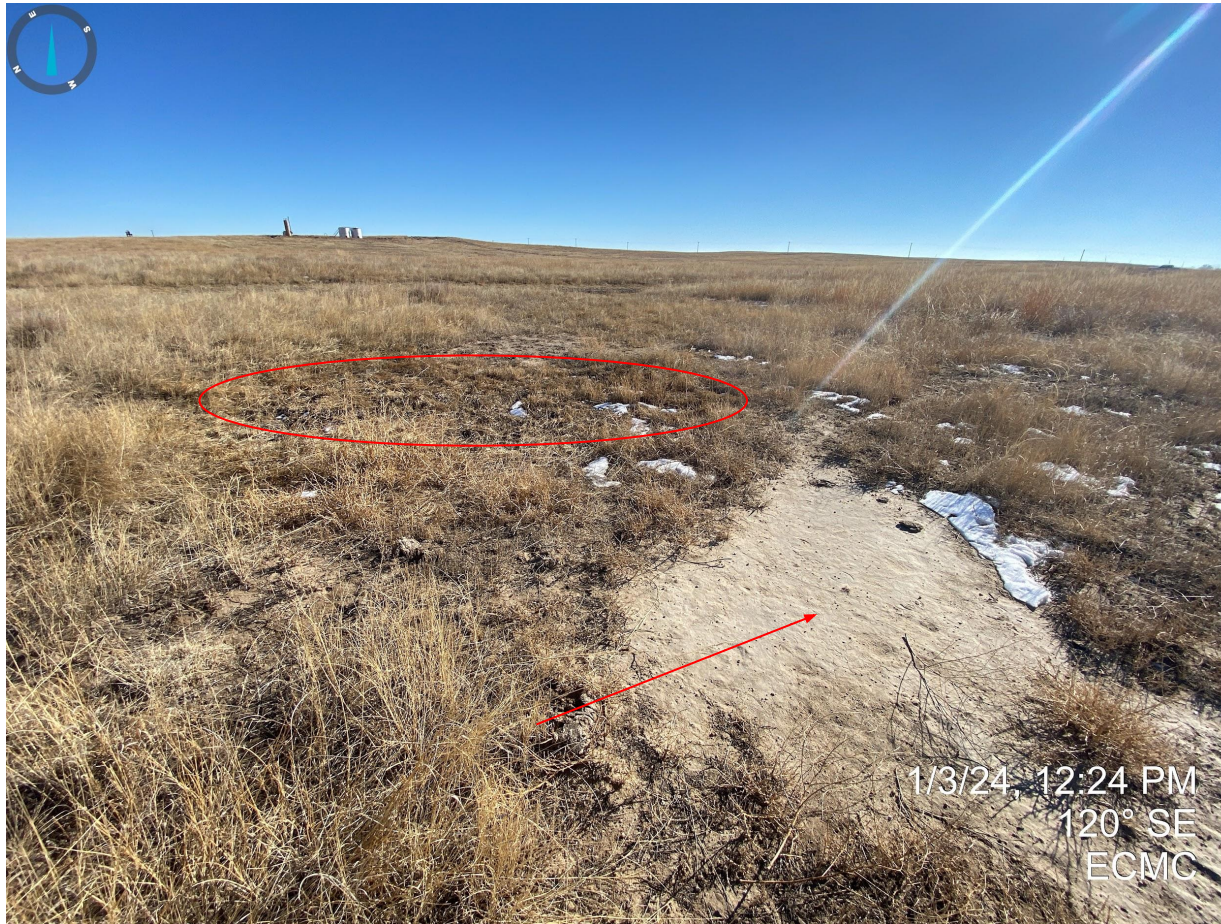
Photo 3. Subsidence (red circle) and bare soil (red arrow) issues at the former wellhead.

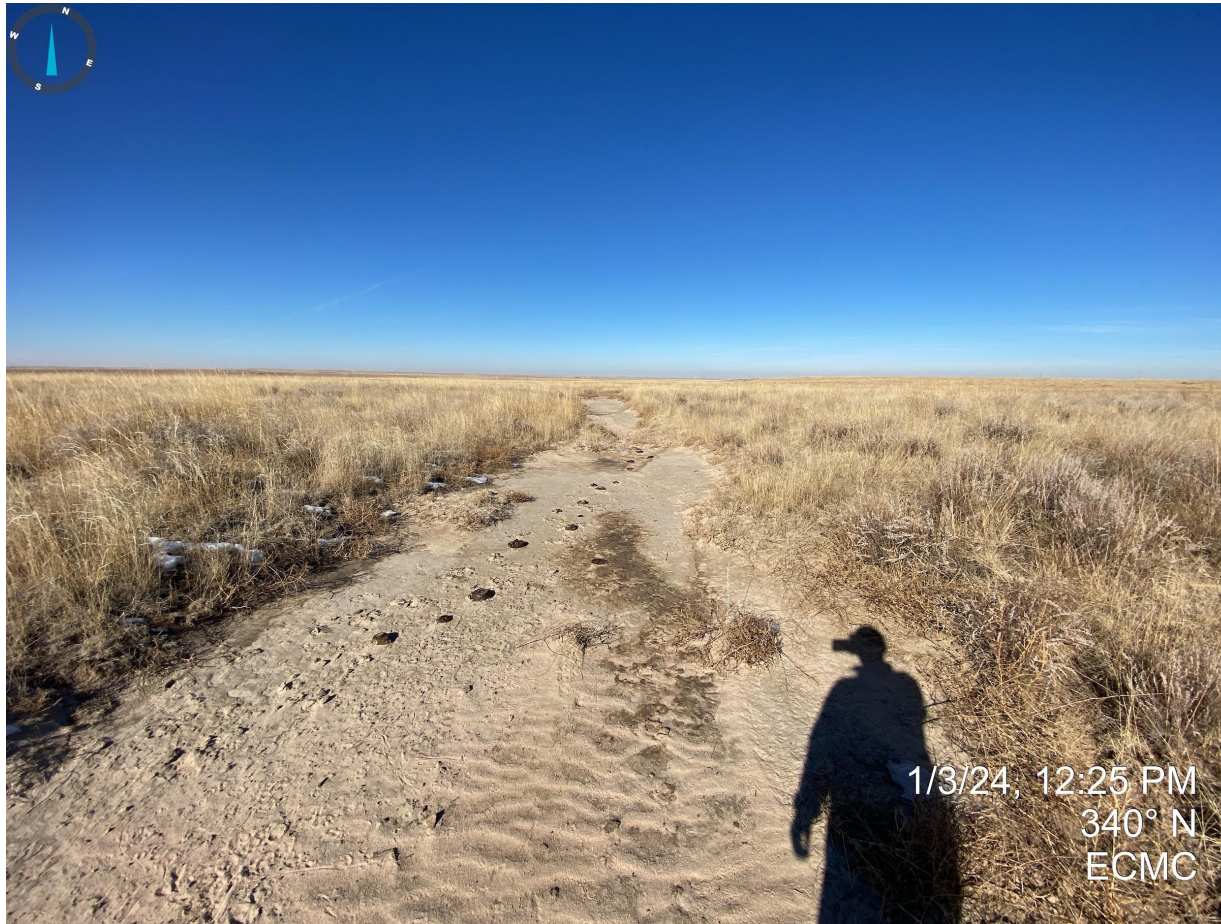
Photo 4. The access road, north of the former well location has not been reclaimed as evidence by bare/exposed soils and contouring/grading issues.

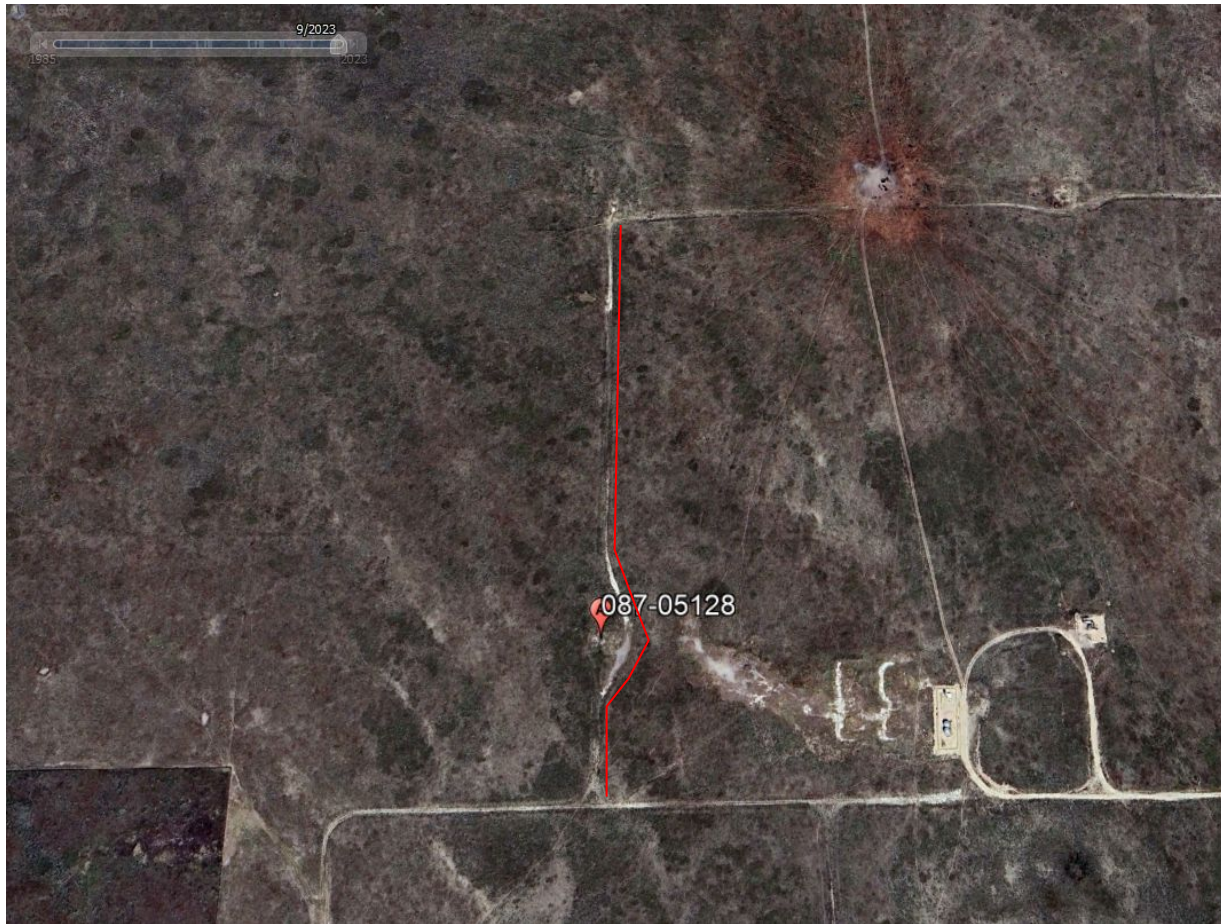
Photo 5. Google Earth aerial imagery (circa 09/2023) illustrates the access roads which have not been reclaimed (red arrow).
