Final Reclamation and Stormwater Inspection

Operator: WESTERN OPERATING COMPANY - 95620

Location ID: 313656

Inspection Photos
Location Name: Sand River #4
Location ID: 313656

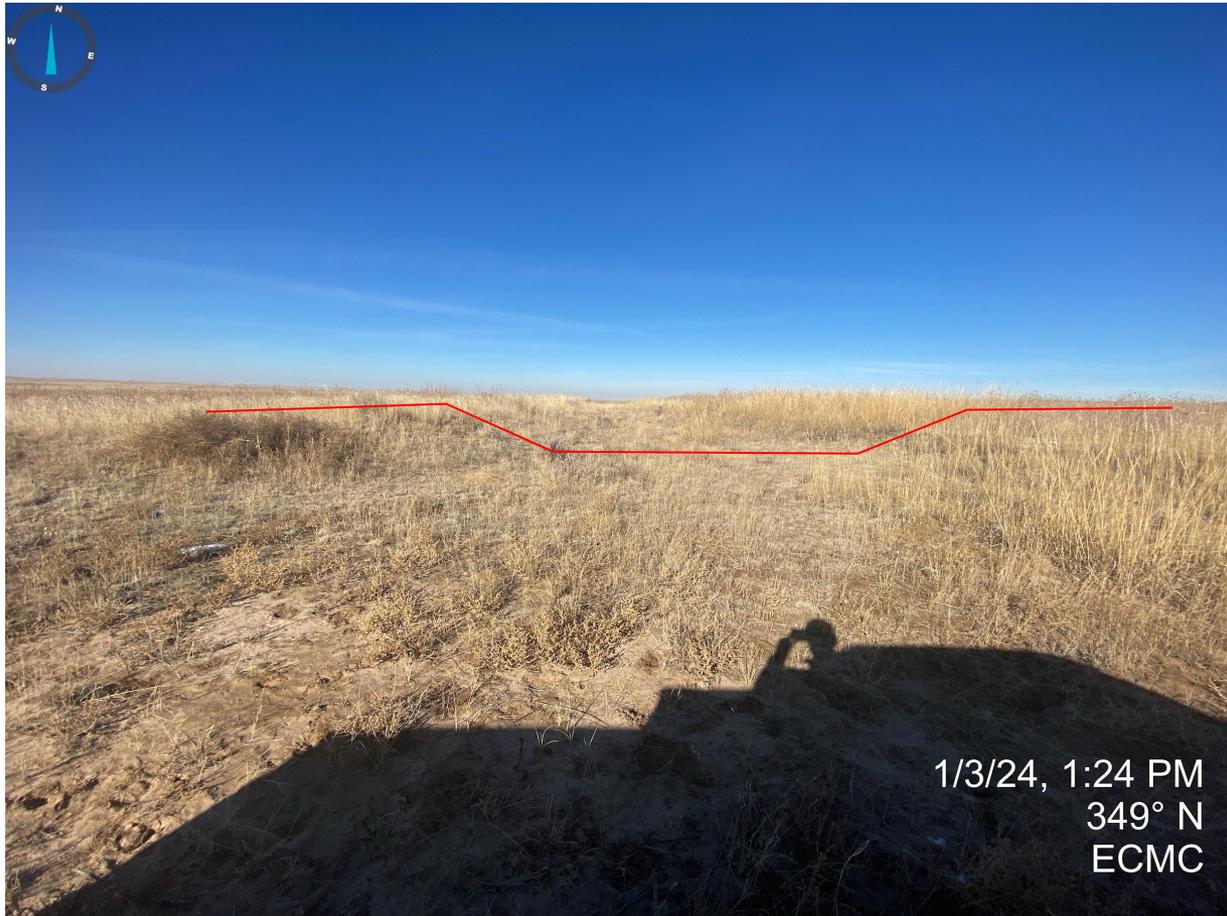
Photo 1. Taken from the location entrance. Photo illustrates that the access road has not been regraded or contoured to reflect adjacent reference areas, or pre-disturbance levels.

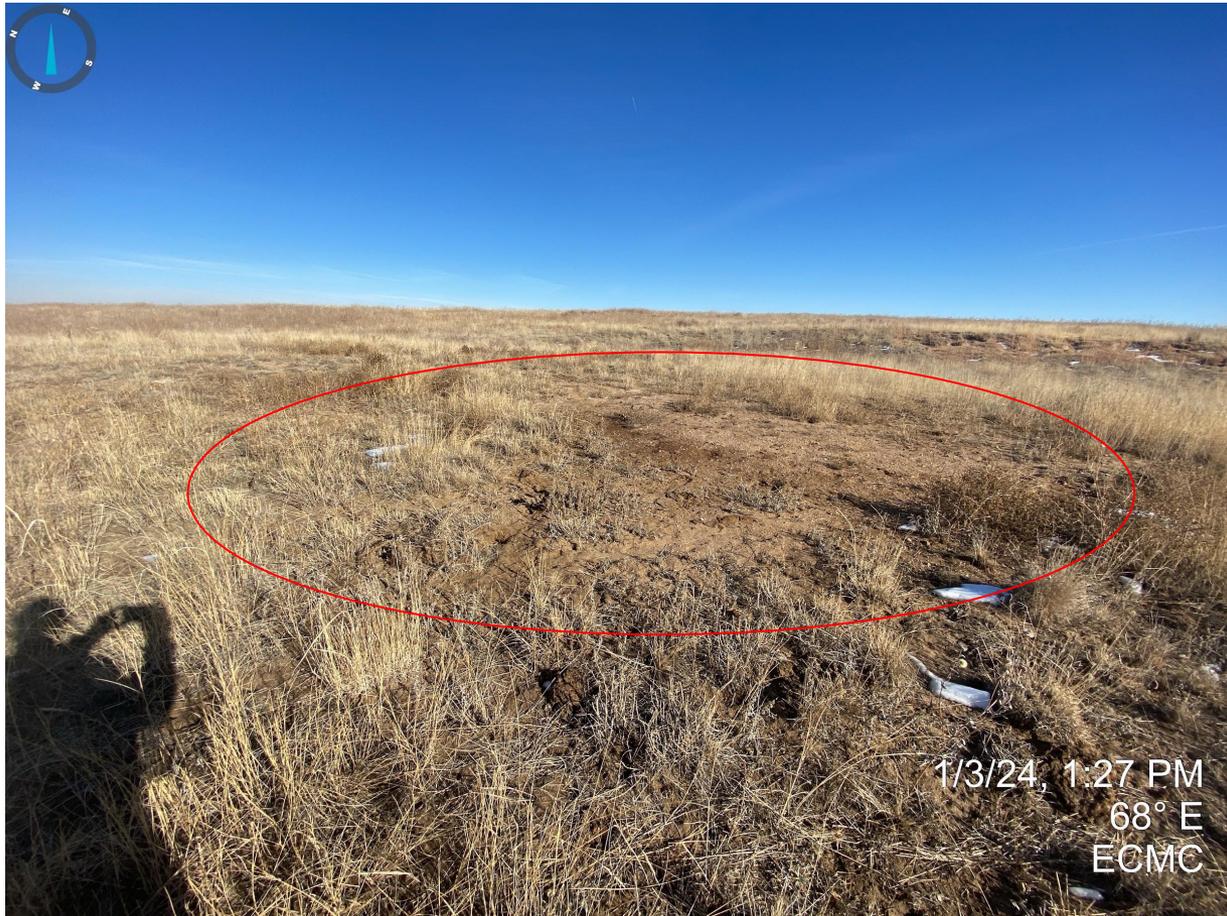
Photo 2. South of the former well location. It does not appear that any reclamation activities have occurred since the previous inspection. The location is still experiencing areas of non-uniform vegetation cover (bare/exposed soils) and undesirable vegetation.

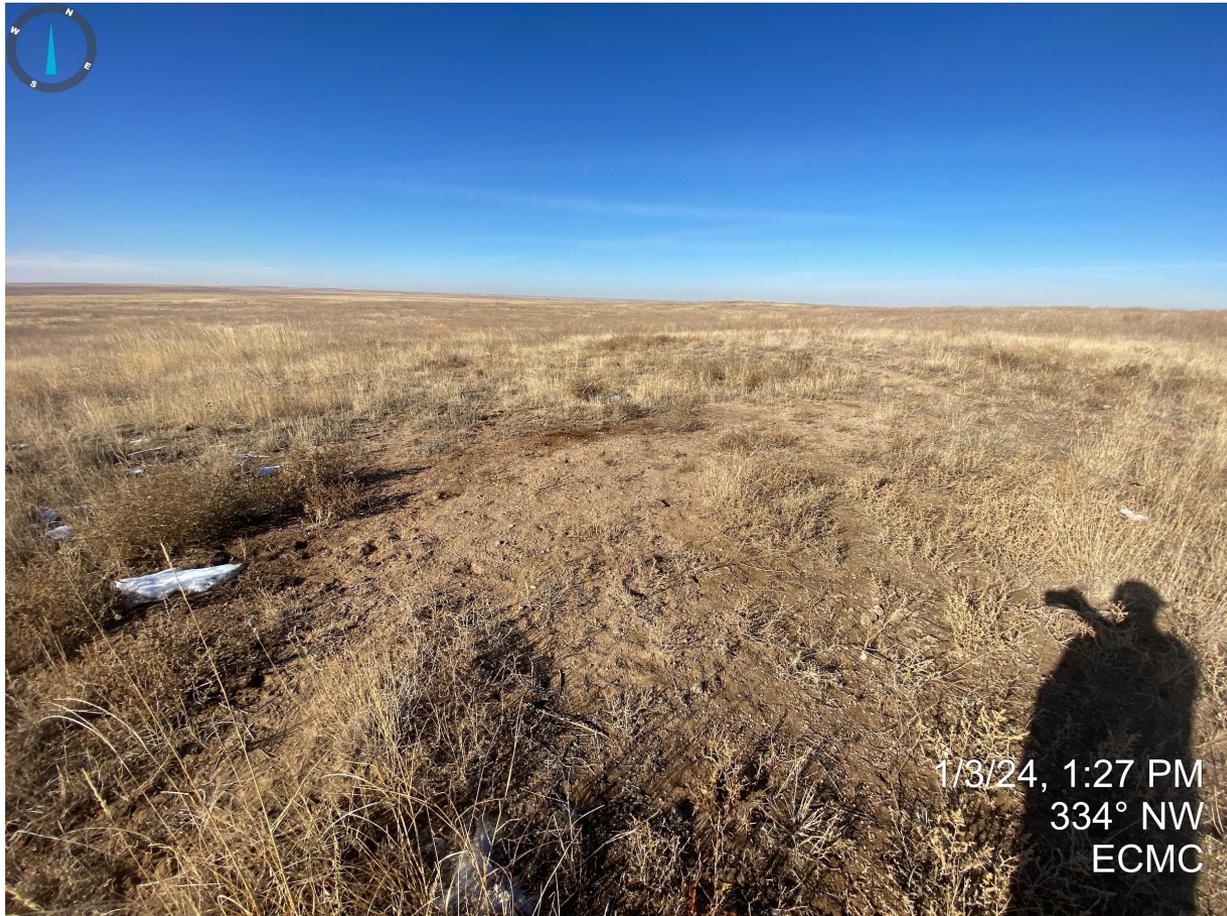
Photo 3. South end of former well location; see comments in Photo 2.

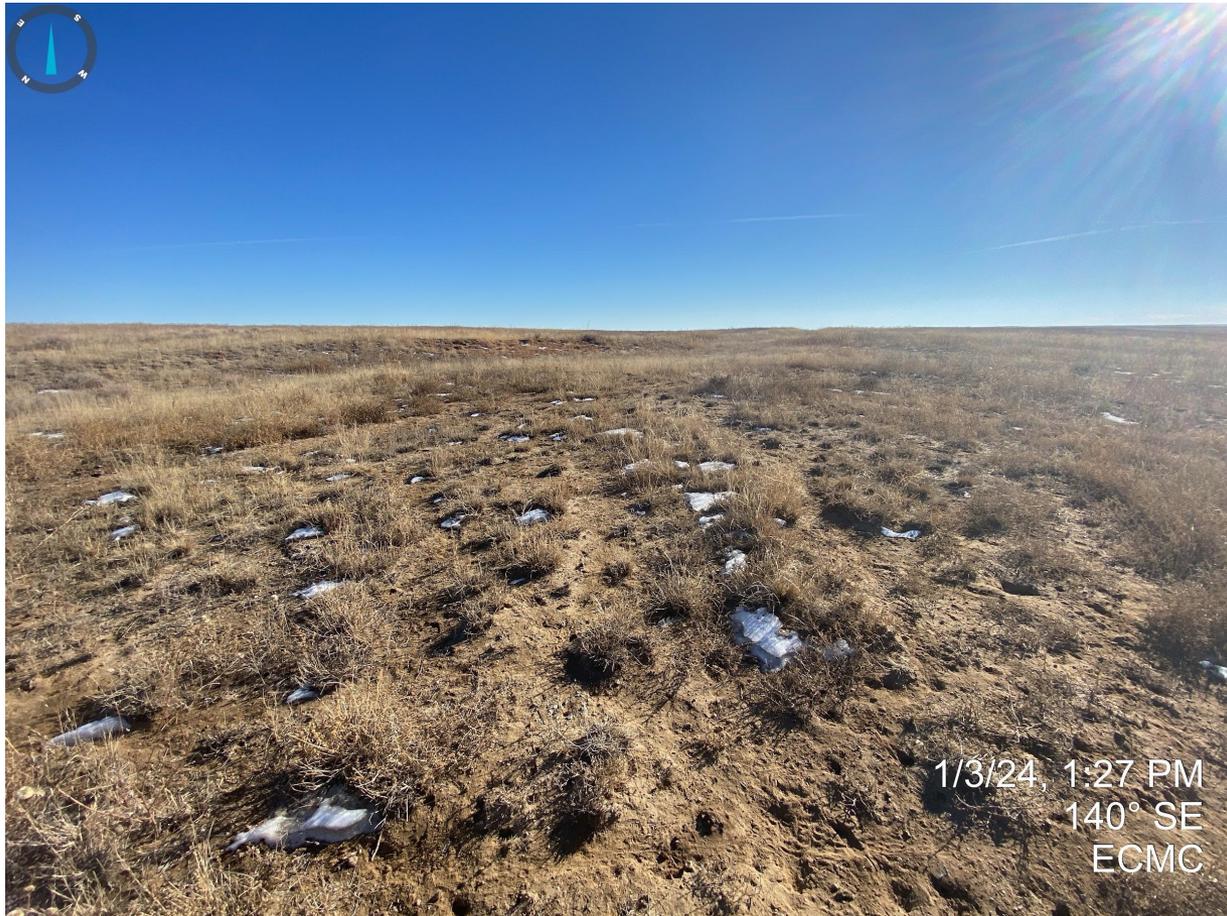
Photo 4. North end of former well location; see comments in Photo 2.

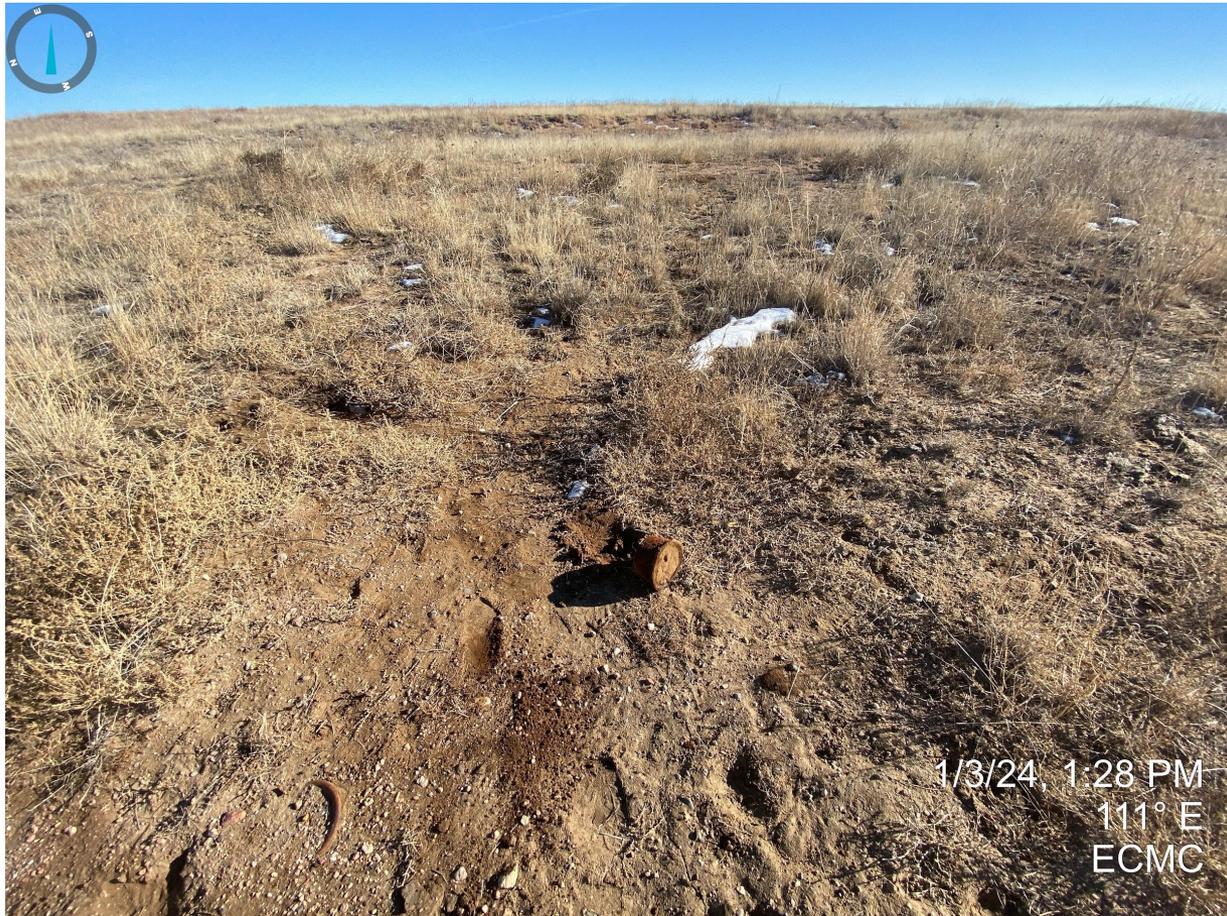
Photo 5. Bare soils, metal debris and undesirable vegetation (e.g. kochia and russian thistle) observed near former wellhead.

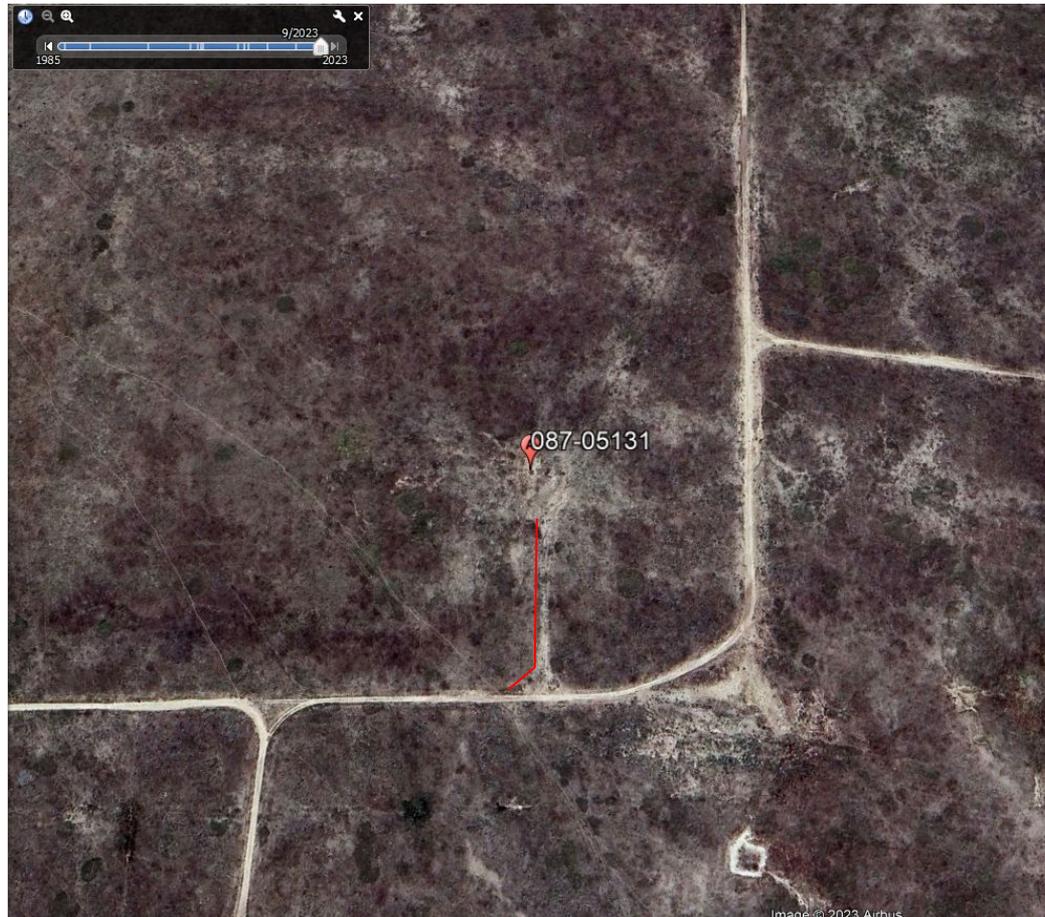
Photo 6. Google Earth aerial imagery (circa 09/2023) illustrating the portion of the access road (red outline) that will need to be reclaimed per 1004 rules.
